# Christian's Minde Settlement, Jervis Bay Territory

Historic Heritage Management Plan—Volume 2 Inventories

June 2025

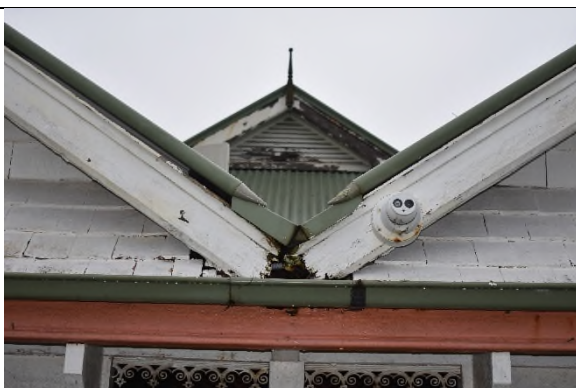
Figure 41 Timber in poor condition, southwestern elevation.

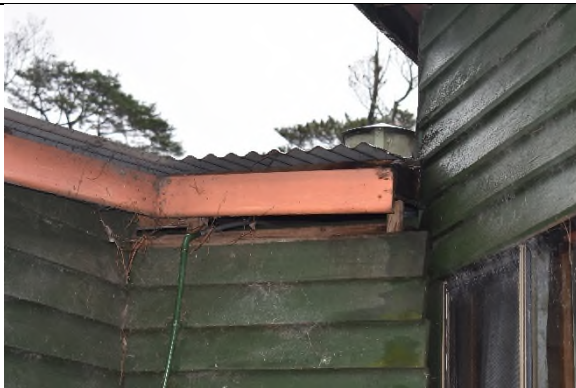
Figure 45 Loose fascia on southern elevation.

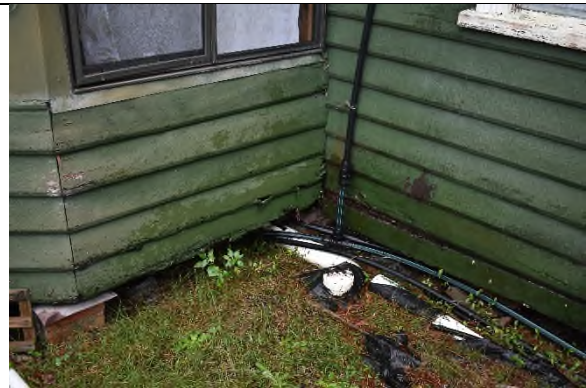
Figure 46 Weatherboards in poor condition on southern elevation.

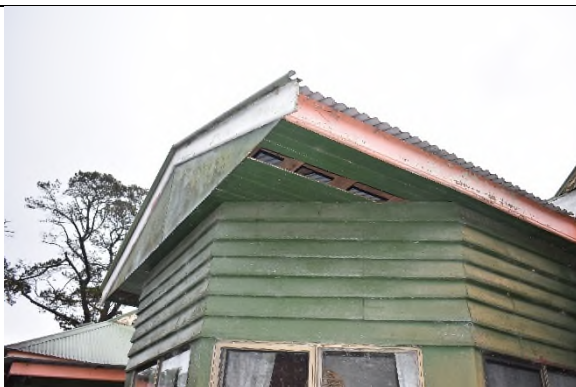
Figure 47 Missing soffit board on southern elevation.

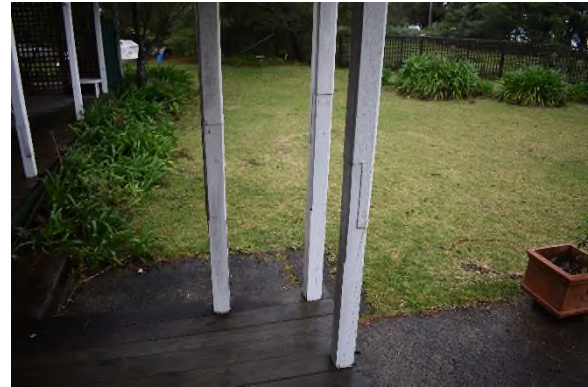
Figure 50 Previous repairs to verandah posts.

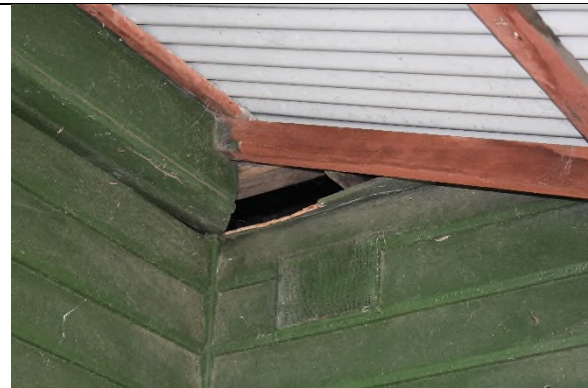
Figure 52 Missing external weatherboard.

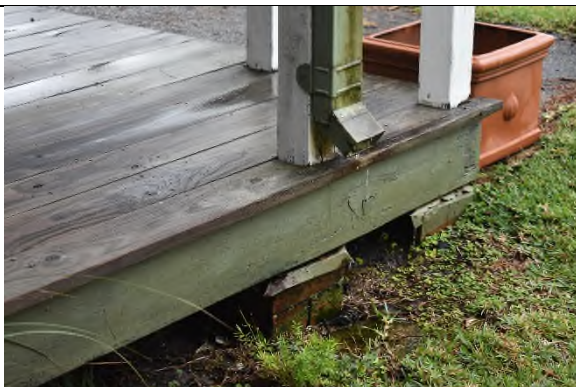
Figure 53 Downpipes draining directly to soil and building foundations.

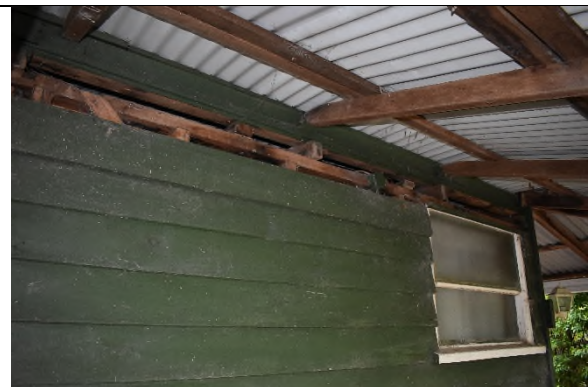
Figure 54 Missing external weatherboards.

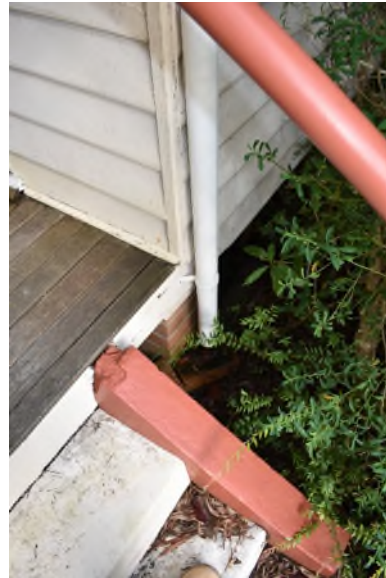
Figure 97 Downpipe draining directly to soil and foundations.

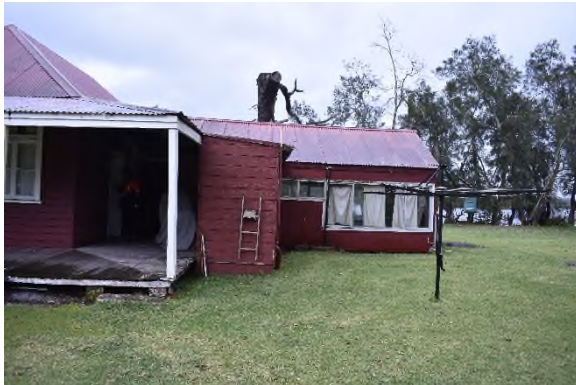
Figure 105 Northern end of eastern elevation, showing cardroom on lean and in poor condition.

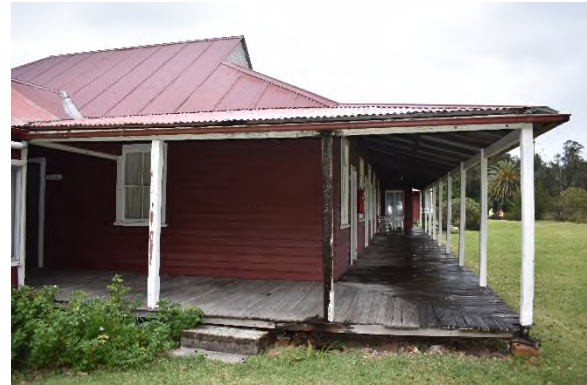
Figure 106 Northwestern corner, showing decaying verandah posts, loose gutter and verandah boards in poor condition.

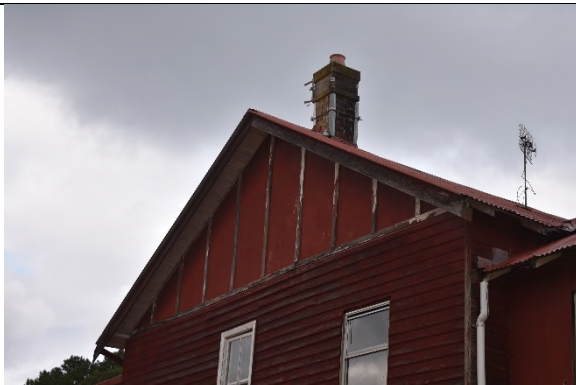
Figure 107 Detail of southern end, with chimney secured by metal straps and gable end cladding in poor condition.

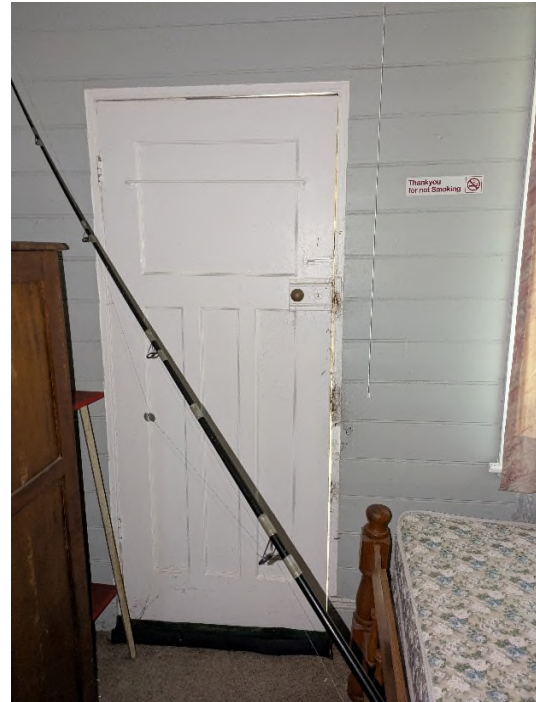
Figure 112 Internal door to western verandah.  
Note spiderwebs and door does not hang flush.

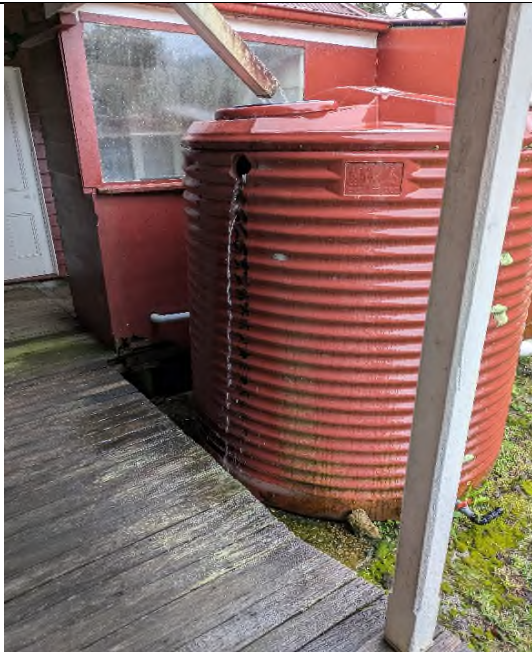
Figure 113 Water tank overflowing directly to the verandah decking, posts and building foundation.

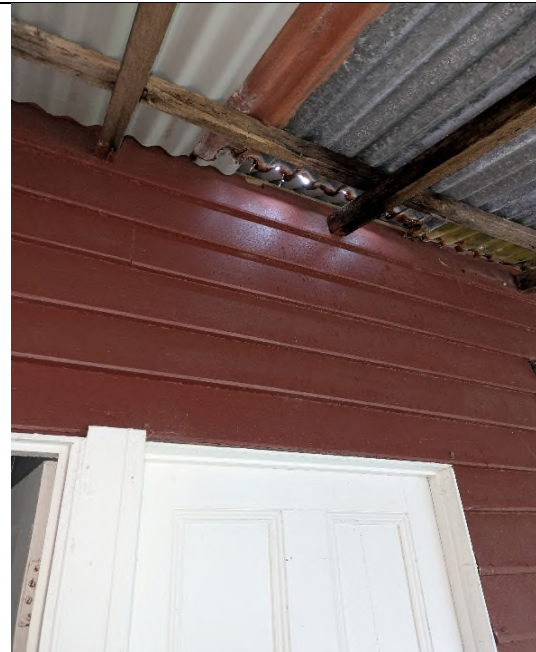
Figure 114 Hole in verandah roof sheeting.

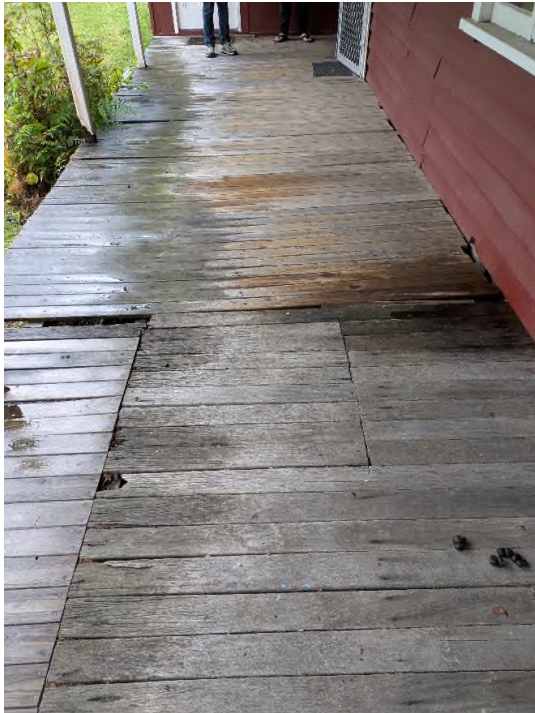
Figure 115 Patched sections of verandah boards.

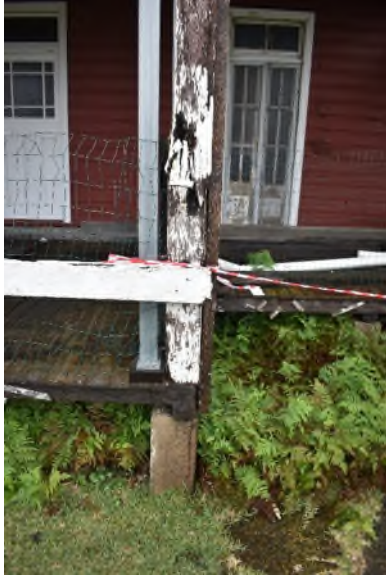
Figure 135 Decaying verandah post on western elevation.

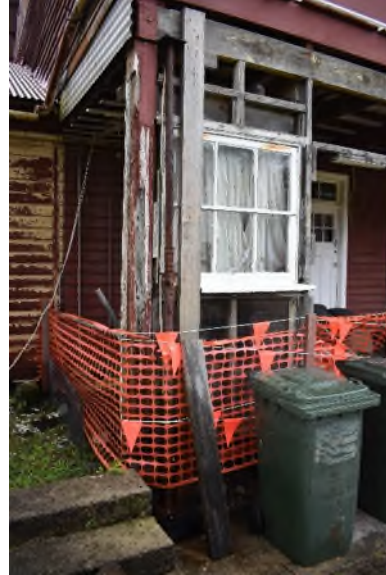
Figure 136 Location of removed annexe on eastern verandah, with timber in poor condition.

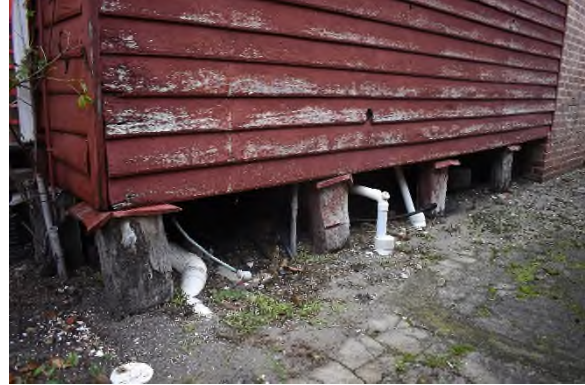
Figure 140 Timber pilings in poor condition.

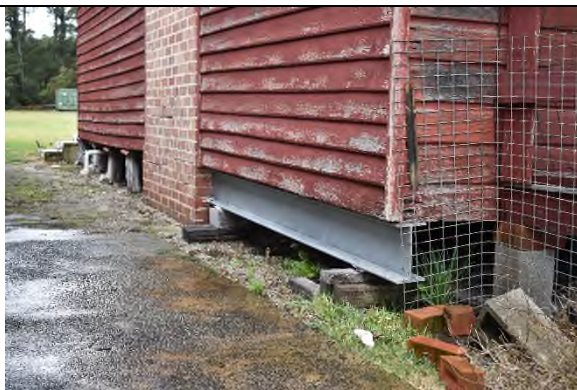
Figure 141 Steel beam inserted to provide structural support to foundations.

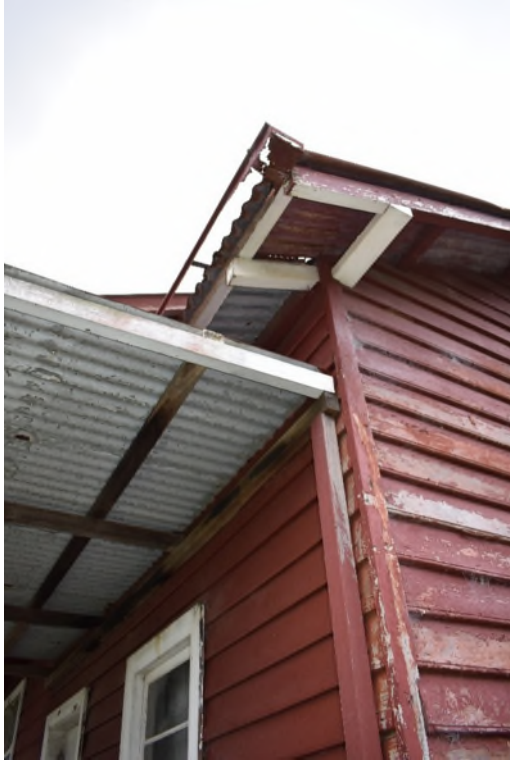
Figure 143 Rusted, non-functional gutter.

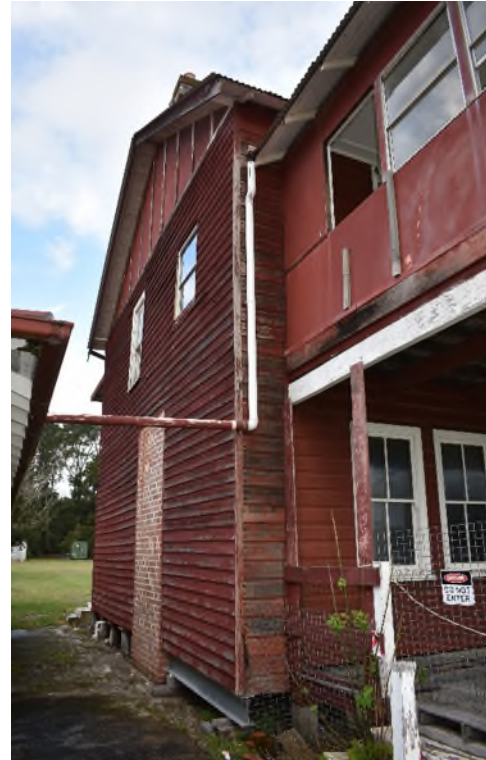
Figure 144 Northern elevation side of building, with unsympathetic services installation and verandah enclosure on upper level.
