**FLYING FISH COVE LANDSLIDE MITIGATION – ARUP / STAGE 1 CONTRACTOR RED LINE MARK UP**

**FLYING FISH COVE QUANTITATIVE LANDSLIDE RISK ASSESSMENT - GHD**

# Landslide Mitigation Concept Design Report

## Flying Fish Cove, Christmas Island

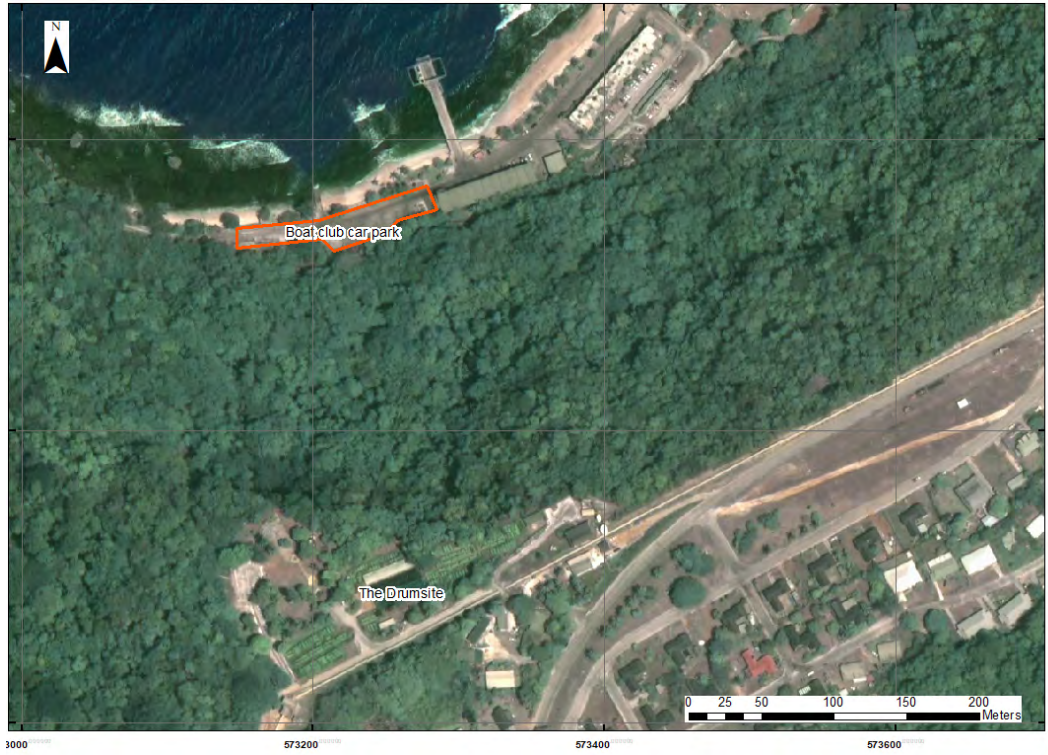
Figure 3 - Drumsite Location

Bowden [3] noted that storm water drainage was being discharged from the Drumsite, a development located directly above the Boat Club car park. The position of the Drumsite relative to the Boat Club is indicated in Figure 3. There were also several springs observed at the toe of the cliffs. Since Bowden's 2017 report [3], a new storm water drainage system was installed at the Drumsite, effectively re-directing the storm water away from the slope. The Flying Fish Cove Harbour Master recently noted that the installation of the new storm water drainage has reduced the springs after a heavy rainfall (personnel communication 15 May 2019).

The 2016 and 2017 debris flows at the Boat Club were described by Bowden [3] as channelised debris flows. It is likely that the channelised nature was in part caused by the increased storm water run-off from the Drumsite development located at the crest of the slope. The Drumsite had been undergoing incremental development since the early 2000s, gradually increasing the volume of storm water run-off on to the slope. It can be surmised that the sudden occurrence of channelised debris flows in this area were in part caused by the gradual increase of storm water flow on to the slope directly above the Boat Club.

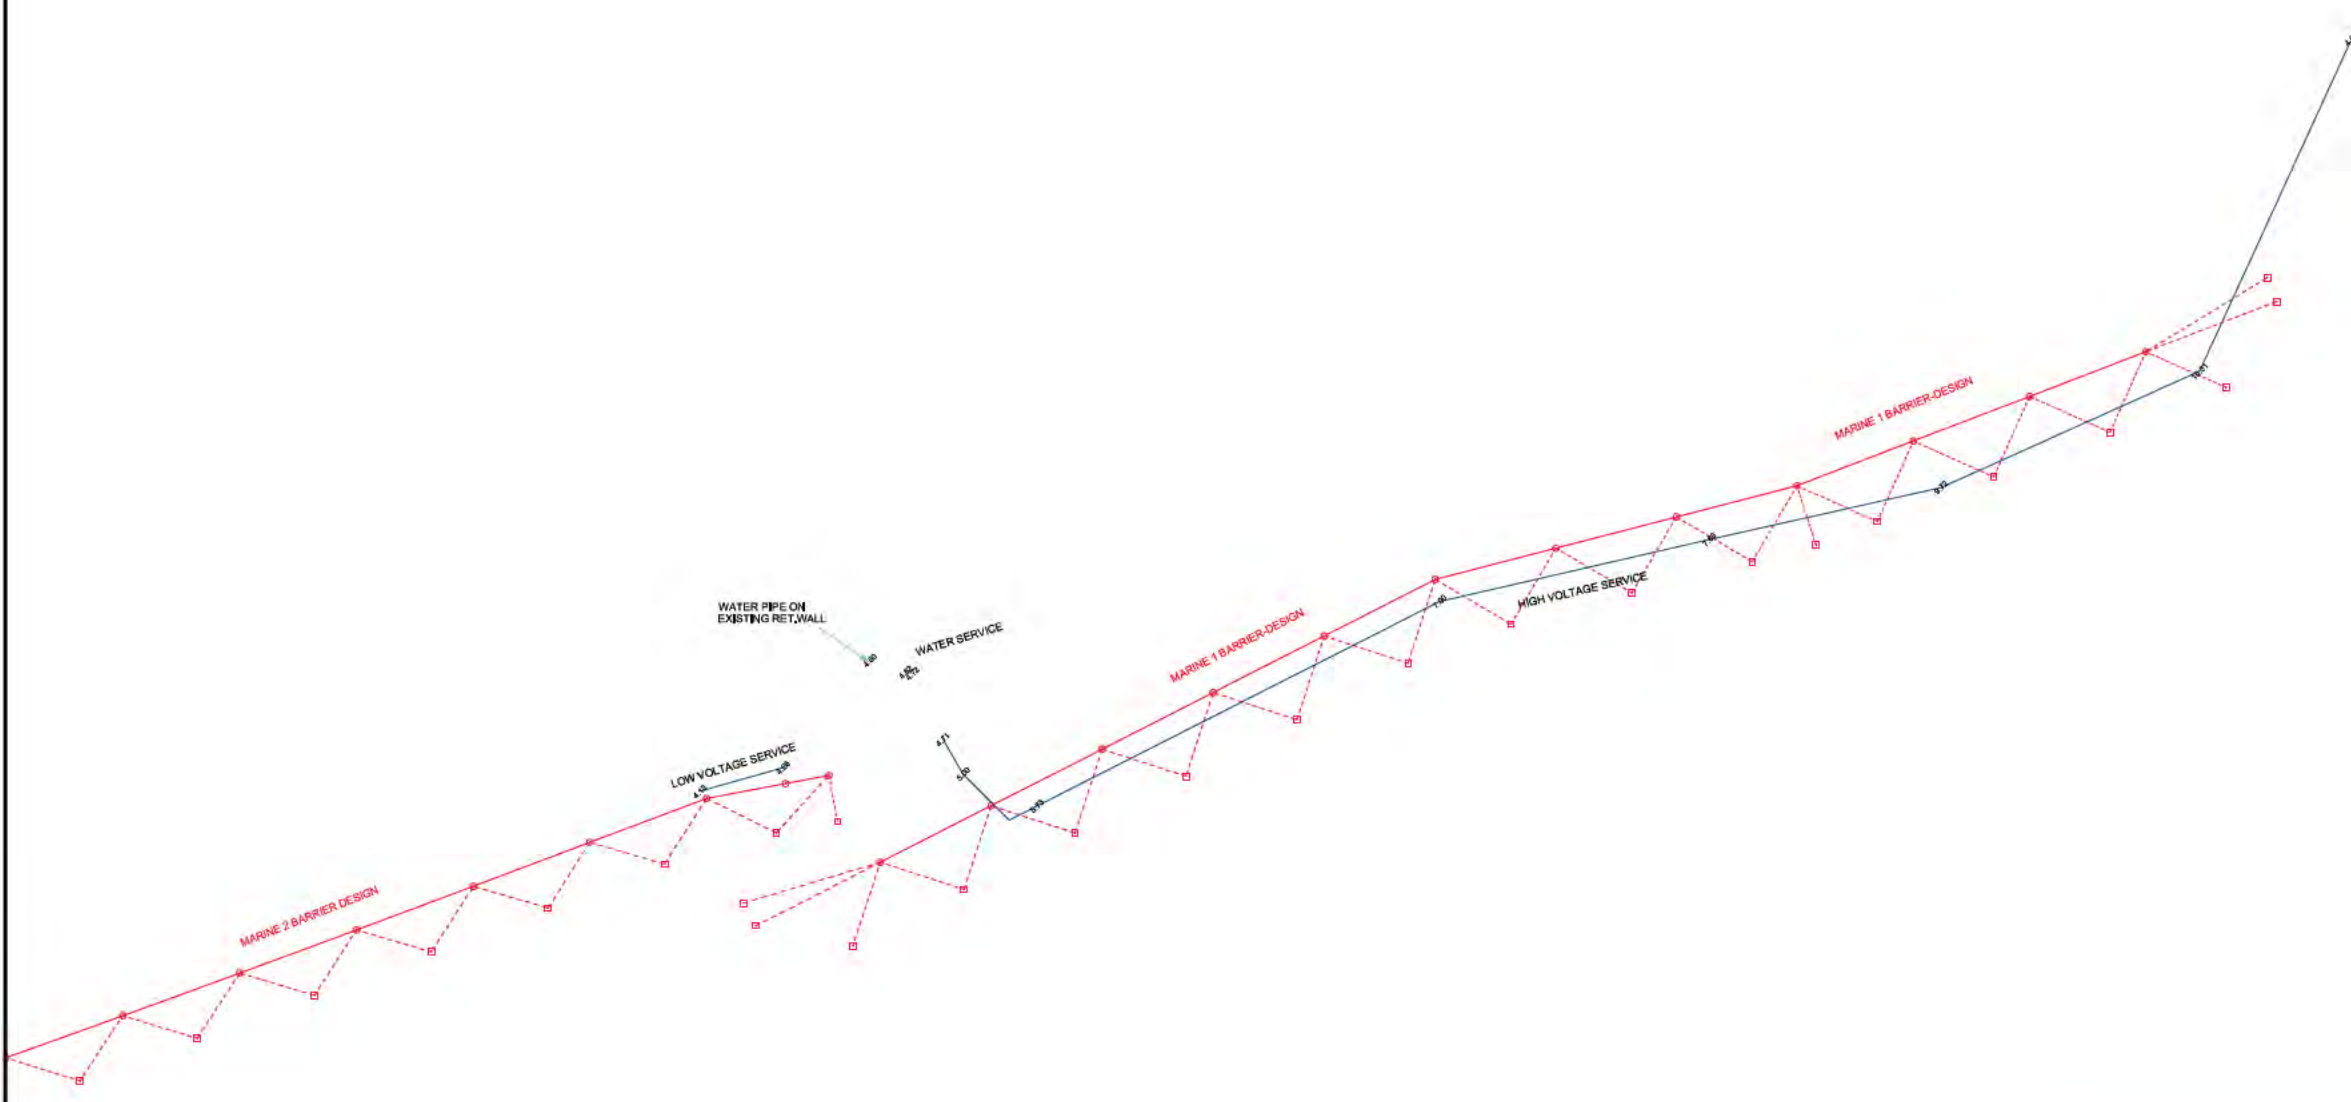
The analysis shows that the maximum bounce height at the rockfall barrier is about 3.6m and the maximum kinetic energy at the barrier is about 2932kJ. To address the rock/boulder fall hazards, it is therefore suggested that a 5000kJ barrier with at least 5m high shall be sufficient.

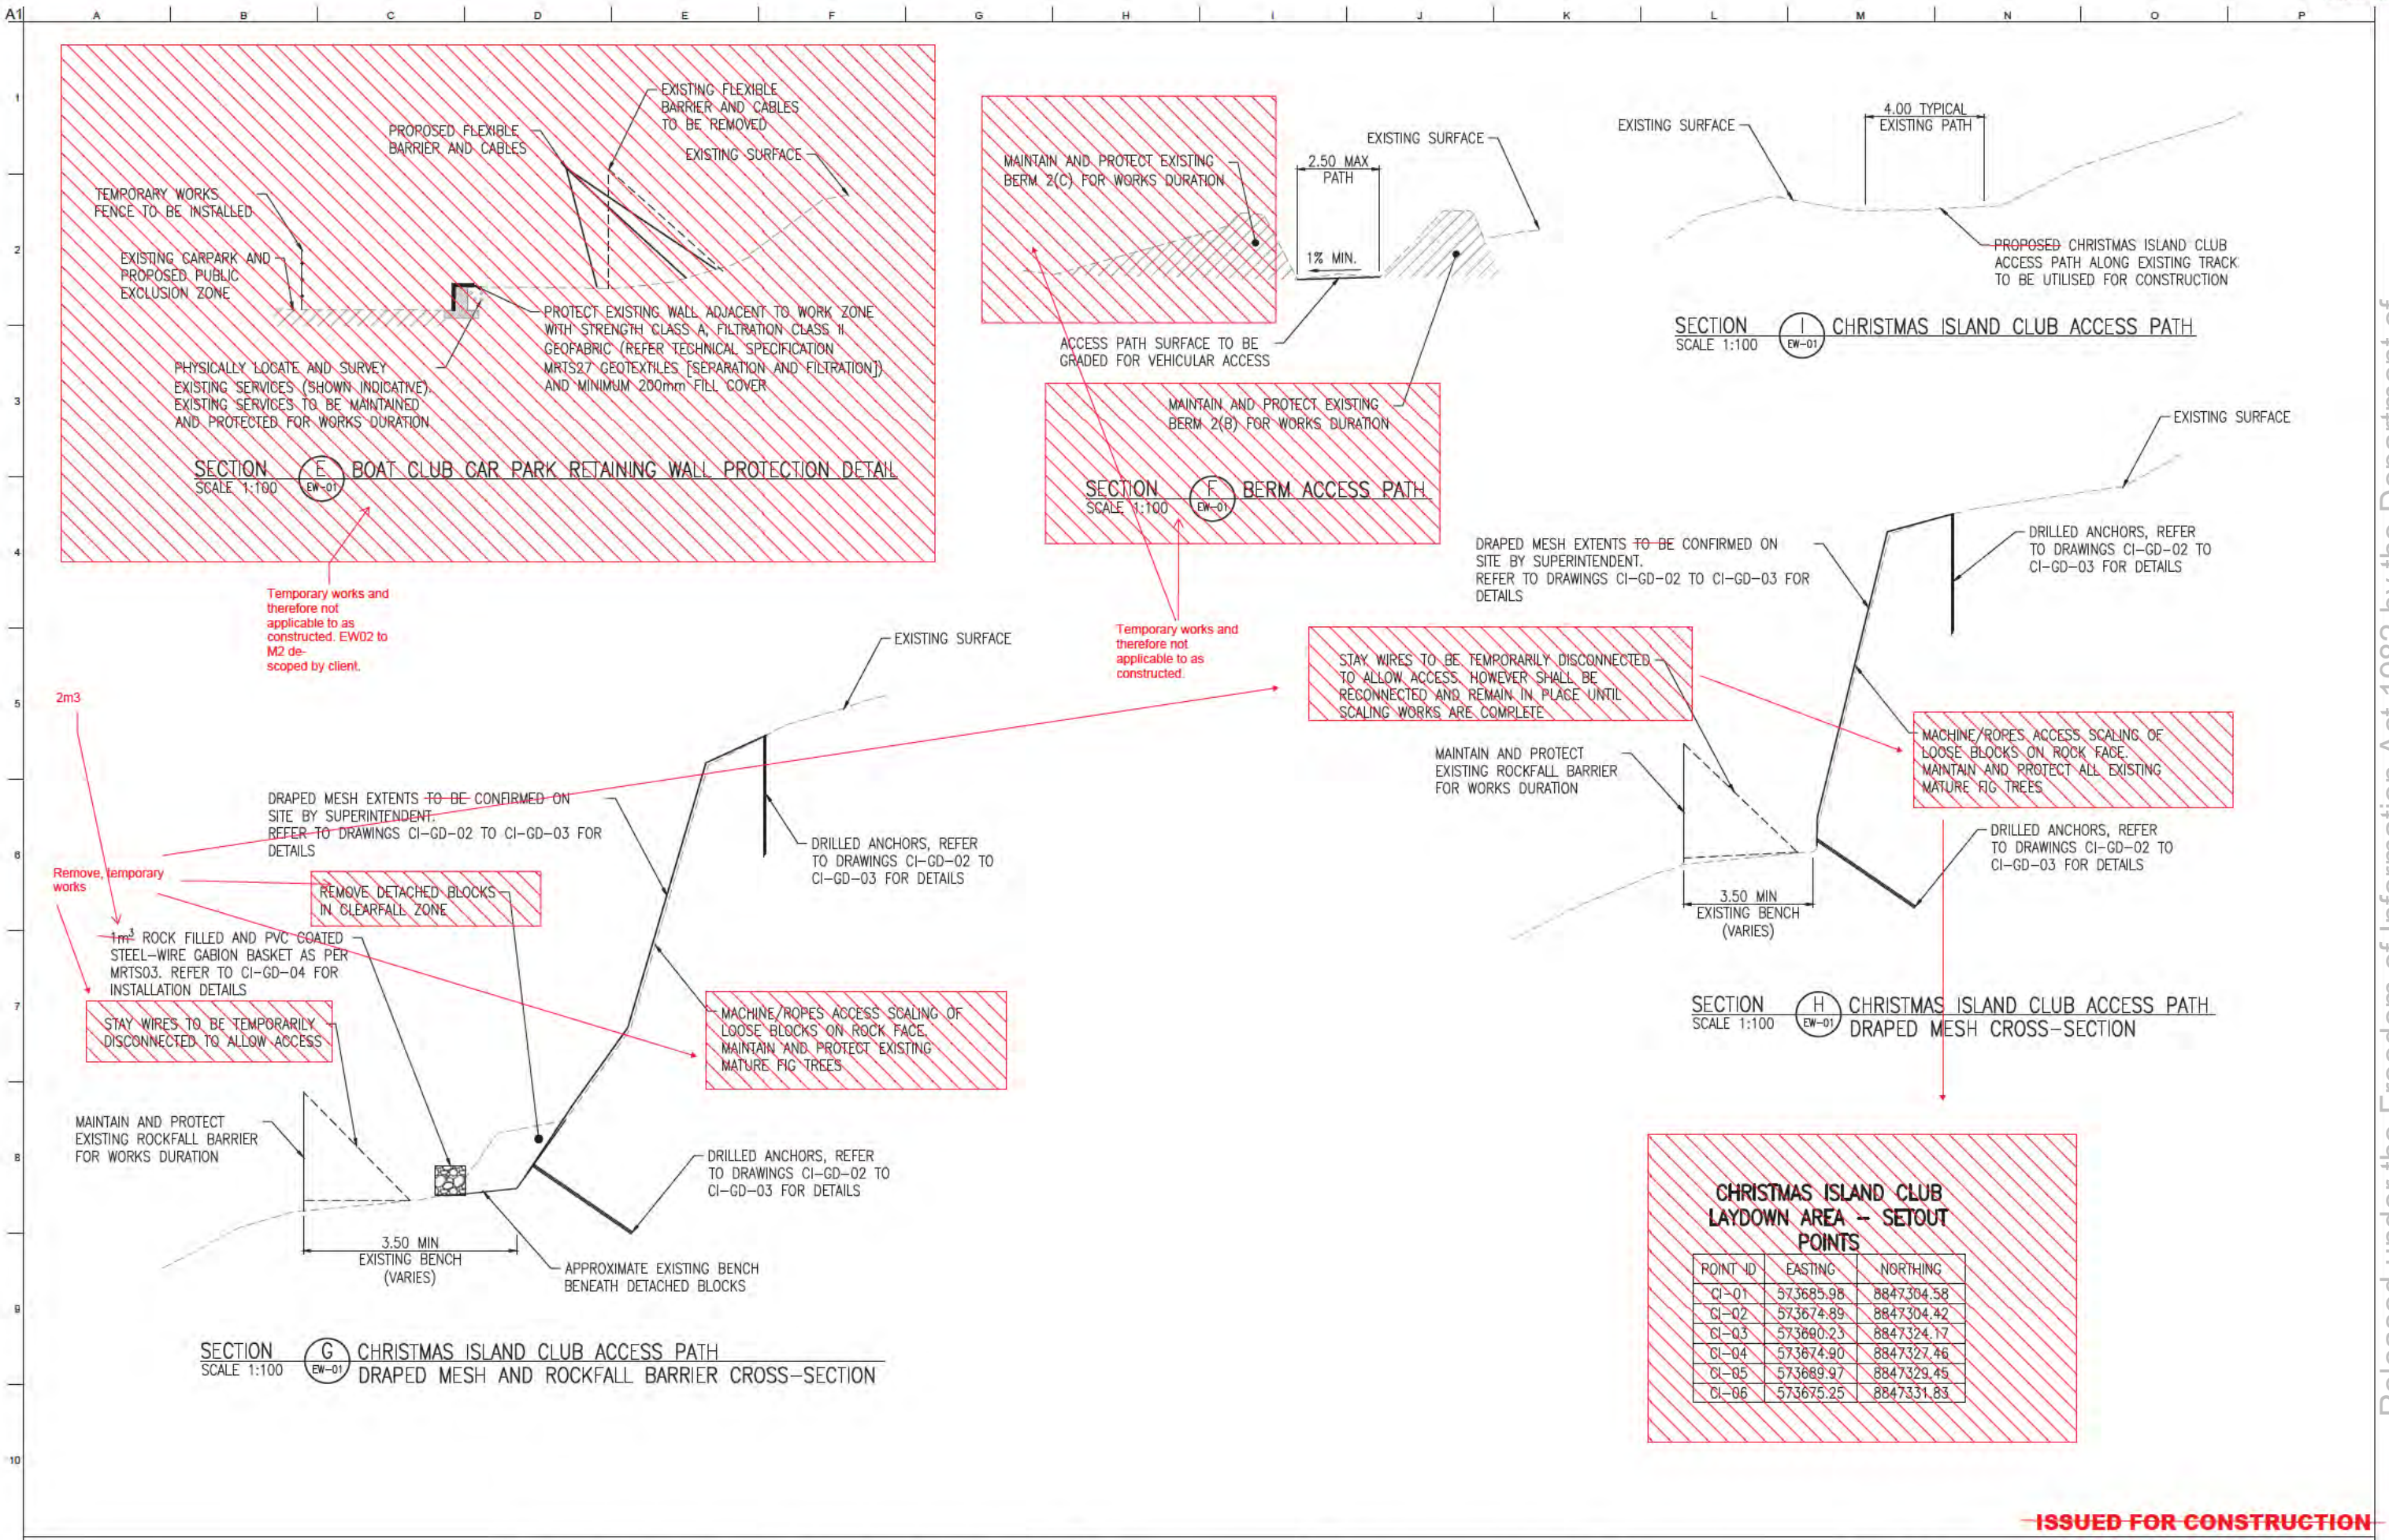
Temporary works and therefore not applicable to as constructed. EW02 to M2 de-scoped by client.

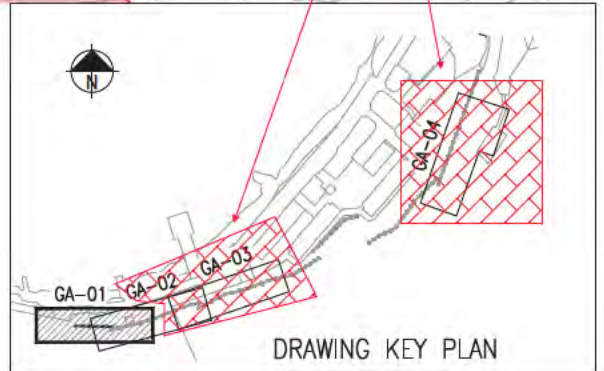
Ecology exclusion zone due to possible nesting tree as noted on site with Ecoscape ecology consultant, as per BAR. Area outside the work zone and mainly inaccessible.

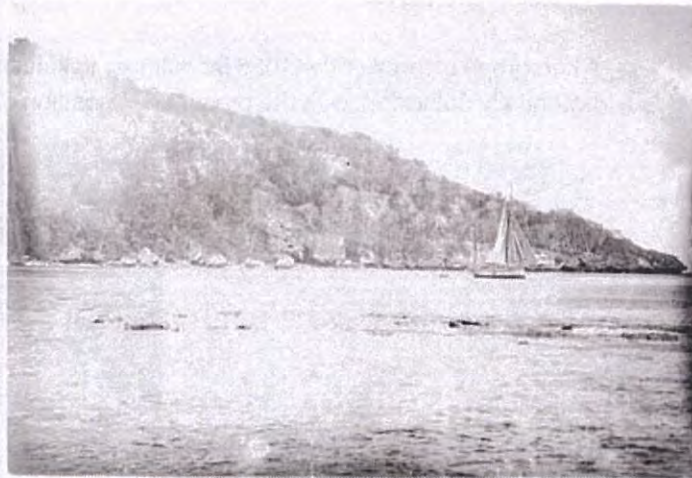
South side of Flying Fish Cove. Note the large boulders sitting on the reef, assessed as large rockfall debris.

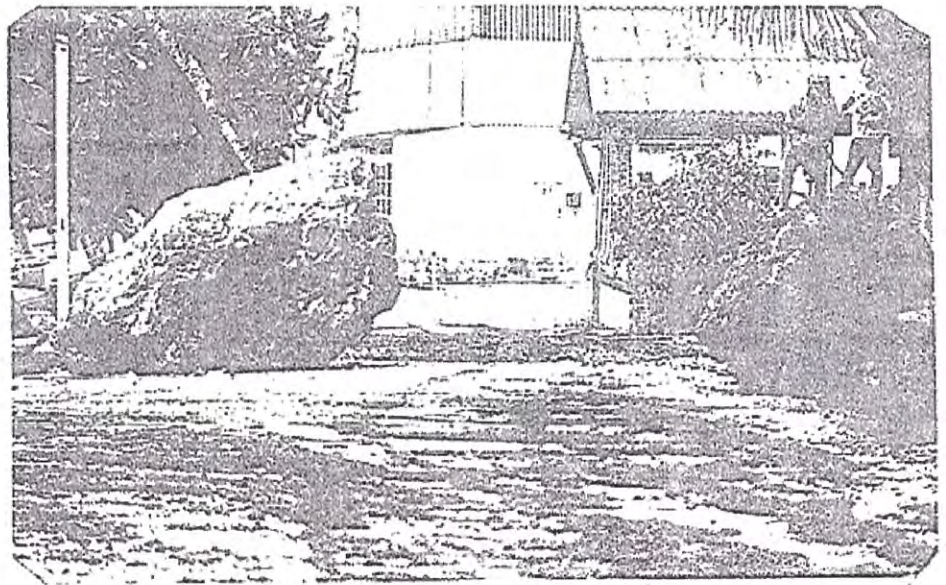
Date	Description
	<p>The damage was primarily caused by four large boulders of palagonite tuff, totalling 12m<sup>3</sup> with the largest boulder 6m<sup>3</sup>. The boulders were observed to come to rest between the barbecue area and the road, with two boulders reaching the beach and sea.</p> <p>The following photographs, reproduced directly from the British Phosphate Commissioner report (Barnett, 1972), present a record of the size and position of the largest of the boulders.</p>

The largest of the boulders, approximately 6m<sup>3</sup>, came to rest on the road.

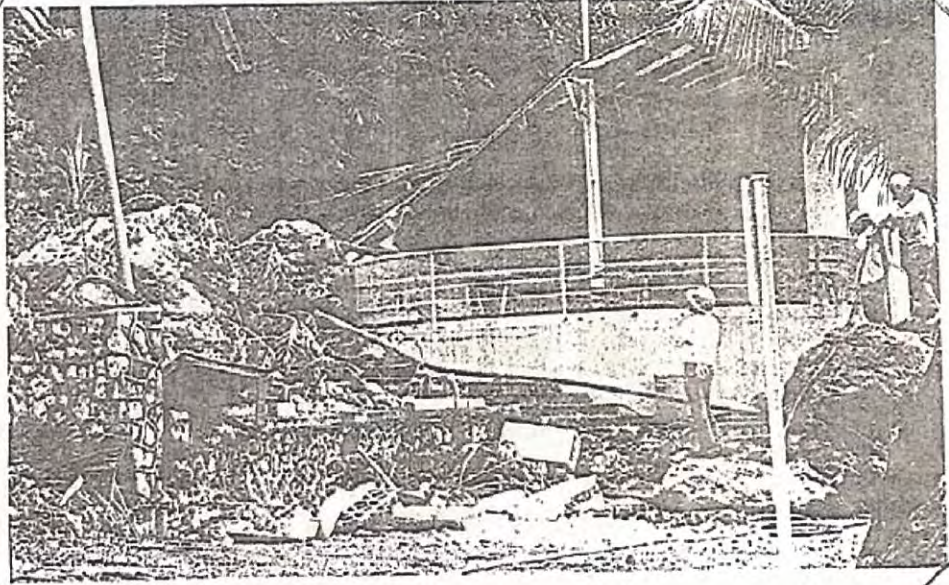
<p>View of the destroyed barbecue area, note the large boulders and debris at the toe of the slope.</p> <p>Subsequent to this fall, a rockfall protection fence was erected in 1975 in the vicinity of the Boat Club and Marine Department buildings, consisting of untreated and welded rail steel, approximately 2m high (Golder, 1992). The fence was erected just up slope of the toe, approximately 2m high.</p>
1983/84	<p>Boat Club roof damaged by rockfalls, described in Golder, 1992. There is no further information as to the size and number of the rockfalls associated with this incident.</p>
1985	<p>A rockfall event behind the Kampong Area (potentially upslope of fence 408), resulted in rocks reaching the road close to the former housing blocks, damaging parked cars.</p> <p>Mesh rockfall fencing, approximately 1.8m high, was erected upslope of the Boat Club/Marine Building and a steel rockfall fence erected behind the Kampong area (exact location unconfirmed).</p>

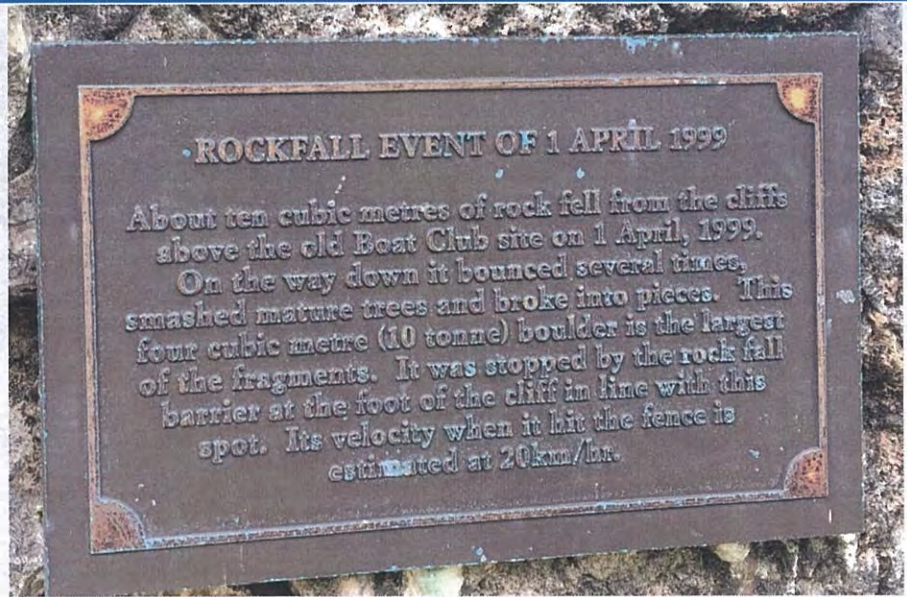
The record of this rockfall is presented on a plaque attached to a large boulder adjacent to the beach, at the site of the former Boat Club buildings. The information suggests that the boulder removed from the fence was estimated as 4m<sup>3</sup>. The plaque is attached to a boulder estimated to be less than half the size of that described. It is possible that the boulder may have broken up on moving, subsequently degraded or was grossly over estimated on recording.

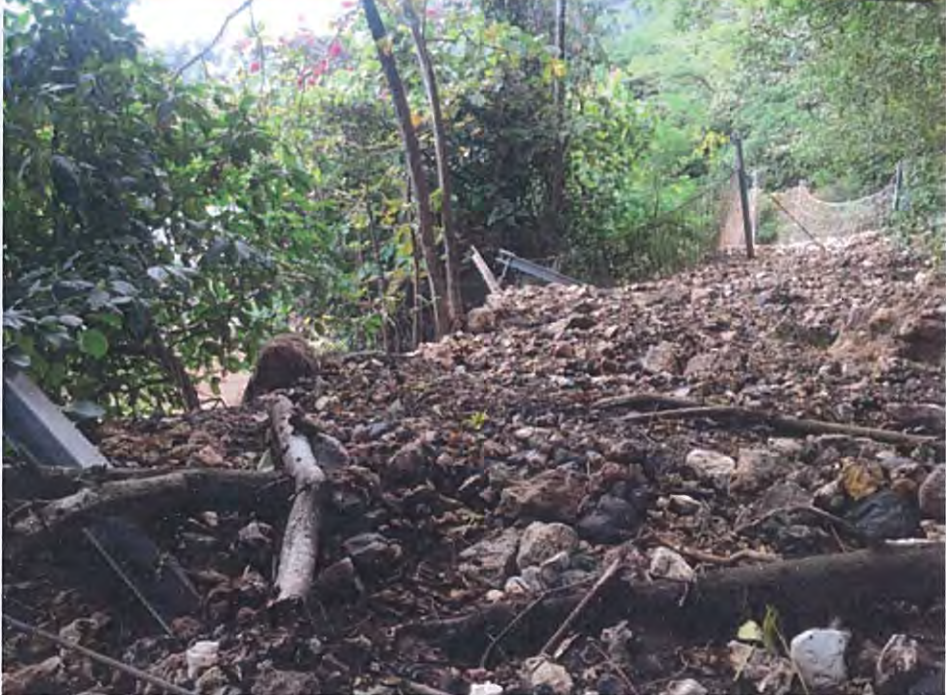
View from above the destroyed Boat Club fence.

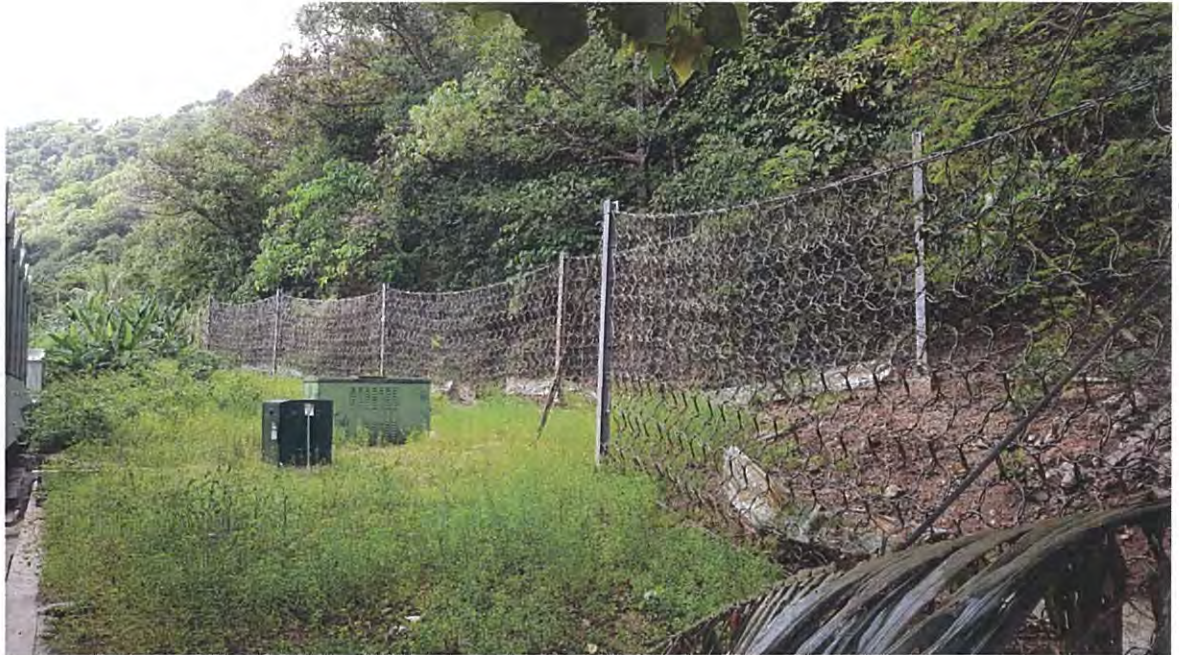
**Figure 8. View of Rockfall Barrier behind the Marine 1 building**

A number of the previous reports state that the estimated design life of the barriers is 20 years.

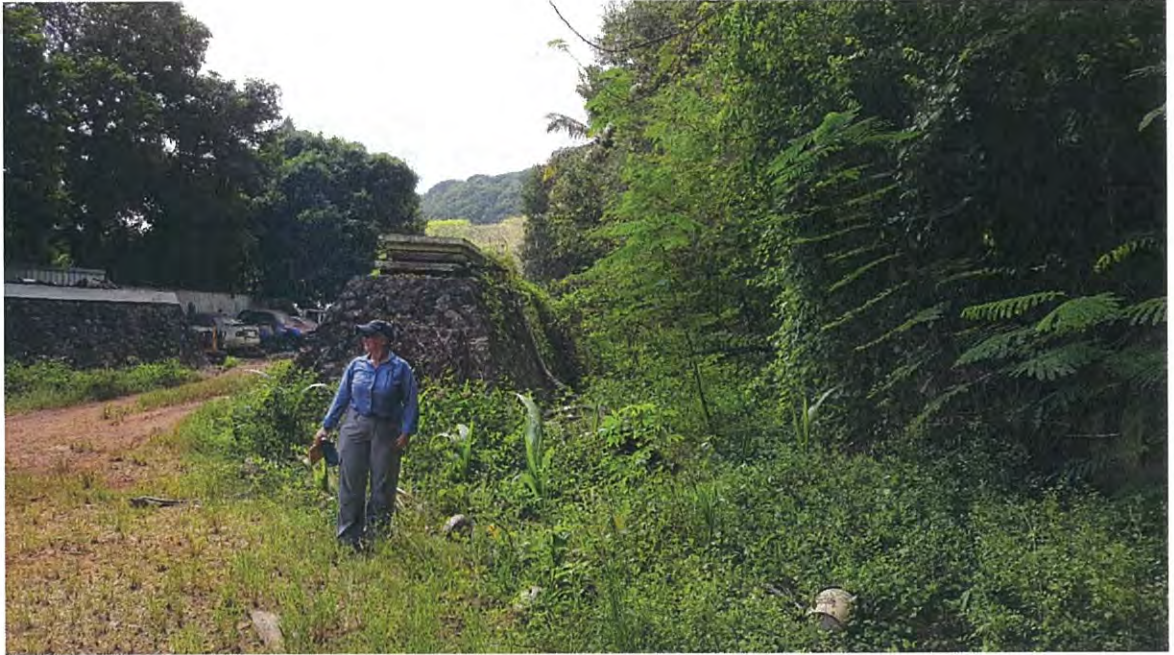
**Figure 9. View of Berms Below 408 Fence**

The 2000 Baynes Geological report only provided a concept sketch of a berm. The actual design, construction methods and energy absorbing capacity of the berms are not known. The berms observed on site at about 2m high with steeply sloping sides and completely covered by stone flagging as shown in (Figure 9).
