**Australian Government**  
**Department of Infrastructure,  
Regional Development and Cities**

# **INVESTIGATION INTO ALLEGATIONS OF WASTE MISMANAGEMENT PRACTICES BY AIRSERVICES AUSTRALIA AT DARWIN INTERNATIONAL AIRPORT**

**FEBRUARY 2019**

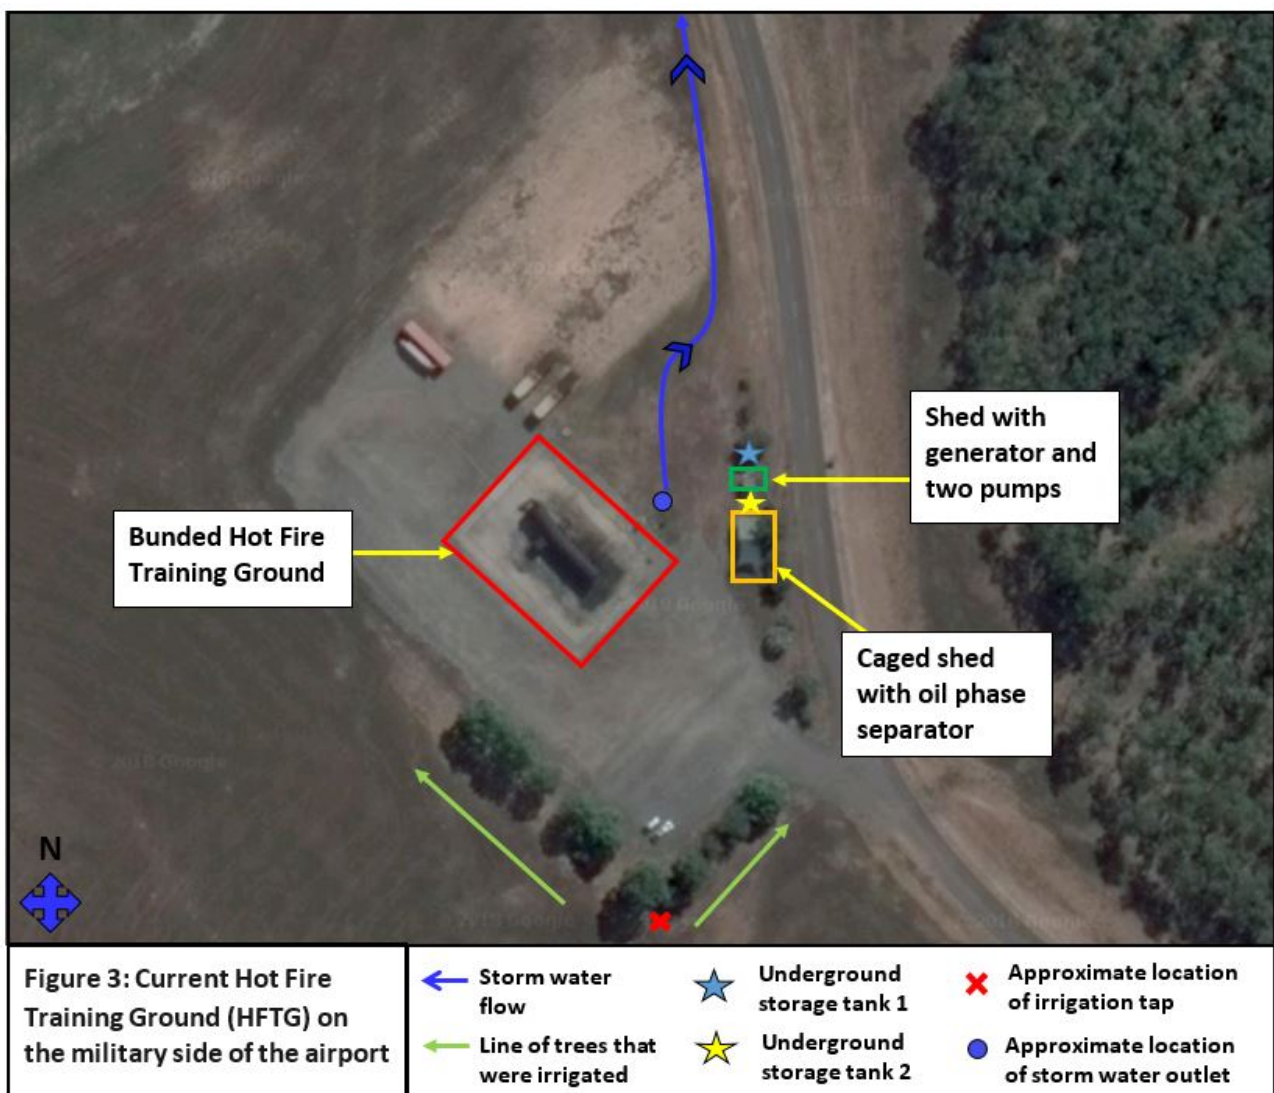
- two sheds:
  - the Northern shed houses the generator and a pump (**Figure 3**);
  - the second shed (the Southern shed) houses the oil phase separator (**Figure 3**);

- to the South of the HFTG site are two lines of trees bordering the graveled area and a decommissioned irrigation tap and stand;
- the trees and irrigation tap (marked by a red X in **Figure 3**) are discussed in Allegation 1.
