## CASE SUMMARIES

RS 01 - RS 80

N.H.&amp;M.R.C. Road Accident Research Unit

Road Accident Study 1996-97

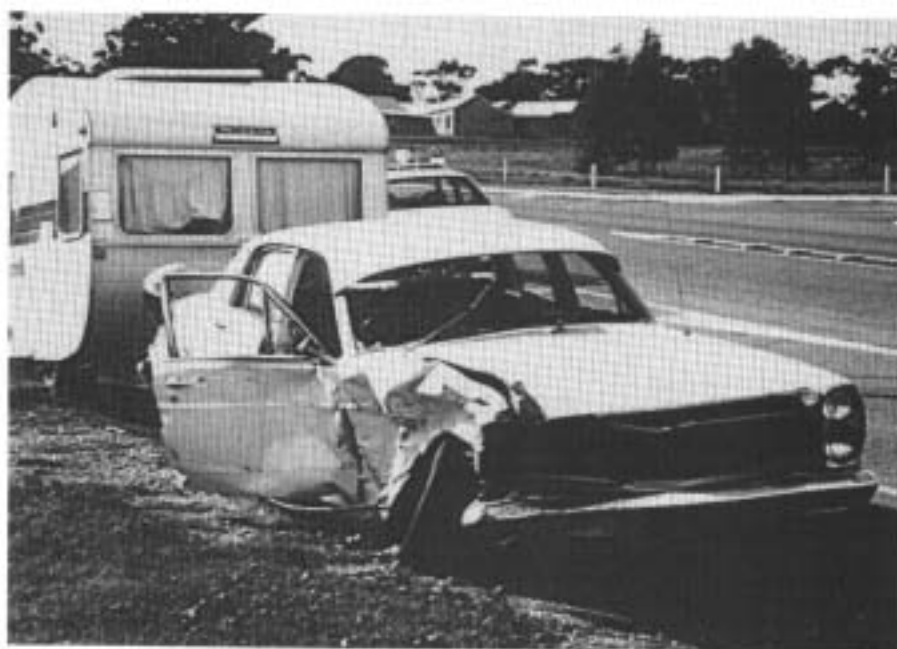
FIGURE A2: Crash 02. Ford Fairlane and caravan in rest position showing impact damage to right side.

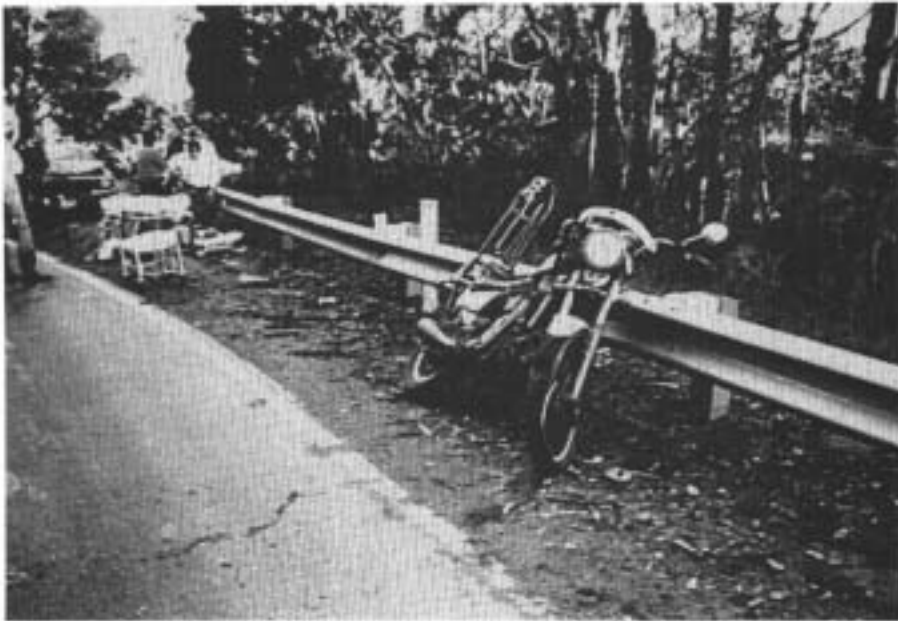
FIGURE A3: Crash 03. View of crash site showing motorcycle in foreground and Holden Monaro in background.

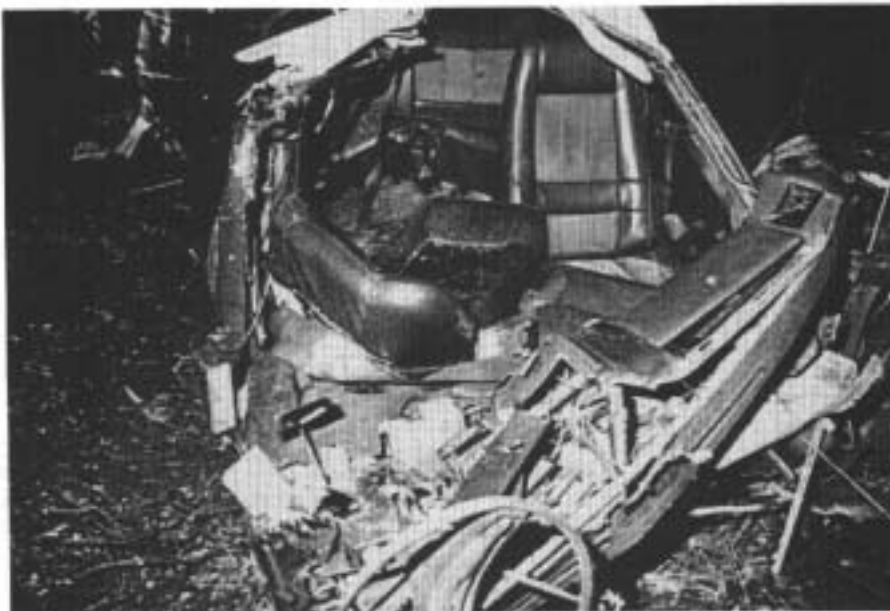
FIGURE A4: Crash 04. Damage to Ford Falcon stationwagon following impact with tree. The front of the car has been torn off exposing the passenger compartment. Note that the driver's seat is detached from its mounting.

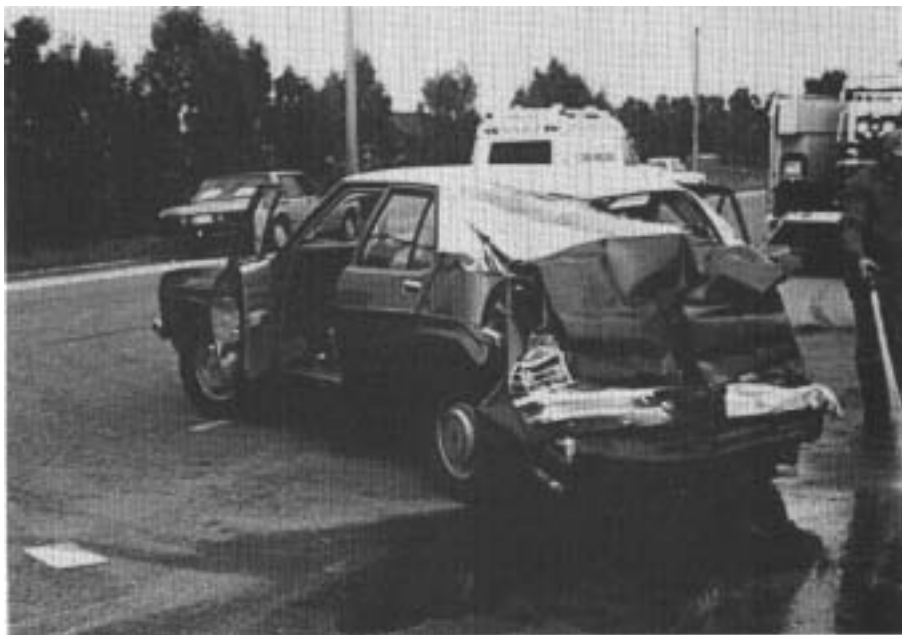
FIGURE A6: Crash 06. Impact damage to Holden Kingswood Sedan. Note impressions on the compressed boot from the bull bar of the semi-trailer.

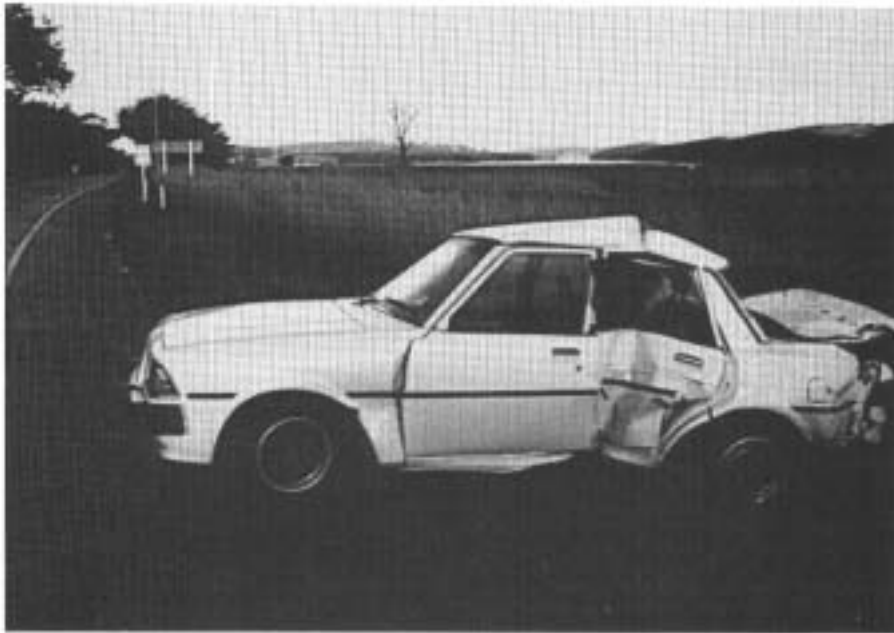
FIGURE A7: Crash 07. Final position of the car. Note impact damage to the left rear door and corner from impact with road sign.

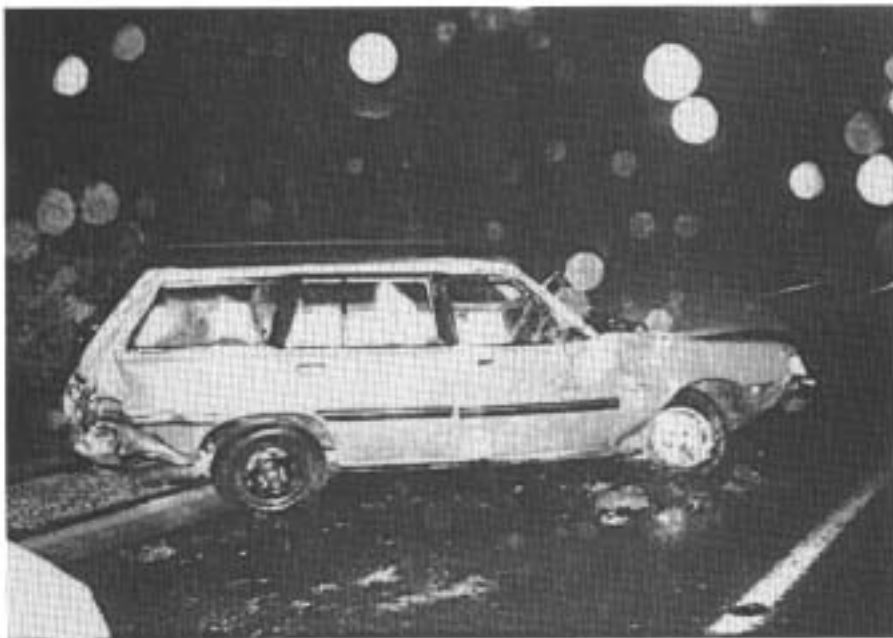
FIGURE A8: Crash 08. Final position of the station wagon showing impact damage to the right side.

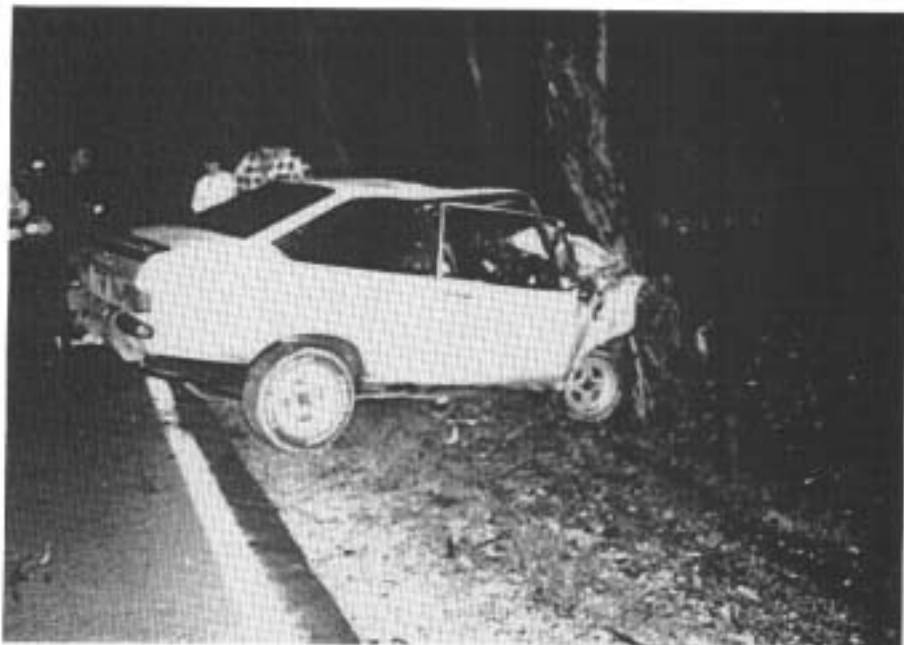
FIGURE A9: Crash 09. Final position of the car showing impact damage to the front right corner.

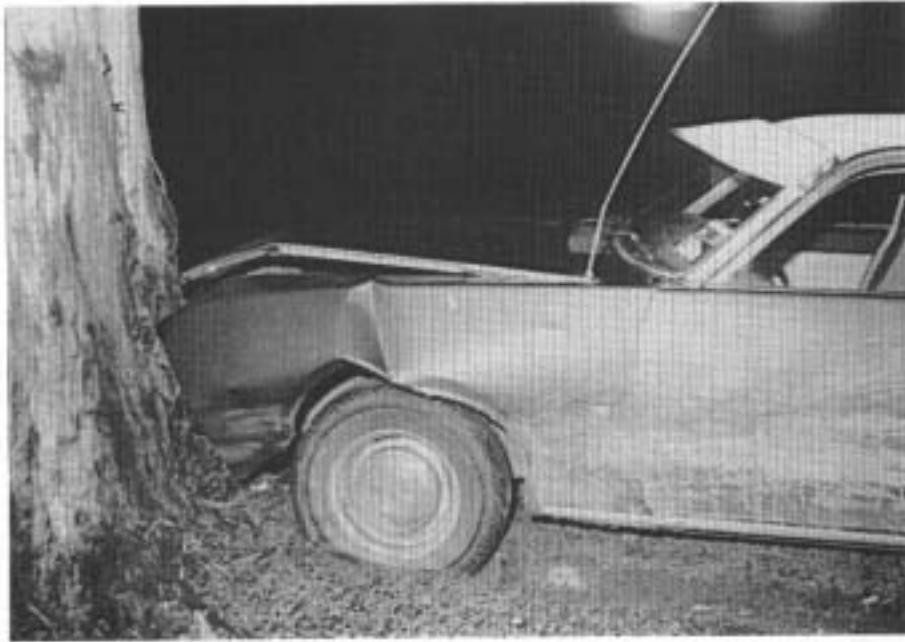
The car was proceeding north on a straight, two-lane section of road at approximately 80 km/h at night. The driver was returning home after visiting friends. The left front tyre deflated rapidly, pulling the vehicle sharply to the left and onto the damp, grassed, shoulder. The driver braked hard but made no attempt to steer back onto the bitumen surface, thinking that doing so would cause the vehicle to go increasingly out of control. The vehicle skidded on the grassed verge for 43 metres before striking a large tree with the left front. The vehicle sustained only minor damage. Speed at impact is estimated to be between 10 and 20 km/h. After impact the driver was slumped forward and to the left. An examination of the left front tyre revealed a 7/32" steel twist drill bit embedded in the tyre.

FIGURE A11: Crash 11. Impact damage to the left side of the car. Note deflated left front tyre.

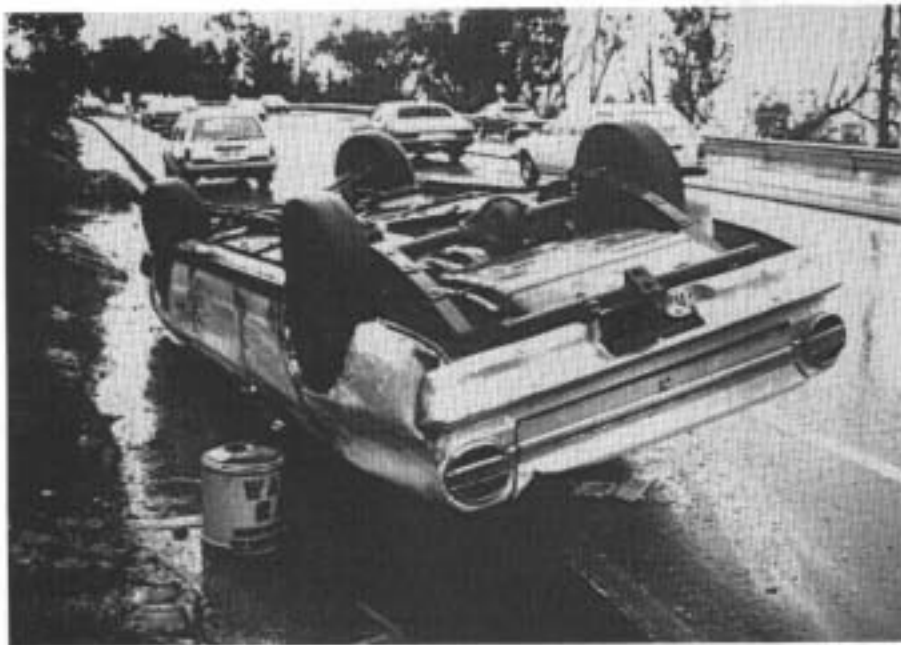
FIGURE A12: Crash 12. Final position of the car. Note scrape marks down right side from impact with embankment.

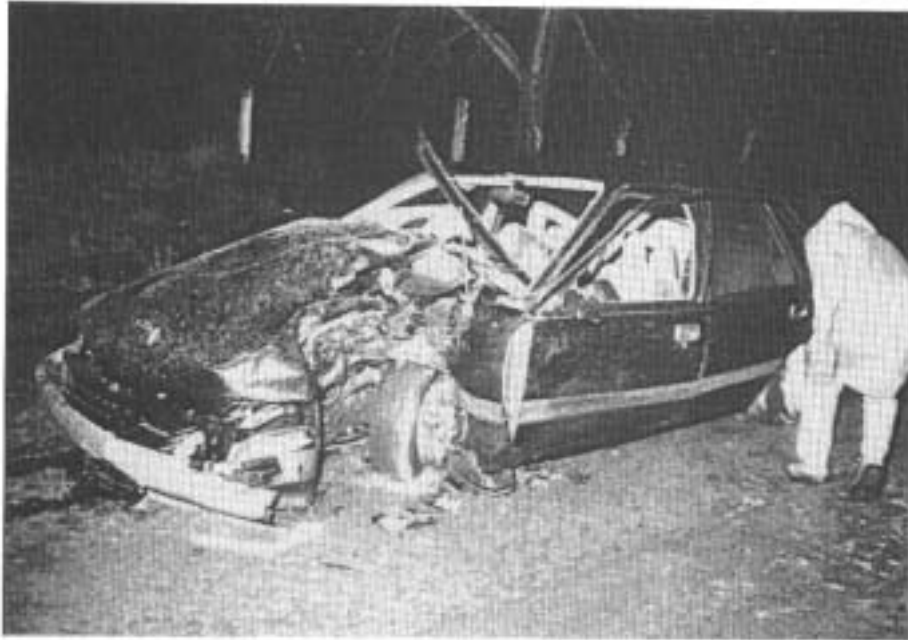
FIGURE A15: Crash 15. Final position of the car showing impact damage from striking a tree. Note distortion of door frame which was struck by the driver as he was ejected from the vehicle.

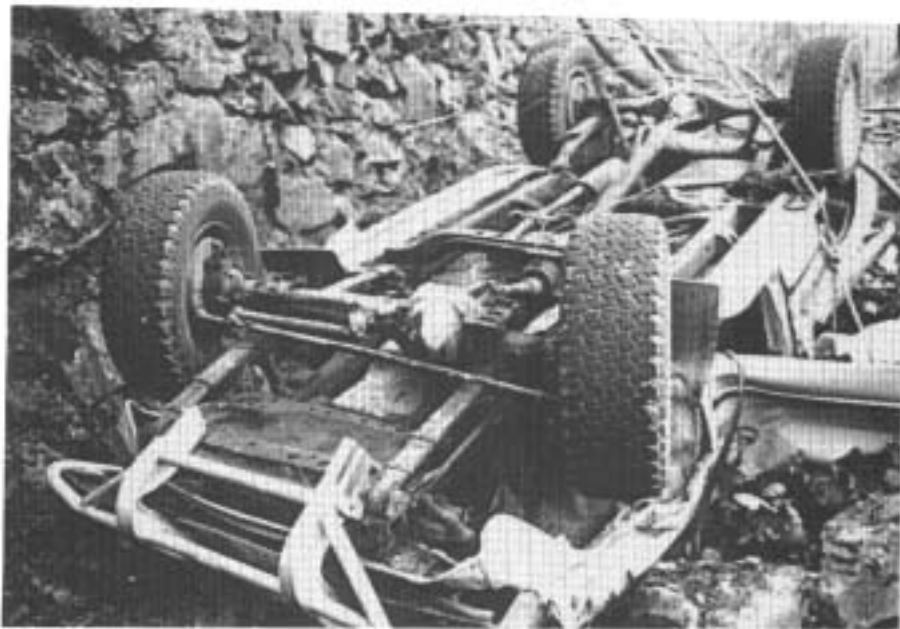
FIGURE A16: Crash 16. The final position of the utility at the bottom of a 5m. drop.

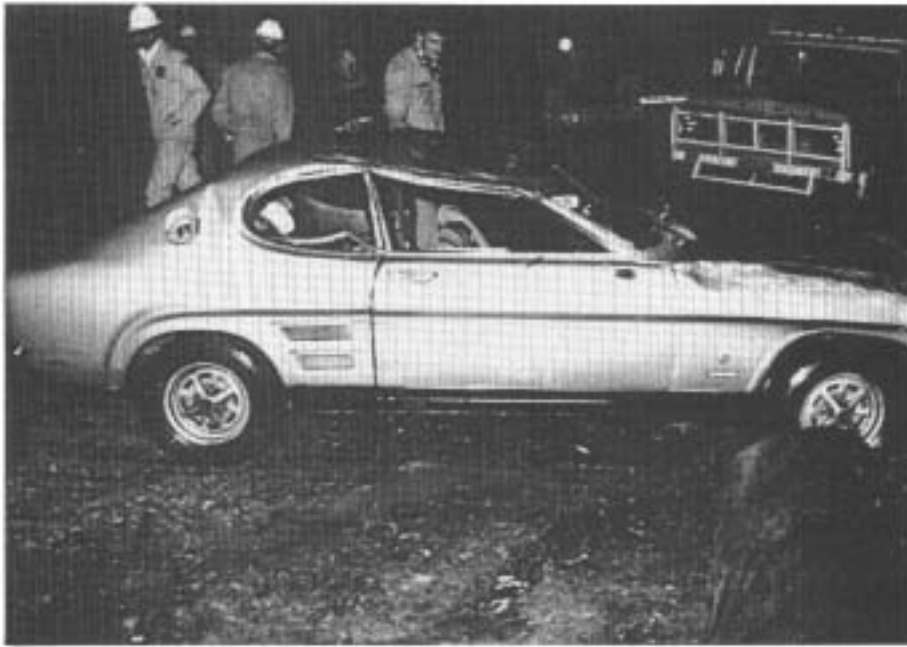
FIGURE A17: Crash 17. Ford Capri after being righted showing distortion of roof resulting from rollover, and scrape marks on the right front mudguard from contacting the road surface.

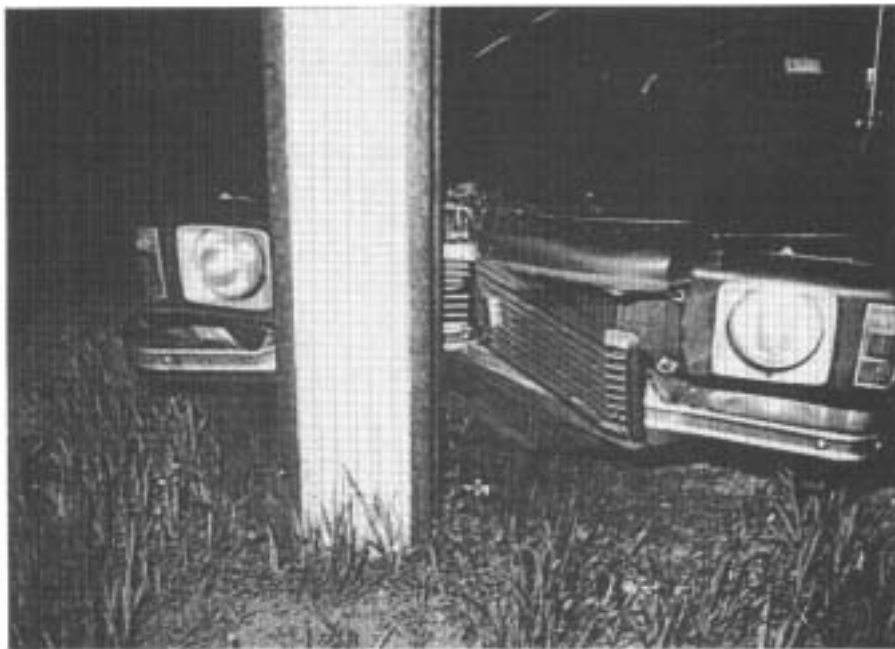
FIGURE A18: Crash 18. The final position of the car with impact damage to the front from impact with the pole.

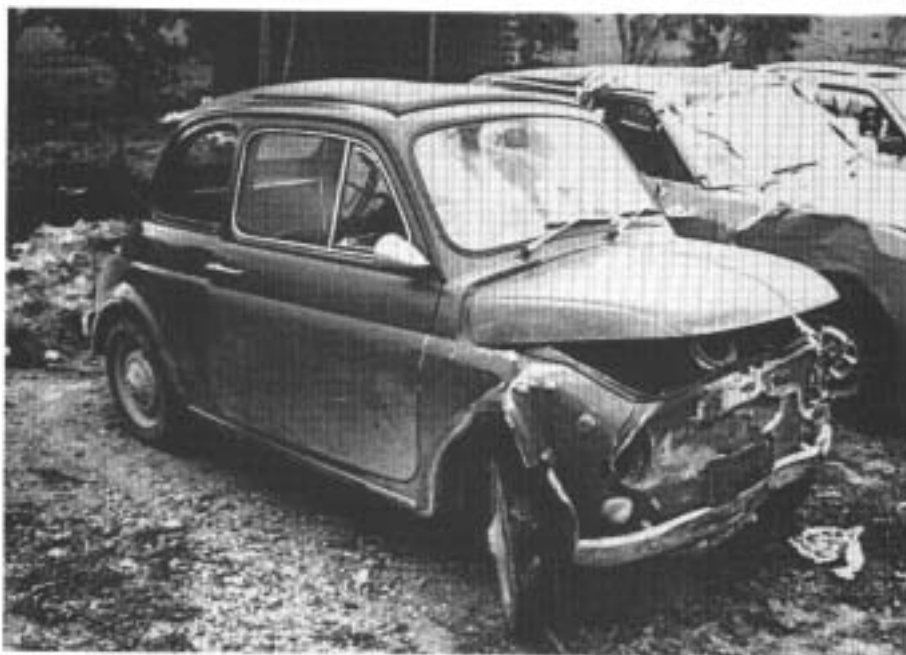
FIGURE A19: Crash 19. Impact damage to front of Fiat 500.

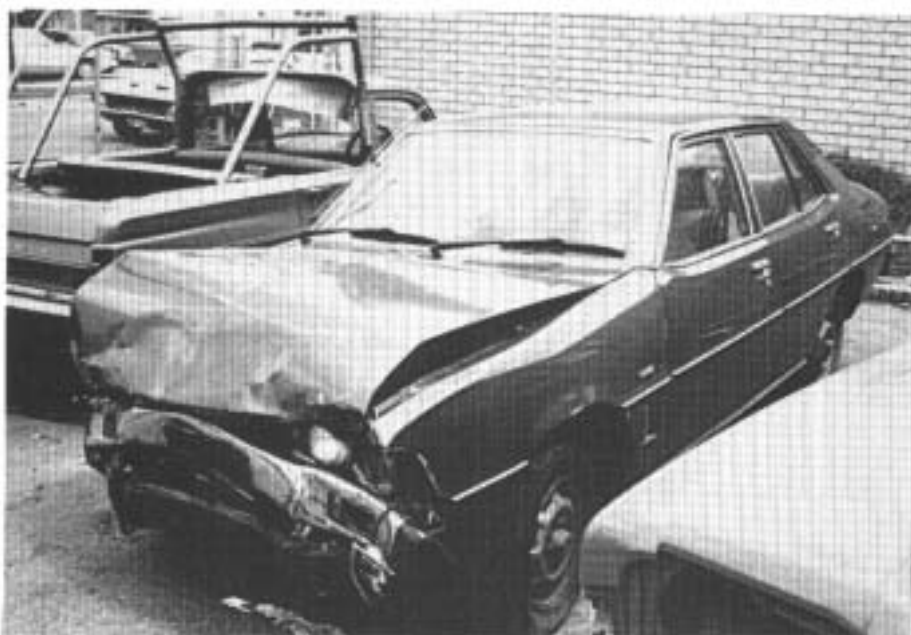
FIGURE AZO: Crash 19. Impact damage to front of Sigma sedan.

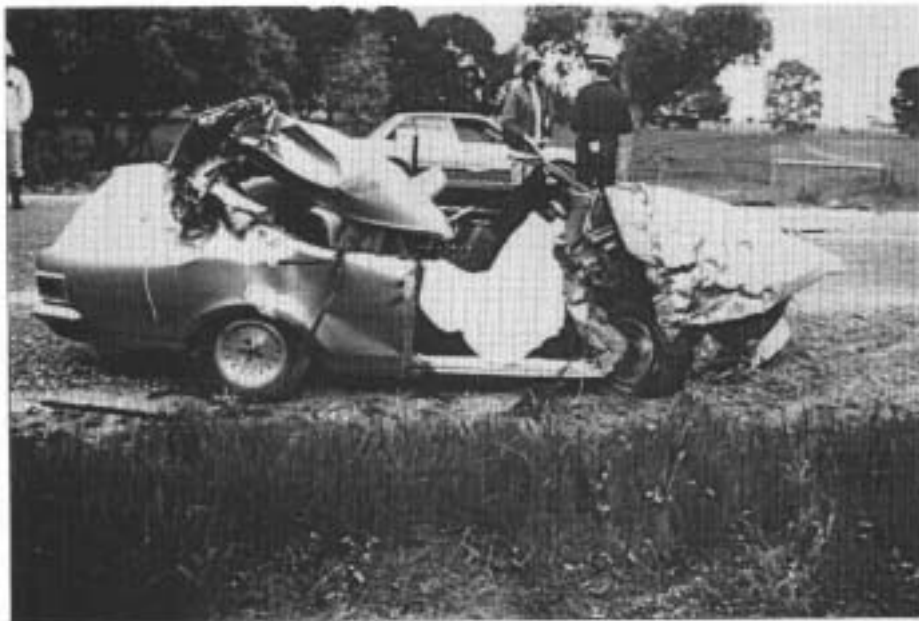
FIGURE A21: Crash 20. Final position of Holden Monaro showing extensive impact damage to right side and roof.

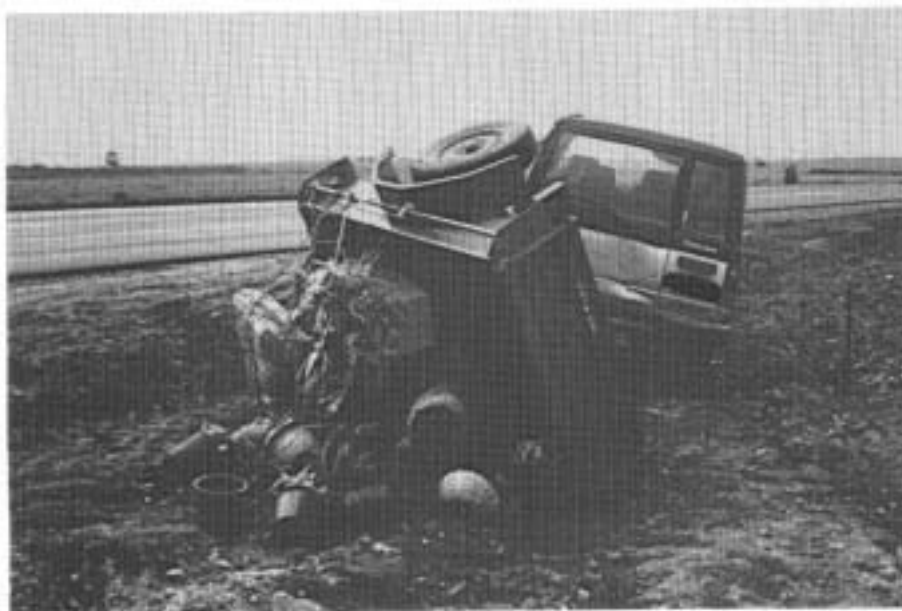
FIGURE A22: Crash 21. The final position of the Holden Jackaroo which came to rest on its left side and has been rolled back onto its wheels.

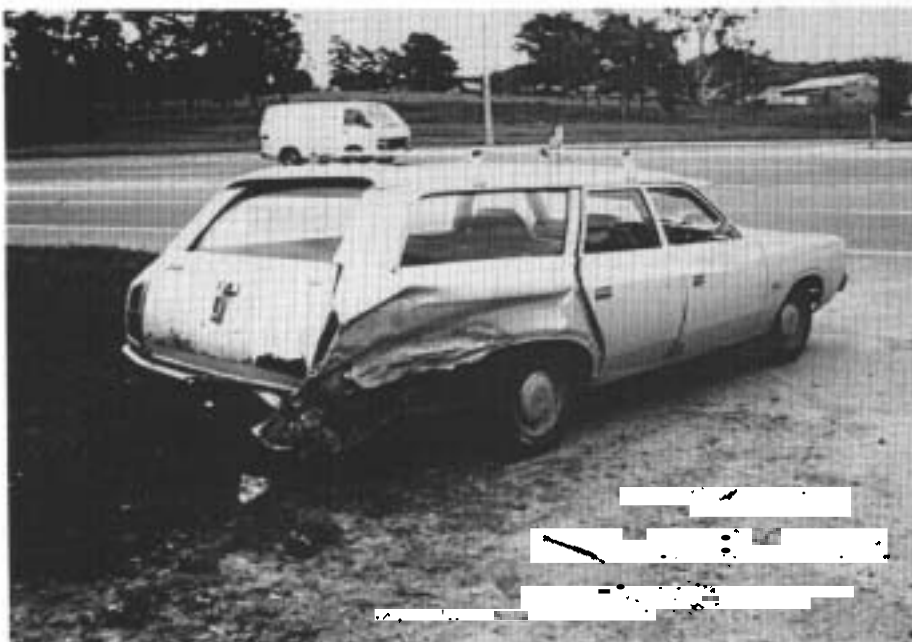
FIGURE A26: Crash 26. Impact damage to the right side of Valiant station wagon.

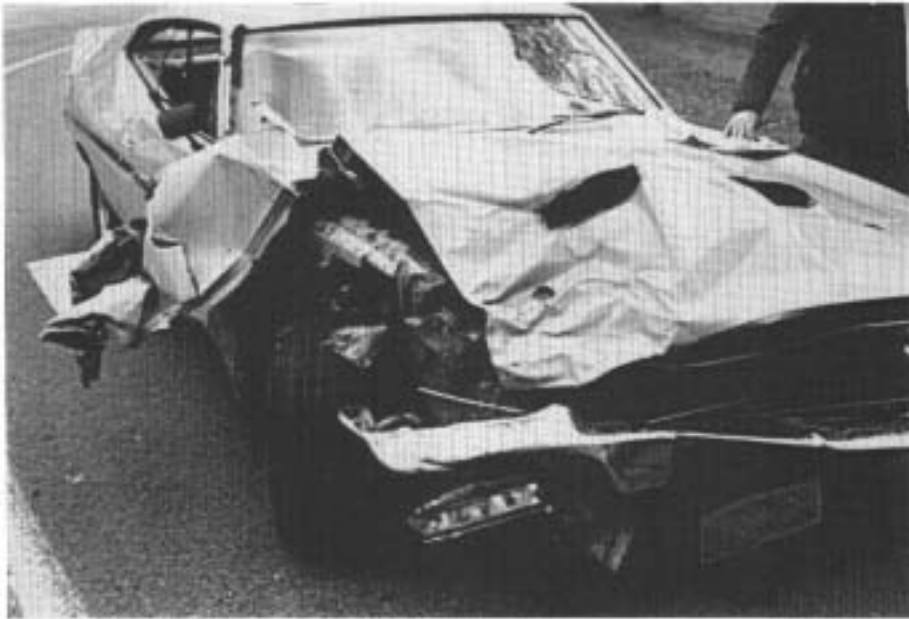
FIGURE A27: Crash 26. Impact damage to the right front and side of Ford Falcon.

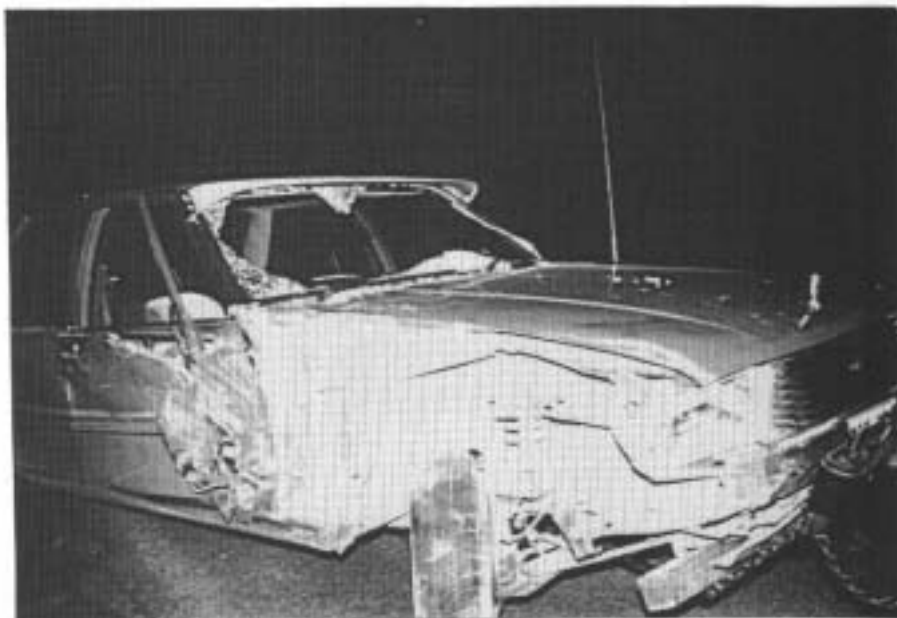
FIGURE A28: Crash 27. Impact damage to the right side of Ford Falcon. Note shattered windscreen, struck by front seat passenger.

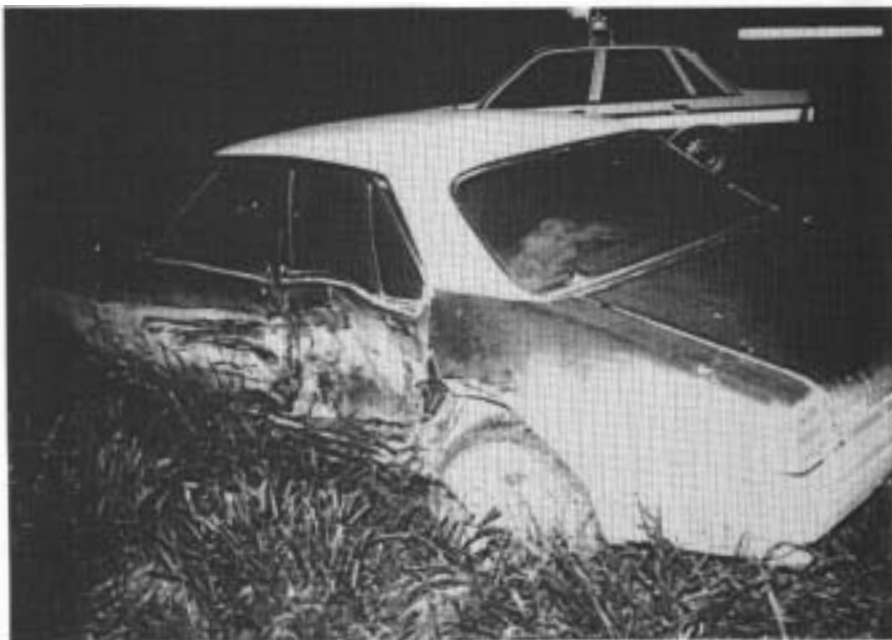
FIGURE A30: Crash 28. Holden Kingswood in its final position with damage to its left side.

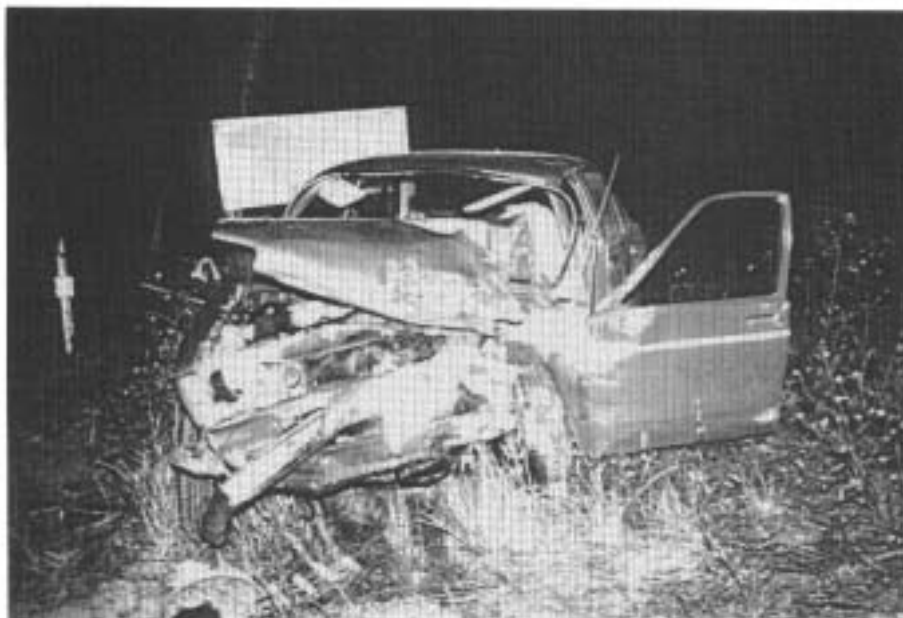
FIGURE A31: Crash 28. Holden Gemini in its final position with damage to the left front corner from striking Holden Kingswood.

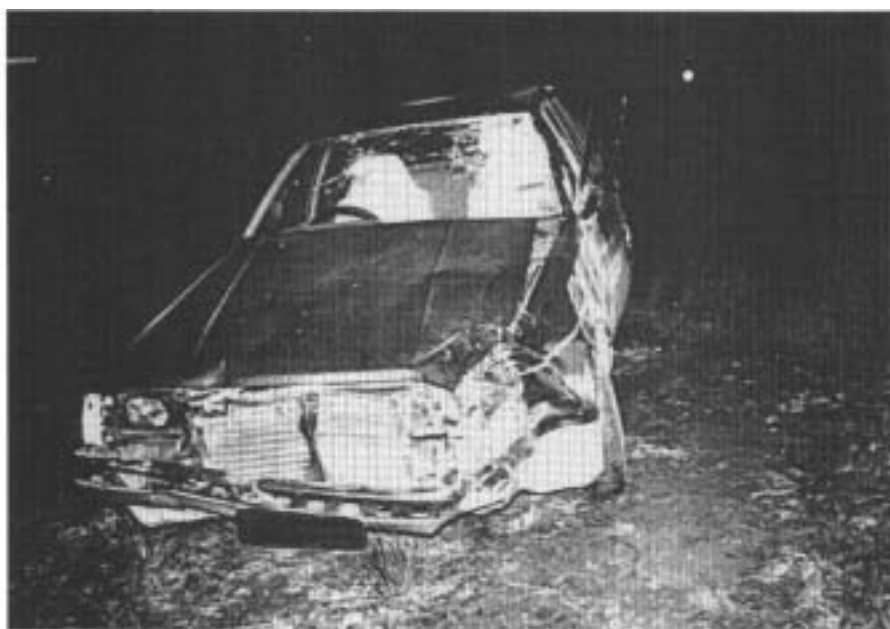
FIGURE A32: Crash 29. Damage to the left front of Nissan Pulsar from striking tree. Note occupant contacts on windscreen.

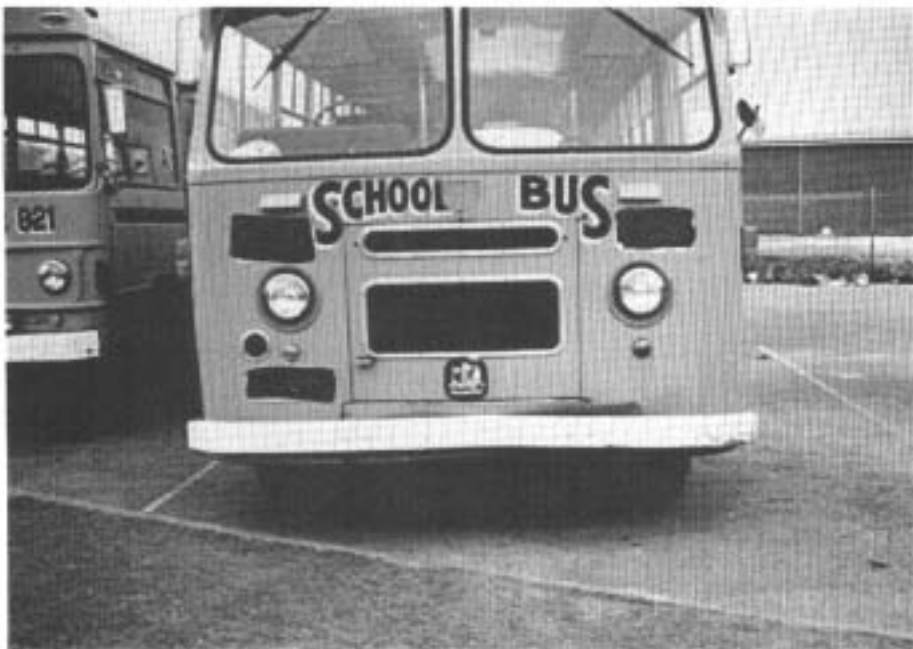
FIGURE A34: Crash 30. School bus. Damage above left end of bumper bar due to contact with motorcycle, which was on its left side.

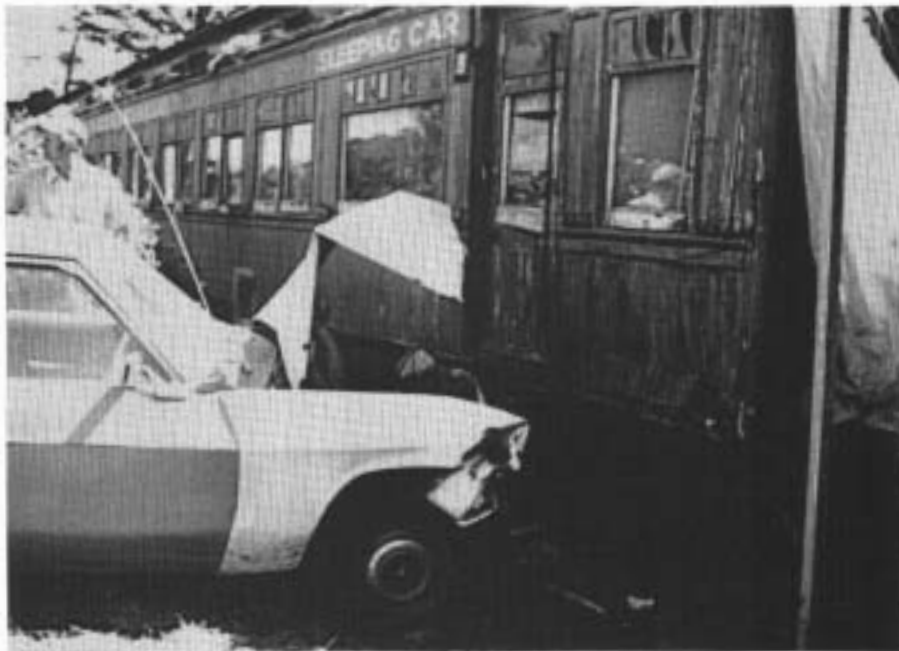
FIGURE A35: Crash 32. Final position of Holden Kingswood after impact with fixed carriage used as railway museum.

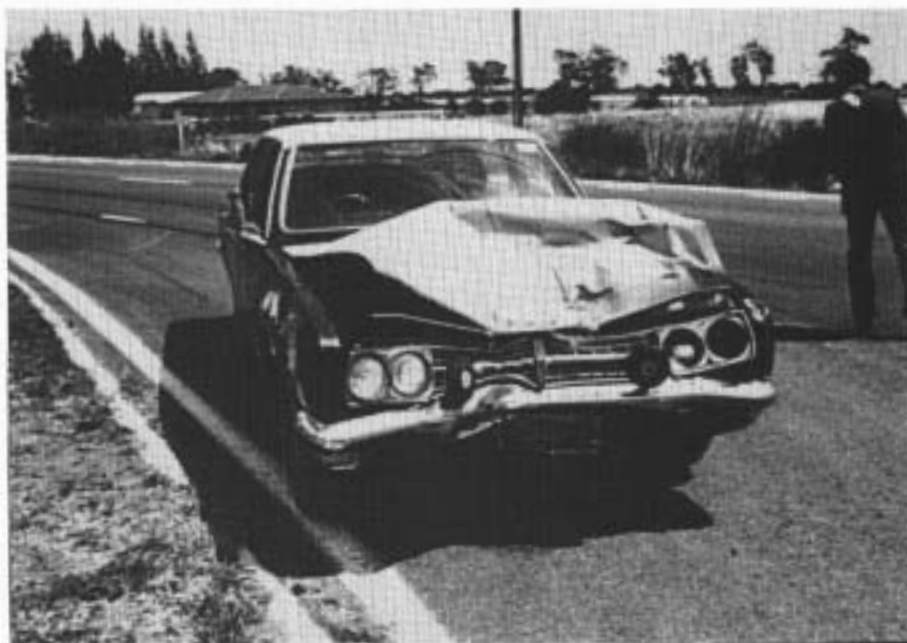
FIGURE A36: Crash 33. Final position of Holden Kingswood. Frontal damage due to striking right rear wheels of the trailer of a tray top truck.

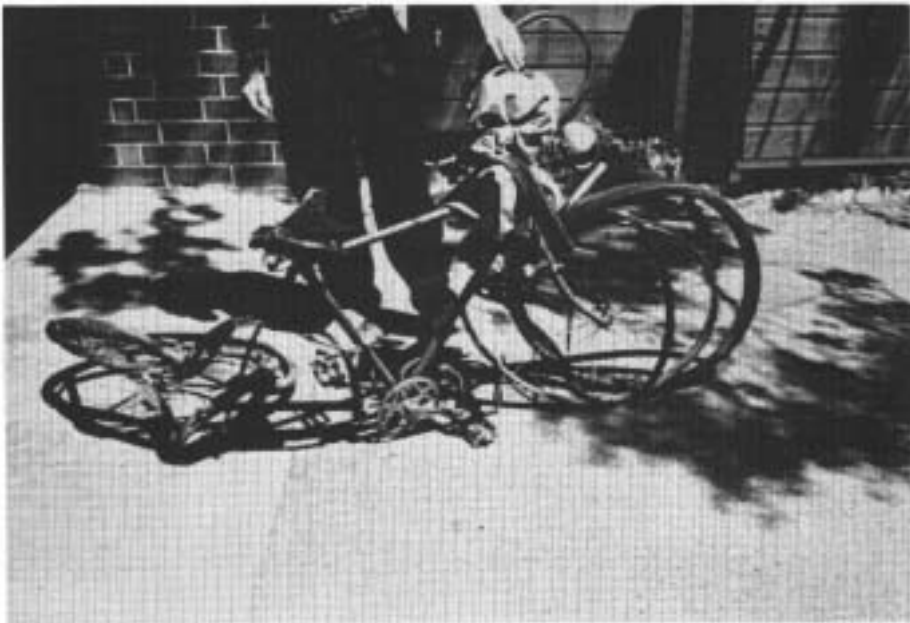
FIGURE A38: Crash 34. Damage to bicycle struck from the rear by a semi-trailer.

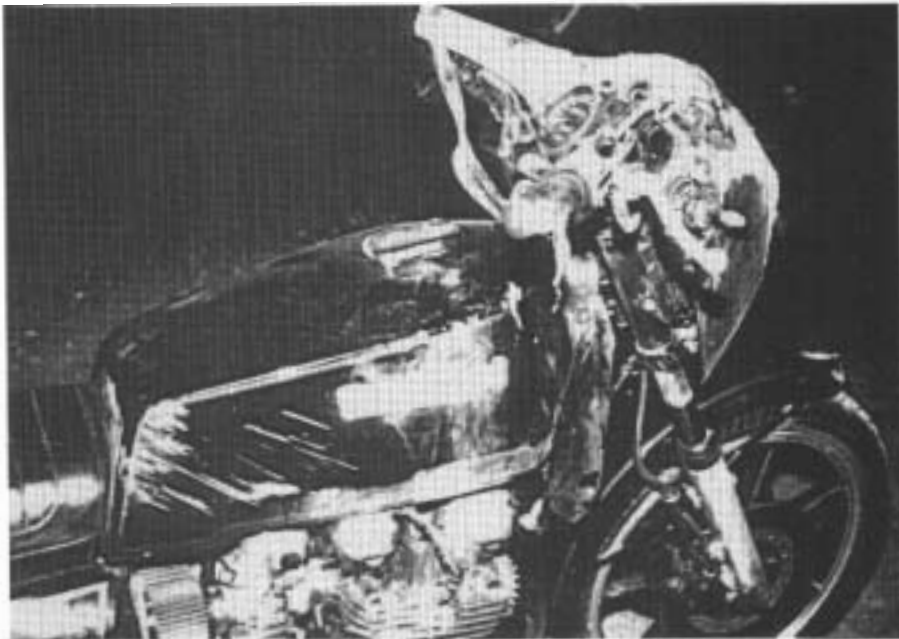
FIGURE A40: Crash 35. Damage to right side of motorcycle. Note scrapes to fuel tank from contact with road surface.

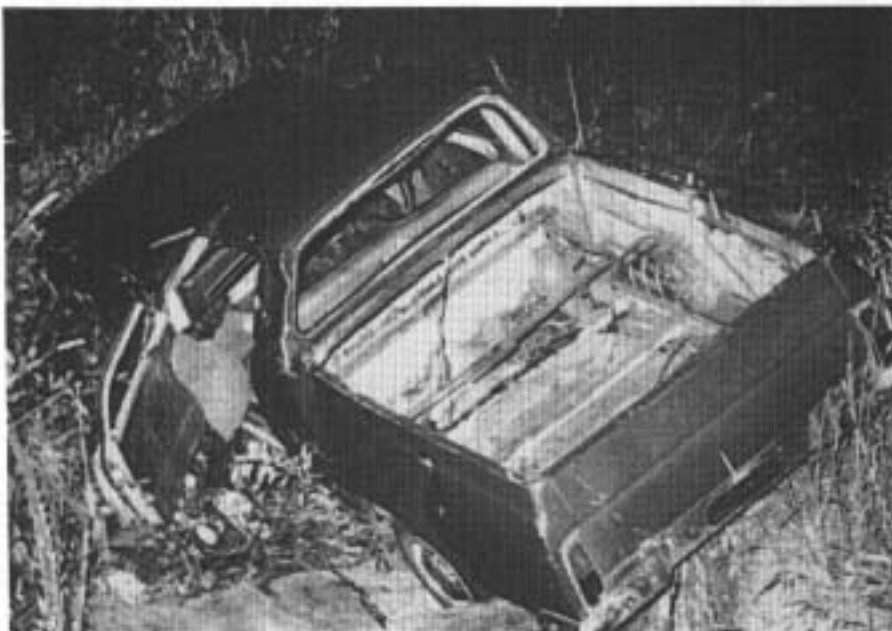
FIGURE A42: Crash 37. Final position of the utility. Note open left door through which two of the occupants, who both died, were partially ejected; and the severe rusting of floor pan of the rear load compartment.

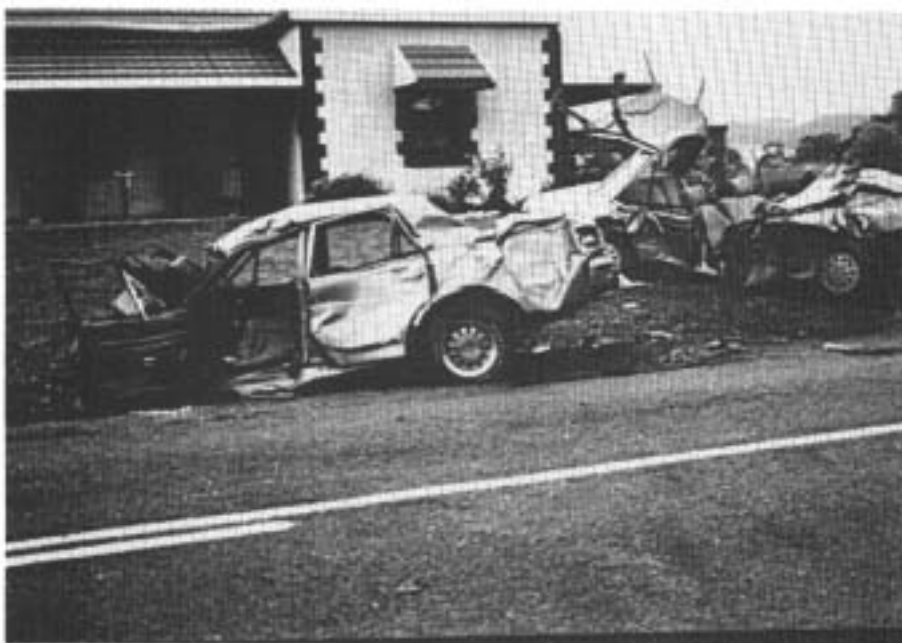
FIGURE A43: Crash 38. The final positions of both cars and the damage to each.

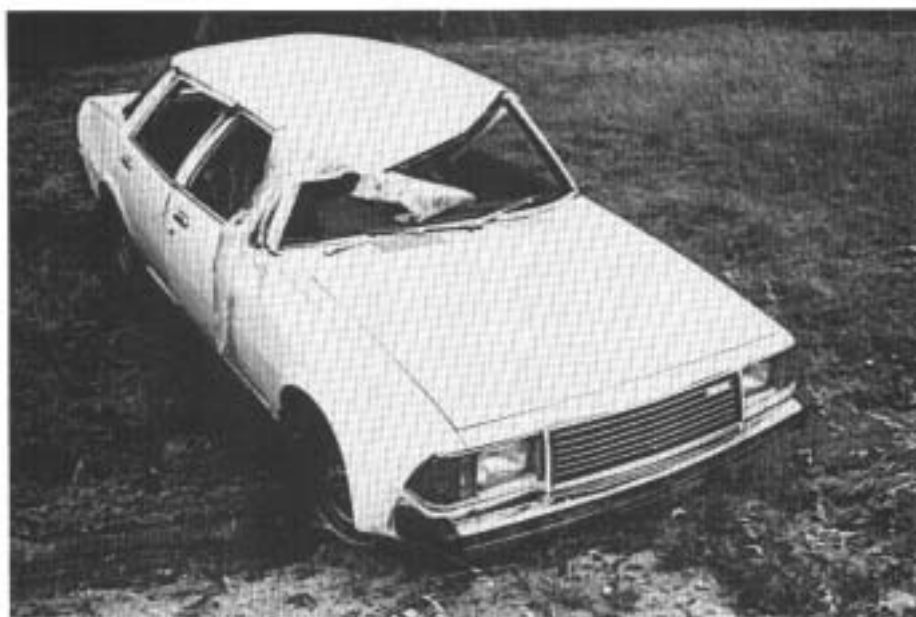
FIGURE A44: Crash 39. Final position of the car and damage to roof sustained during rollover.
