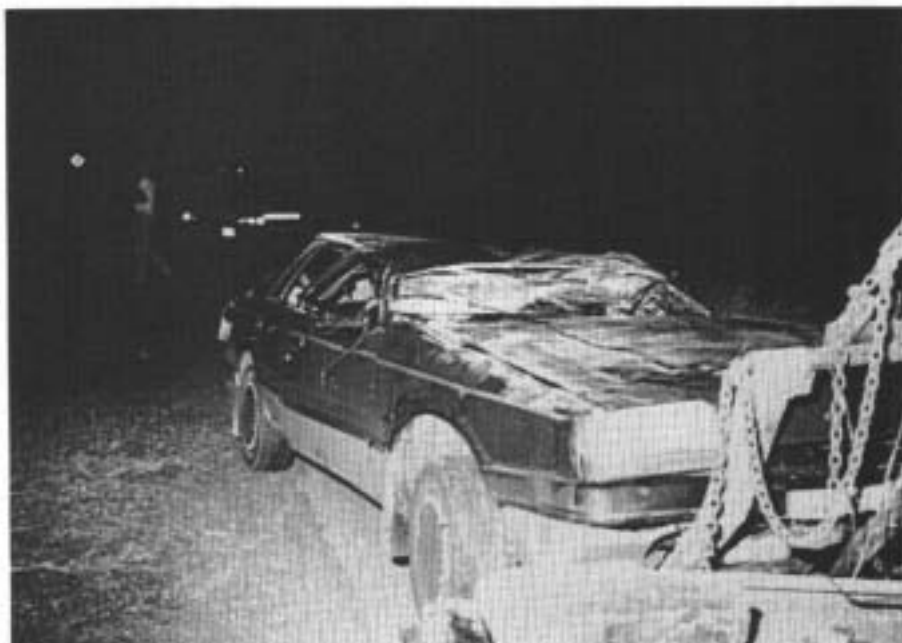
FIGURE A45: Crash 40. Damage to the car following roll-over. Note roof crushed to top of front seat backs.

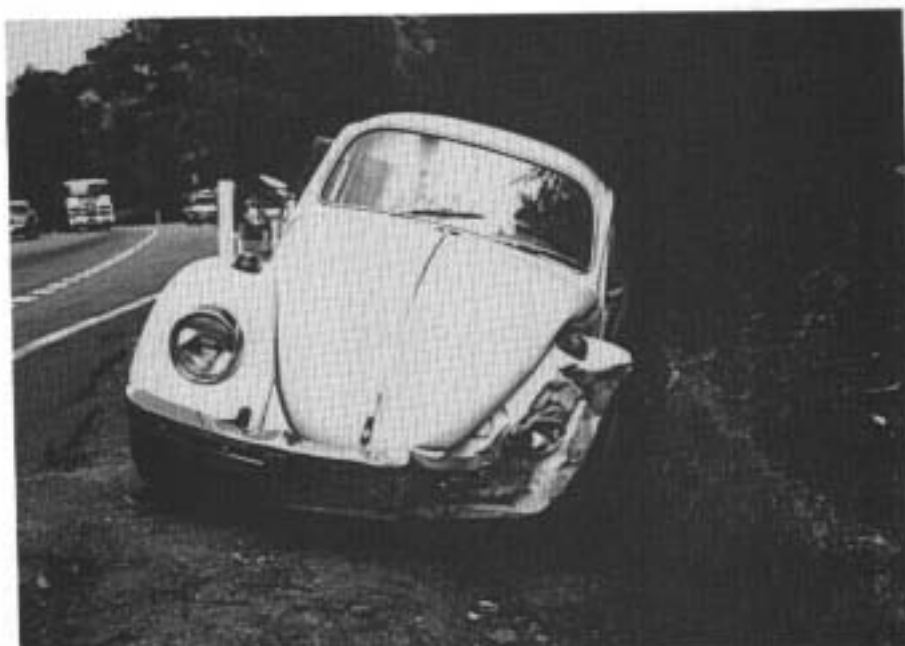
The car was travelling east, uphill at approximately 70 km/h in the right lane of a four lane arterial road divided by a narrow raised median. The driver, an elderly man travelling with her daughter, drove only infrequently and had not driven for three months. She was on her way to see her doctor to renew her driver's licence. One of several trucks travelling in the left lane just ahead of the car appeared to drift towards the right lane. The driver of the case vehicle, presuming that the truck was going to collide with her, veered to the right, mounting the raised median with her right wheels. Her vehicle then swerved back to the left, passing between two trucks travelling in the left lane, and struck a concrete retaining wall with the left front corner and left side. The vehicle came to rest with its left side against the retaining wall.

FIGURE A46: Crash 41. The final position of the car. Note damage to the left front corner due to impact with a concrete retaining wall.

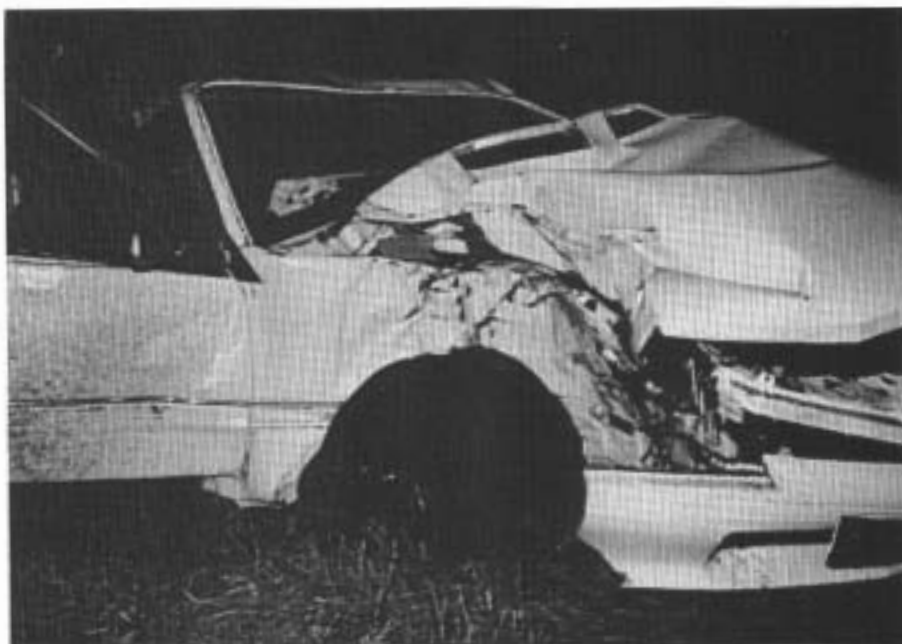
FIGURE A47: Crash 42. Damage to the right front side of Holden Commodore due to impact with tree.

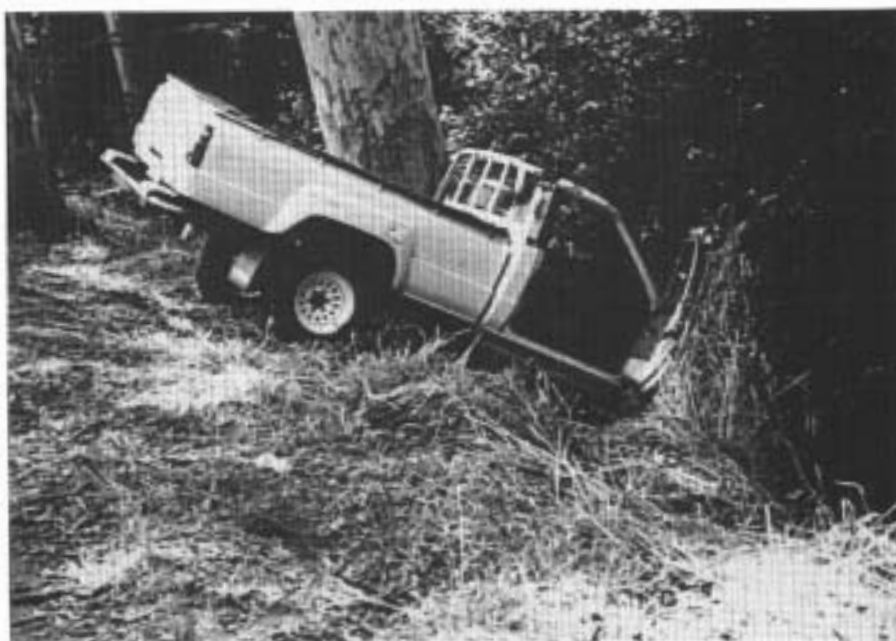
FIGURE A48: Crash 43. Final position of the utility.

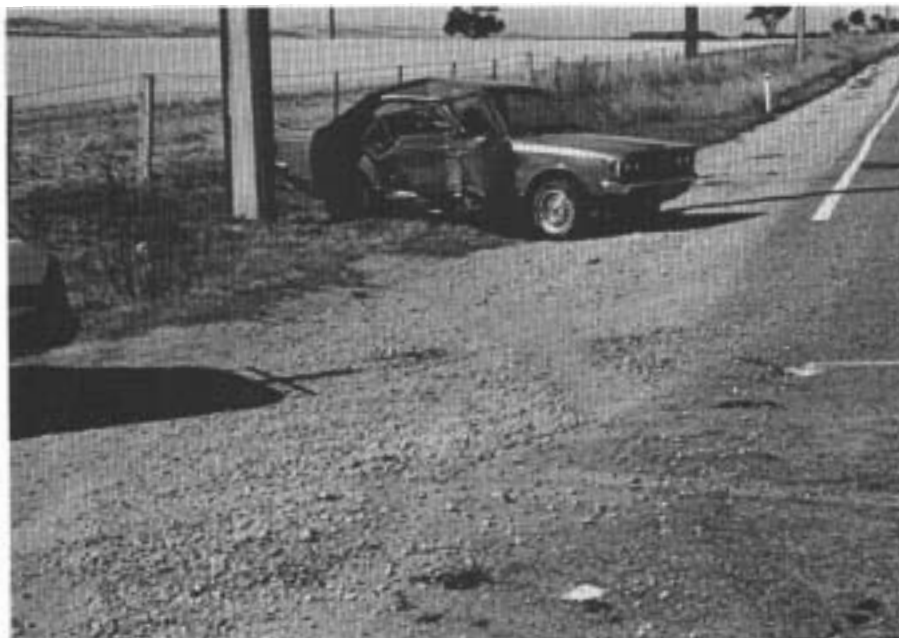
FIGURE A49: Crash 44. Final position of Toyota Corona. Note damage to right side and forward displacement of 'B' pillar due to impact with pole.

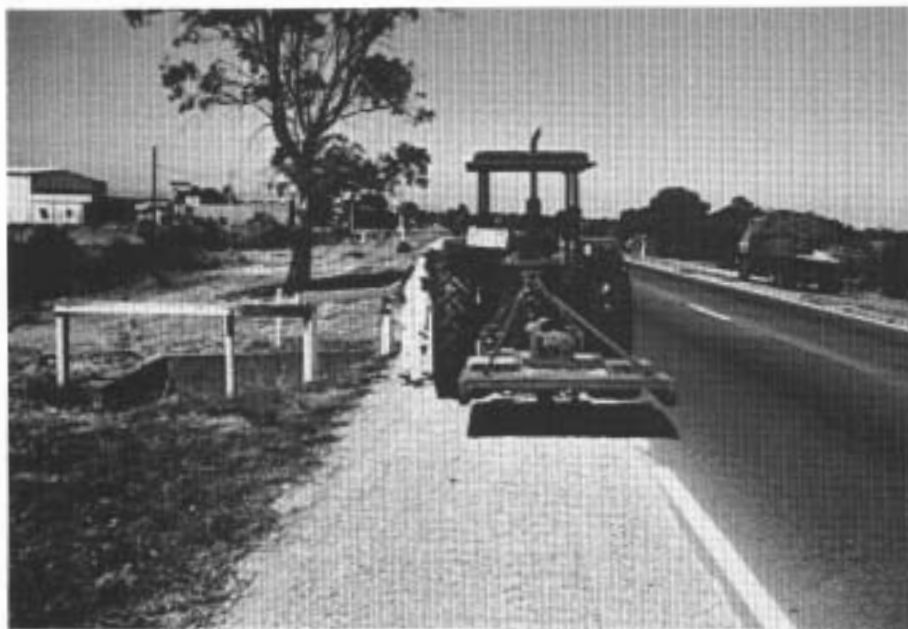
FIGURE A50: Crash 46. Tractor with mower attachment struck by motorcycle. The motorcycle contacted the right rear corner of the mower.

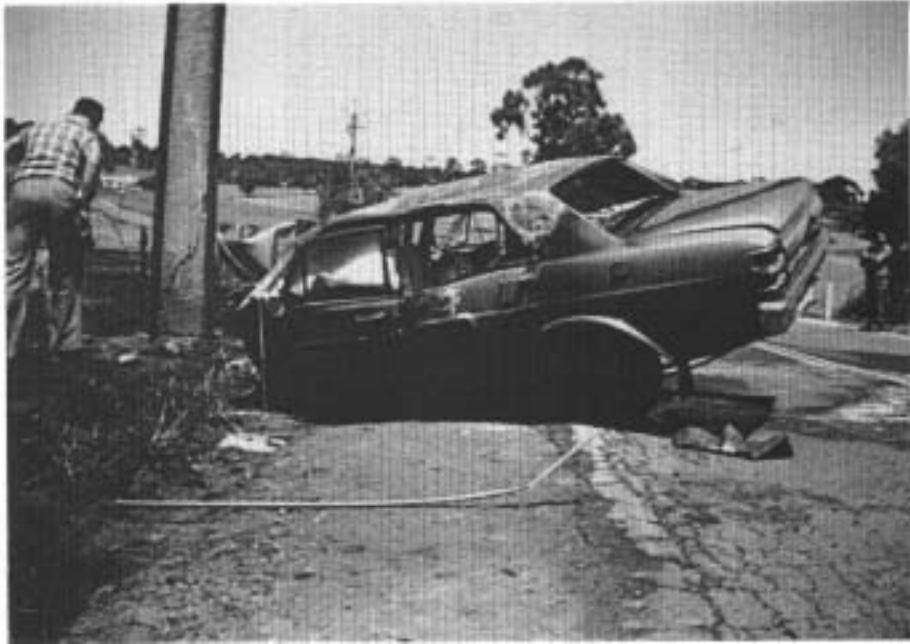
FIGURE A51: Crash 47. Final position of the car. Note damage to left front corner and scorching of the paint work from the fire which started after the impact.

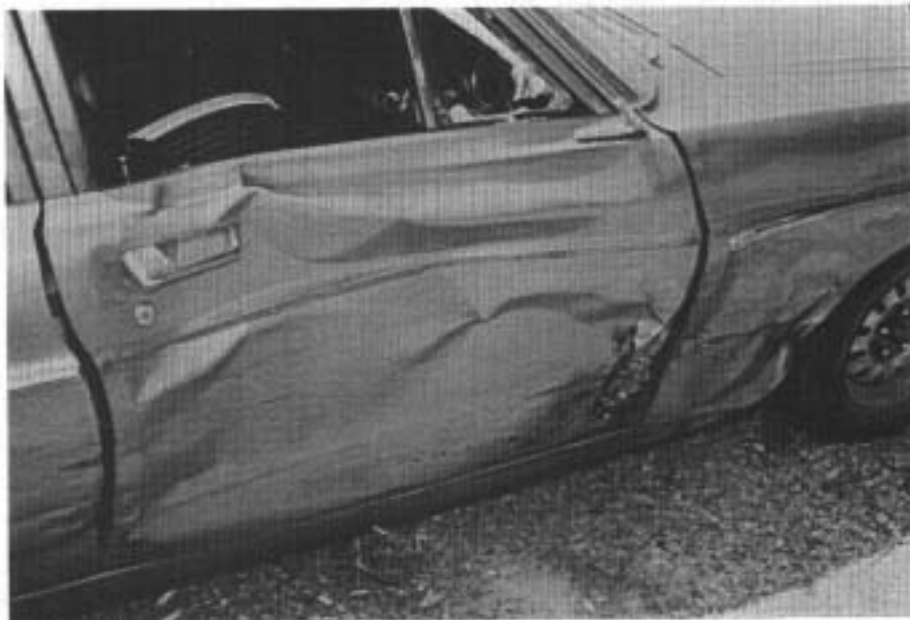
FIGURE A52: Crash 48. Damage to the right side of the car due to impact with the motorcycle and rider.

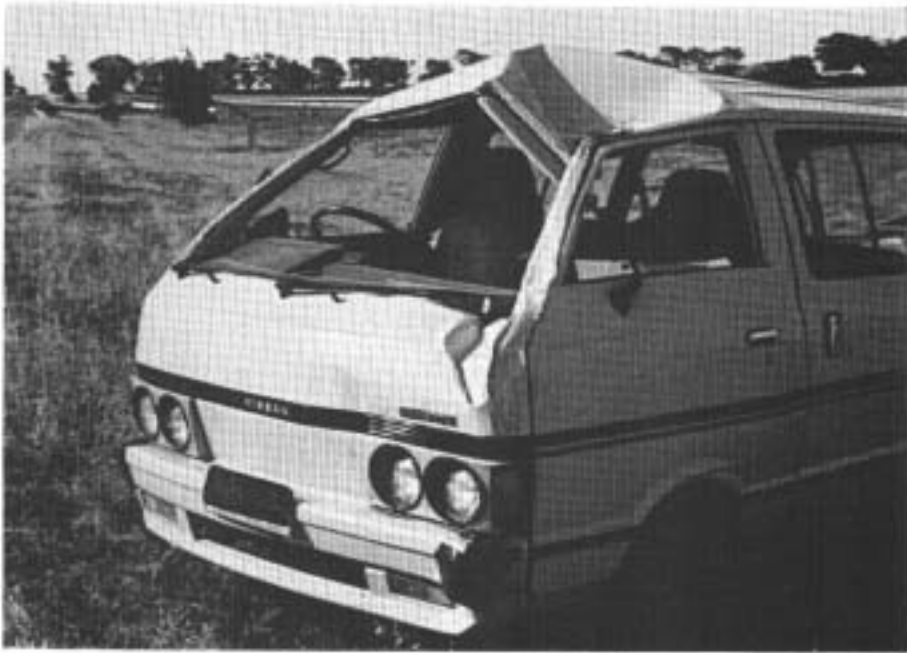
FIGURE A53: Crash 49. Final position of van showing damage sustained during rollover.

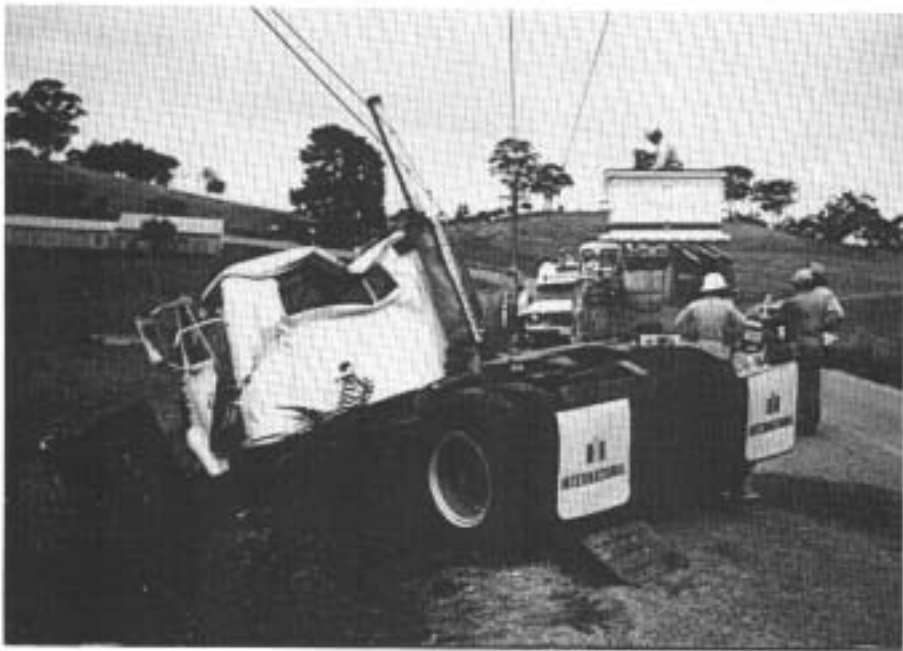
FIGURE A54: Crash 50. Final position of prime mover. Note deformation to right side of the roof due to impact with utility pole.

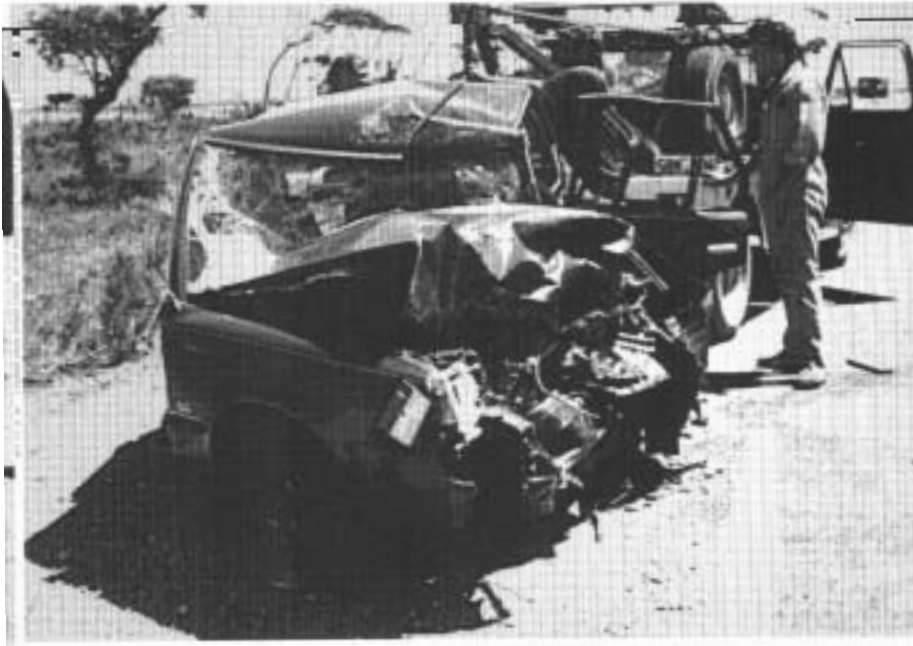
FIGURE A55: Crash 52. Frontal damage to Toyota Corona.

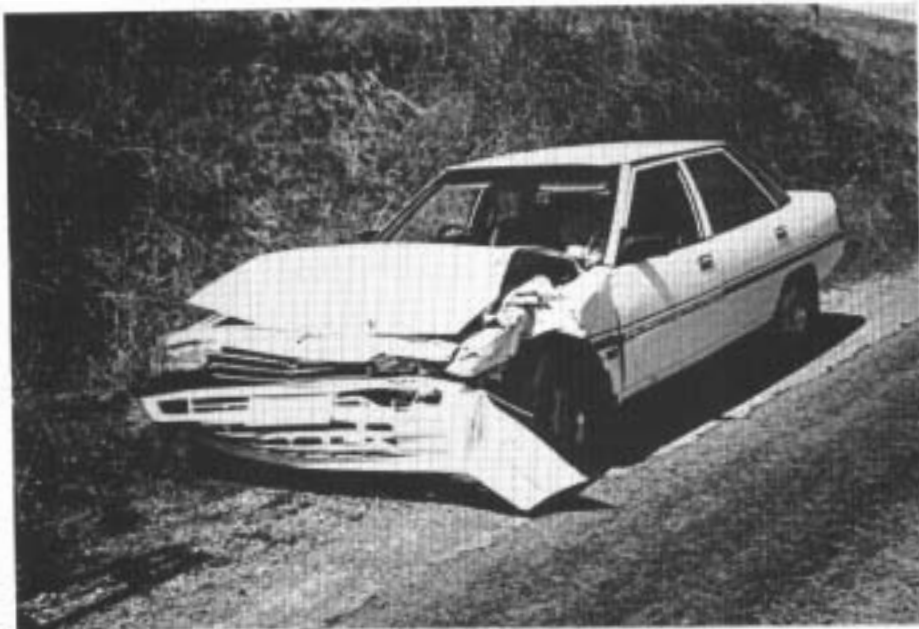
FIGURE A56: Crash 53. Frontal damage to Mitsubishi Magna.

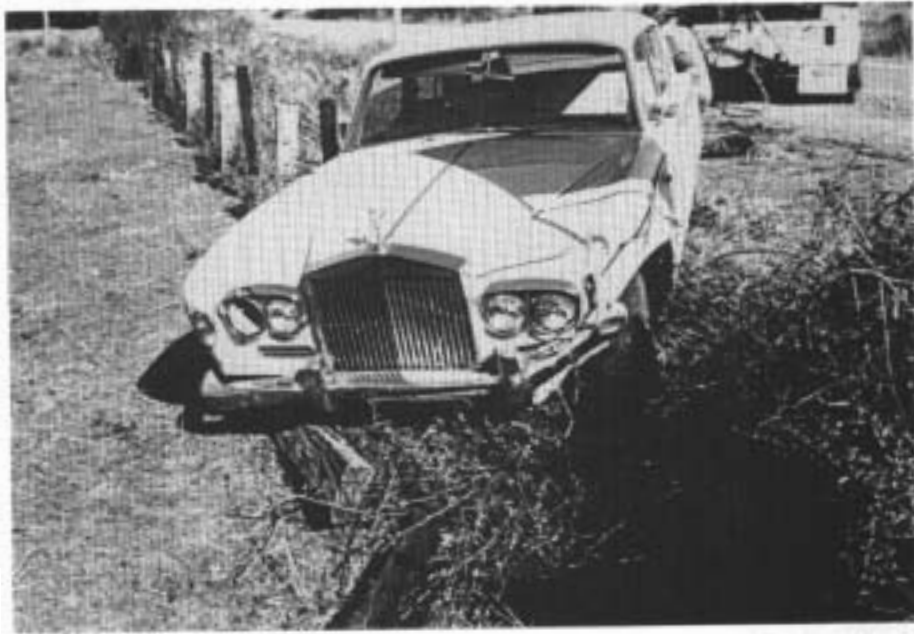
FIGURE A57: Crash 54. Final position of Rolls Royce, and frontal damage due to impact with fence post.

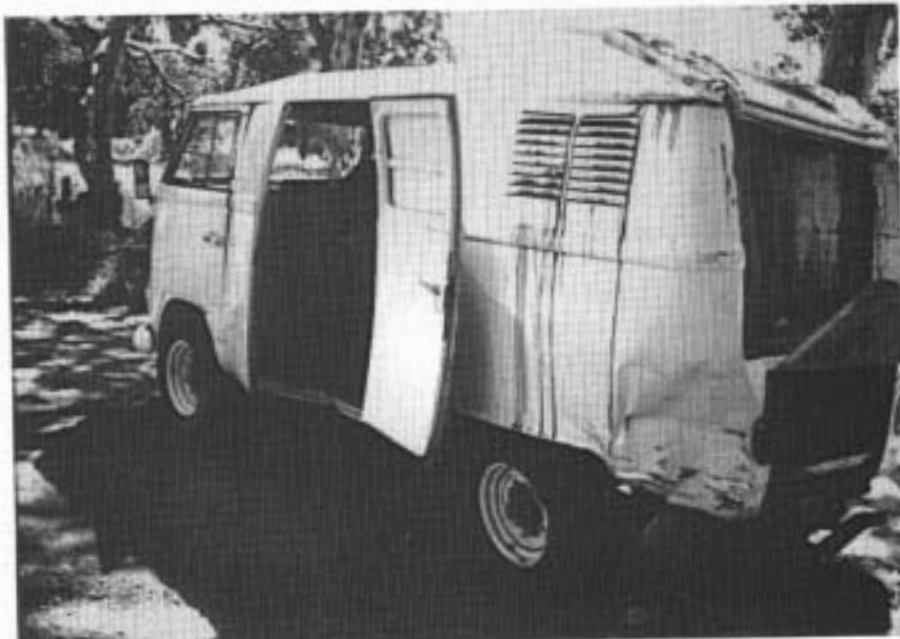
FIGURE A58: Crash 55. Damage to left side of van. Centre and rear doors opened during the rollover allowing the rear occupants to be ejected.

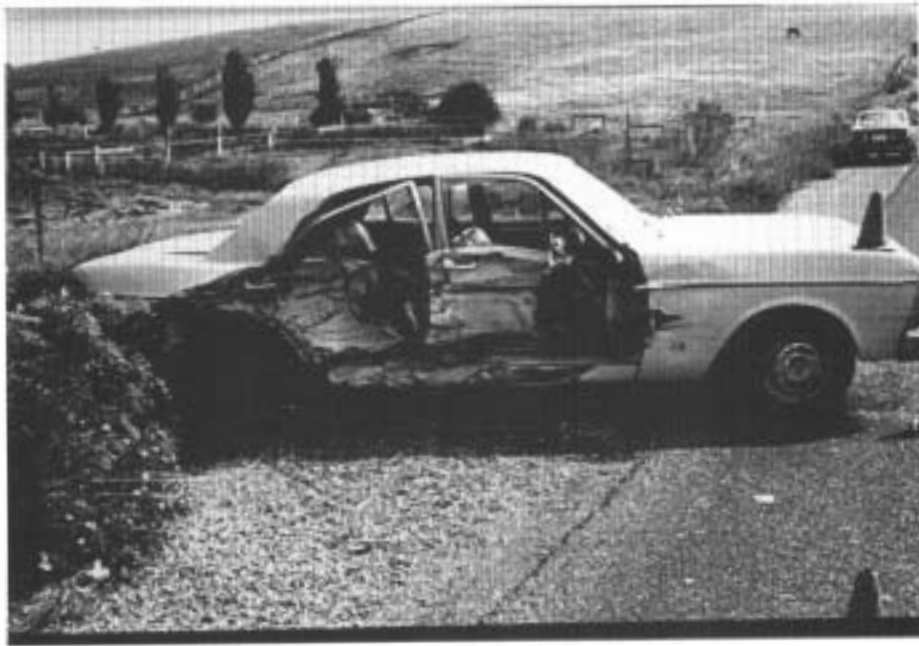
FIGURE A59: Crash 57. Final position of Ford Falcon and damage to right side.

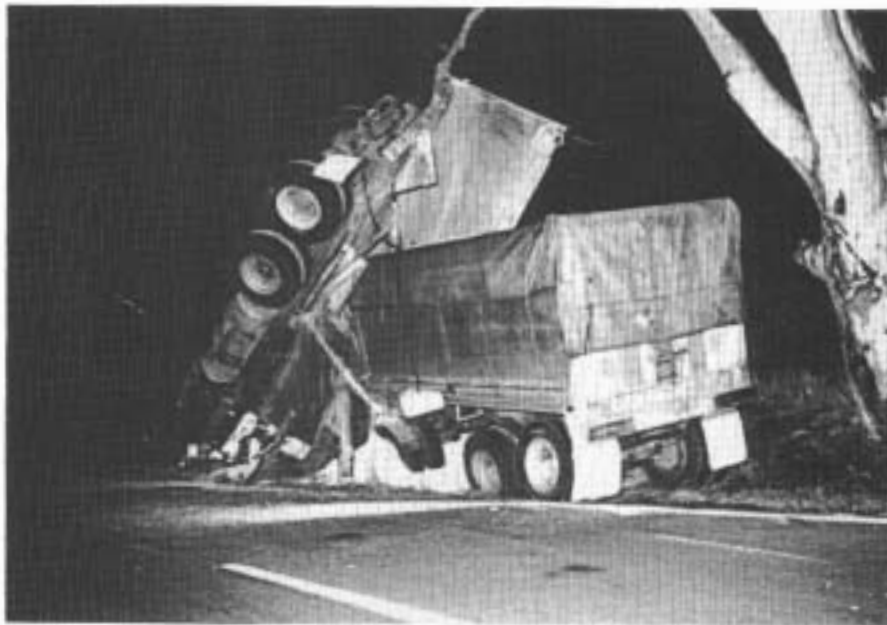
FIGURE A60: Crash 58. Final position of the tip truck.

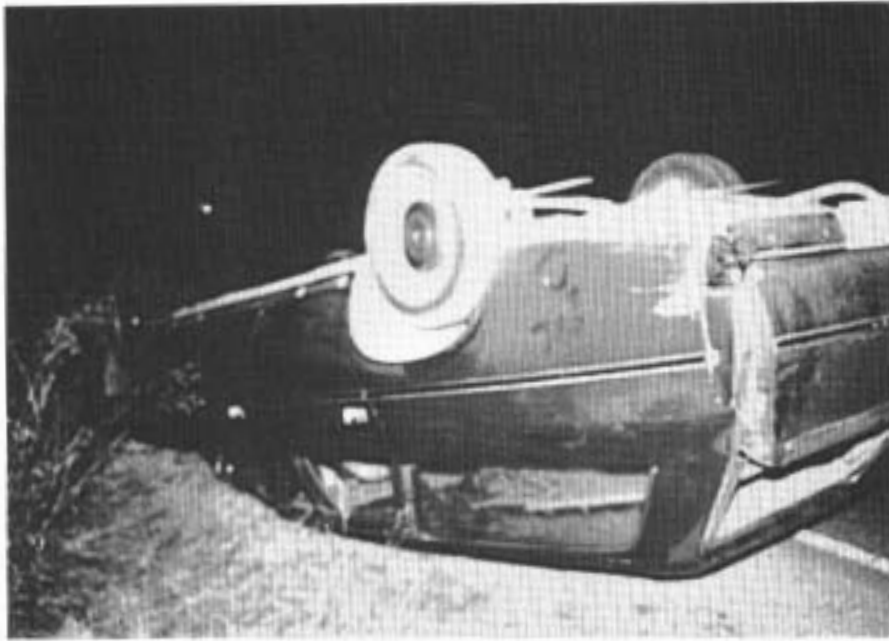
FIGURE A61: Crash 59. Final position of the station wagon.

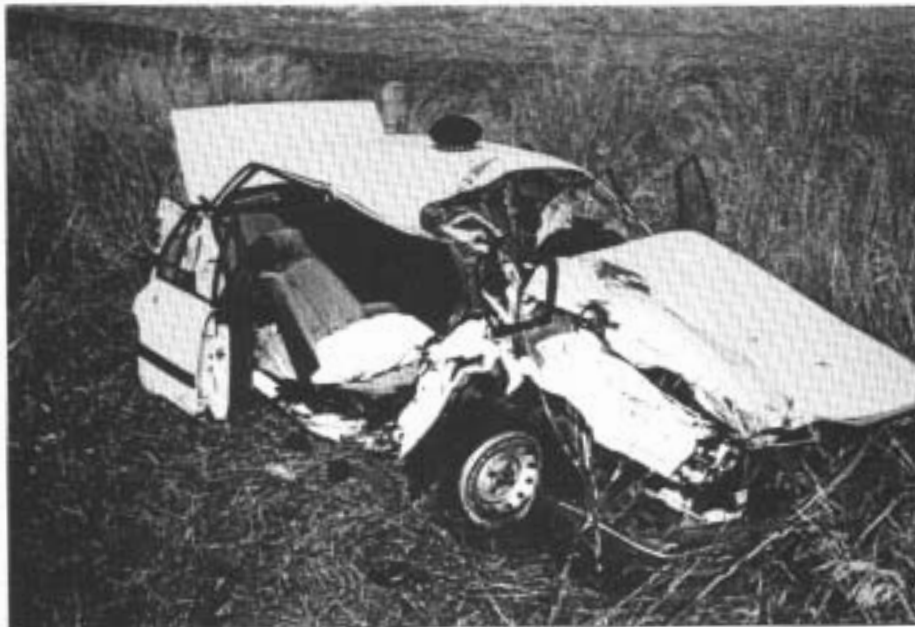
FIGURE A62: Crash 60. Final position of Holden Camira showing extensive damage to the right side due to impact with the semi-trailer.

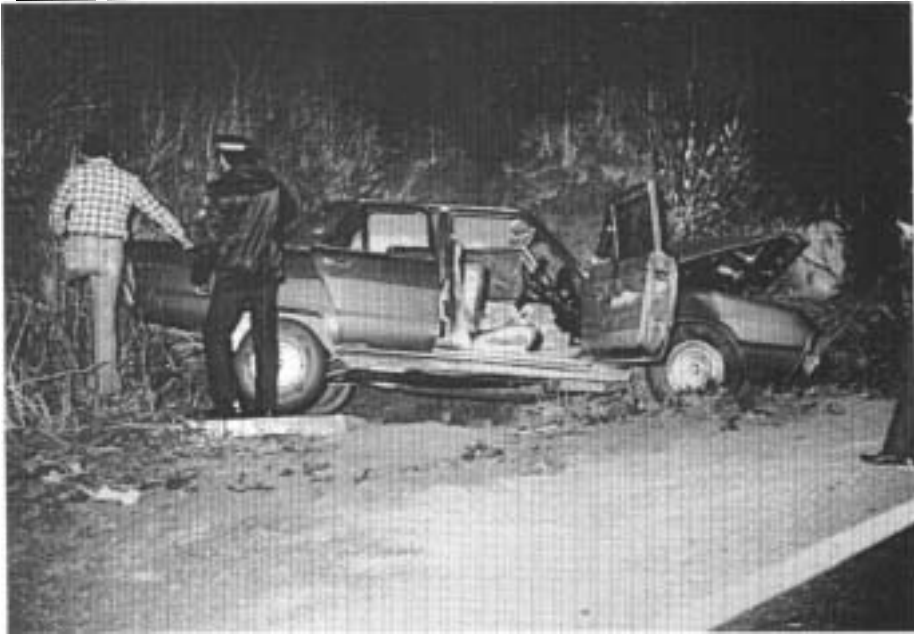
FIGURE A63: Crash 63. Final position of Valiant sedan against embankment.

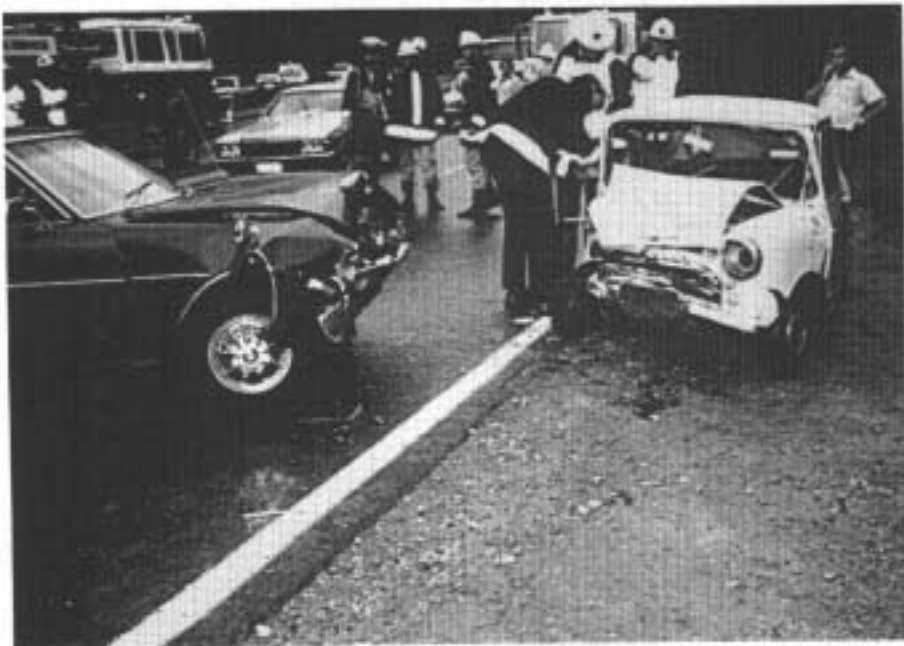
FIGURE A64: Crash 64. Final position of Toyota Celica sedan and Morris Mini sedan.

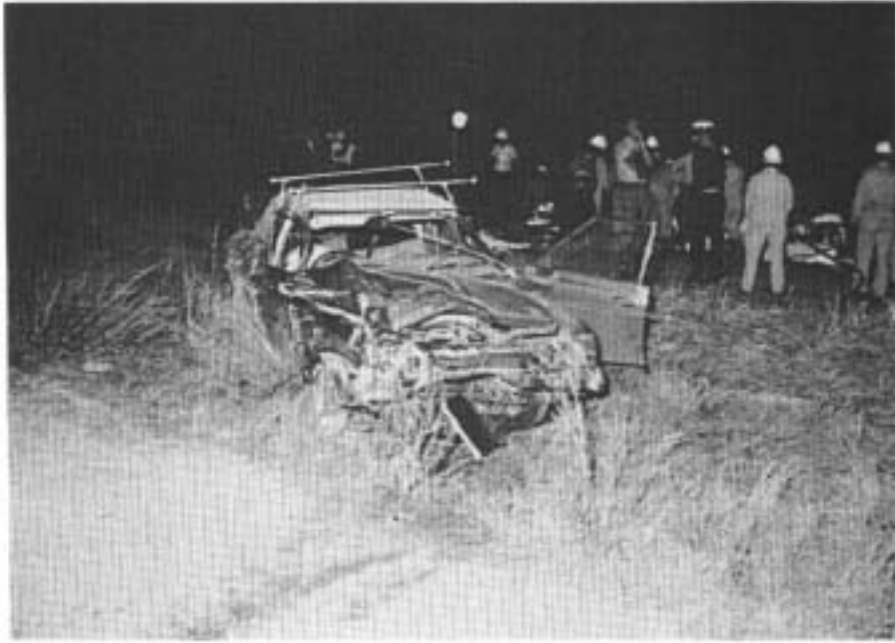
FIGURE A65: Crash 65. Final position of Ford Cortina showing damage to front and right side. The Datsun 180B is visible in the background surrounded by Emergency Service personnel.

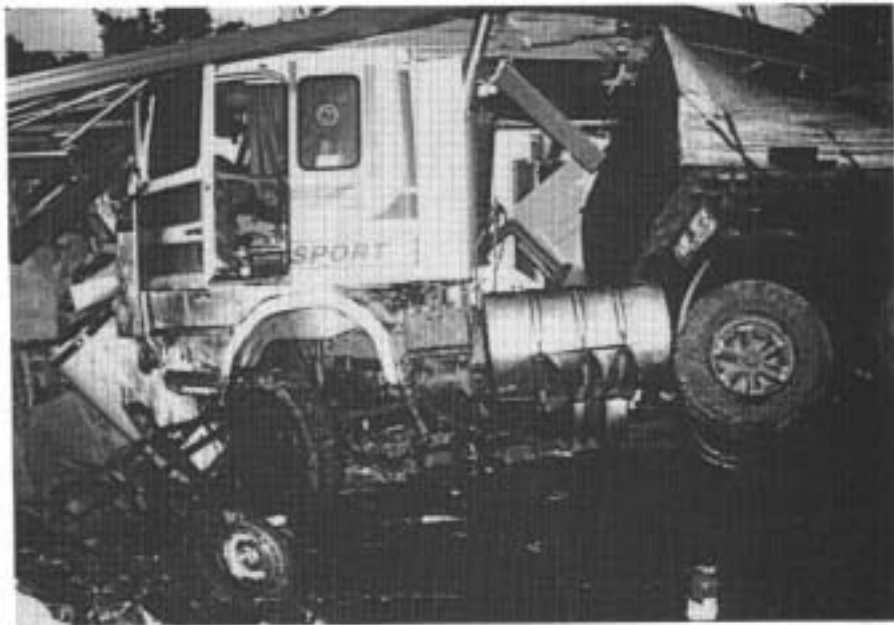
FIGURE A66: Crash 67. Final position of semi-trailer inside the rear of a house. Note Holden Commodore trapped beneath the prime mover.

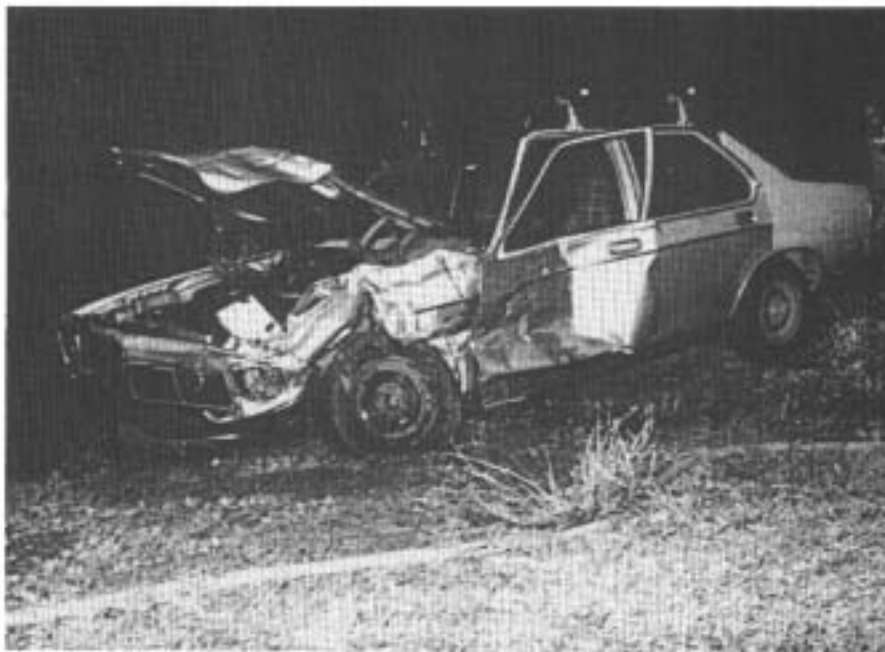
FIGURE A67: Crash 69. Final position of Holden Torana showing impact damage to left side.

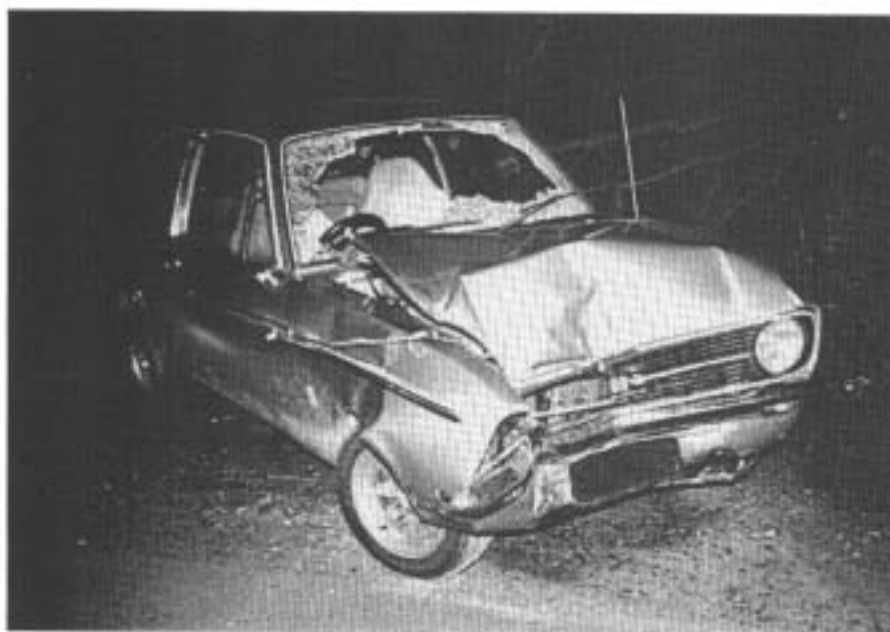
FIGURE A68: Crash 70. Final position of Ford Escort showing crash damage to front and right side. Note windscreen broken from contact by the unrestrained driver.

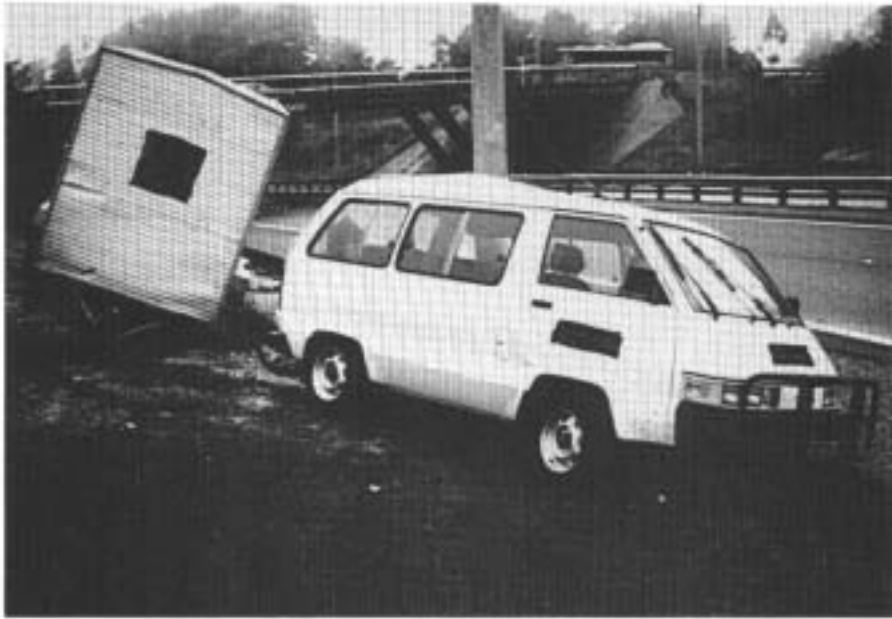
FIGURE A69: Crash 71. Final position of the van which came to rest against a non-frangible pole. Note the trailer which has become detached after breaking off the towbar from the van.

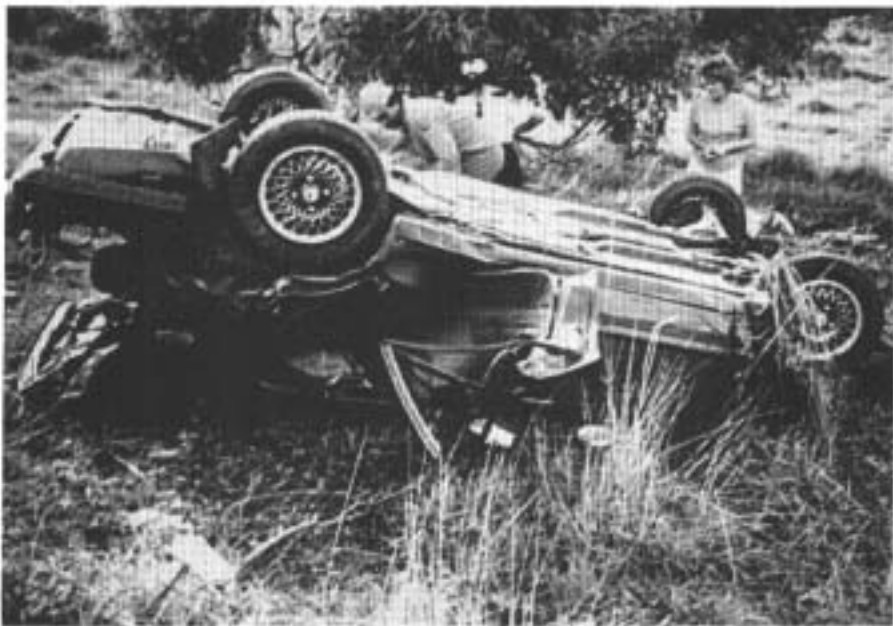
FIGURE A70: Crash 72. Final position of the car. Note extensive crushing of the roof into the occupant space.

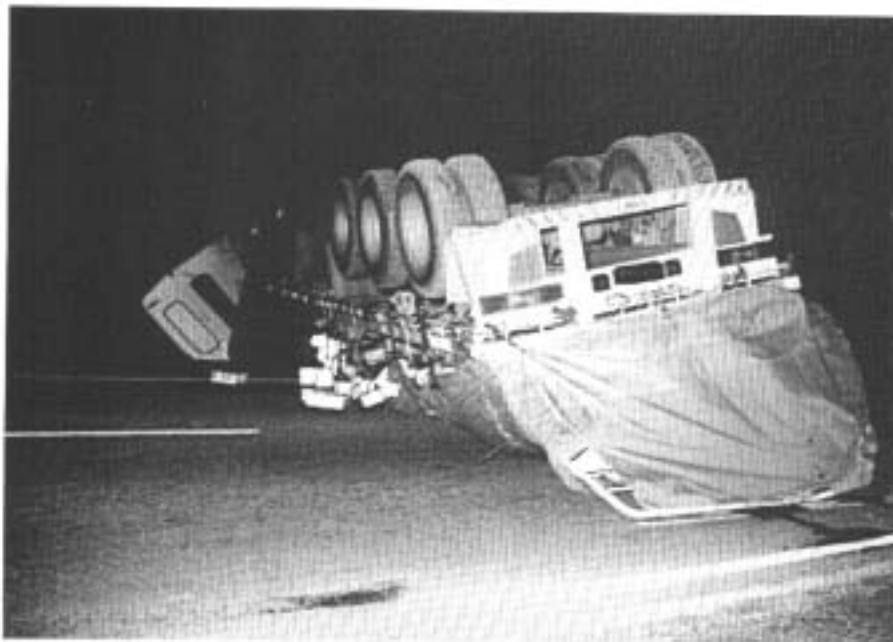
FIGURE A71: Crash 73. Final position of the semi-trailer showing partial loss of load.

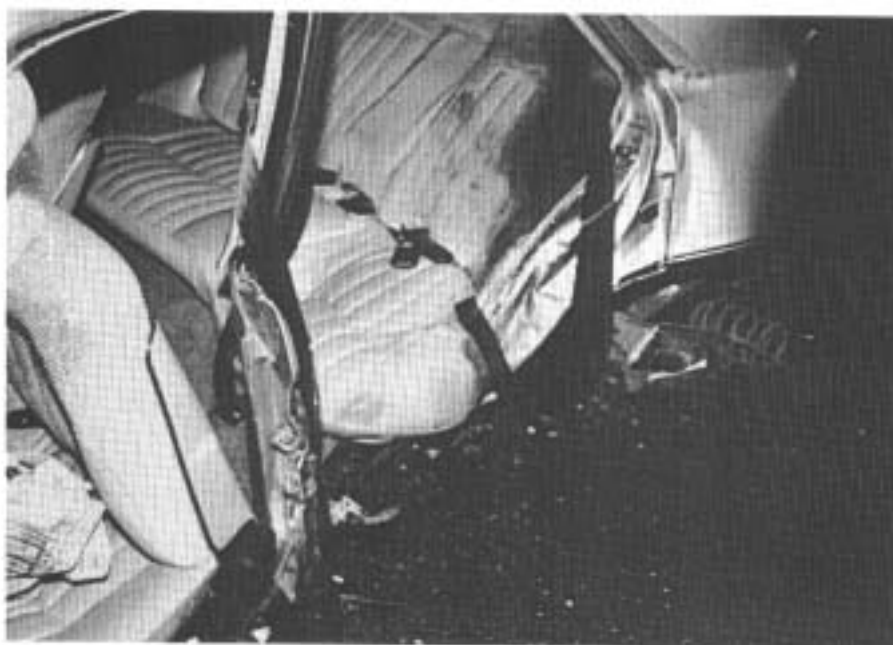
FIGURE A72: Crash 74. Left side of Sigma sedan which struck a tree on the left rear door. Note the intrusion into the rear seat occupant space. Left rear seat passenger was killed.

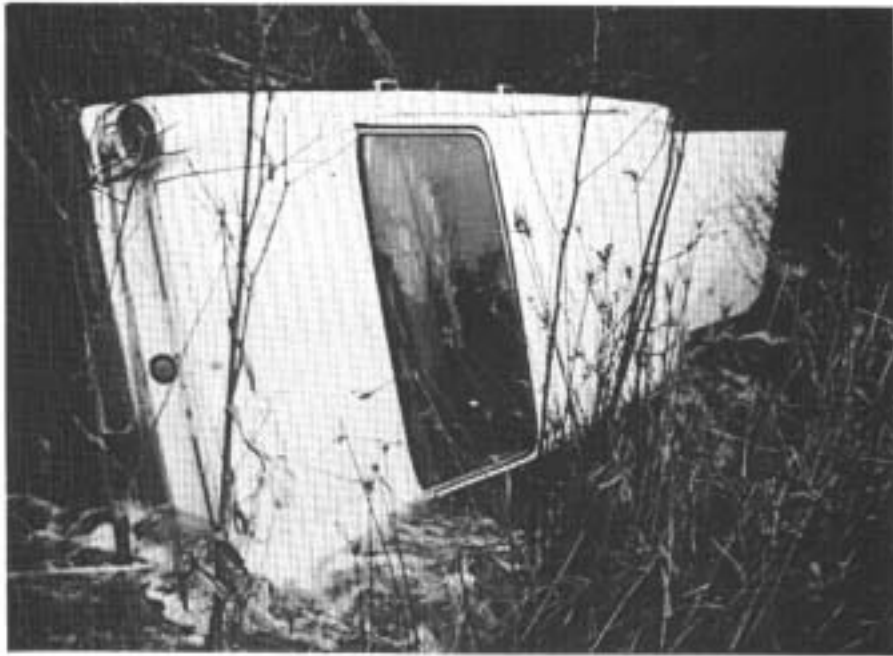
FIGURE A73: Crash 75. Final position of the car which came to rest on its right side in a fast flowing stream.

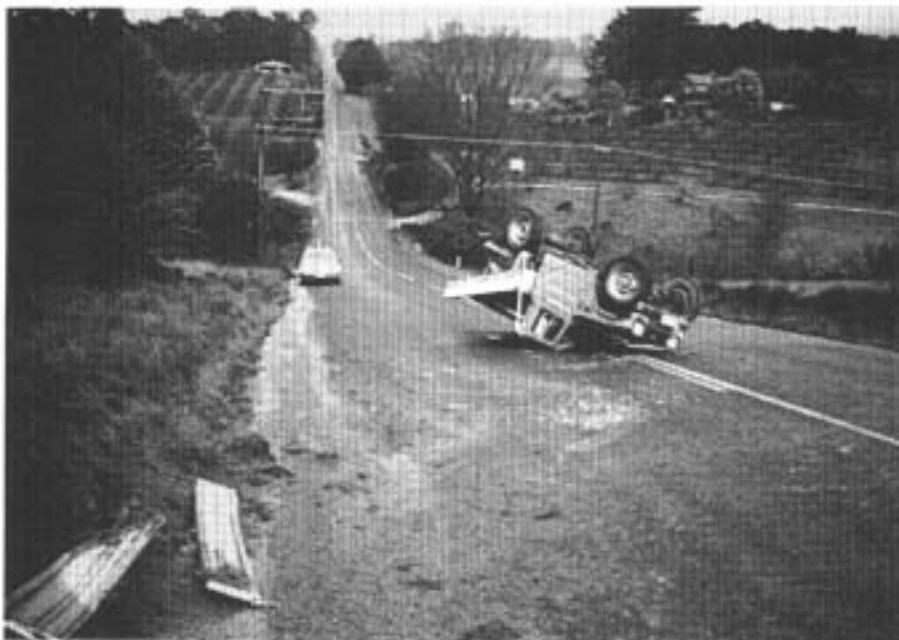
FIGURE A74: Crash 76. Final position of the utility. Note panels from the rear tray on the shoulder of the road.

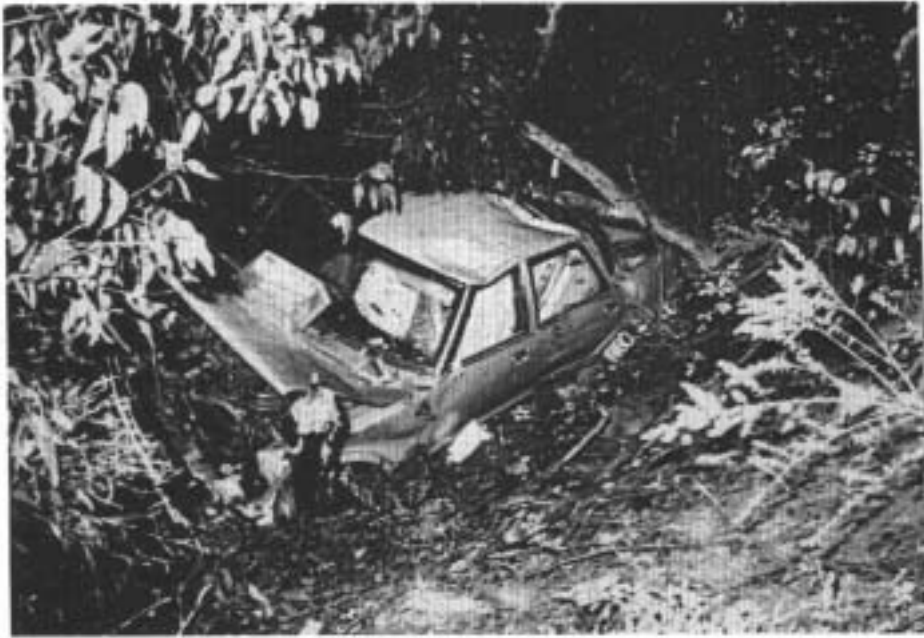
FIGURE A75: Crash 77. Final position of the car down an embankment.

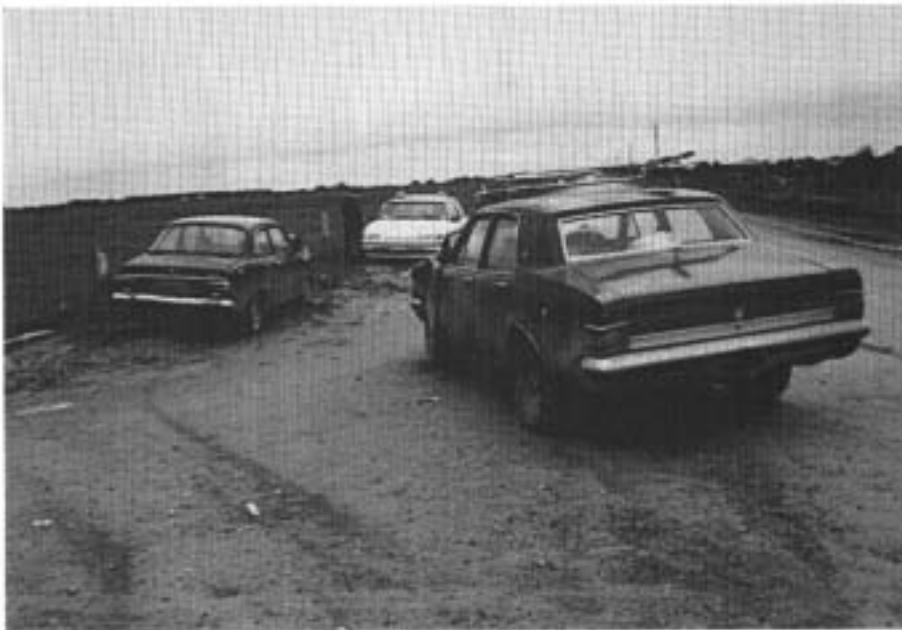
FIGURE A76: Crash 78. Final positions of Holden Premier sedan and Ford Escort sedan. Note skid marks indicating the vehicles' paths after impact.
