Report No.	Date	Pages	ISBN	ISSN
CR 155	June 1995		0 642 51261 2	0810-770X

**STUDY OF HEAVY VEHICLE CRASHES IN URBAN AREAS**

Report on Heavy Vehicle Black Spot Investigations - Melbourne

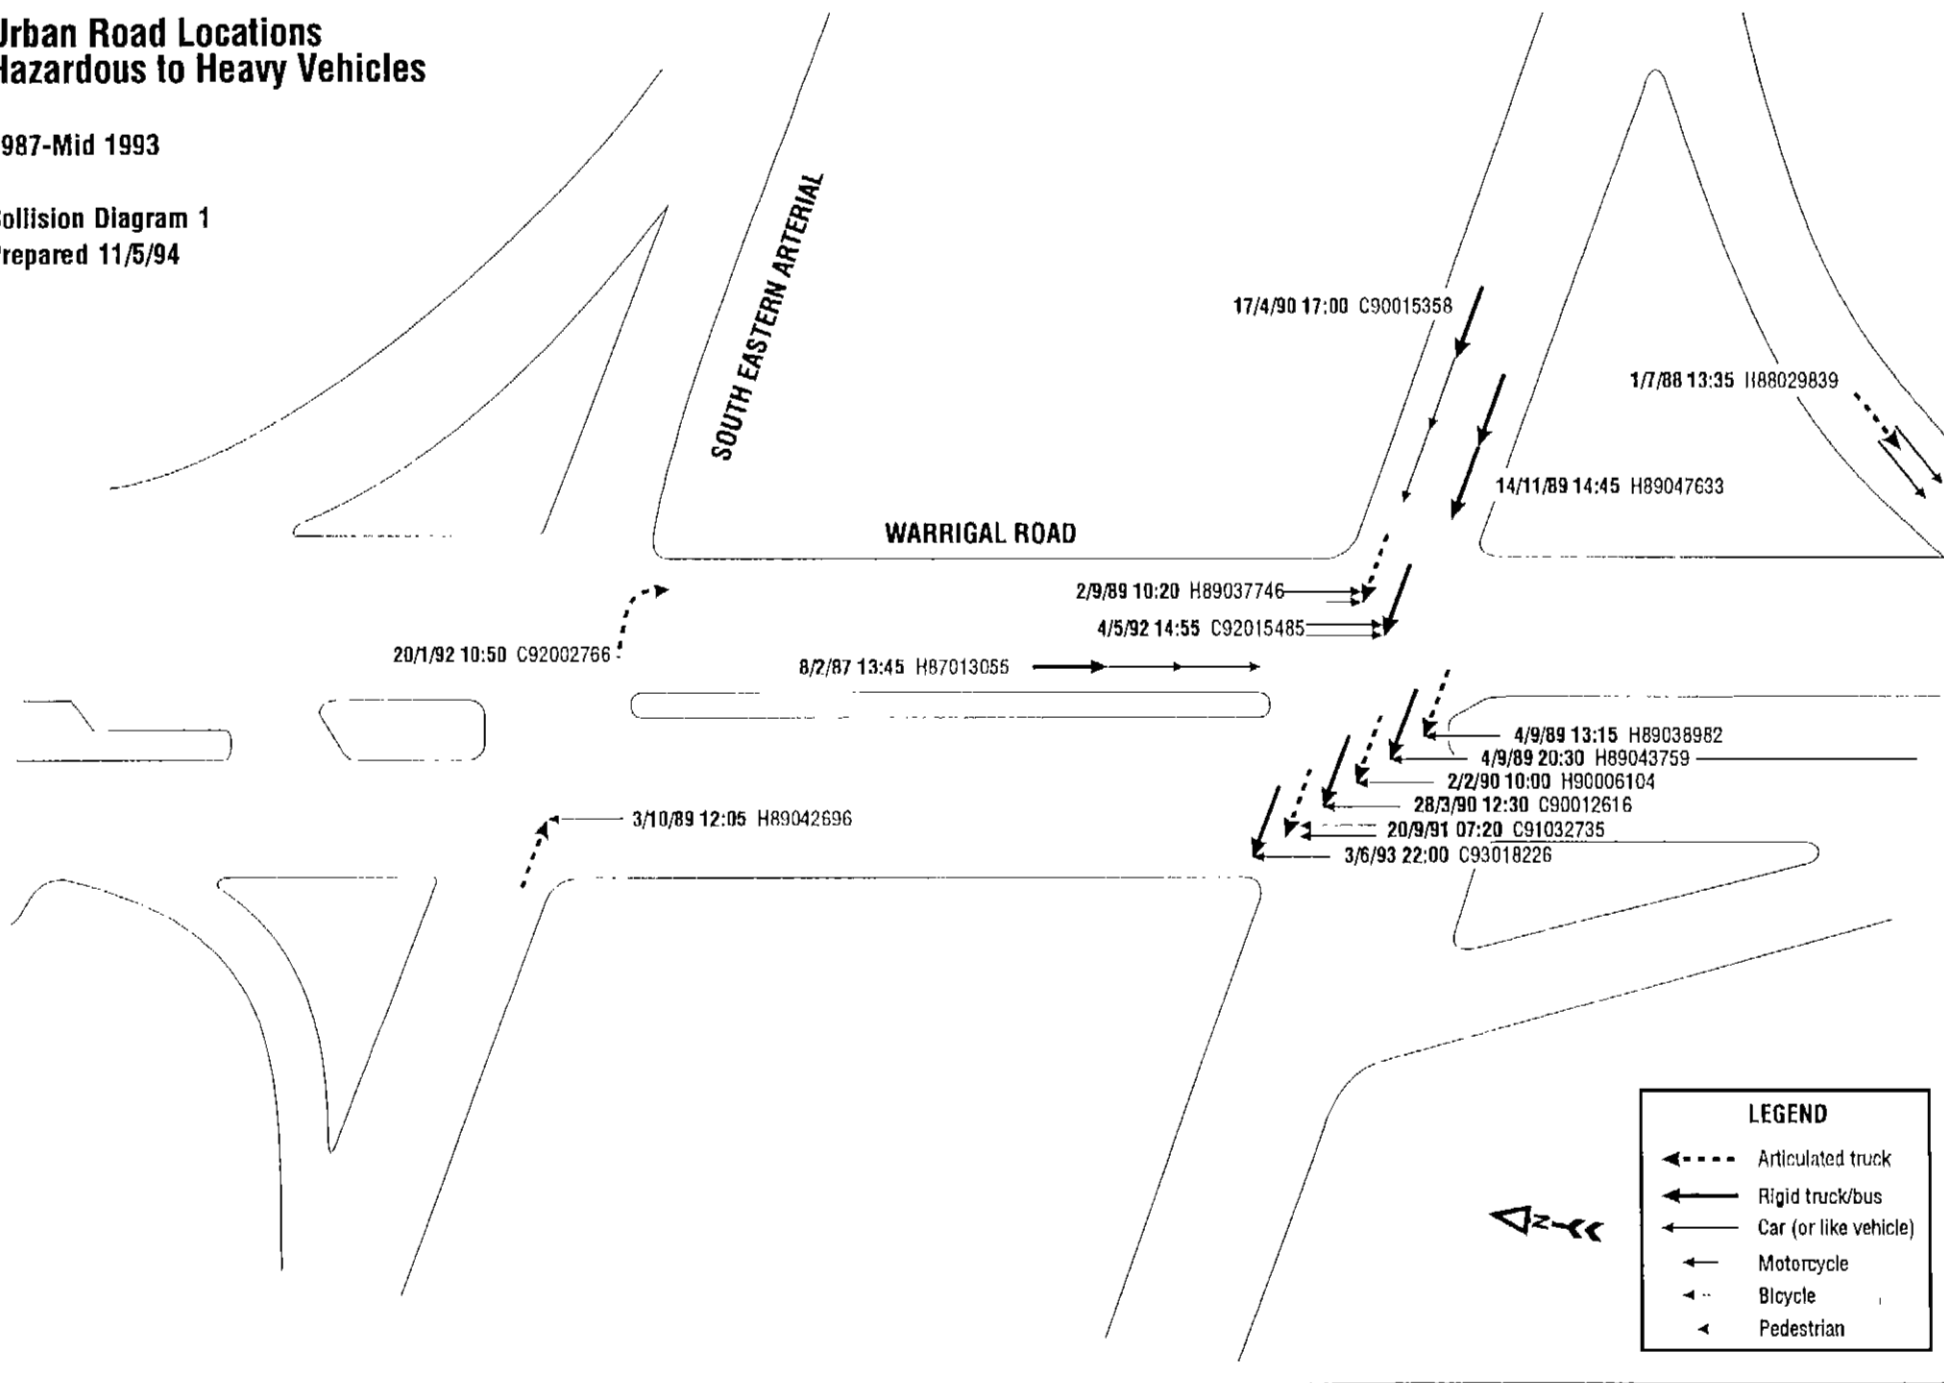
Collision Diagram 1

- **high vehicle speeds** on both roads but especially the SEA;
- a tendency for motorists in general, and heavy vehicle drivers in particular, to "**run the red**" (heavy vehicles were exclusively involved on the SEA). In seven of the nine cross-traffic crashes, the heavy vehicle entered on a red signal or just as the signals were changing to red. In five of these cases, **heavy vehicle brake failure or poor braking performance** was mentioned in Police reports as factors. In two instances Police considered the **signal inter-green times to be too short** for the circumstances.

- **high vehicle speeds and congested traffic conditions** - for many Melbourne bound motorists on the South Eastern Arterial, the intersection is the first signalised intersection (and one of only a few along the SEA) to be encountered after a relatively long period of driving at high speeds under freeway conditions.;
- the drivers of heavy vehicles being unable to stop in time to avoid colliding with stationary or near-stationary vehicles (rear-end collisions are characteristic of traffic signal crash patterns generally). **Brake failure of heavy vehicles** was cited in one of the three cases, while in other cases the cause may be the **inferior braking performance** of heavy vehicles compared to lighter vehicles and/or to **poor decision-making** by drivers of heavy vehicles faced with a red or changing signal display.

With the recent grade-separation of this intersection under the Victorian Transport Accident Commission's Accident Black Spot Program, most of the potential for crashes of the type found here has been eliminated. However, it is recommended that the signal all-red periods be checked to ensure that adequate safety exists for traffic leaving the SEA to turn right into Warrigal Road.

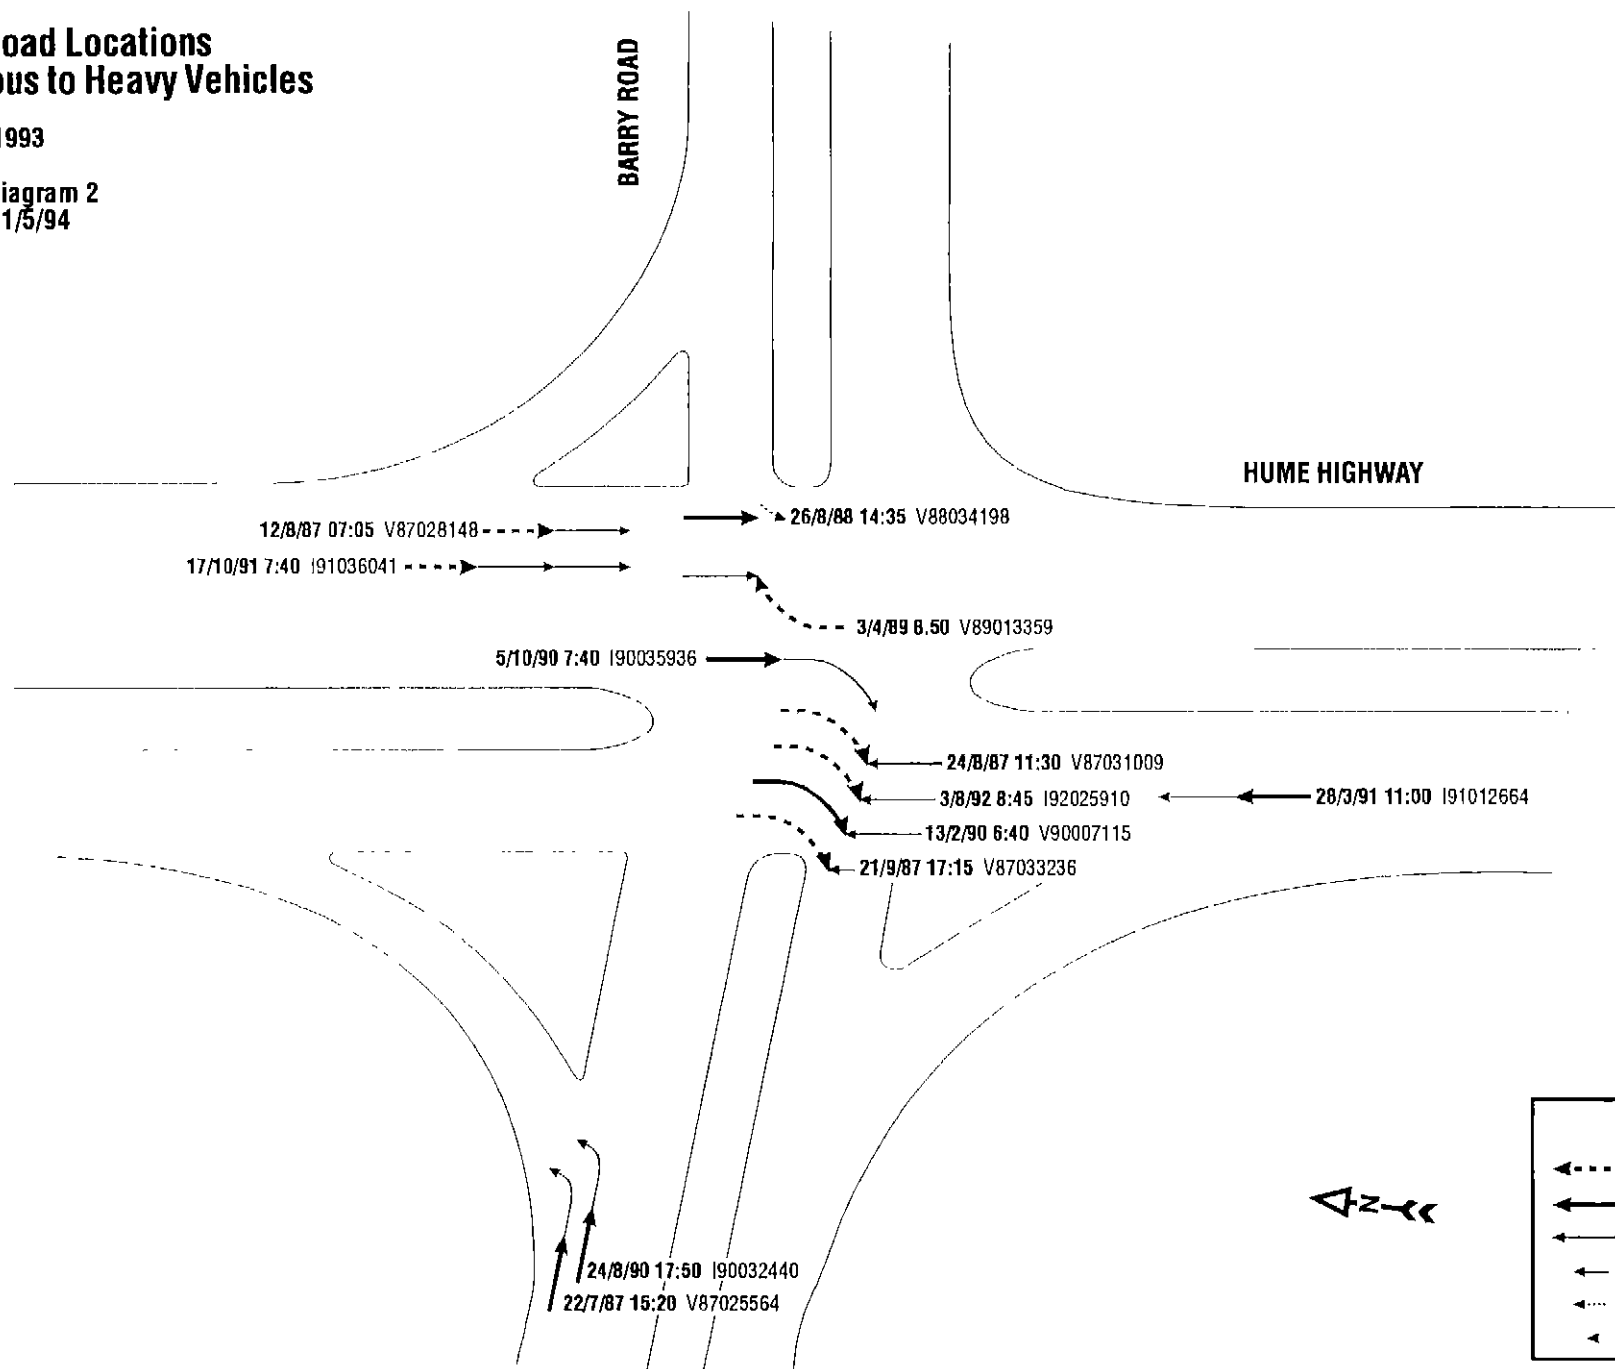
Collision Diagram 2  
Prepared 11/5/94

- drivers of heavy vehicles **failing to comply with right turn phases**, i.e. the red arrow display;
- the possibility that **insufficient all-red time** is provided for safe clearance between the termination of the right turn phase and the introduction of the through phase for Hume Highway traffic. Heavy vehicles, whose overall length means that extra time is required to clear the conflict area, may need a longer than standard all-red period for safe operation. Evidence in Police reports suggests that these crashes tend to occur at or around the end of the right-turn phase.

- **high vehicle speeds and congested traffic conditions.** Adjusting to urban traffic conditions and lower speeds could present some difficulties in judgement for motorists in general, and for drivers of heavy vehicles in particular, given that many drivers would have been travelling for long periods in rural highway/freeway conditions;

- the drivers of heavy vehicles being unable to stop in time to avoid colliding with stationary or near-stationary vehicles (rear-end collisions are characteristic of traffic signal crash patterns generally). Brake failure was cited in one instance, while in other cases, the cause may be due to the **inferior braking performance** of heavy vehicles compared to lighter vehicles and/or to **poor skid resistance** of the highly trafficked pavement and/or to **incompatible decision-making** by drivers of light and heavy vehicles when faced with a red or changing signal display;

- **left turn slip lane geometry** of the type situated on the N-W corner may, because of its relatively long sweeping path and low angle of intersection with conflicting through lanes, cause safety problems for left turners using them. Vehicle speeds tend to be high and detection of conflicting traffic is made more difficult by drivers having to look backwards as they approach the conflict area.

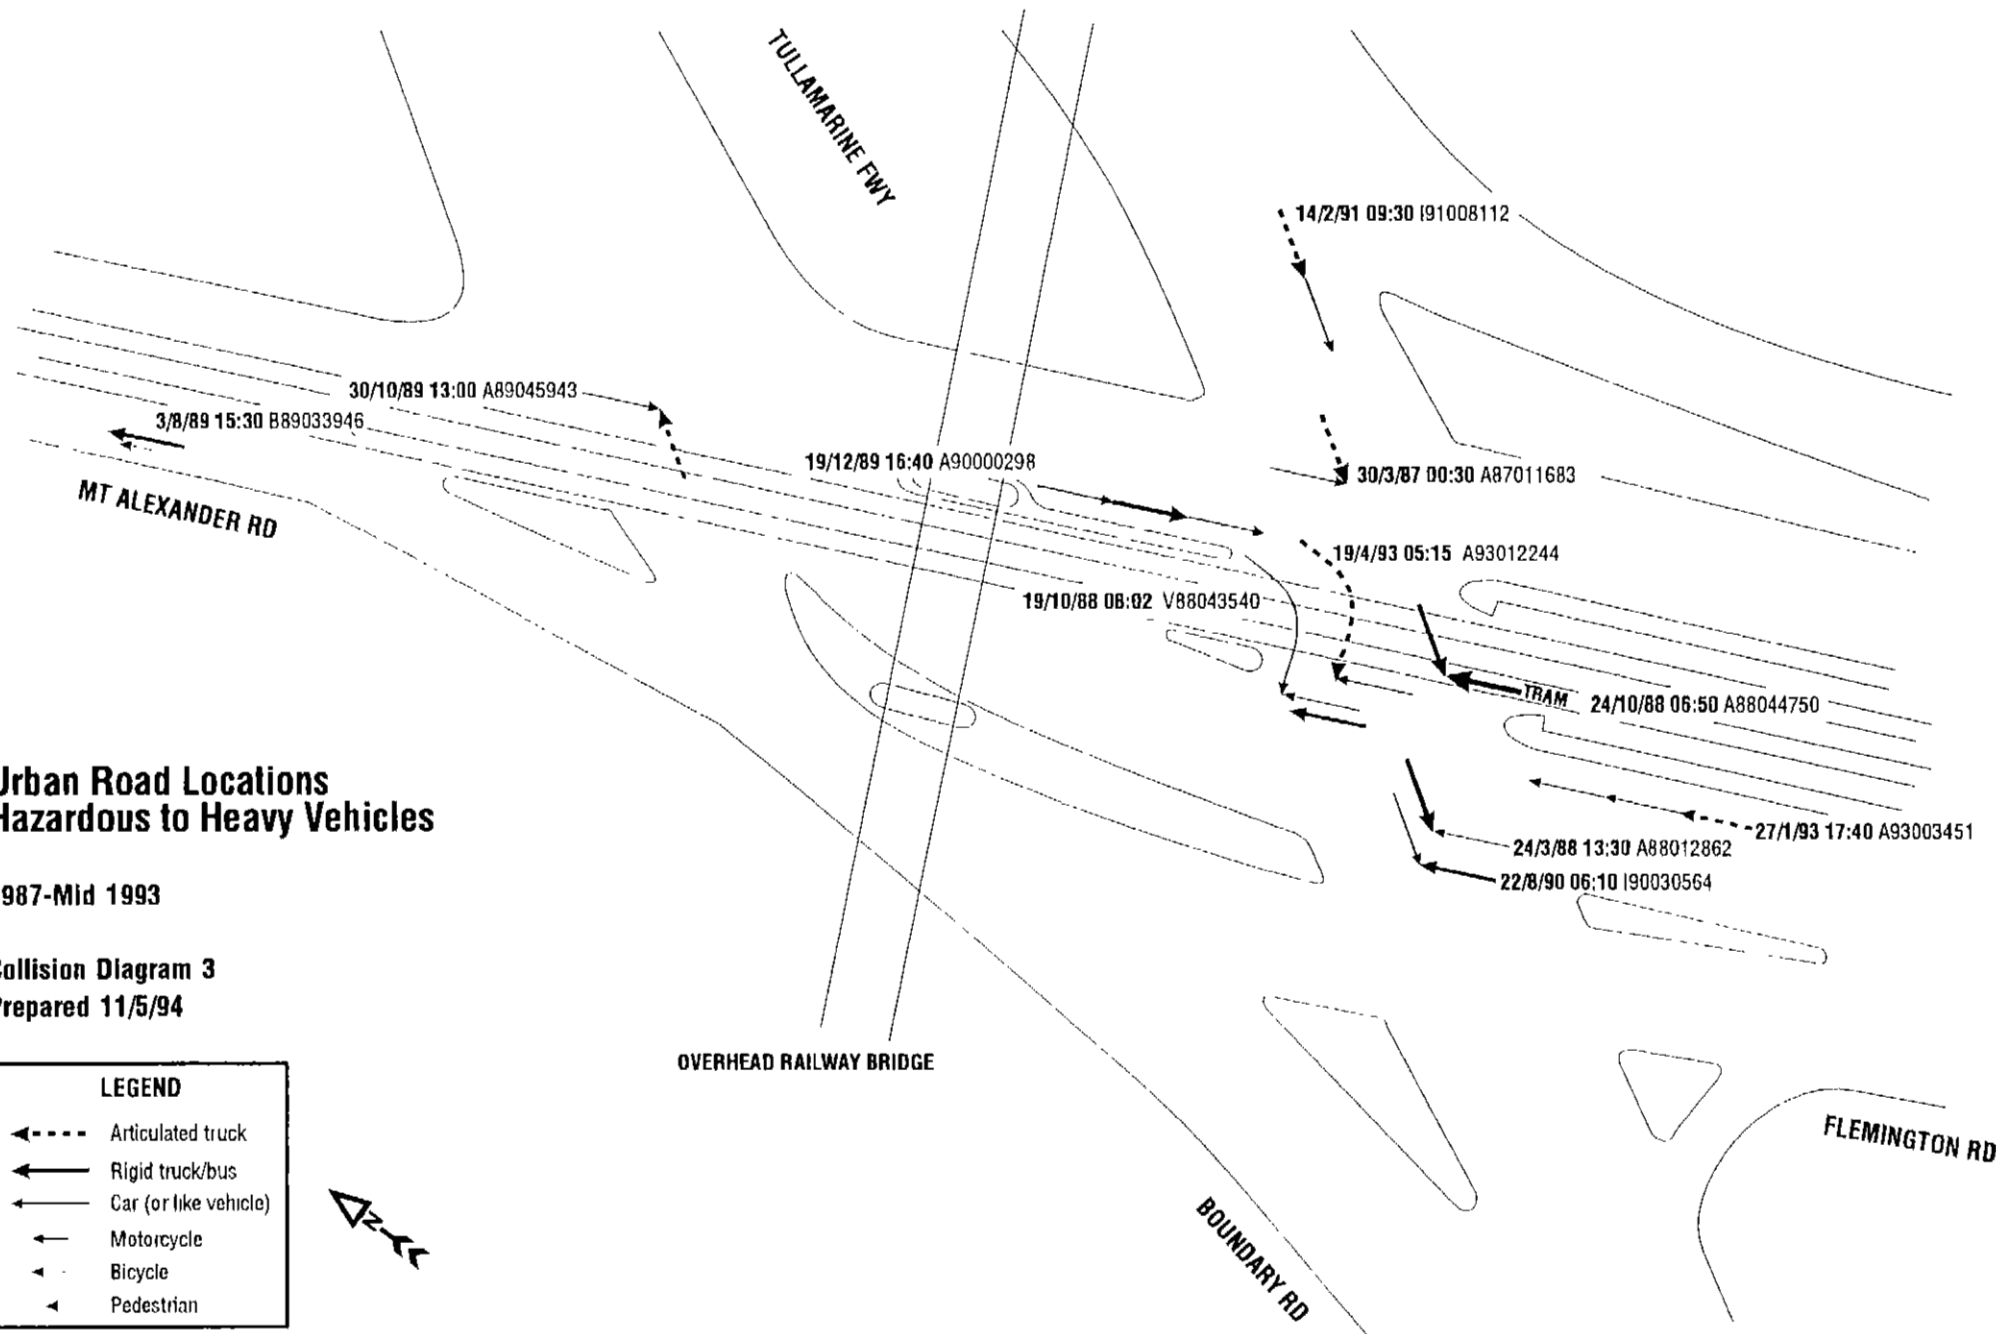
- evidence from Police reports indicates that in at least three of the cross-traffic crashes, the drivers of the heavy vehicles **failed to comply with red signals**,

- standard **inter-green periods may be inadequate** given the dimensions of heavy vehicles and high proportion of heavy vehicles using the intersection;

- complex intersection layout, signal displays, route/directional signing and congested traffic conditions create a **demanding traffic environment** for all users of the intersection.

- upgrade the standard of traffic signal displays by erecting mast arms to reduce problems caused by larger heavy vehicles themselves obscuring signal displays and, in particular, improve the visibility and conspicuity of traffic signal displays presently obscured by the railway bridge structure and the curved alignment of the northern approach;
- install a red light camera to address the reported failure of some drivers of heavy vehicles to comply with red signals;
- increase the all-red periods to better provide for the dimensions and the high proportion of heavy vehicles using the intersection.

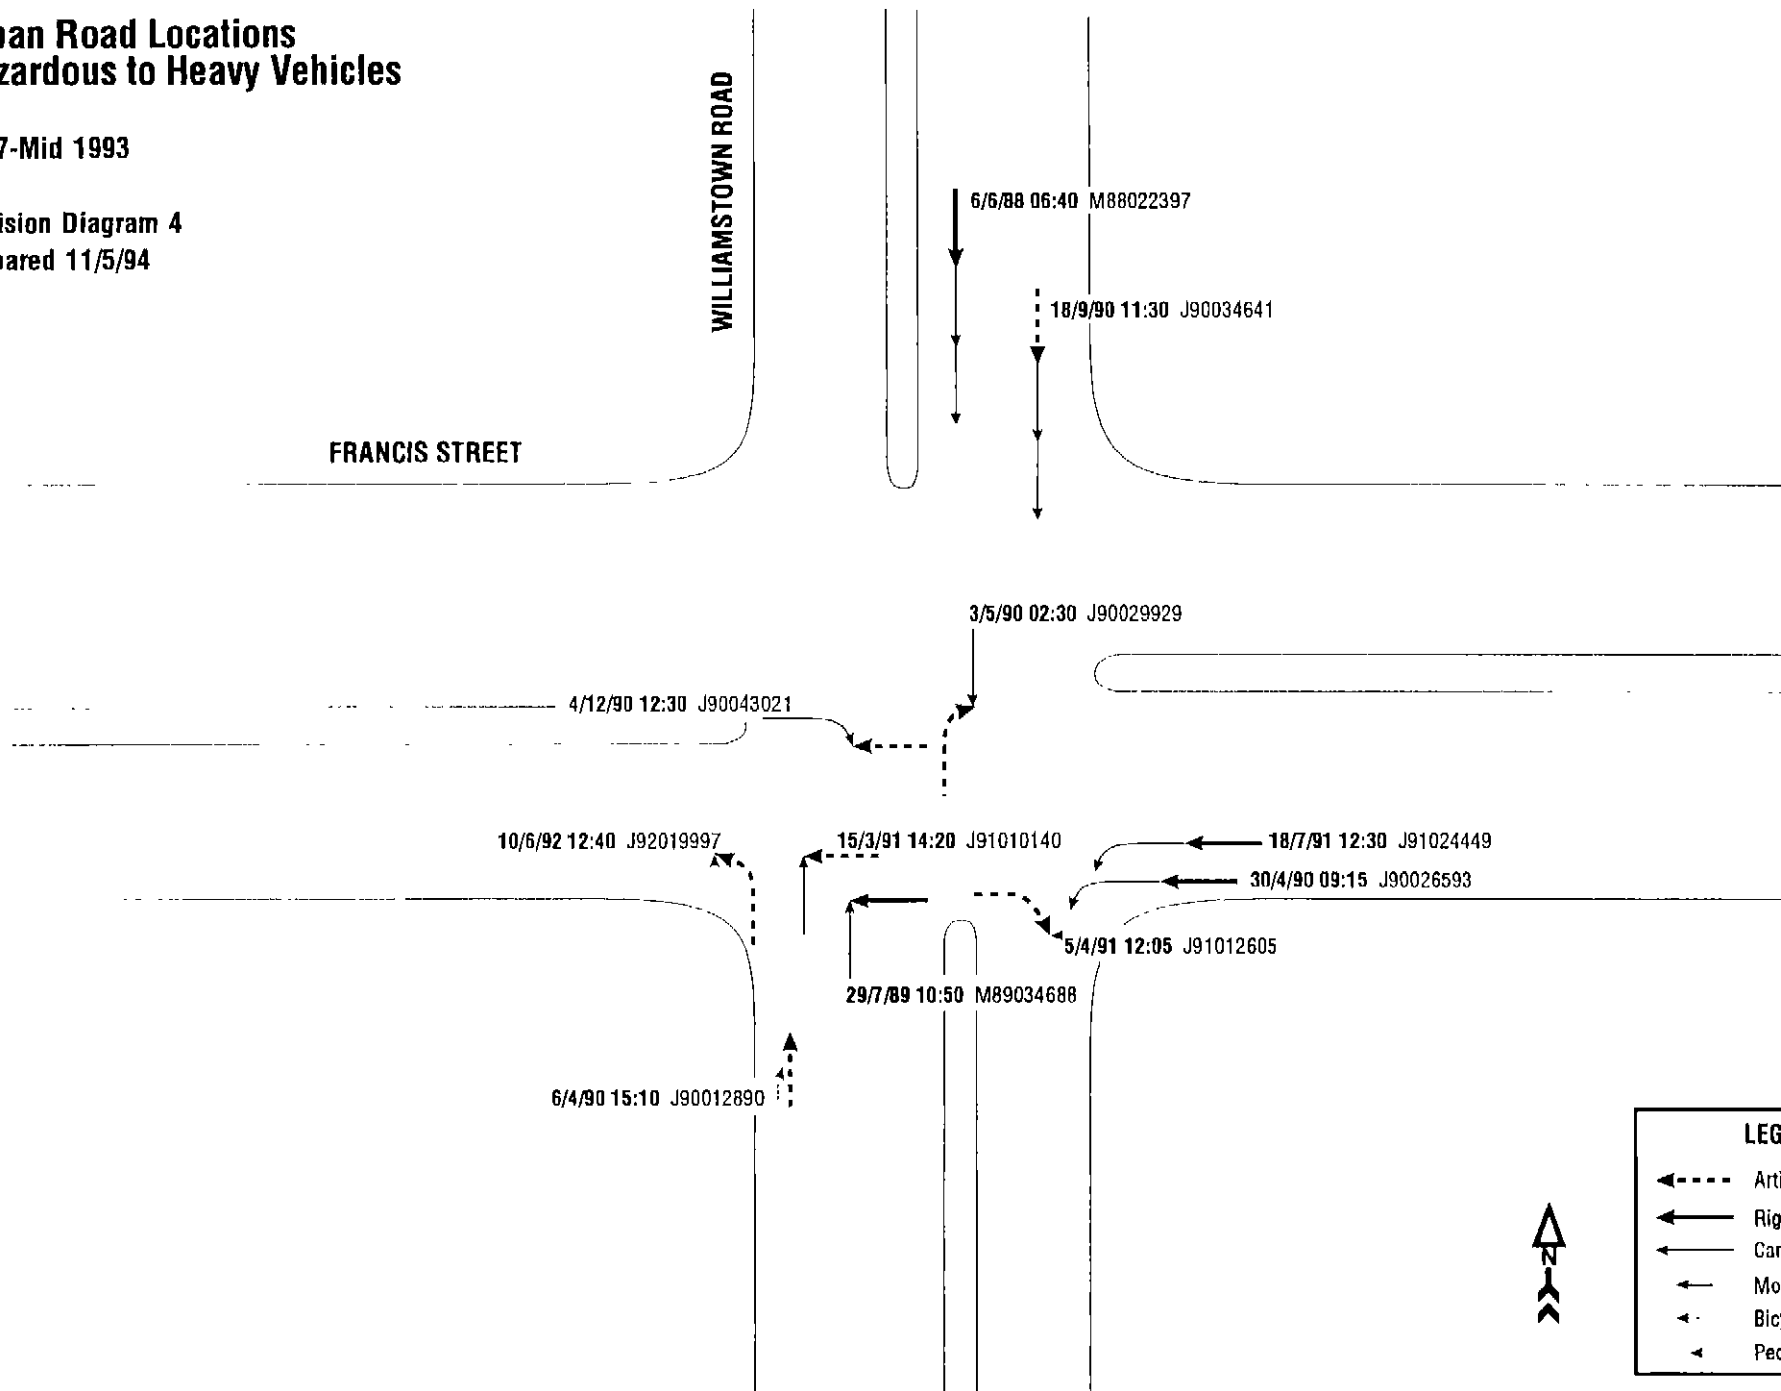
Collision Diagram 4  
Prepared 11/5/94

- there is no evidence to suggest particular risks due to heavy vehicles in either of the two right-through crashes. In one case the driver of the other vehicle was reported by Police to have failed to comply with signals. In the other case the crash occurred while the driver of the other vehicle was making a filter turn.

- the drivers of heavy vehicles being unable to stop in time to avoid colliding with stationary or near-stationary vehicles (rear-end collisions are characteristic of traffic signal crash patterns generally). Brake failure was cited in one instance, while in other cases, the cause may be due to the **inferior braking performance** of heavy vehicles compared to lighter vehicles and/or to **poor skid resistance** of the highly trafficked pavement and/or to **incompatible decision-making** by drivers of light and heavy vehicles when faced with a red or changing signal display;

- **left turn slip lane geometry** of the type situated on the S-E corner may, because of its relatively low angle of intersection with conflicting through lanes, cause safety problems for left turners, especially those following other left turners. Vehicle speeds tend to be high and detection of conflicting traffic is made more difficult by drivers having to look backwards as they approach conflict areas at or within the slip lanes.

- **inappropriate pedestrian behaviour** may have contributed to these crashes. The tight radius for left turning heavy vehicles south to west presents potential hazards to pedestrians if trucks encroach unexpectedly onto or near the footpath while turning.

- improve pavement skid resistance, especially on the north approach, to better provide for the special needs and shortcomings of heavy vehicles braking at traffic signals;
- upgrade the standard of traffic signal displays by erecting mast arms to reduce problems caused by larger heavy vehicles themselves obscuring signal displays and, in particular, improve the visibility of traffic signal displays on the north approach;
- modify the geometry of the left turn slip lane situated on the S-E corner to increase the angle of intersection with conflicting through lanes. This measure will reduce left-turning heavy vehicle speeds and also reduce the difficulty for drivers looking to the right as they approach the conflict area.

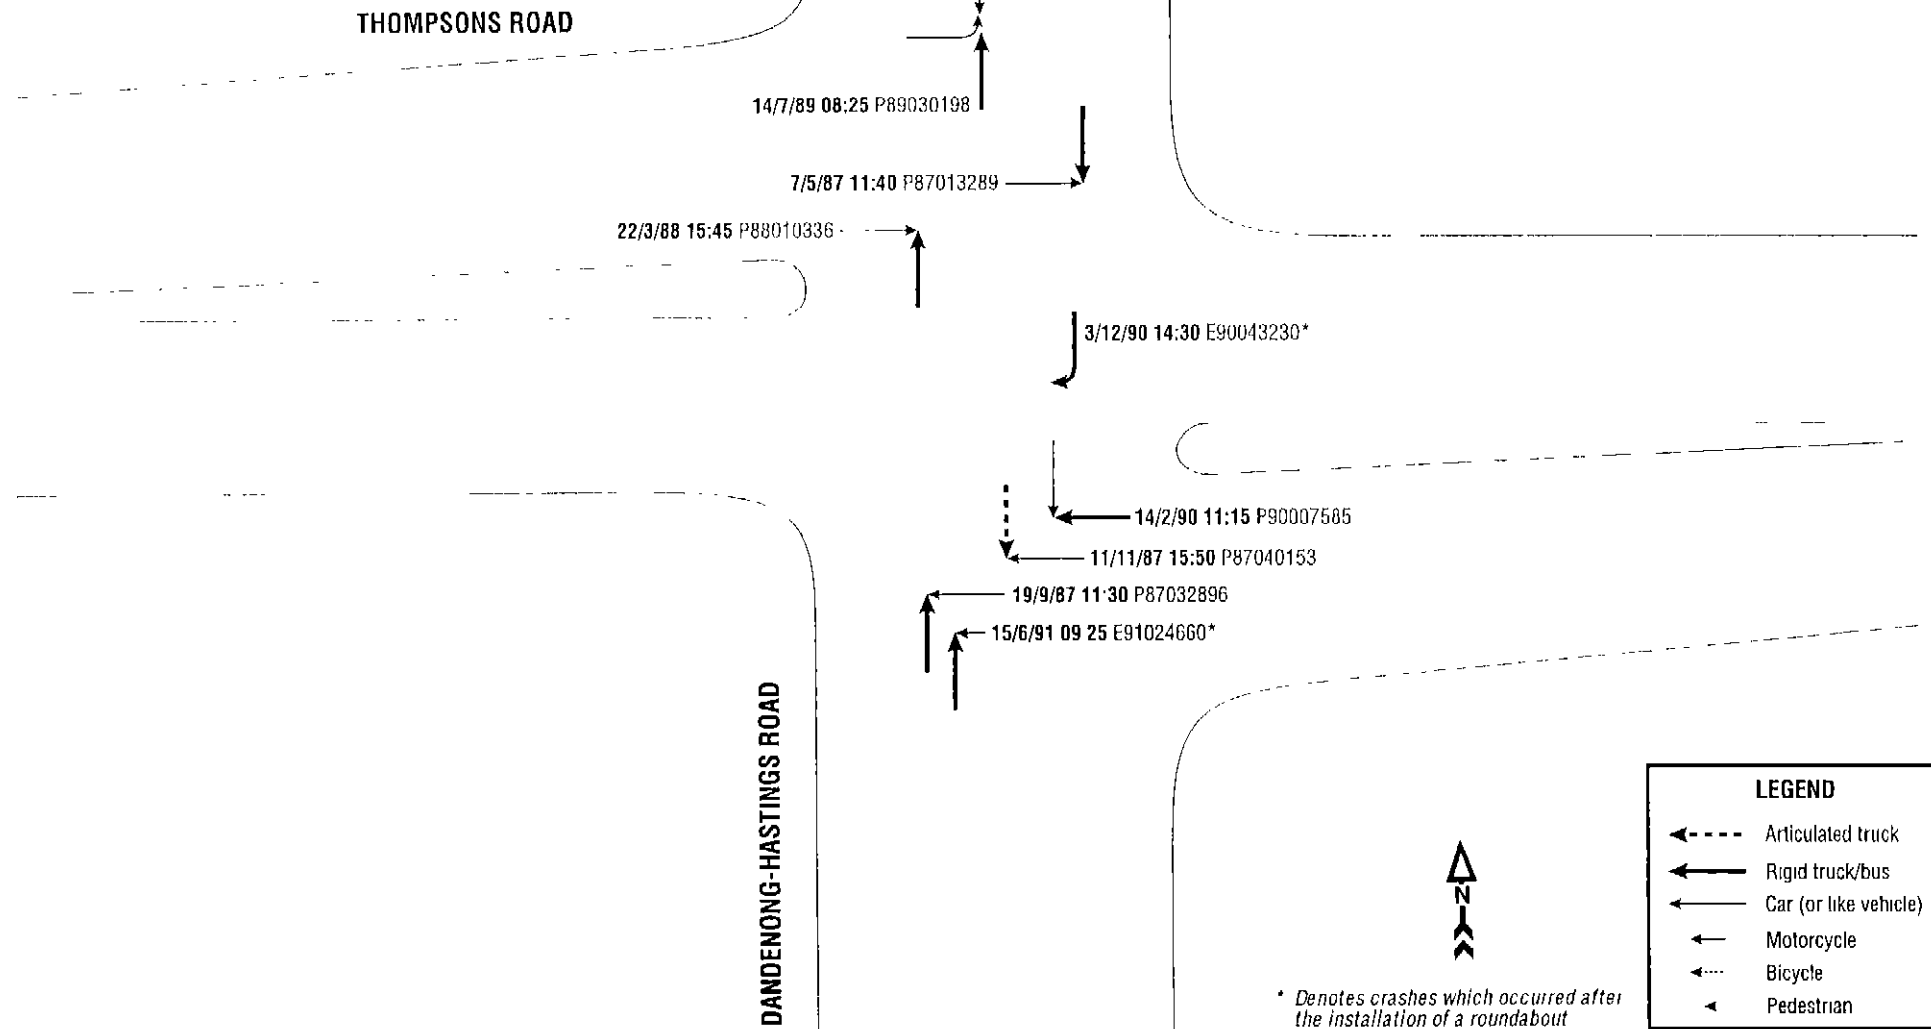
Collision Diagram 5  
Prepared 11/5/94

<b>Speed:</b> Probably - very high (100+ km/h) on both approaches to the intersection.
<b>Alignment/Topography:</b> No
<b>Intersection Geometry (if applicable):</b> No.
<b>Intersection Control (if applicable):</b> Stop signs in high speed zones, with single lane conflicting flow require drivers to exercise considerable skill in gap selection.
<b>Road Surface (friction and roughness):</b> Unlikely - super-elevation within the roundabout may present problems for vehicles with a high centre of gravity.

<b>Roadside Features/Hazards:</b> No, although there is a potential hazard in the form of a utility pole positioned on the departure from the roundabout. This arrangement presents a serious potential hazard in high speed environments
<b>Land Use:</b> No.
<b>Traffic Operation:</b> Traffic volumes and speeds are high on Dandenong-Hastings Road. Single lane approach flows make gap selection in Dandenong-Hastings Road especially difficult.
<b>Delineation:</b> Unlikely.
<b>Street lighting:</b> No.
<b>Sight Distance:</b> Unlikely
<b>Road Divided/Undivided:</b> Unlikely - most crashes occurred under staggered-T layout.
<b>Lane Configuration (e.g. lane drop/merge, etc.):</b> Unlikely.
<b>Lane Provision for Turning:</b> Unlikely.
<b>Road works:</b> No.
<b>Shoulder Condition:</b> No.
<b>Other:</b> Gap selection - Police reports frequently mention failure by drivers on Thompsons Road to give way to Dandenong-Hastings Road drivers as the main reason for crash occurrence.

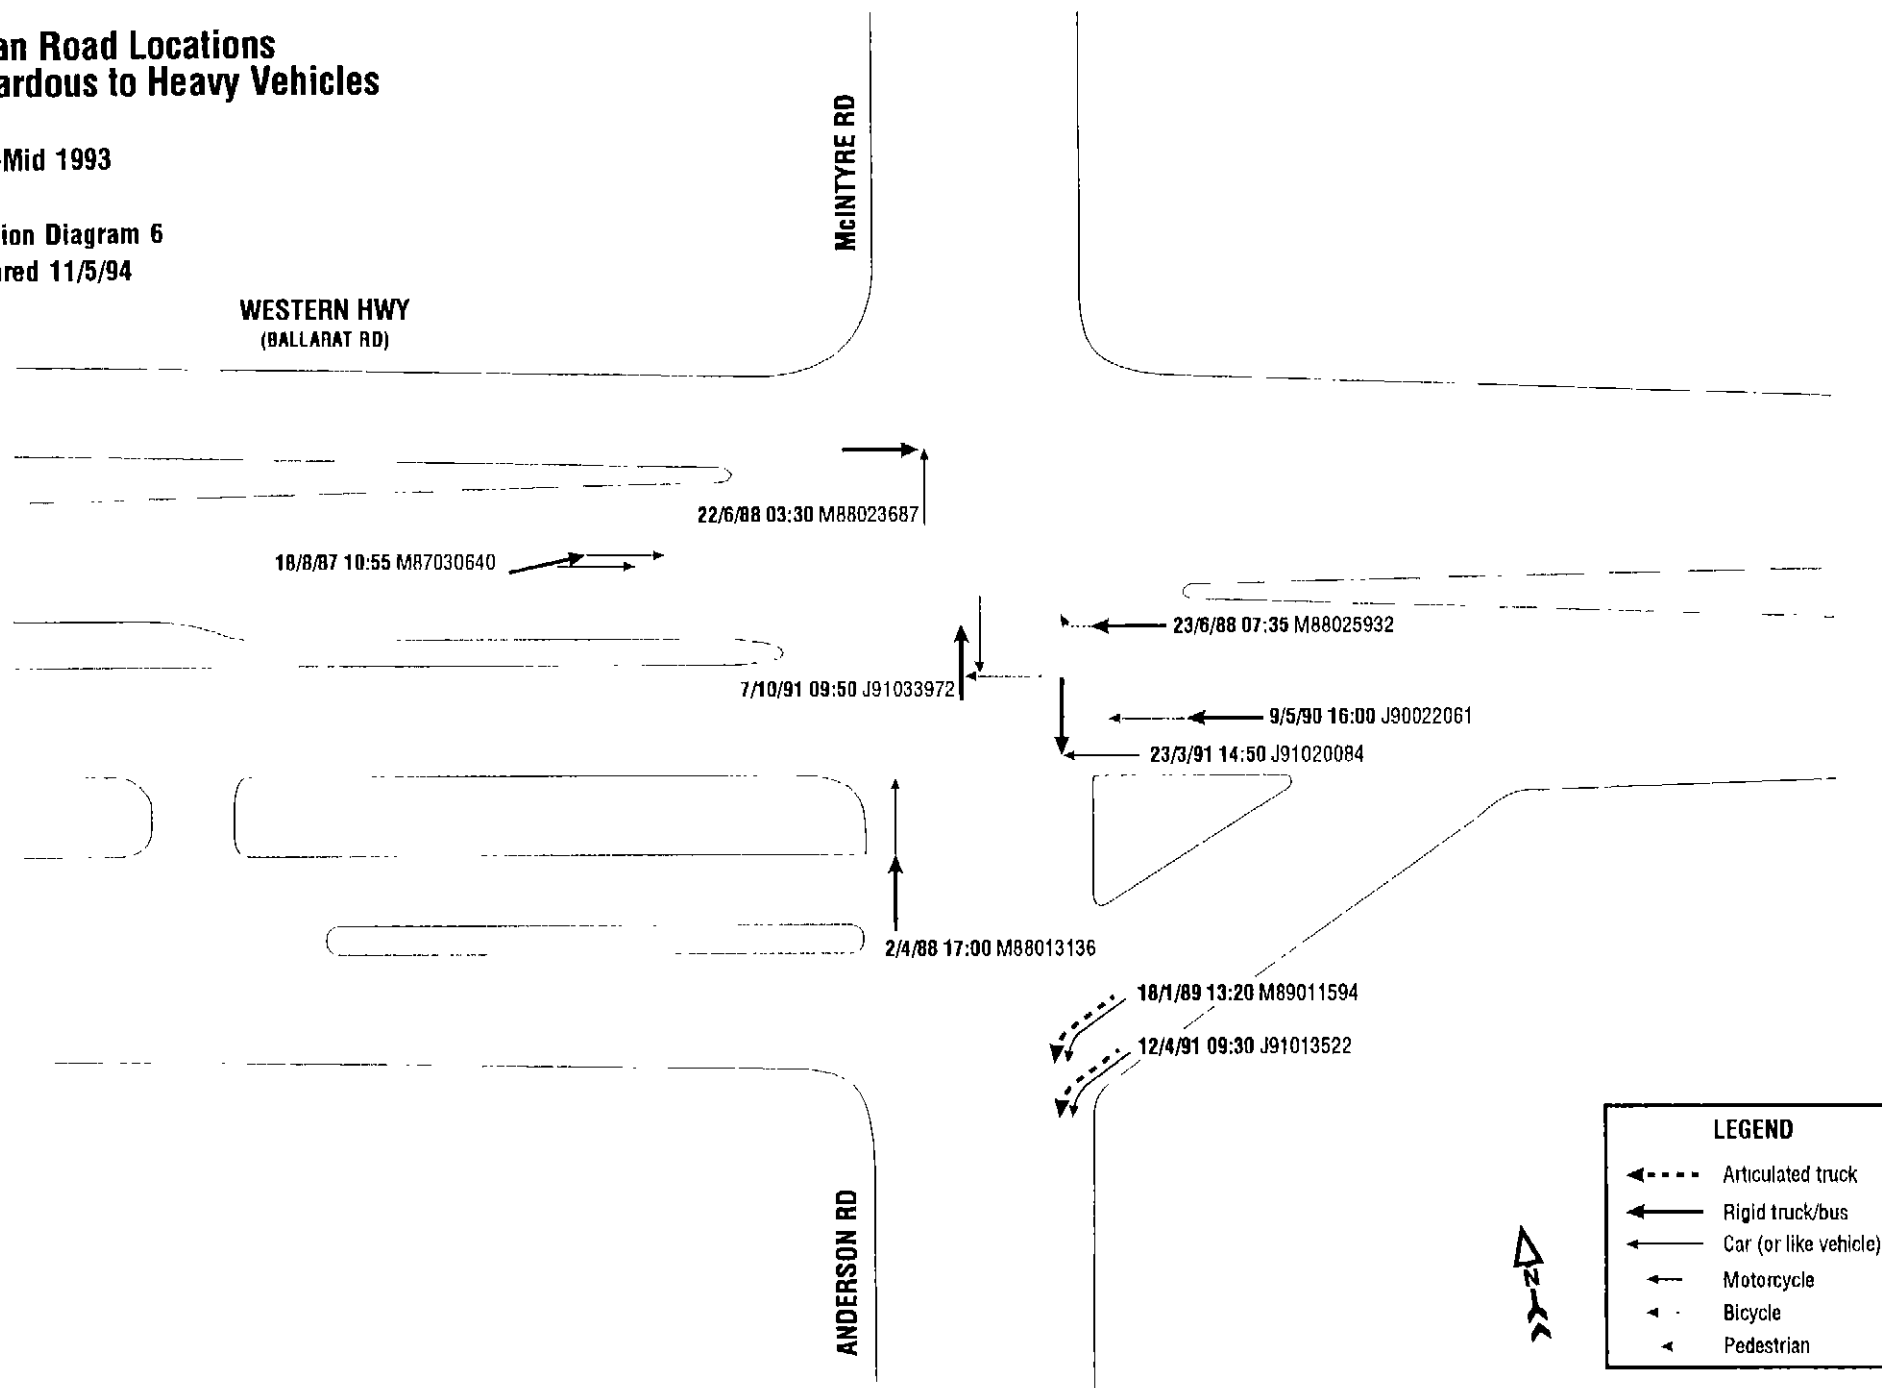
Collision Diagram 6  
Prepared 11/5/94

- **high vehicle speeds and congested traffic conditions** on Western Highway;
- in all cases the heavy vehicle was the striking vehicle indicating that the drivers have **difficulty responding to changing circumstances** ahead (e.g. starting up from a stationary position when signals change from red to green or stopping when signals are red). It is noteworthy that, while rear-end collisions are characteristic of traffic signal crash patterns generally, heavy vehicles seem to be over-involved in such crashes as the striking vehicle;
- the worn condition of the pavement, and a consequent **low skid resistance**, may also be a factor in rear-end collisions.

- the left turn movement from east to south is particularly difficult for heavy vehicles because of the relatively narrow lanes available on the approach to and departure from the turn. **Lane encroachment by heavy vehicles** occurs because of the combination of **inadequate lane widths and the geometry of the turn**. The other side swipe crash was due to the driver of a heavy vehicle taking evasive action after a lighter vehicle changed into the heavy vehicle's lane.
