Structural Assessment of Christmas Island Skate Park

Reference No: PR 10012272

March 2015 | 15-34

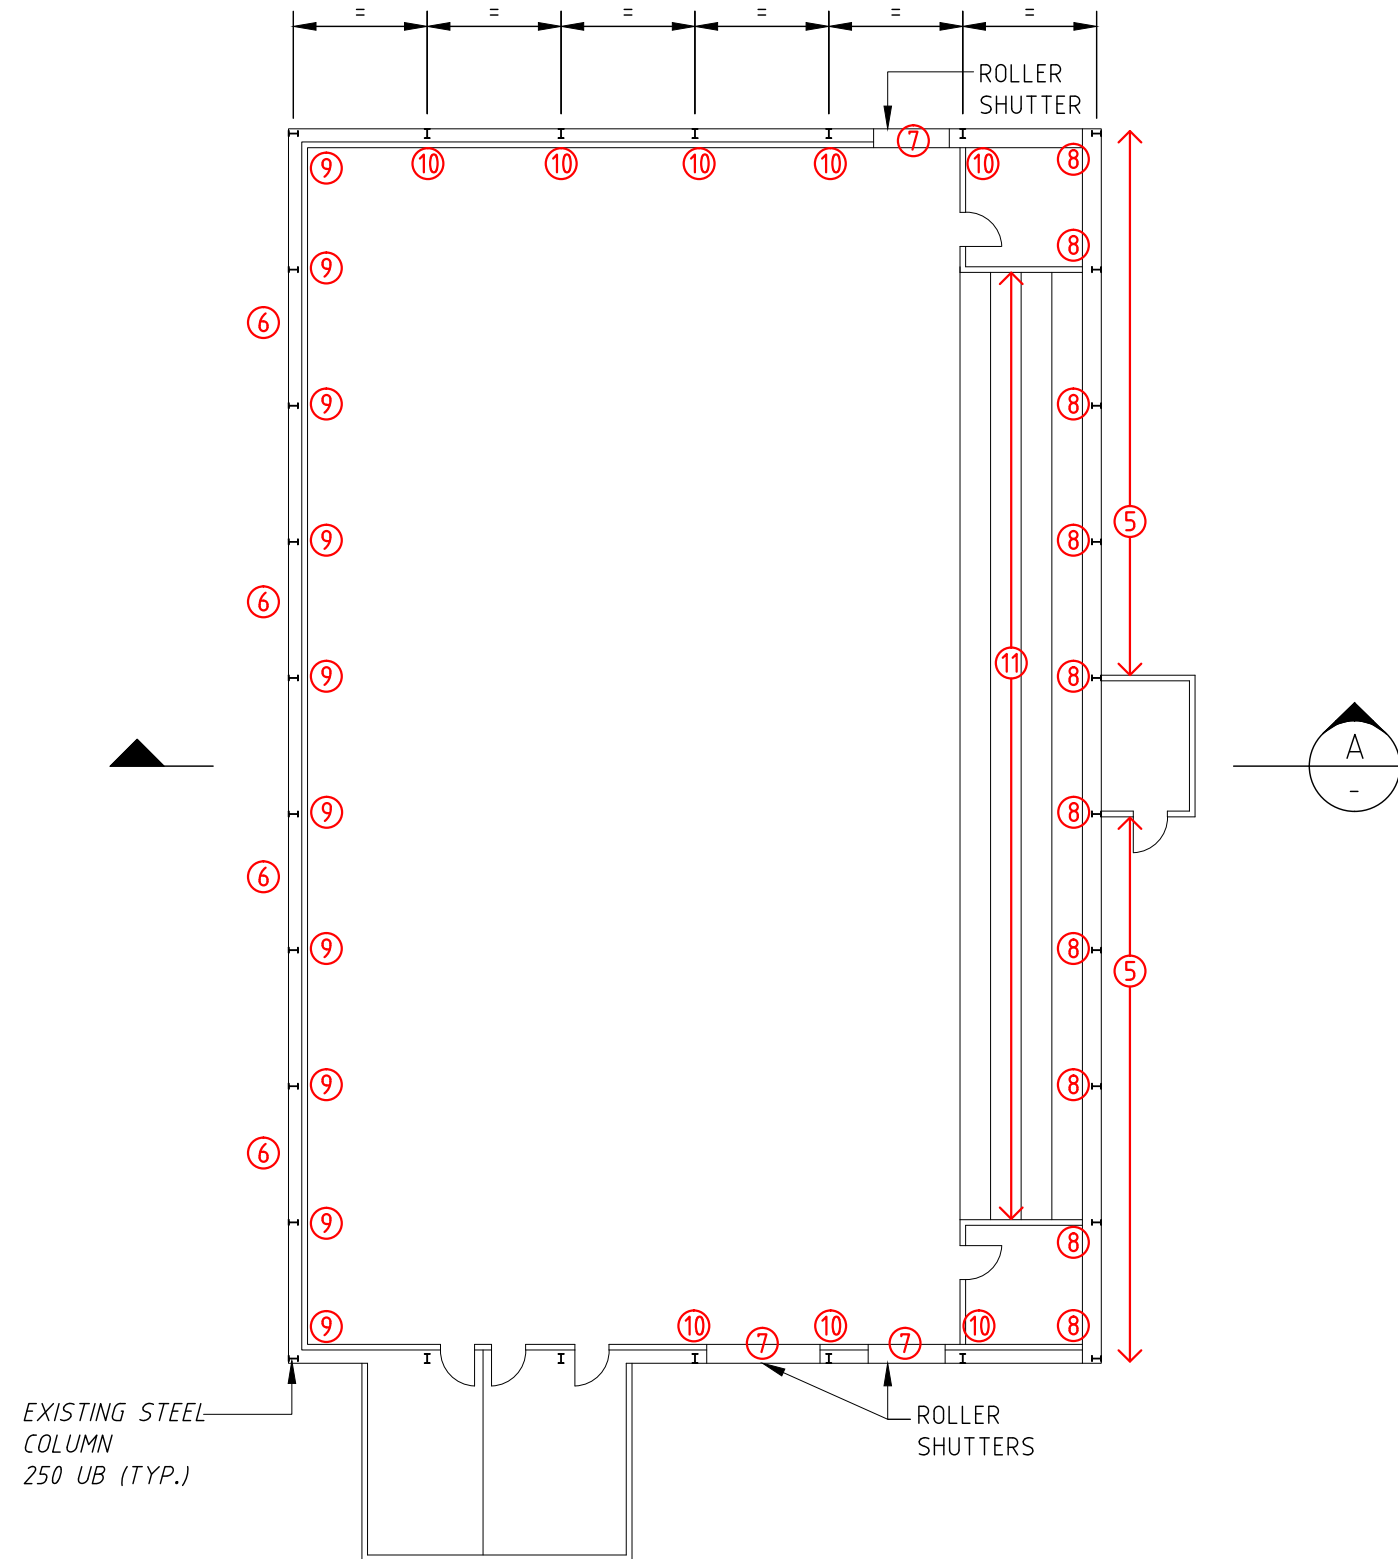
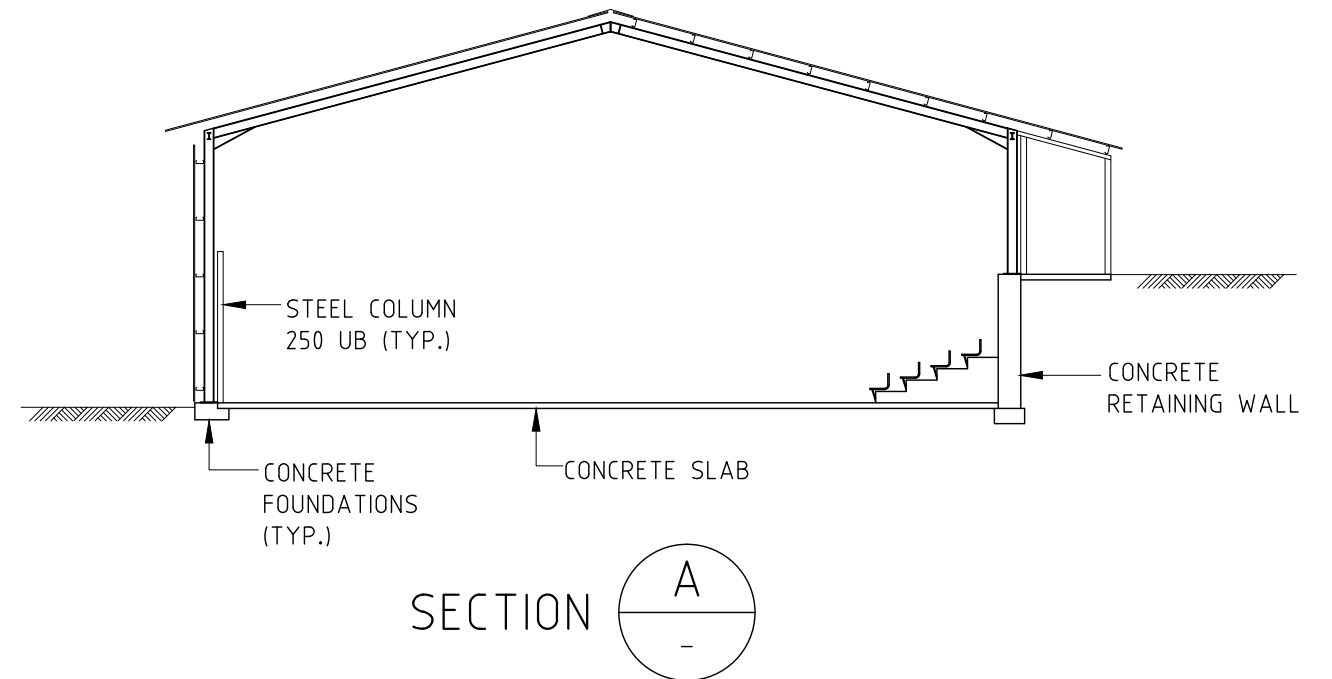
CHRISTMAS ISLAND SKATE PARK
MAIN STRUCTURE FLOOR LAYOUT

S101 item 4	Corrosion at Roof Ventilators	-	Ongoing corrosion resulting in failure	Low	Replace ventilators as part of re-sheeting of building
Wall Cladding					
S100, item 5	Corrugated wall sheeting along Western wall does not extend to underside of eaves, allowing weather ingress into building	6	The internal structural steel along the top of the wall is exposed to the aggressive atmospheric conditions and will continue to corrode more rapidly	Low	Extend wall sheeting to underside of eaves to prevent weather ingress into building
S100, item 6	Broken window panes at high level in Eastern wall	7 Typical	Collapse of damaged panes resulting in severe injury/death. Weather ingress into building resulting in property damage	Low	Replace all window panes with toughened safety glass
S100, item 7	Corrosion of exposed structural steel framing around roller shutter openings	8 Typical	Long term corrosion failure if corrosion allowed to continue to propagate unchecked	Low	Abrasive blast clean steelwork to remove all corrosion and repaint with a rust inhibitor. Provide external cladding over steel to prevent exposure to aggressive atmospheric conditions

S100, item 10	Corrosion at base of columns at Northern and Southern walls.	14, 15 Typical	Corrosion failure if corrosion allowed to continue to propagate unchecked	Medium	Upon completion of abrasive blast cleaning, site weld additional steel plates as necessary to strengthen reduced steel profile prior to re-painting. Consider additional concrete encasement at column base to prevent ponding water ponding
Miscellaneous					
S100, item 11	Corrosion of plastic seat support framing, damaged and loose seats	16 Typical	Sharp exposed metal edge causing injury. Failure of further seating	Low	Remove all corroded seat framing as necessary

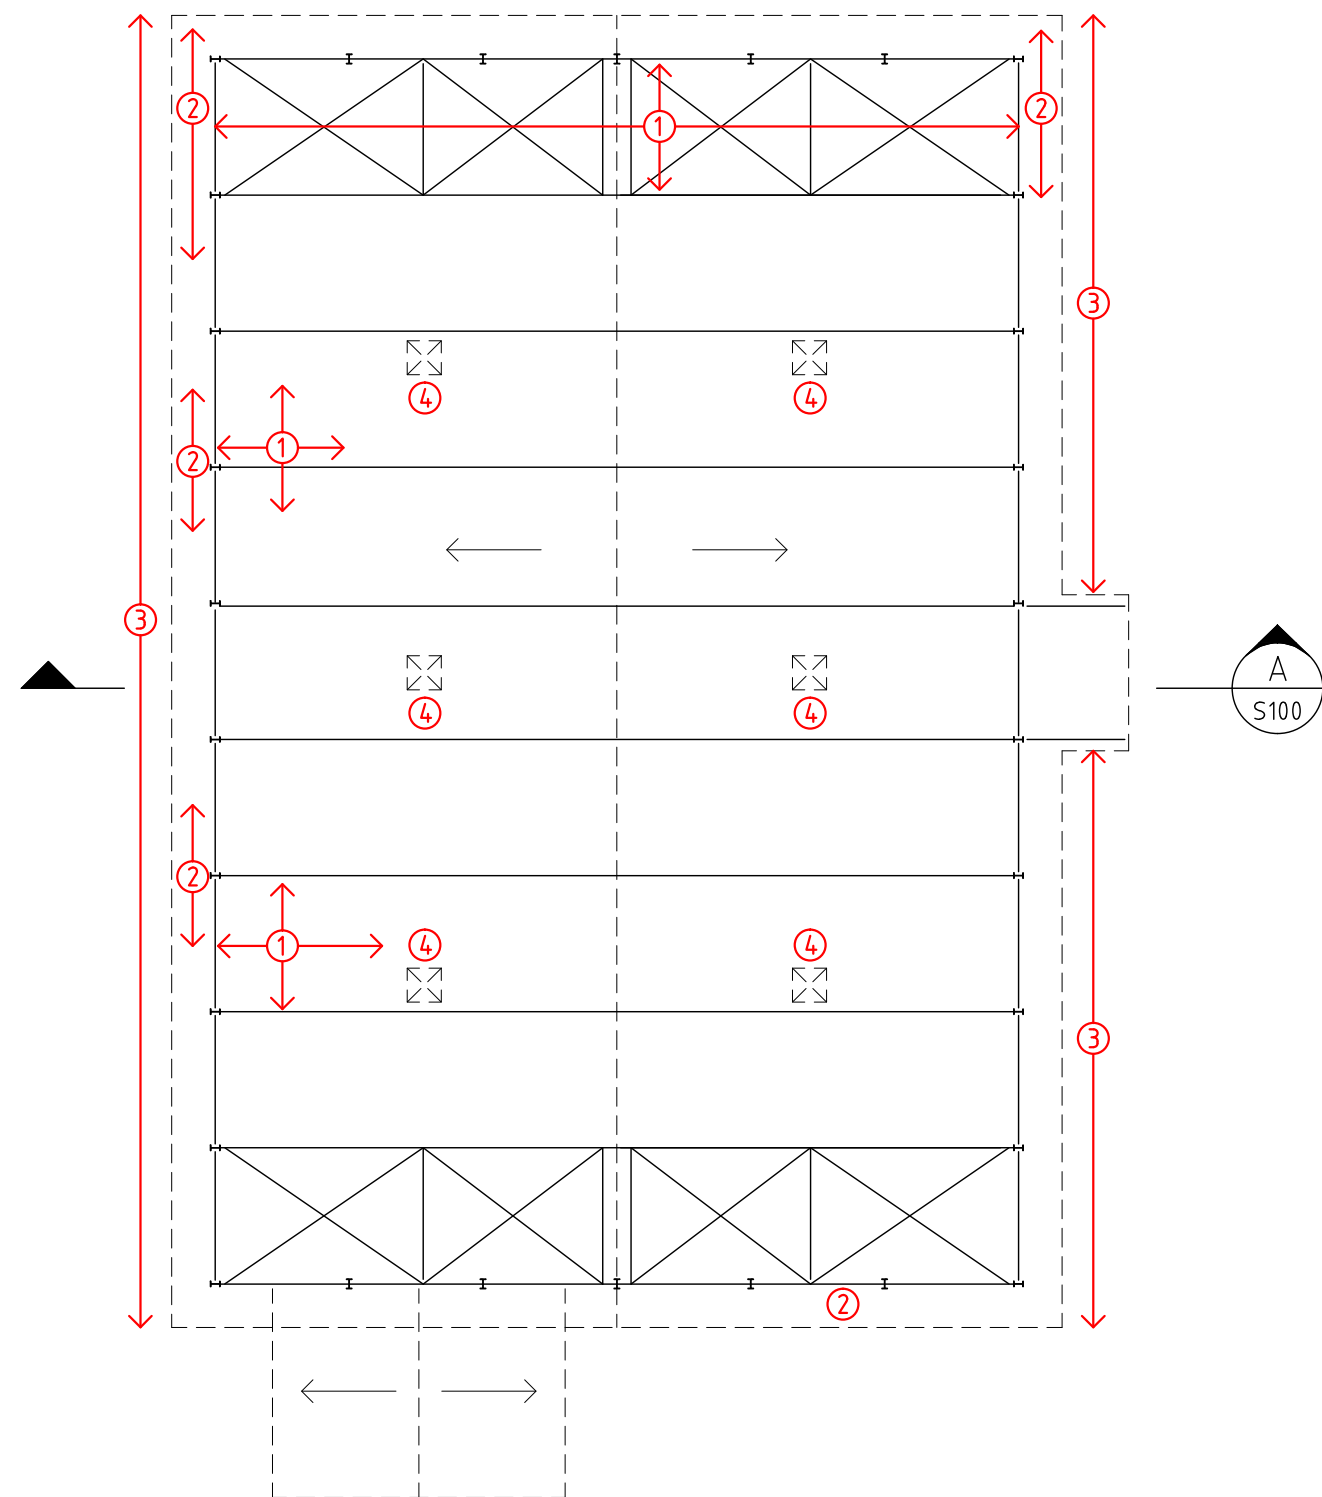
CHRISTMAS ISLAND SKATE PARK
MAIN STRUCTURE ROOF LAYOUT

Dwg Ref. (Apdx B)	Observations	Photos (Apdx C)	Risk	Risk Category	Recommendations
Roof Cladding					
S101, item 1	Missing areas of roof sheeting	1, 2	Water ingress into building causing internal damage. Further roof sheeting failure due to failure of screw fixings and/or timber purlins. Accelerated corrosion of internal steelwork exposed to aggressive atmospheric conditions	Medium	Schedule all roof and wall sheeting and supporting purlin and girt framing for removal and replacement, refer section 3.2
S101, item 2	Missing sections of eaves cladding and structural support framing	3, 4 Typical	Water ingress into building causing internal damage. Further failure of support framing and localised collapse of eaves sheeting.	Medium	Replace missing support framing and sheeting as part of overall sheeting replacement
S101 item 3	Deterioration of roof eaves inclusive of: -Corrosion of structural steel supports -Warping of timber edge board -Corrosion of screw and bolt fixings	5,6 Typical	Water ingress into building causing internal damage. Further failure of support framing and localised collapse of eaves sheeting.	Medium	Schedule all eaves support framing for replacement as part of overall re-sheeting of building

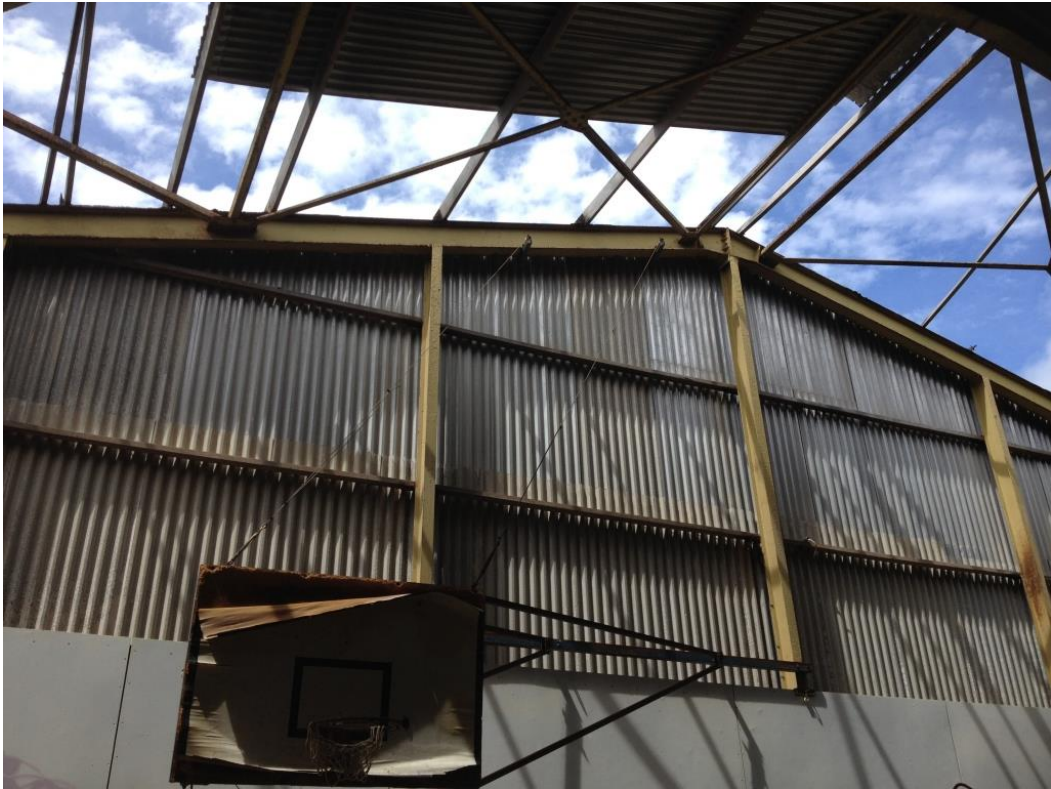
Photograph 1: Missing roof sheeting at Northern end bay of building

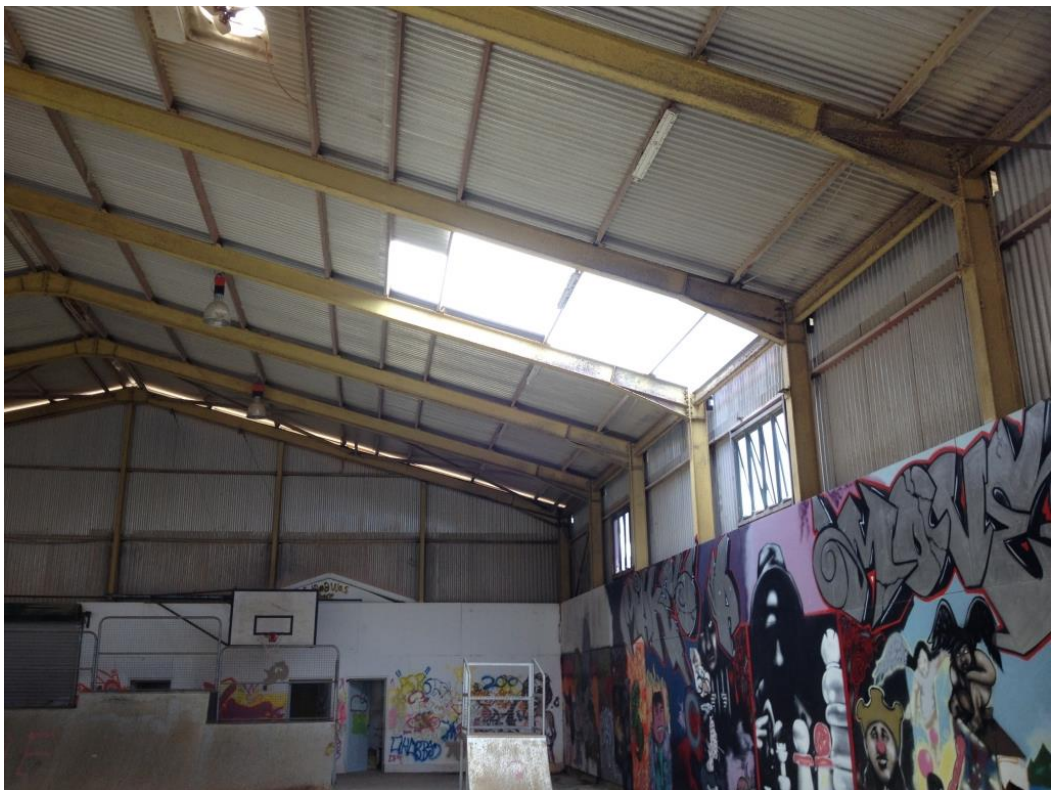
Photograph 2: Missing roof sheeting near centre of eastern side of roof

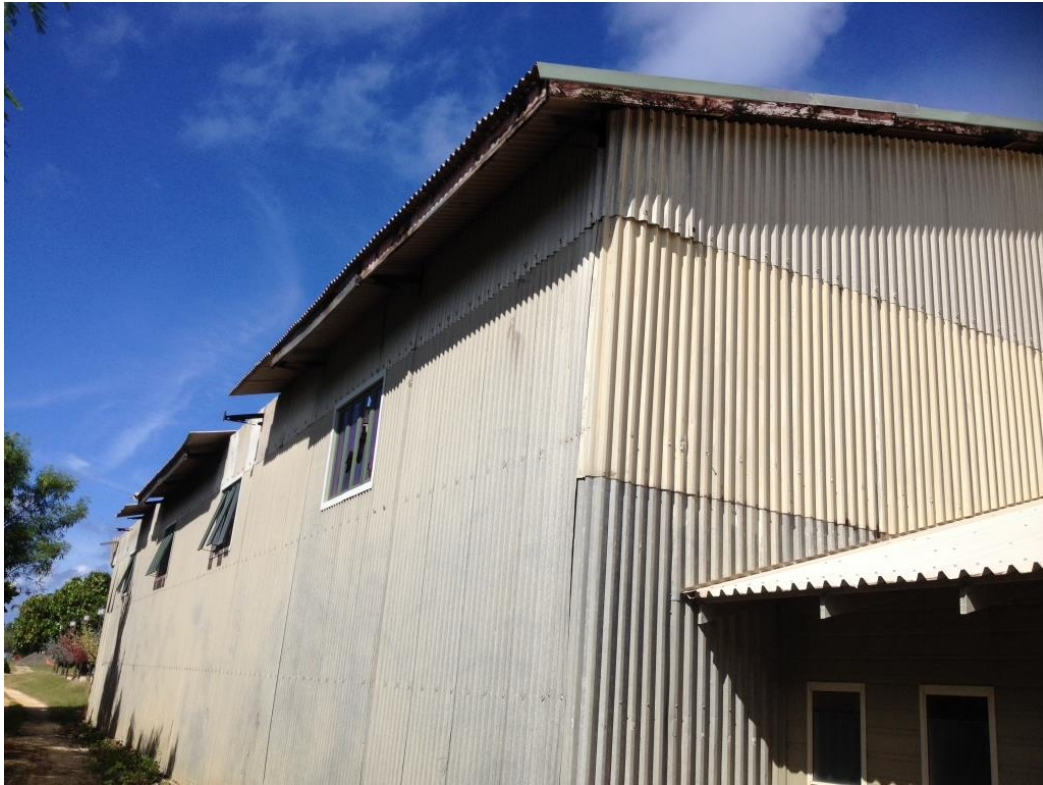
The exposed structural steel brackets fixed to the top of the portal frame columns to support the roof eaves are in very poor condition. Several are missing and others are substantially corroded to the point where their structural adequacy has been compromised. These brackets are in need of removal and replacement.

Photograph 3: Sections of missing eaves cladding and structure along Eastern wall

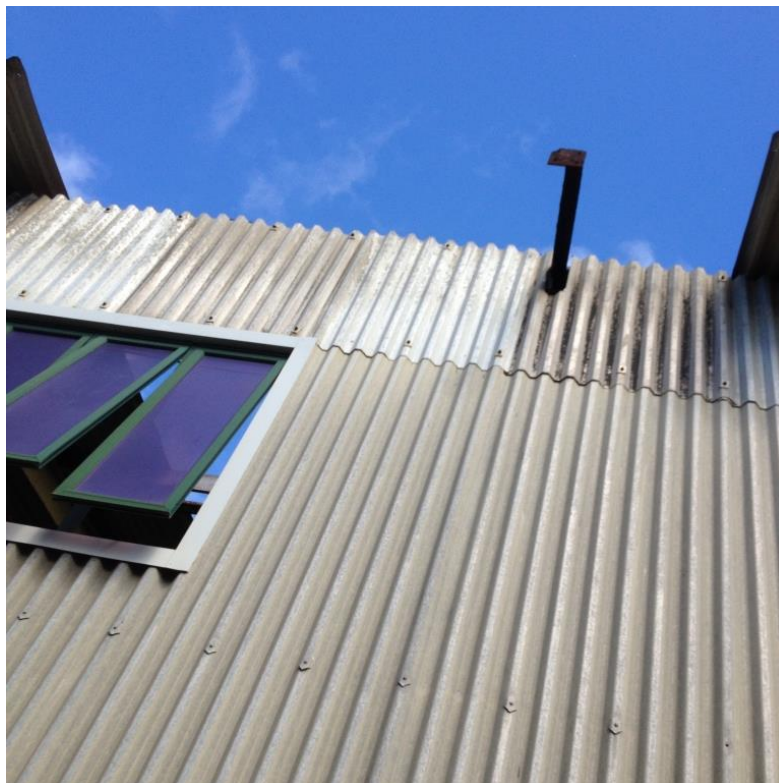
Photograph 4: Missing eaves support framing and cladding at Eastern wall

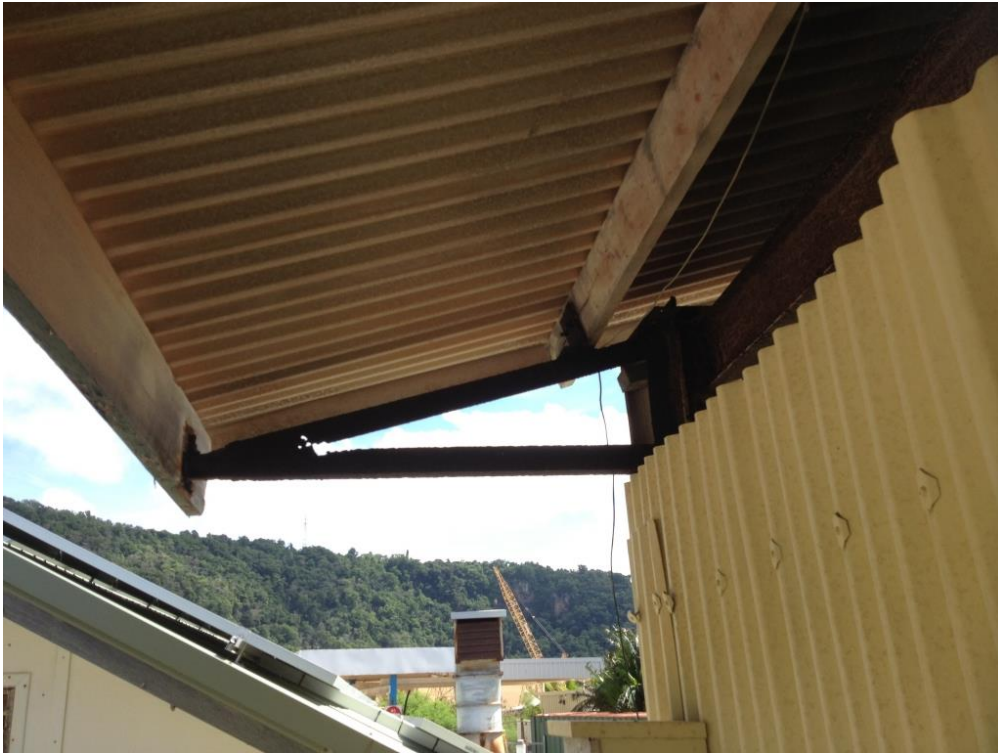
Photograph 5: Typical corrosion of structural steel eaves support framing

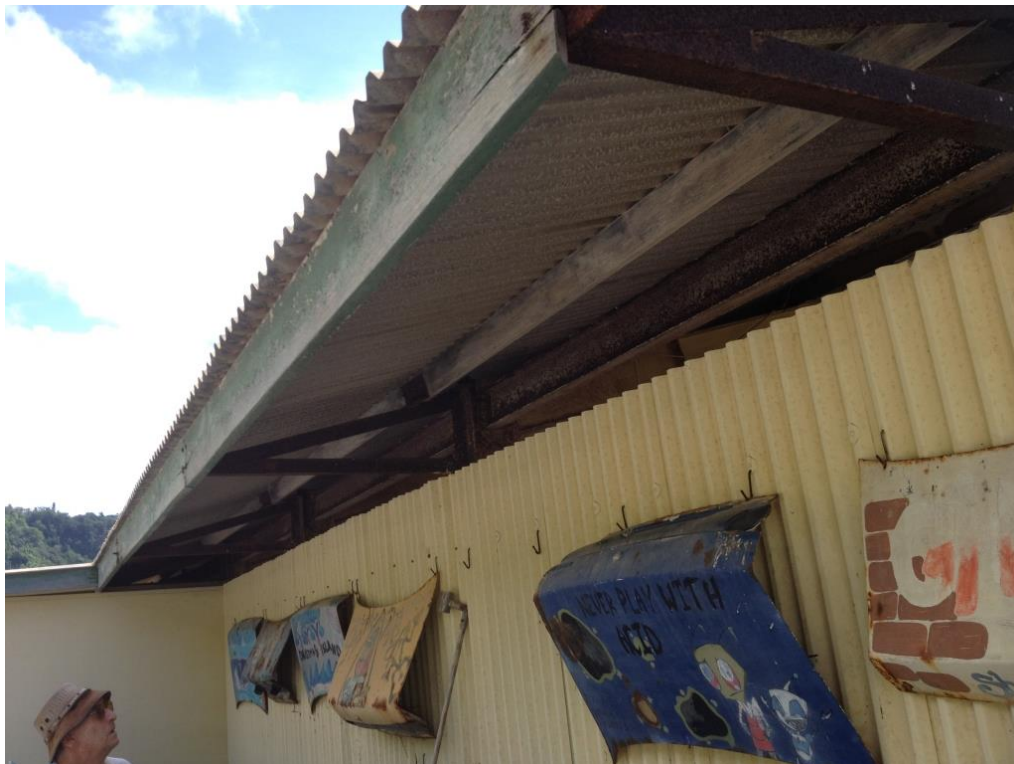
Photograph 6: Typical weathering and corrosion at eaves support framing

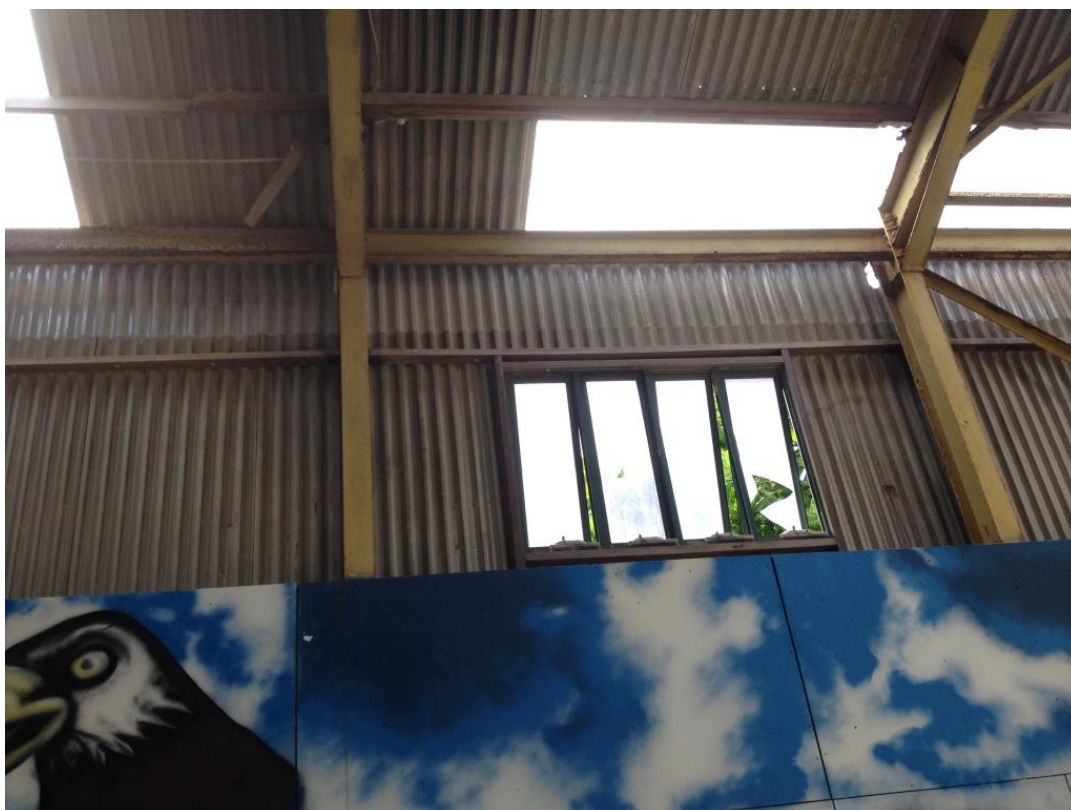
Photograph 7: Typical broken window panes at high level in Eastern wall

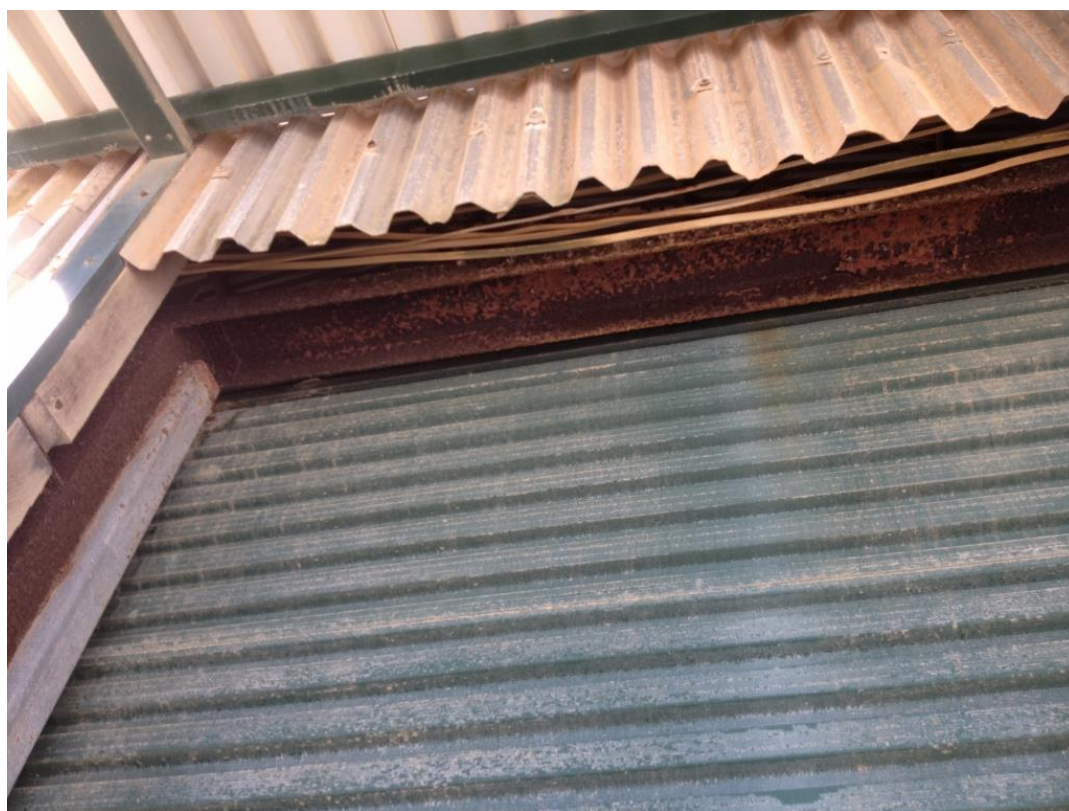
Photograph 8: Typical corrosion of exposed structural steel framing at roller shutter doors

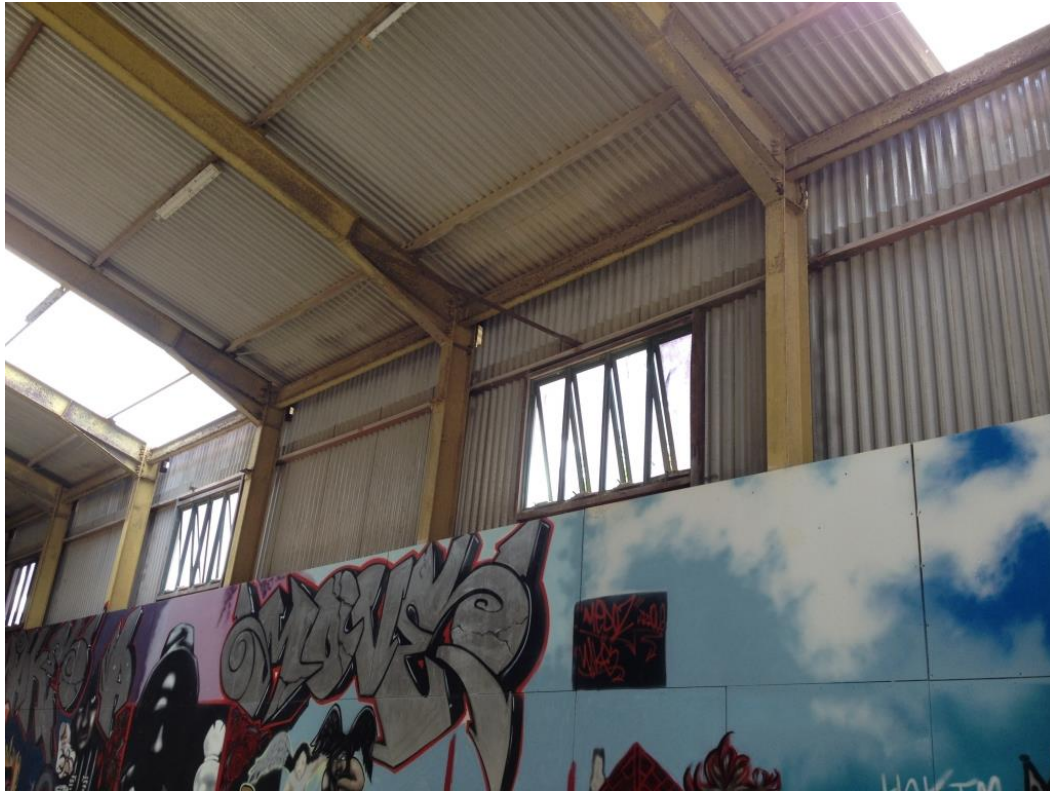
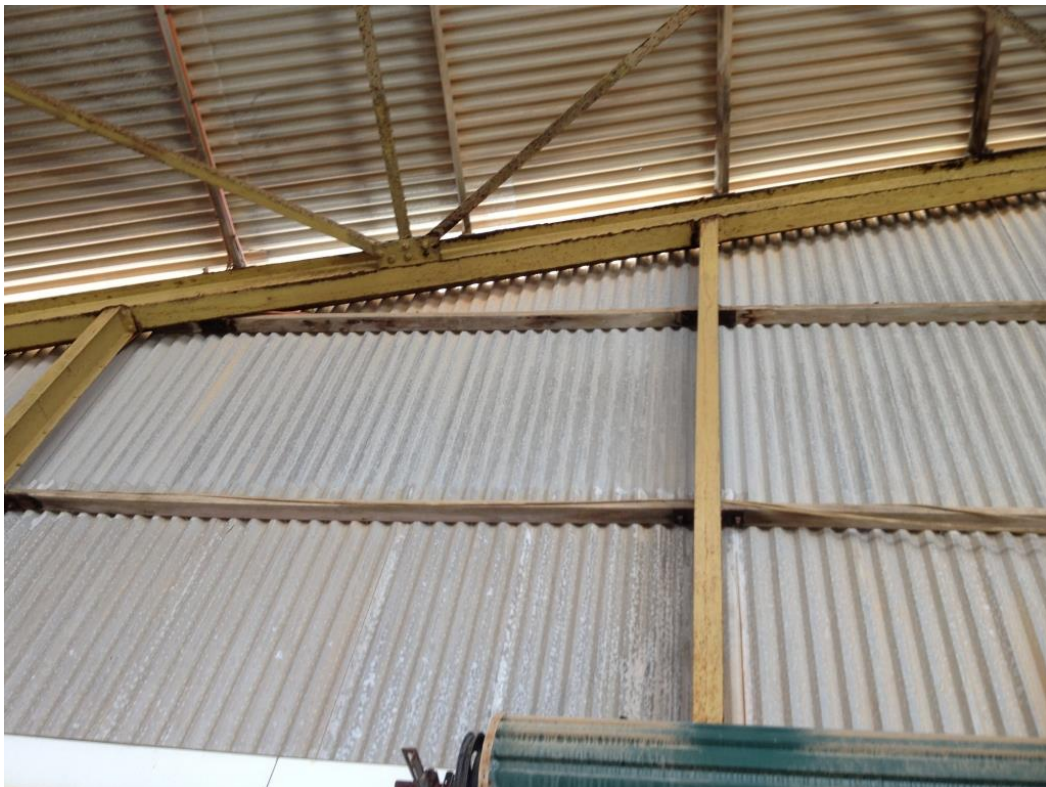
The existing paint finish to the internal structural steel portal frames and angle roof and wall bracing has deteriorated and there is minor surface corrosion throughout. Heavier corrosion was observed along the top of the western wall (where the wall sheeting does not extend full height), at the top corner connections and at the base of all columns.

In our opinion the extent of corrosion observed at most locations will not yet have compromised the structural adequacy of the members. If left untreated however, the corrosion will continue to propagate, leading to loss of section capacity and eventual failure of structural steel members.

Exposed Structural Framing					
-	General deterioration of paint finish and corrosion of structural steel portal frames	9,10 Typical	Long term corrosion failure if corrosion allowed to continue to propagate unchecked	Low	Schedule all structural steelwork to be abrasive blast clean to remove all corrosion. Re-paint with a zinc rich epoxy primer, refer section 3.1
S100, item 8	Heavy corrosion at base of portal frame columns at Western wall	11,12 Typical	Corrosion failure if corrosion allowed to continue to propagate unchecked	Medium	Upon completion of abrasive blast cleaning, site weld additional steel plates as necessary to strengthen reduced steel profile prior to re-painting. Consider additional concrete encasement at column base to prevent ponding water ponding
S100, item 9	Corrosion at base of columns and floor plates along Eastern wall. Corrosion of base of columns at Northern wall	13 Typical	Corrosion failure if corrosion allowed to continue to propagate unchecked	Medium	Upon completion of abrasive blast cleaning, site weld additional steel plates as necessary to strengthen reduced steel profile prior to re-painting. Consider additional concrete encasement at column base to prevent ponding water ponding

Photograph 9: Typical deterioration of paint finish and corrosion of exposed structural steel framing

Photograph 10: Typical deterioration of paint finish and corrosion of exposed structural steel framing

We recommend that the building cladding be temporarily removed to allow all structural steel elements to be abrasive blast cleaned to remove all corrosion back to shiny metal. A structural engineer should then be involved to inspect the identify areas where the steel sections have been significantly reduced in thickness and a boilermaker engaged to site weld additional steel strengthening plates in place where required.

Upon the completion of cleaning and strengthening works, all steelwork should be repainted with a zinc rich epoxy primer to protect against further corrosion, prior to application of a top coat.

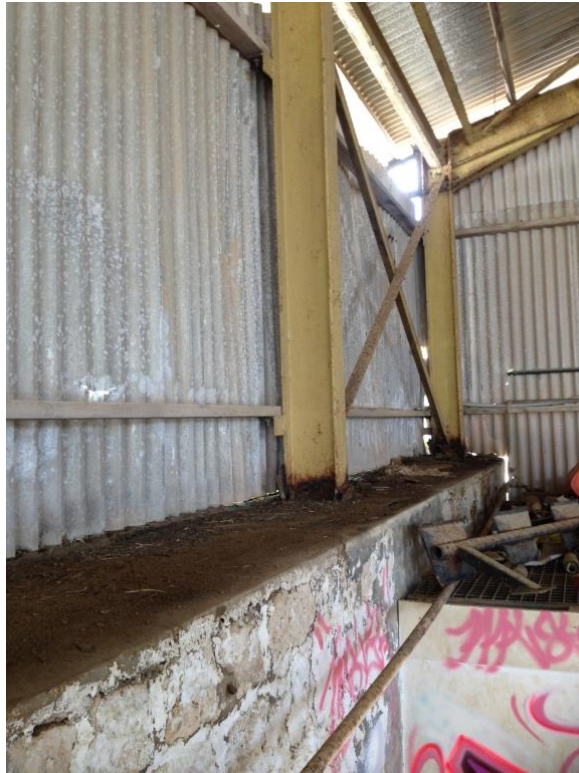
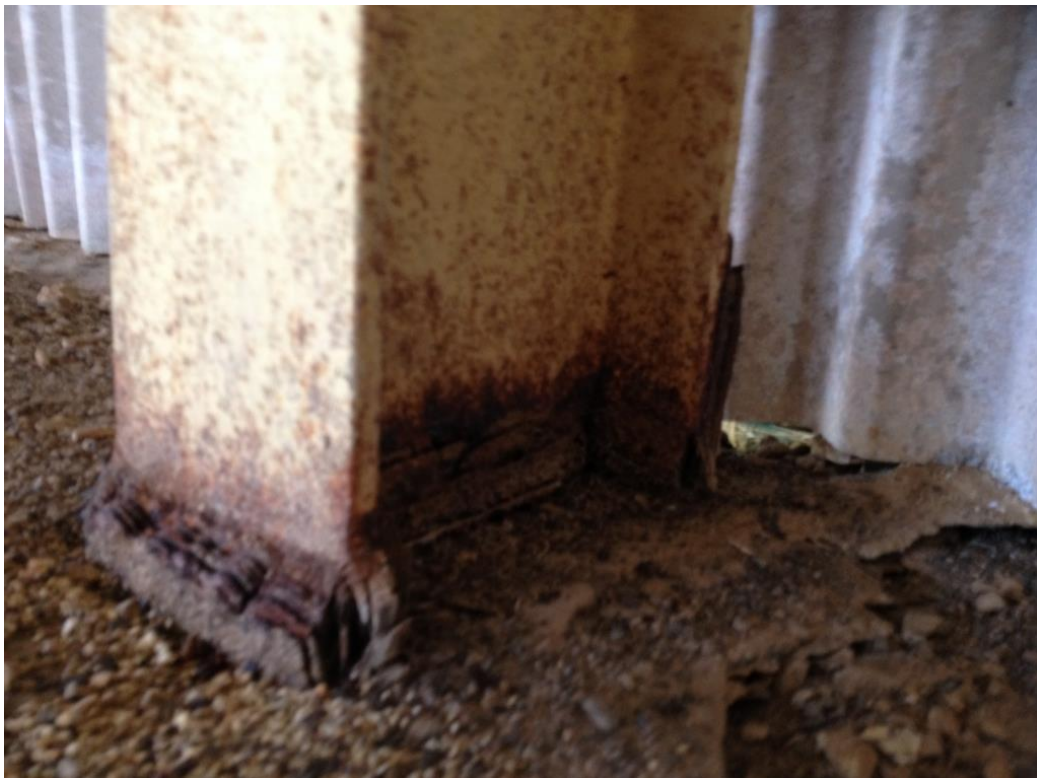
Photograph 11: Typical corrosion of at base of columns at Western wall

Photograph 12: Typical corrosion of at base of columns at Western wall

Corrosion is present at the base of all columns and we recommend that further concrete encasement be provided at all column bases to prevent water from ponding at the base of the steel.

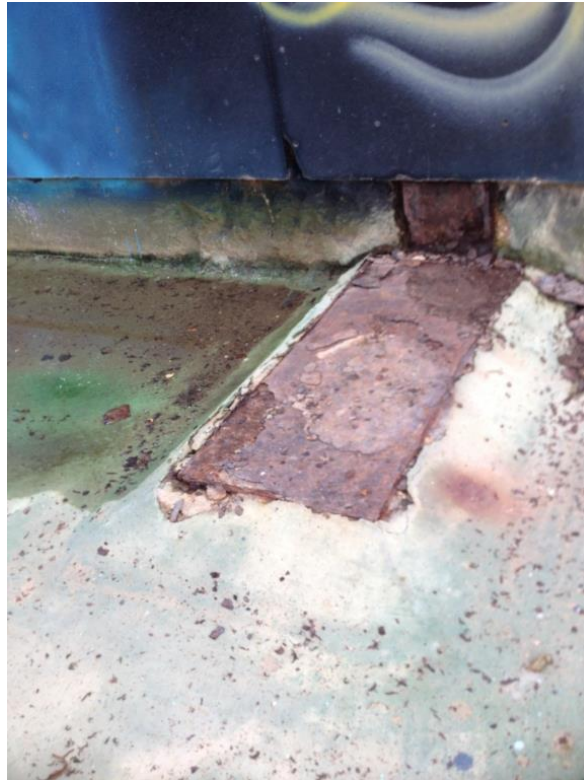
Photograph 13: Typical corrosion at base of columns in Eastern wall

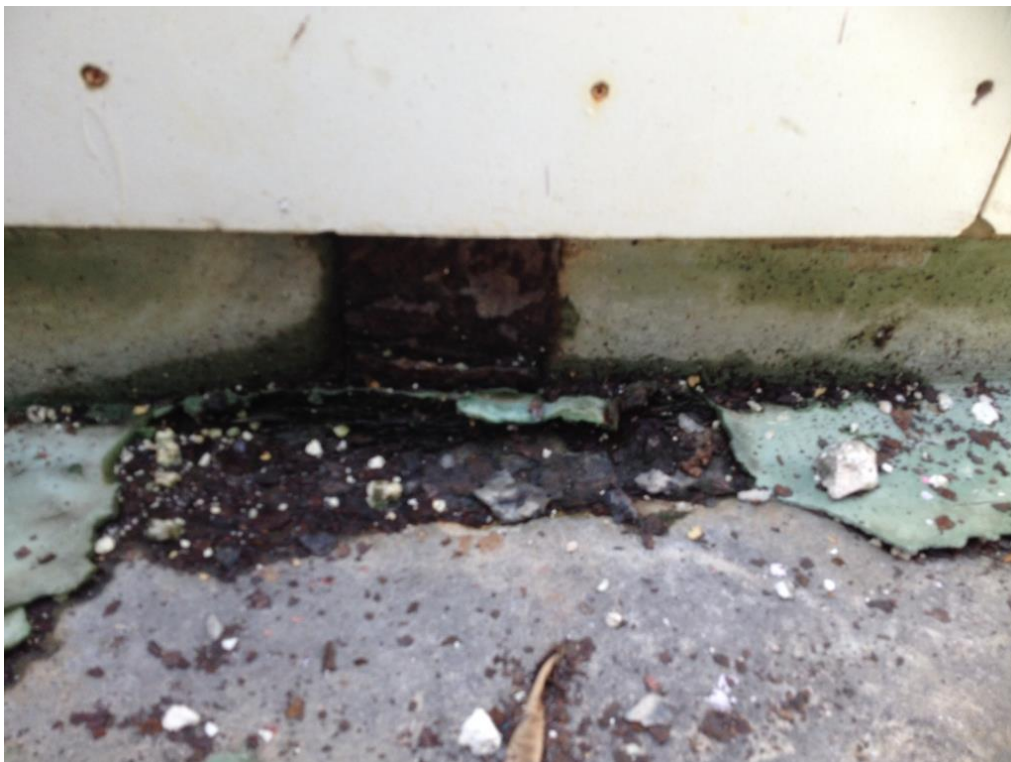
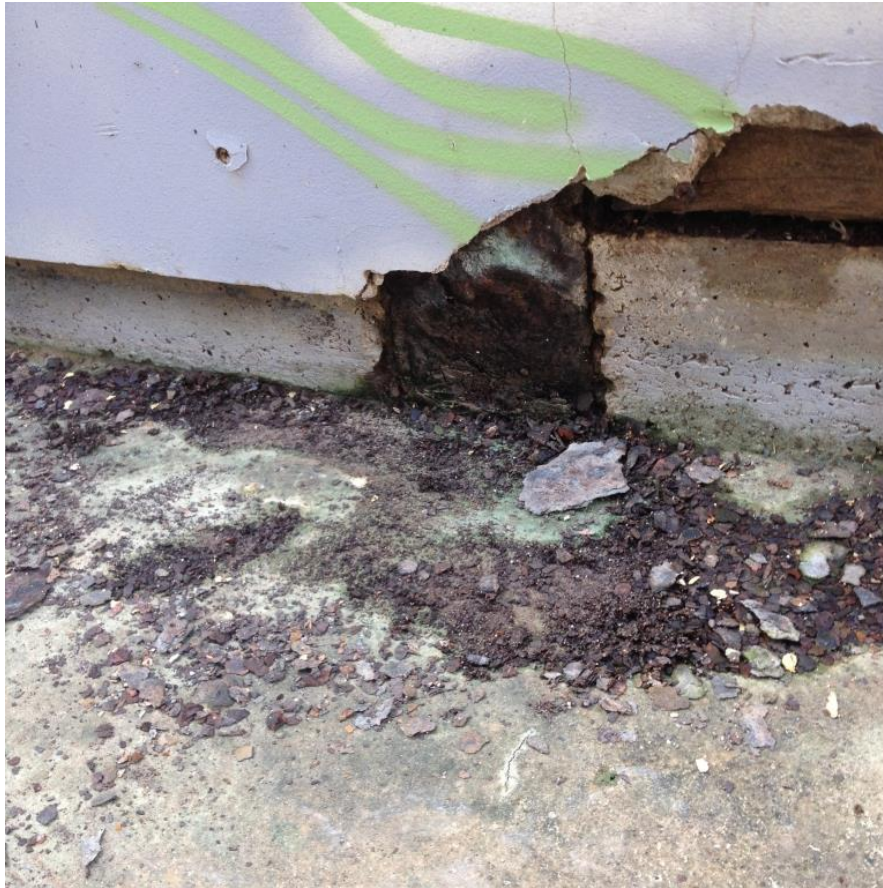
Photograph 14: Typical corrosion at base of columns in Northern and Southern walls

Photograph 15: Typical corrosion at base of columns in Northern and Southern walls

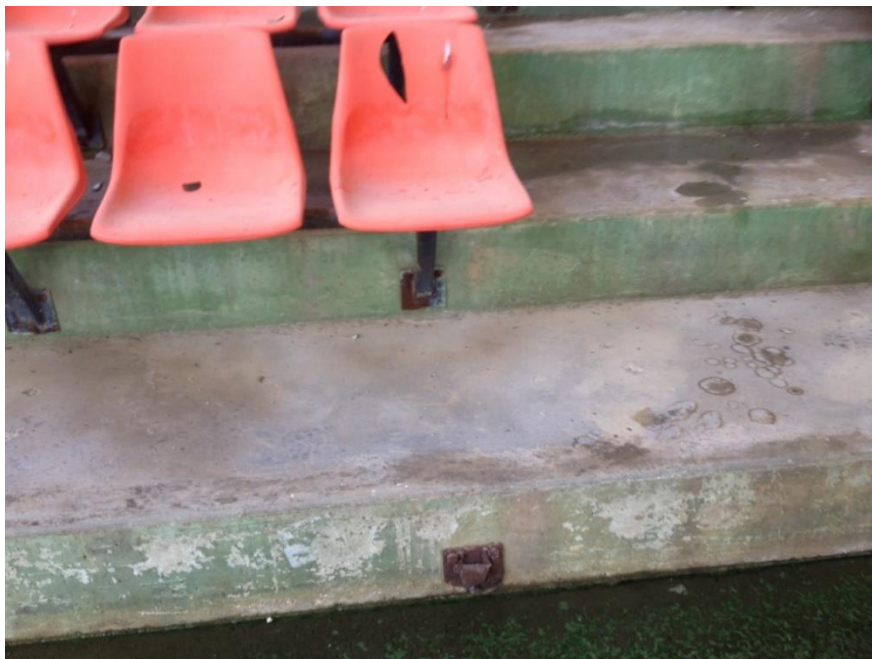
Photograph 16: Damage to plastic seats and corrosion of support framing
