DEPARTMENT OF INFRASTRUCTURE AND REGIONAL DEVELOPMENT

# Norfolk Island Roads Audit and Strategy Report

301015-03669 – REP-001

01 September 2015

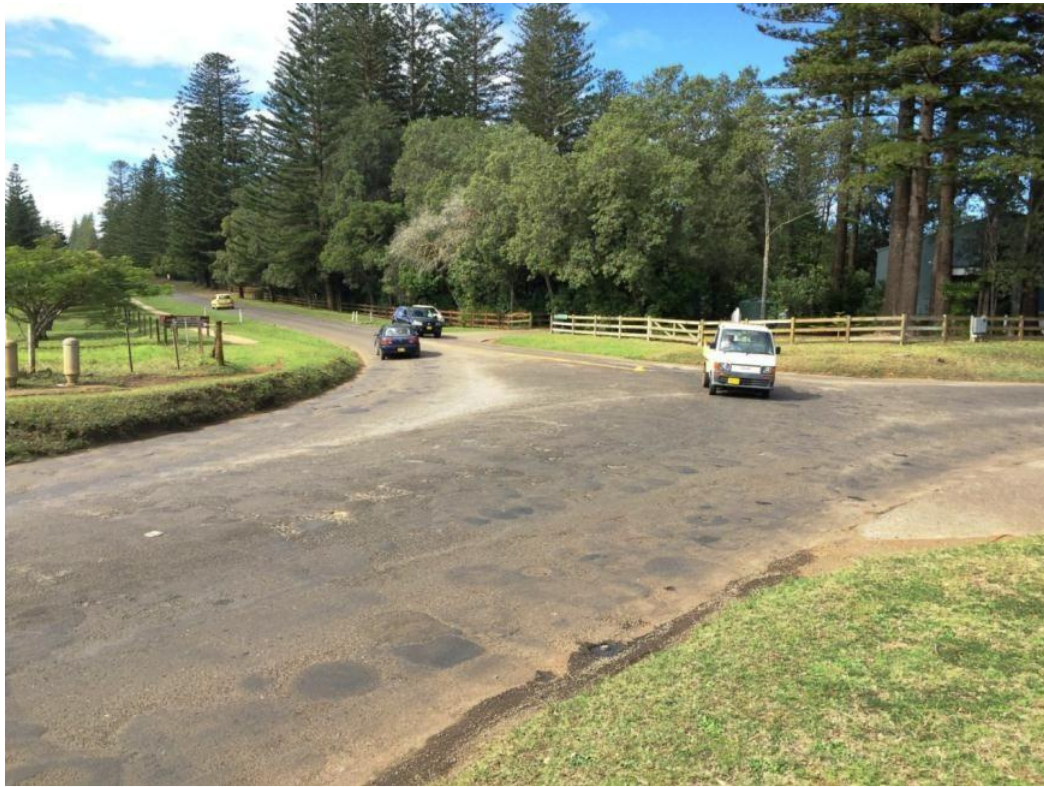
**Intersection of Taylors Road and QEA looking east towards QEA**

The 2010 report referenced above stated this intersection was first or second busiest on the island. There are problems with sight distance for motorists approaching the intersection along Queen Elizabeth Avenue (QEA) and although a stop sign is provided on the QEA leg, its presence is not obvious to motorists approaching from Taylors Road. This is mainly a problem for tourists however it creates frustrations for the locals who are tempted to drive dangerously around them. Motorists coming from Burnt Pine and turning left through the intersection are observed to drive well in excess of a safe speed. A driveway access to a business is located very close to the intersection and creates a risk of rear-end crashes as people queue to cross the line of traffic to enter the business. The footpath is unformed and narrow as it turns the corner from QEA and heads toward Burnt Pine. The footpath in this vicinity as well as a small part of the intersection is built on privately owned land.

In addition to the intersection and footpath the pavement condition between the school and along Taylors Road to The Village Place is in poor condition. Consideration should be given to reconstructing the pavement as part of the same project.

When determining a program of works for this intersection there is a strong case to be made for providing a paved footpath linking the existing footpath on QEA (which stops approximately 15m short of the intersection) to the town centre. This was rated 4<sup>th</sup> by the stakeholder workshop. The community strongly support the provision of the footpath and have already begun fund raising to pay for the construction.

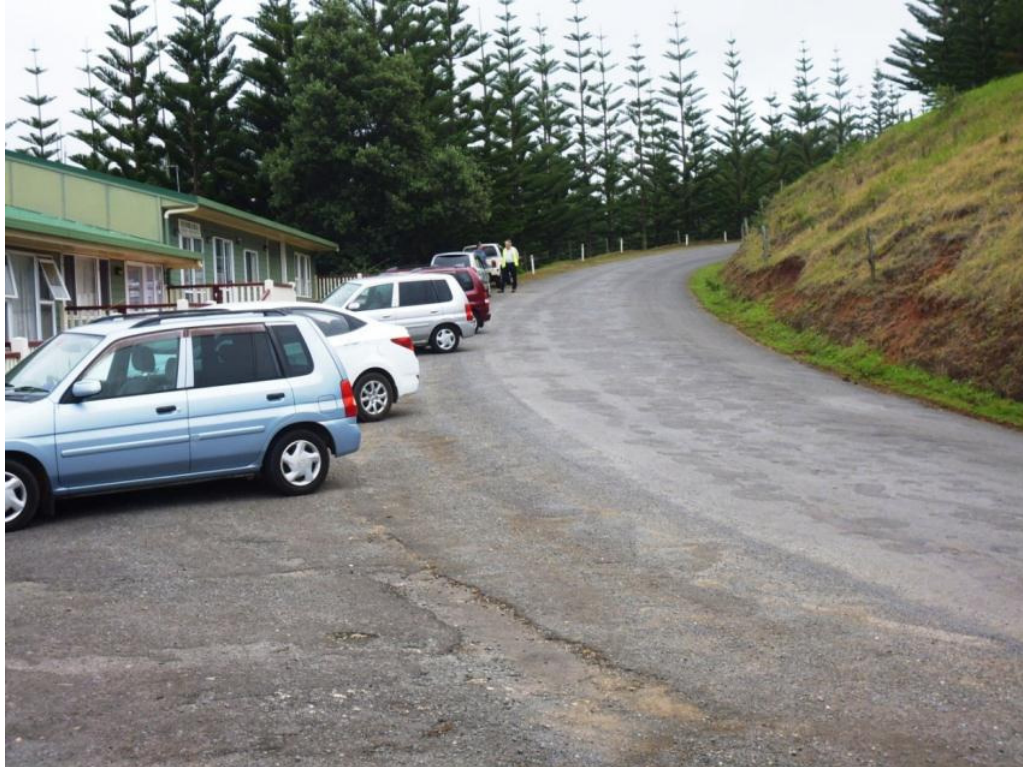
**Angled parking outside Panorama Apartments on Middlegate Road**

It is recommended vehicles only be permitted to park parallel and it be made illegal to enter the parking area by crossing the centre of the road when heading downhill to the south: a left in left out from the south should be required.

It is not recommended the road be widened or straightened in this area.

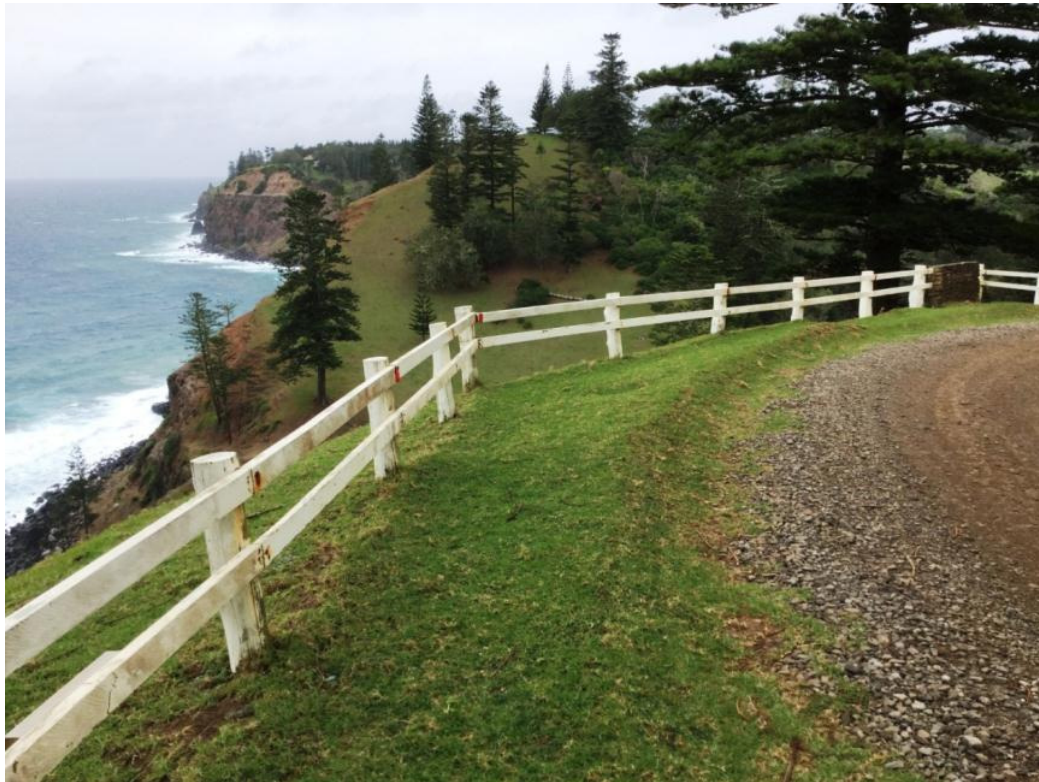
**Safety Barriers in need of replacement on Prince Philip Drive Barriers**

Previous reports have mentioned the high drop off areas around the island and the need to consider increased use of barriers (or other means of deflecting or stopping errant vehicles). This issue was canvassed at the stakeholder risk workshop 27<sup>th</sup> May where 9 areas in particular were identified (see Appendix B2). The workshop report points out that there are hundreds of other areas that pose some degree of risk. A strategy needs to be developed to carefully identify locations that require barriers; it is possible to create a false sense of safety especially when barriers are not erected in certain locations but they are provided in apparently similar locations. The type of barrier also needs to be investigated to ensure appropriateness and consistency.

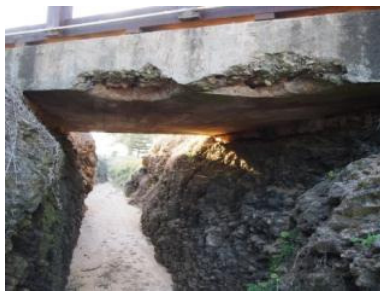
**Corroded seaward slab edge.**

Plan to replace the bridge deck or either provide a new deck (with or without removing the existing deck) or introduce a new structural support beneath the centre of the bridge deck, (noting that such an approach would remain a temporary solution). Alternatively, if the Administration decide to fill in the drainage channel (for environmental reasons) the bridge can be entirely removed.

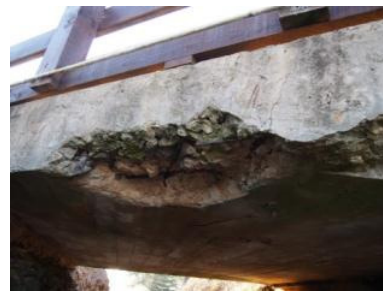
**Steel Reinforcement now ineffective**

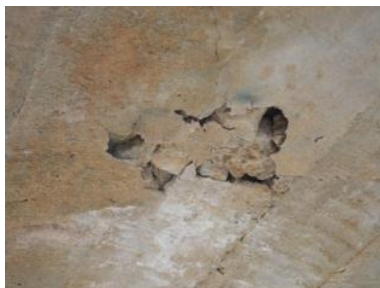
**Poor quality concrete.**

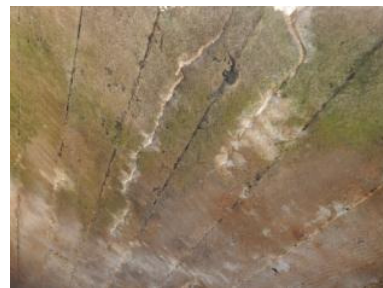
**Cracks with calcification**

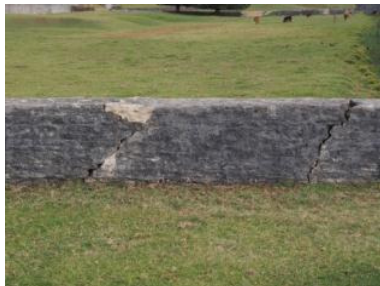
Cracked upstream headwall

1. Accept gradual deterioration of the bridge structure.
2. Perform a thorough investigation to determine the cause of the failure of the bridge structure and provide methods for strengthening and repair.

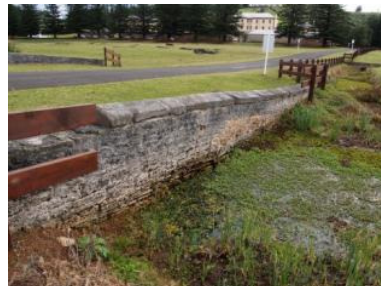
Settled downstream arch and headwall

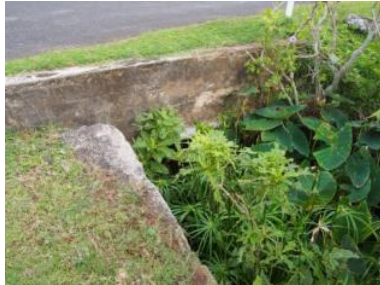
**Upstream partly obscured by vegetation**

Vegetation growth should be removed to ensure adequate storm water flow through the culvert.

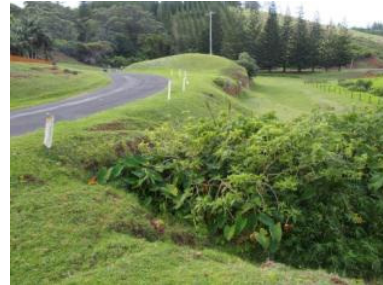
**Downstream culvert vegetation**

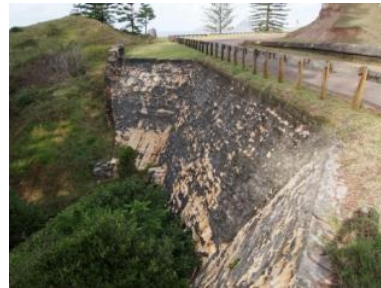
**Splayed downstream wall**

Periodic monitoring for maintenance requirements

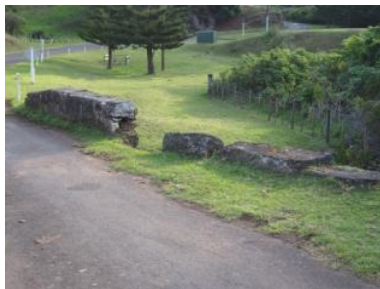
**Damaged downstream headwall**

The rock headwalls are still in need of repair.

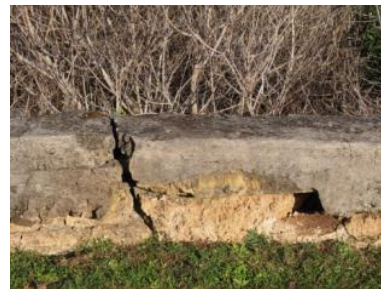
**Damaged upstream headwall**

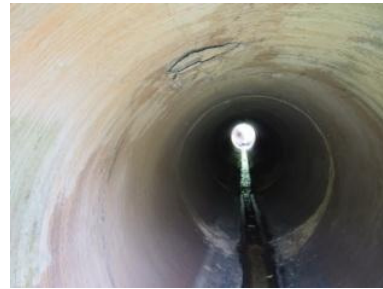
**Damaged RC pipe culvert**

Repair cracked and spalling concrete to reinstate full protection to reinforcement within the RC pipe.

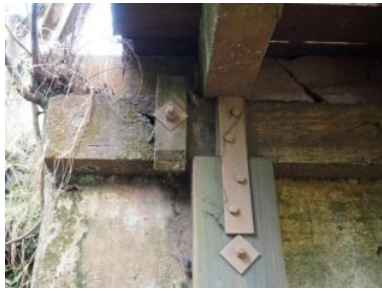
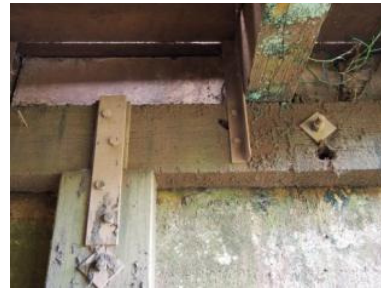
**Deteriorated northern header beam**

1. General maintenance to include periodic removal of accumulated dirt on the deck to minimise moisture at interface of timber members.
2. Guardrail is in need of repainting.
3. The northern header beam should be replaced.
