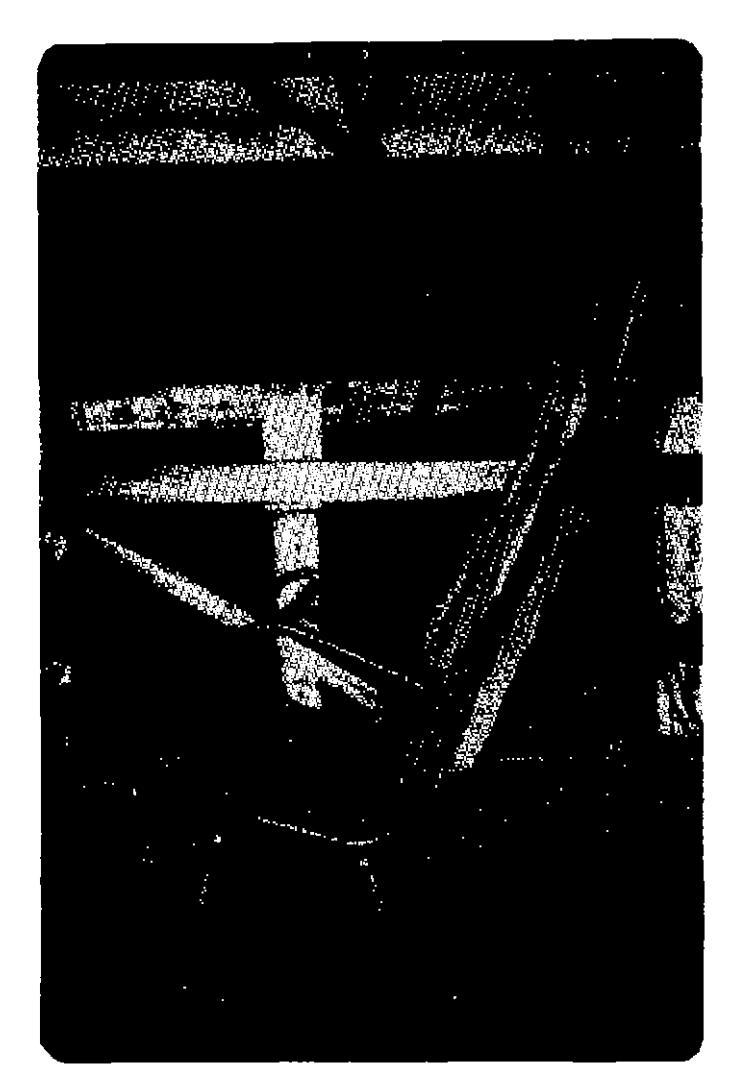
Photograph 6.5 Seat prior to Test No. 2. Note the non-continuous floor mounting plates at the ends of the legs (compare to photo 6.1).

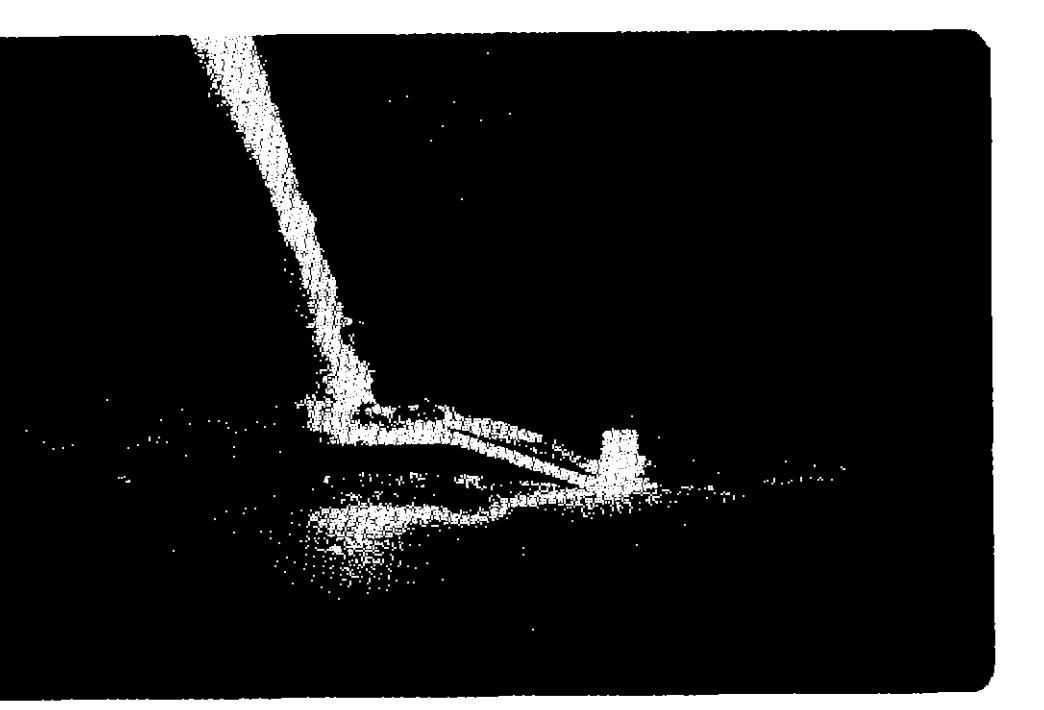
Photograph 6.9. The lifting of the rear seat leg attachment plate is obvious, although there was no sign of imminent failure. III) Test No. 3

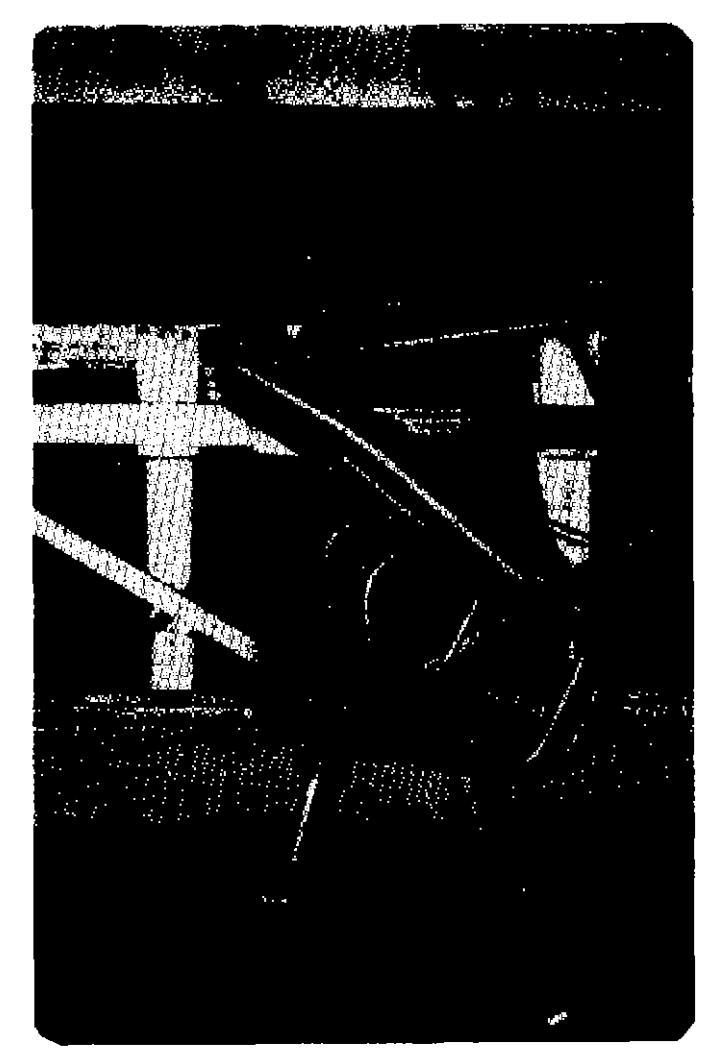
Photograph 6.11.

Failure of this seat was due to localized bending of the four vertical seat back frame tube members at the base of the seat backs, immediately above the end of the stiffening tube inserts as in Test No. 2 (Photo 6.11). There was no noticeable damage to either the seat sub-frame or seat anchorages. Nor was there any apparent skewness.

Identical failure mode and position to that exhibited in Test No. 2 (photos 6.7 and 6.8), i.e. bending of the four seat back tubes just above the upper edge of the inserted strengthening tube. Note that there is no distortion of the floor anchorage plate in contrast to photo 6.9. This seat was the same as the seat tested in Test No. 2, except for the repositioning of the legs and was used to confirm Test No. 2 results and to investigate the possible effects of altering the seat sub frame.

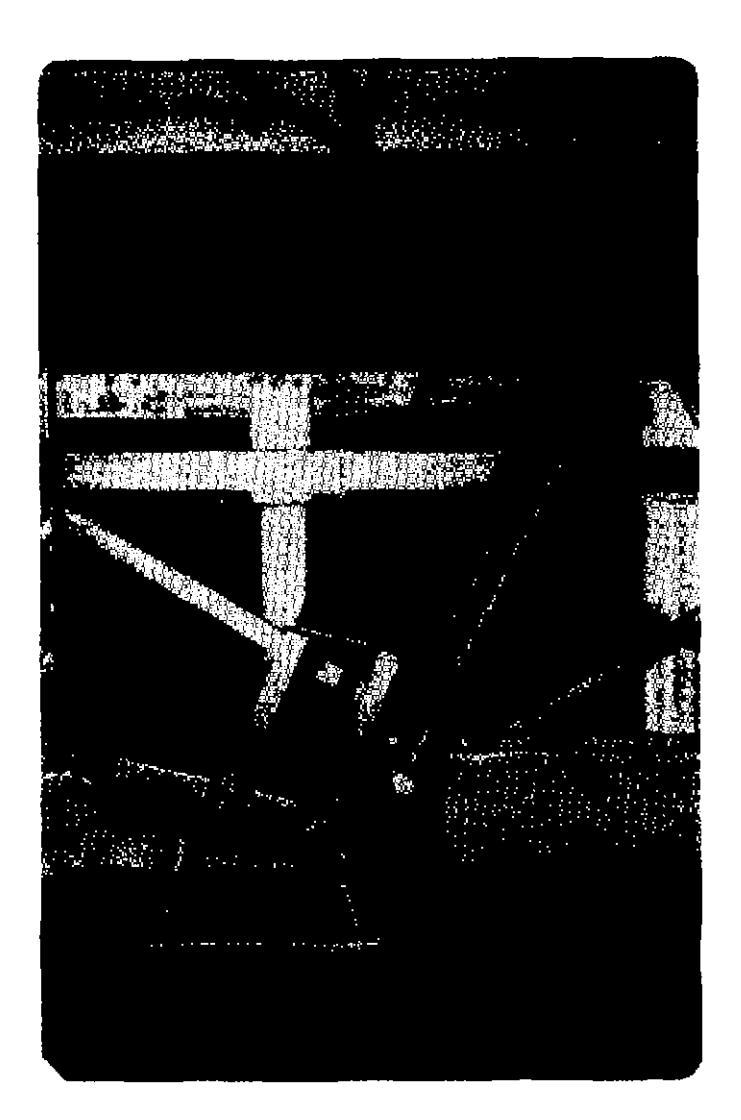
Photograph 6.12. Prior to test No.4. Note that the seat legs are mounted to the sub framing between the two seating positions, the aisle side seat is cantilevered.

Failure of this seat was initially due to localized deformation at the base of the seat back where the frame tube had been crimped to receive the bush for the pivot pin of the reclining seat back (photo 6.12). The crimped tube member deflected inwards, causing the seat squab frame to miss its stop. Once the seat squab stop was rendered useless, the entire force was taken in the shaft of the reclining cylinder fractured at the threaded end of the cylinder shaft (photo 6.13). There was no noticeable damage to either the seat sub frame or the anchorages, nor was there any apparent skewness of the seat during testing, although upon unloading the inboard seat back was 25 mm aft of the outboard seat back.

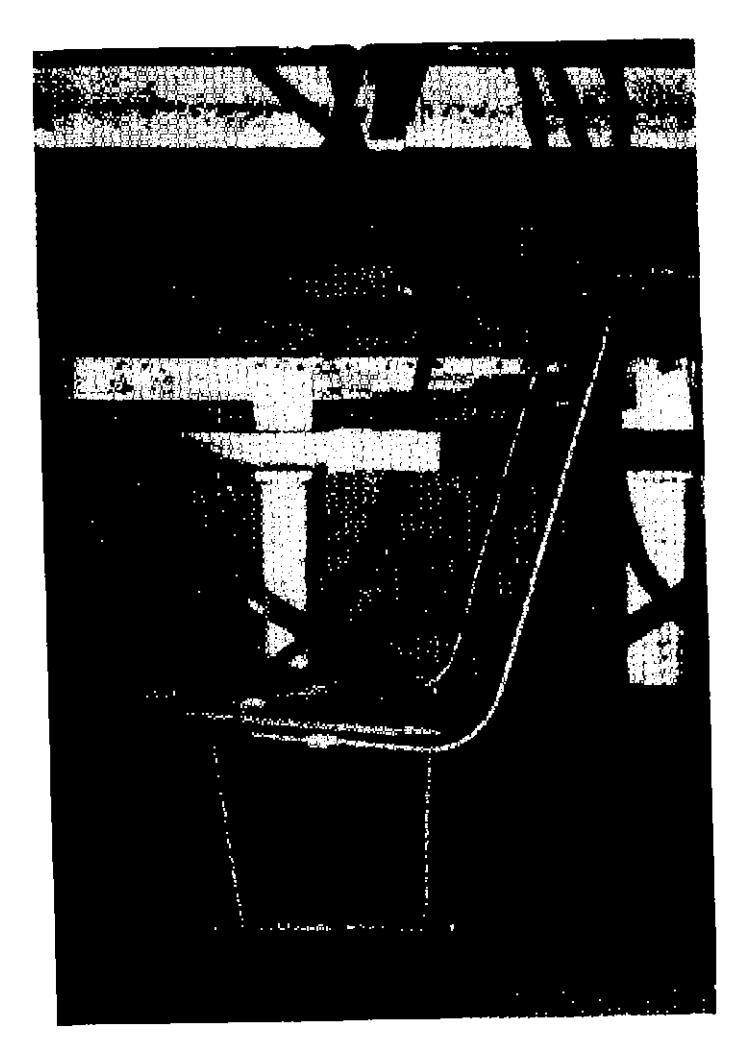
Photograph 6.14. Prior to Test No. 5. Note the absence of the seat back board and the pocketing channels used to retain it. Most route bus seats use plywood boards, usually 'thick, for the basis of both seat back and cushion. It was originally thought that the absence of these boards from the test seats would have very little effect on the test results, as it was considered that the backing boards would not alter the strength of the seat frames significantly. With this particular seat, the method of "pocketing" the seat back board was such that the timber was not held rigidly but instead, was slotted in between two stainless steel channels. Thus the board contributed no strength to the frame as it was not rigidly attached down the sides of seat back.
