Kingston Pier Channel Construction Project

Marine and Terrestrial Ecology Assessment

Department of Infrastructure, Transport, Regional Development and
Communications (DITRDC)

311015-00061_Final

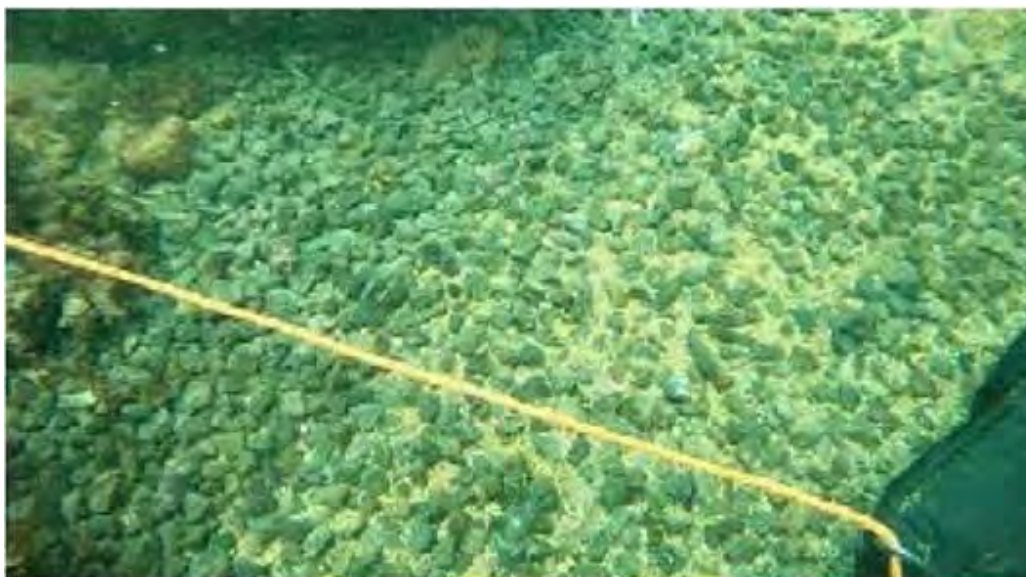
Figure 2-8 Loose gravel identified adjacent to sheet-pile wall.

The Project will involve deepening of the seabed adjacent to Kingston Pier, which poses a risk to potentially undermining the pier's existing sheet-pile wall. A recent hydrographic survey and underwater visual assessment by divers showed that this undermining was already occurring (see Figure 2-7), with evidence of loose gravel fill escaping from between the old and existing sheet-pile wall (Figure 2-8).

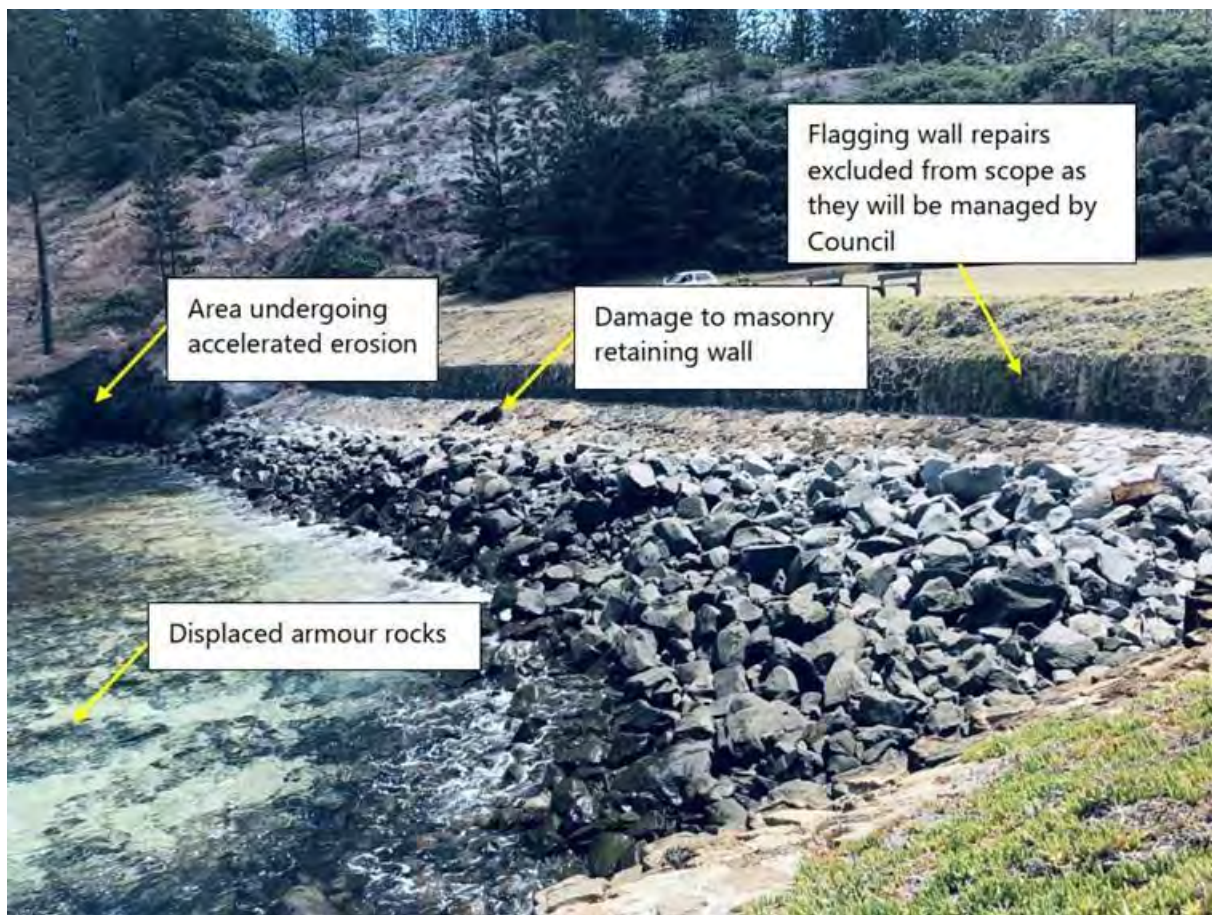
Figure 2-9 Location of rock revetment defects.

The Kingston Pier Rock Revetment, shown in Figure 2-9, is west of and adjacent to Kingston Pier. The revetment is in need of repair and upgrading, to protect the integrity of the masonry and sheet pile wall behind it and repair erosion that has occurred adjacent to the structure.

The revetment comprises a rock berm that has been constructed in front of a masonry block wall that had suffered damage since the original wall was constructed in 1839. The design for the rock berm indicates a minimum rock armour size of 300 kg, but only a single layer of primary armour. The damage to the masonry wall has the potential to allow loss of material through the structure, with the structure losing its retaining properties. There is evidence that the rock revetment is unravelling and rock armour has been displaced from the structure.

It is proposed for the western extent, profile and rock sizes of the revetment to be re-designed to extend the service life of the revetment and protect the wall behind it. This would be undertaken with land based excavator tracking along the revetment and using locally sourced rock.

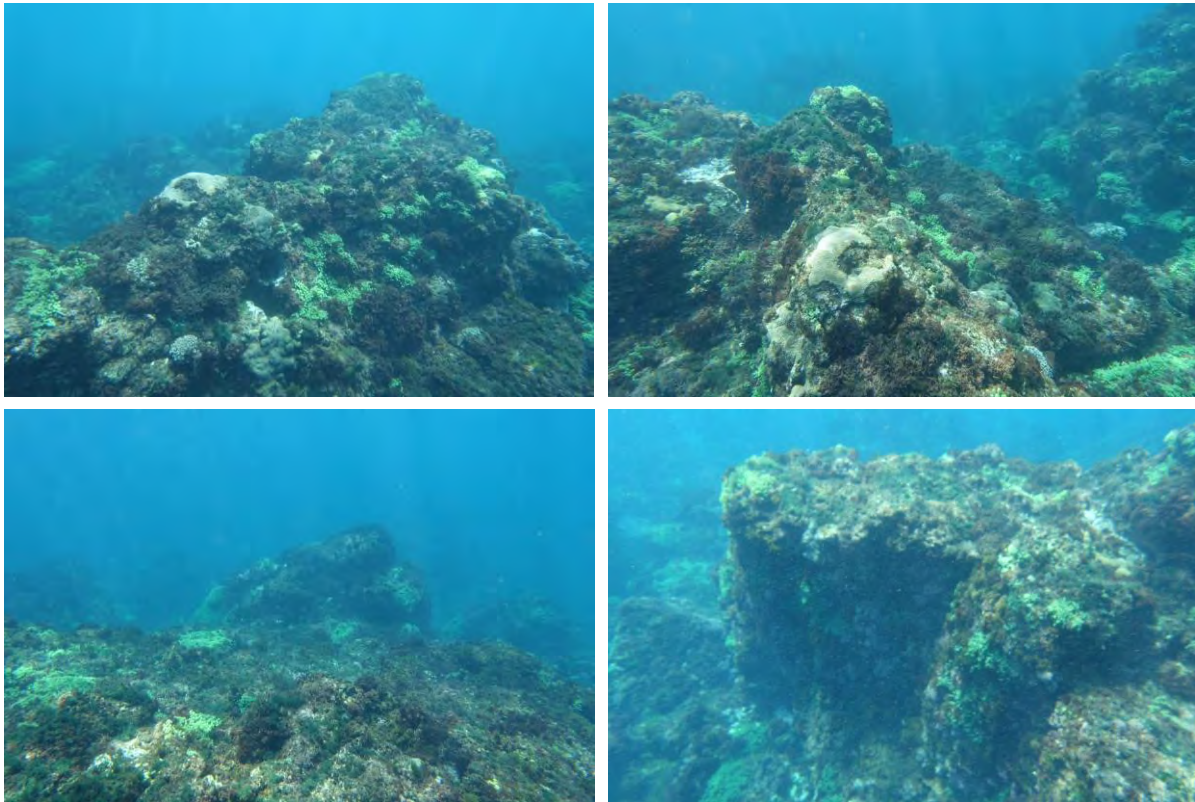
Figure 3-12 Bombora at seaward end of channel, Kingston Pier.

At the time of inspection of the Bombora, no fish or other pelagic species were noted. The substrate was dominated by a high percentage cover of macroalgae with minimal coral cover. Very little bare rock or sand was visible (see Figure 3-12).

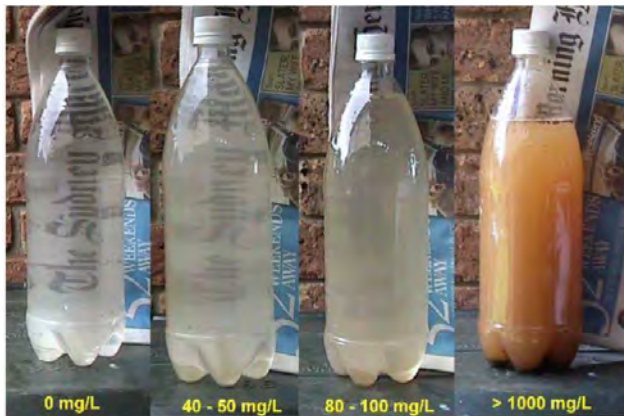
Figure 4-3 Visual representation of suspended sediment concentration.

SSC is presented as milligrams per liter (mg/L). It is noted that at SSC concentrations below 10 mg/L, the plume would not be visible to a casual observer. The appearance of turbid water with varying concentrations of SSC is illustrated in Figure 4-3. Predictions of the sedimentation over the course of the dredging operation are presented as millimeters above seabed.
