# Kingston Pier Channel Construction Project

## UNDERWATER CULTURAL HERITAGE STATEMENT OF HERITAGE IMPACT

Kingston,  
Norfolk Island,  
Australian External Territory

June 2020

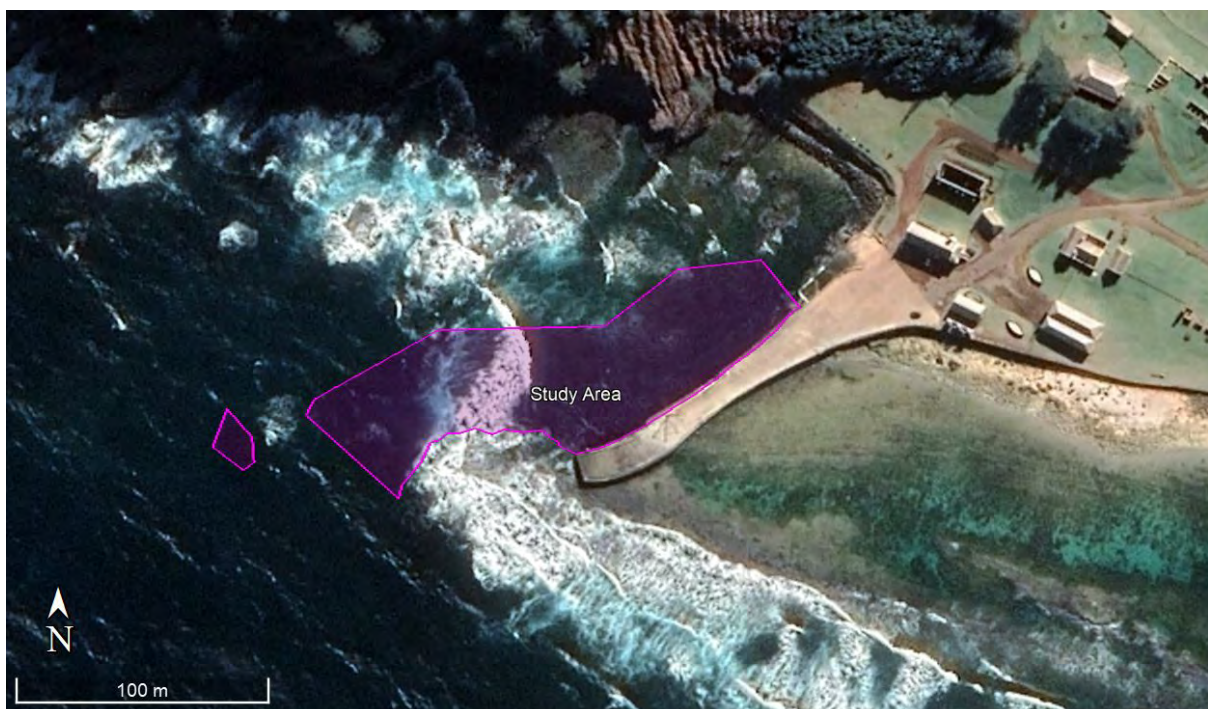
**Figure 2: Study area for the underwater cultural heritage SoHI.** (Base map courtesy Google Maps)

The study area for this underwater cultural heritage SoHI incorporates the maximum extent of proposed dredging with a further approximate 10 m buffer extending from the seaward edge of the construction envelope of the seabed removal option with the greatest extent – See Option 4 in Section 8 (Figure 1 and Figure 2).

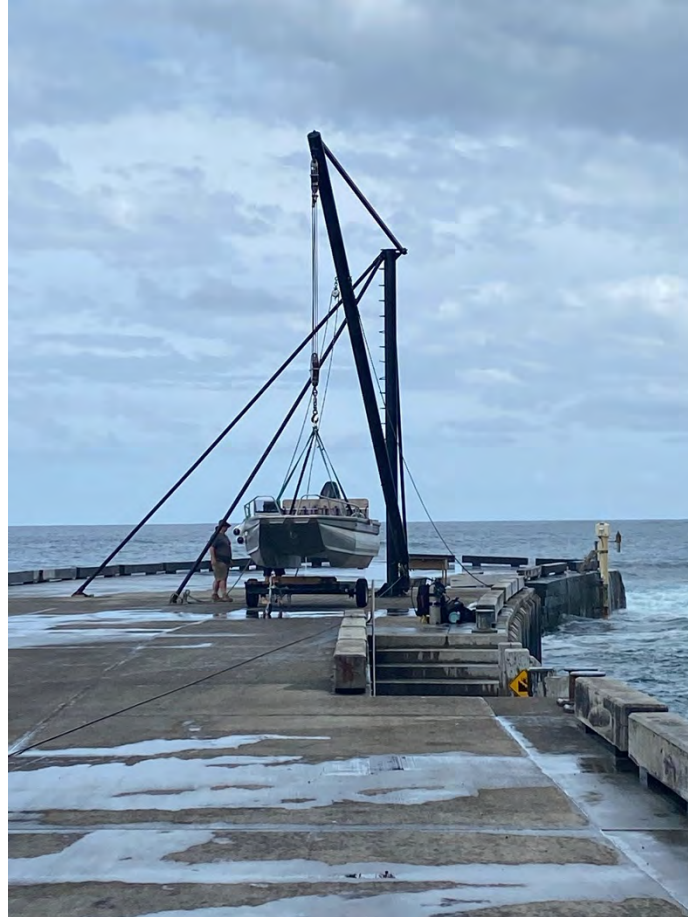
**Figure 21: The dive support vessel Black Dog Cat, using derrick to launch off Kingston Pier. (Image taken 26 February 2020)**

Before the transects were run, the dive boat *Black Dog Cat* was launched from the derrick on the western edge of Pier (Figure 21). While the boat was not required for in-water work, the vessel maintained a watching brief at the entrance to the channel to ensure diver safety from fishing vessel movements.

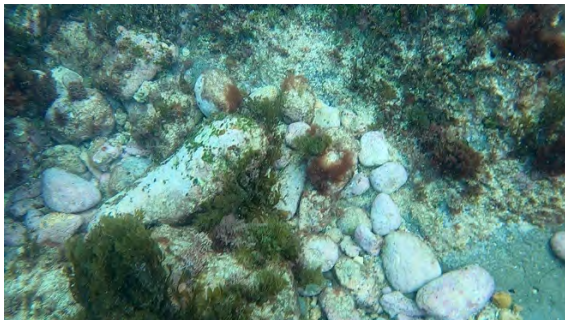
**Figure 24: Example of seabed around the channel entrance.** These smaller cobbles were interspersed between the larger rocks. The grey material in the bottom right corner is the grey tuff. (NI\_SS01\_008\_200226 00:00).

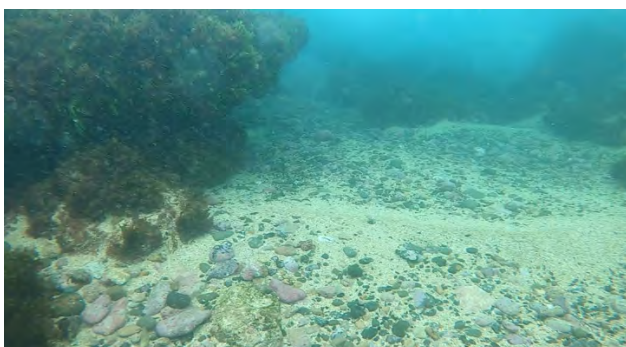
**Figure 26: Example of sand gully at entrance to the channel.** Western edge of fringing reef visible in left side of image. (NI\_SS01\_004\_200226 01:11).

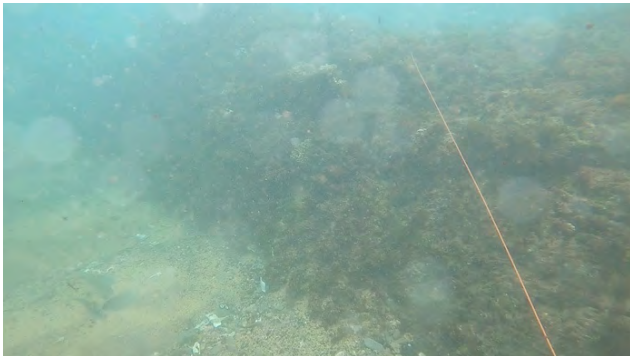
**Figure 33: Dredged area to reef transition at 4.5 m along transect.** (NI\_T1\_0 to 30 m\_200226 1:00)

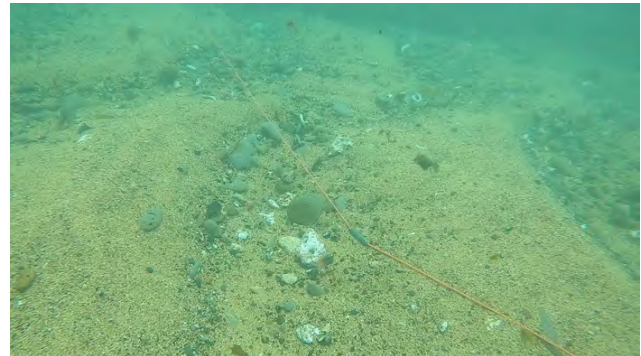
**Figure 34: Dredge line showing sandy seafloor with rock scatters and animal bones.** (NI\_T1\_0 to 30 m\_200226 00:10)

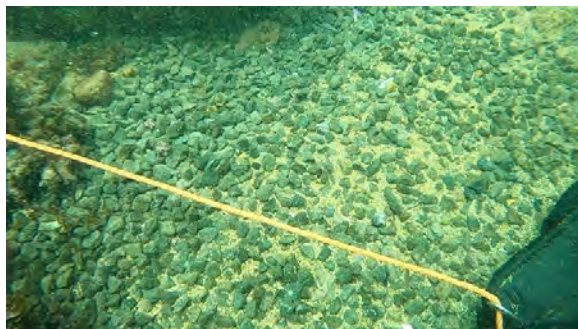
**Figure 39: Gravel infill over sand at the start of Transect 2.** (NI\_T2\_0 to 30 m\_200226 00:00m).

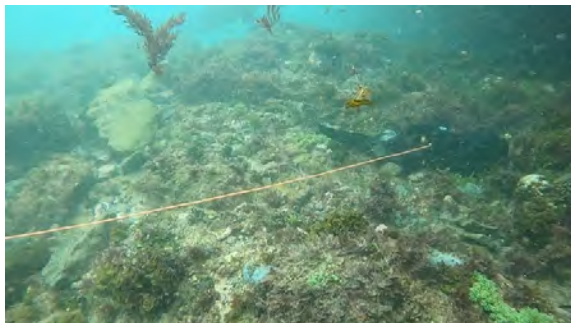
**Figure 46: T3 at 0m facing north parallel to the Pier.** Note rocky reef area drops away at the top of the image. (NI\_T3\_0 to 30m\_200226 00:07).

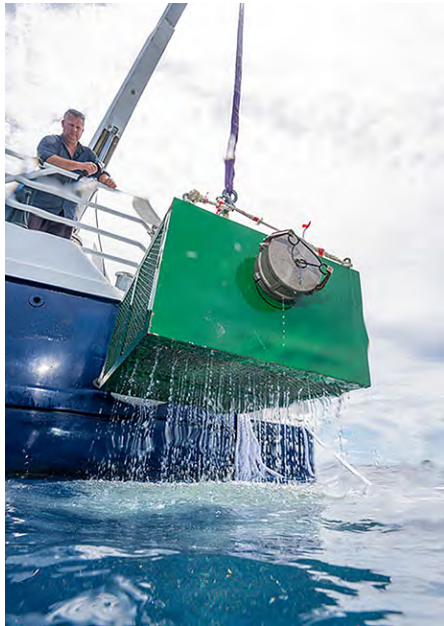
**Figure 75 : Sediment box being lifted from seabed.** (courtesy PDS)

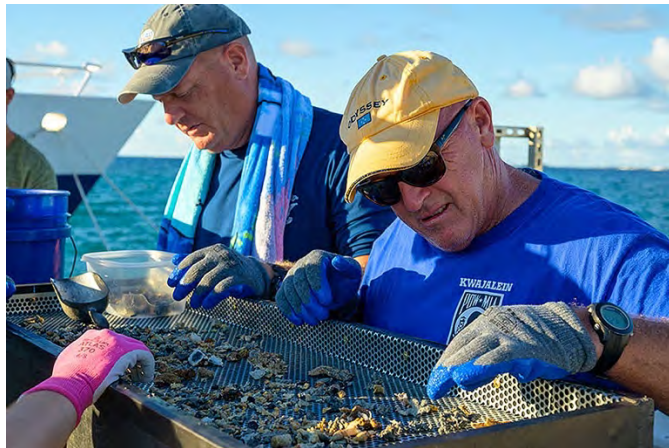
**Figure 76 : Example of sieving.** For this project the sieve system would need to be larger without losing efficiency. (courtesy PDS)
