# Christian's Minde Settlement, Jervis Bay Territory

Historic Heritage Management Plan

June 2025

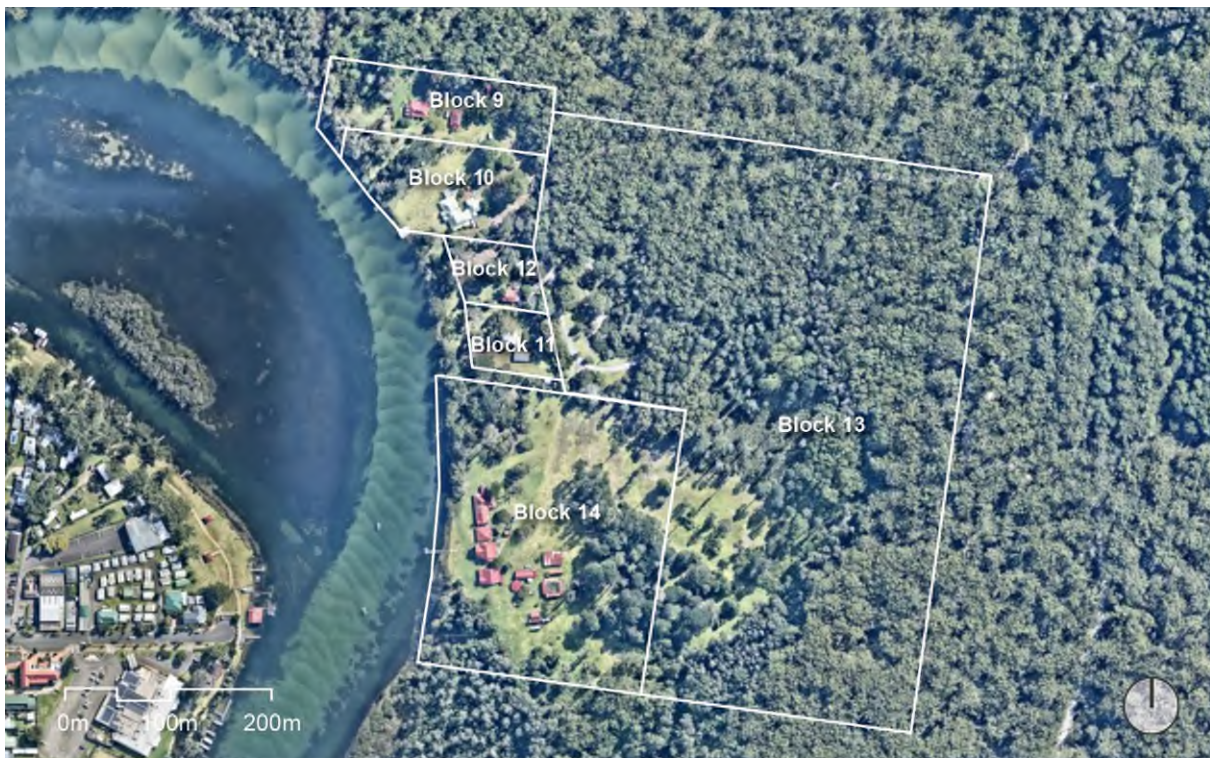
Figure 1.4 The division of lease blocks within Christian's Minde Settlement. The cemetery is not shown but is located to the east of Block 14, surrounded by Booderee National Park. The small portion of land on the water's edge in front of Blocks 11 and 12 is a public reserve. (Source: Nearmap with GML overlay © Nearmap, all rights reserved)

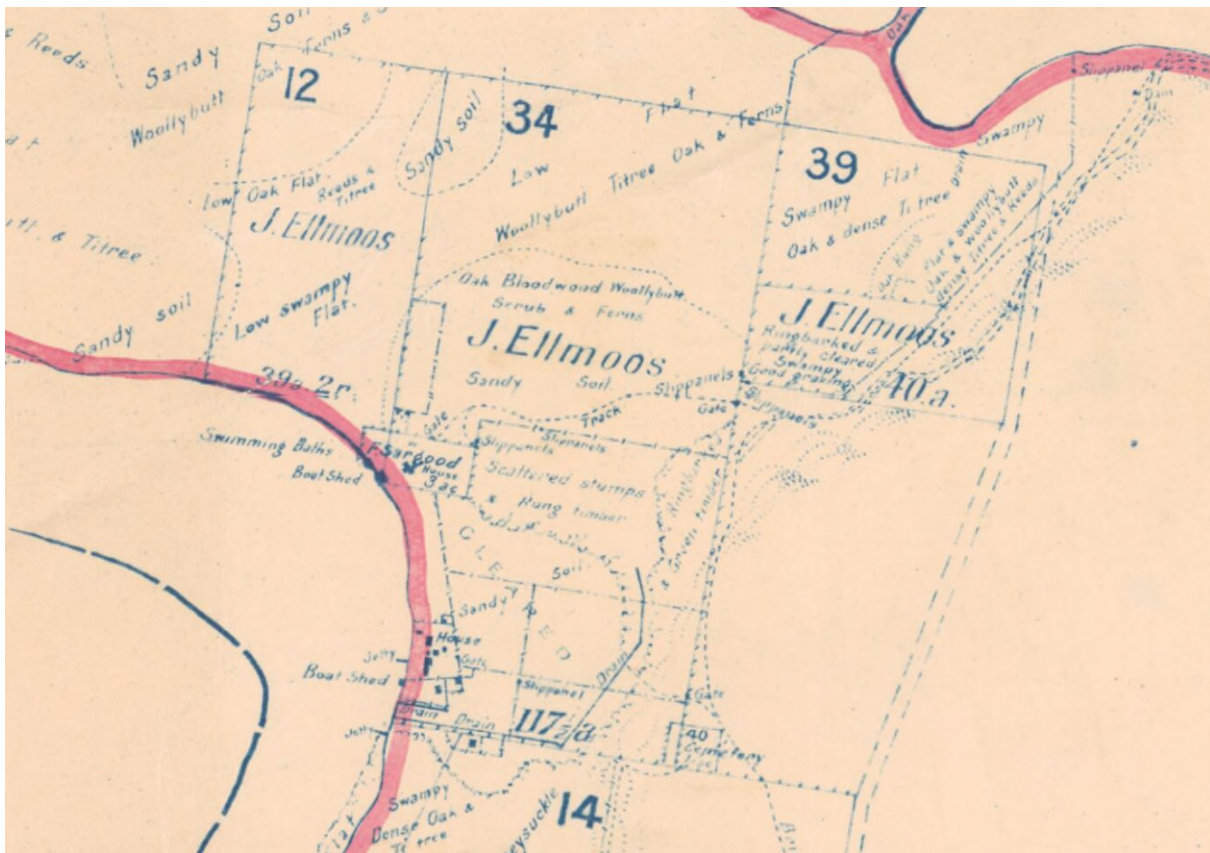
Figure 2.3 Detail from a 1916 topographical map of the Commonwealth Territory Jervis Bay Parish of Bherwerre, County of St Vincent/JTH Goodwin, Chief Surveyor; compiled and drawn by the Department of Home Affairs, Lands & Survey Branch. Note that the boat sheds and jetty are marked, as is the cleared agricultural land surrounded by the hand-dug drain. (Source: NLA, MAP G8982.J4 1916)

The cemetery was technically established on its own block, Block 40, as shown on the charting maps (Figure 2.3) and was dedicated on 1 December 1900.<sup>4</sup> However, it was likely in use earlier.

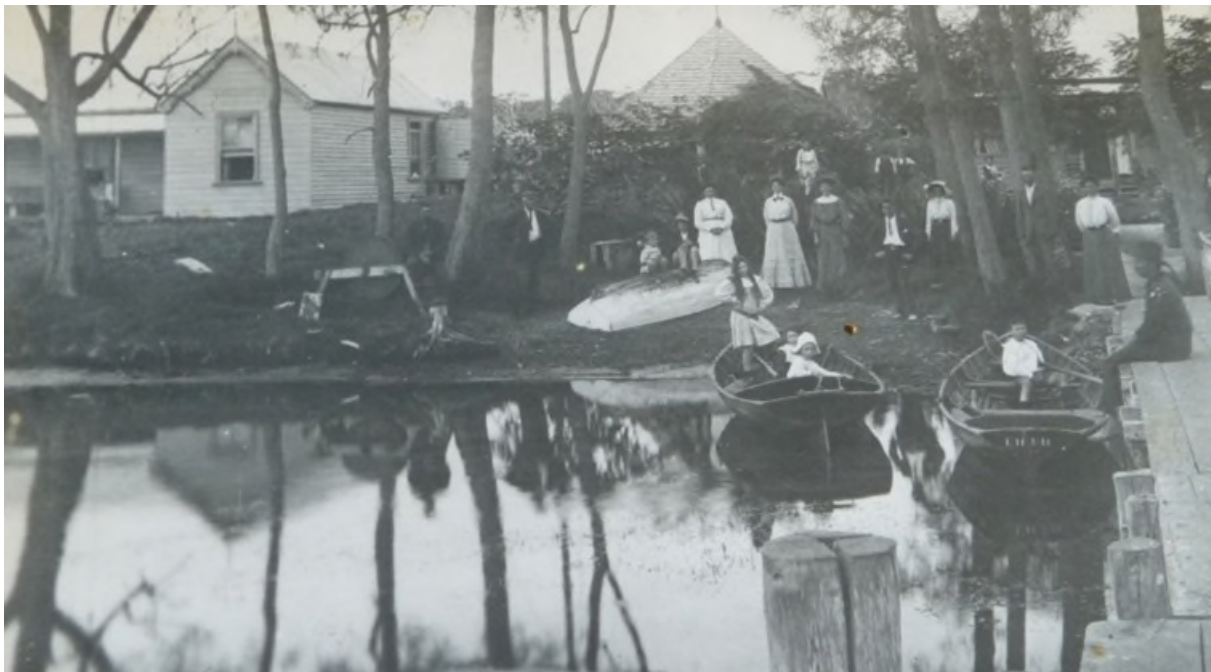
Figure 2.8 Christian's Minde, 1898. The main house is positioned opposite the end of the jetty with the octagonal roofed dining room next door and guest accommodation rooms in the larger cottage along the shore. (Source: Peter and Pam Ellmoos collection)

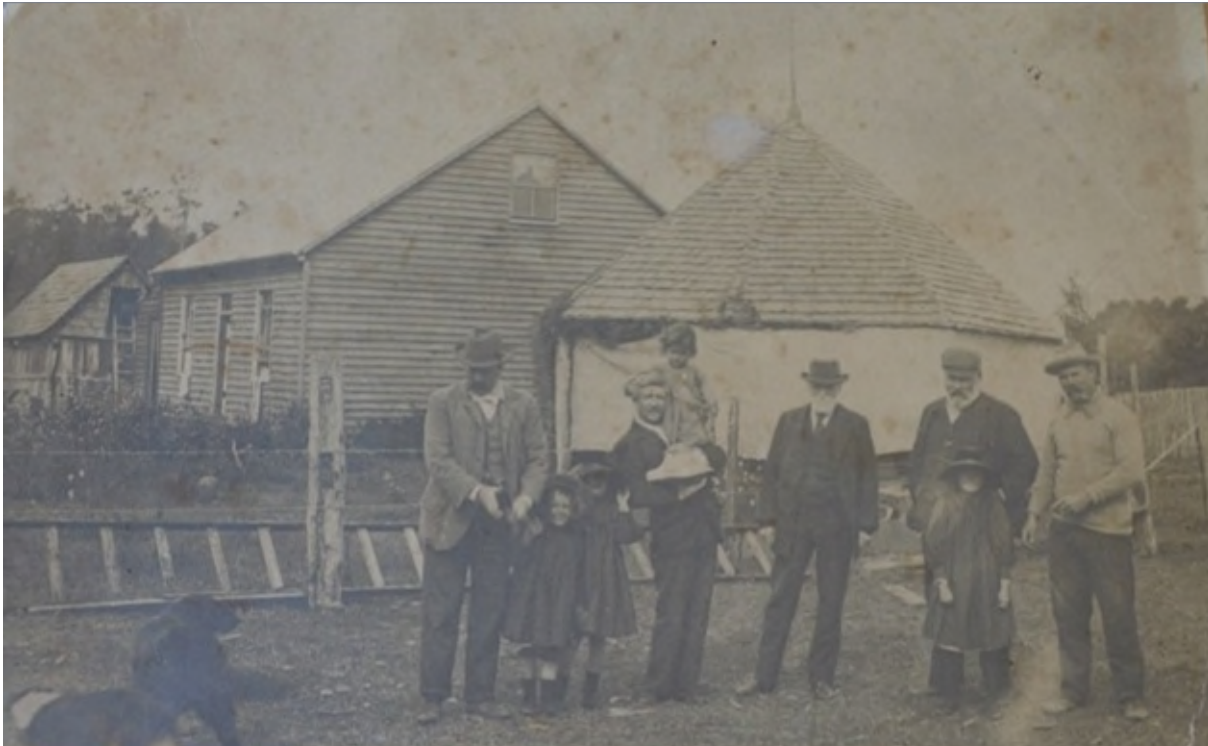
Figure 2.9 Rear view of the main cottage with the octagonal roofed dining room, date unknown. Note the hessian walls. (Source: Peter and Pam Ellmoos collection)

- CM5, a single-storey staff cottage dating from the 1920s. It has additions from the 1960s and was reclad internally and externally in c2016. The c1880s octagonal roofed and hessian sided dining room (Figure 2.9) is no longer extant.

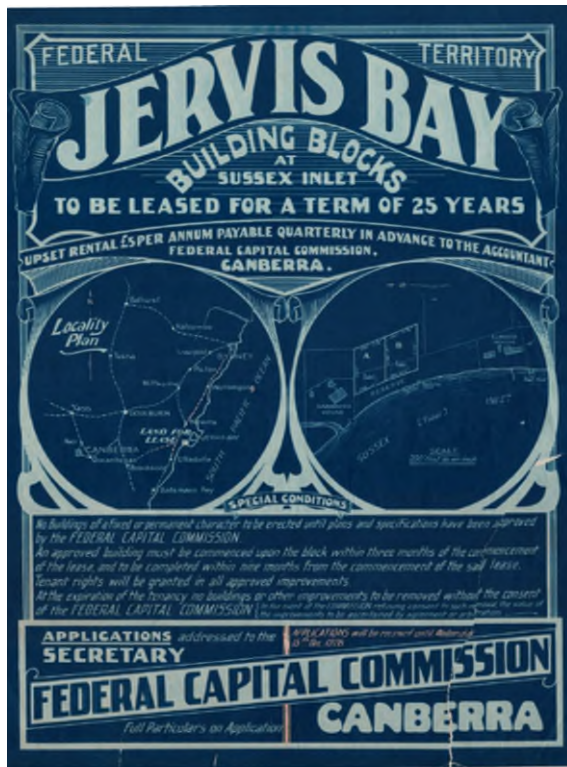
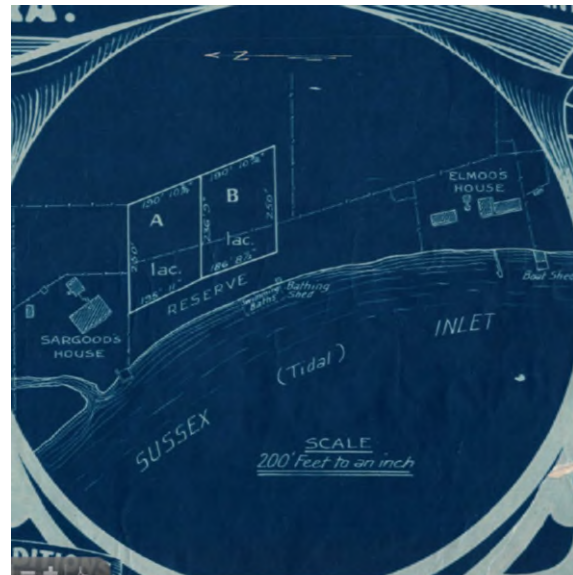
Figure 2.21 Leasing advertisement for Blocks 11 and 12 at Christian's Minde Settlement (marked A and B on the map), December 1926. Note that Block 10 for Kullindi is labelled as 'Sargood's House' and that Christian's Minde is labelled as 'Elmoo's House'. The now-disappeared bathing house and sea baths on the shoreline near the Ardath block are included, as are the boat sheds at Kullindi and Christian's Minde. The kitchen block and dining room at Christian's Minde is clearly recognisable from the octagonal shape of the dining area. The Sussex Inlet Post Office has not yet been added to the c1880s guesthouse. (Source: ACT Archives, Department of the Interior Rural and Land Property Register)

Separately, Blocks 11 and 12 of the site were advertised for lease by the Australian Government in 1926 (Figure 2.21). In 1927, Block 11 was leased to George Junk (married to the youngest Ellmoos daughter, Anna). The residence on Block 11, Ardath, dates from c1927, and is reported to have been moved from an earlier location on Block 14. Block 12 was leased in 1935 to Charles Felsted, who constructed the cottage Pamir. There was no Ellmoos family connection, but it is believed that Felsted was a guesthouse employee.<sup>34</sup>

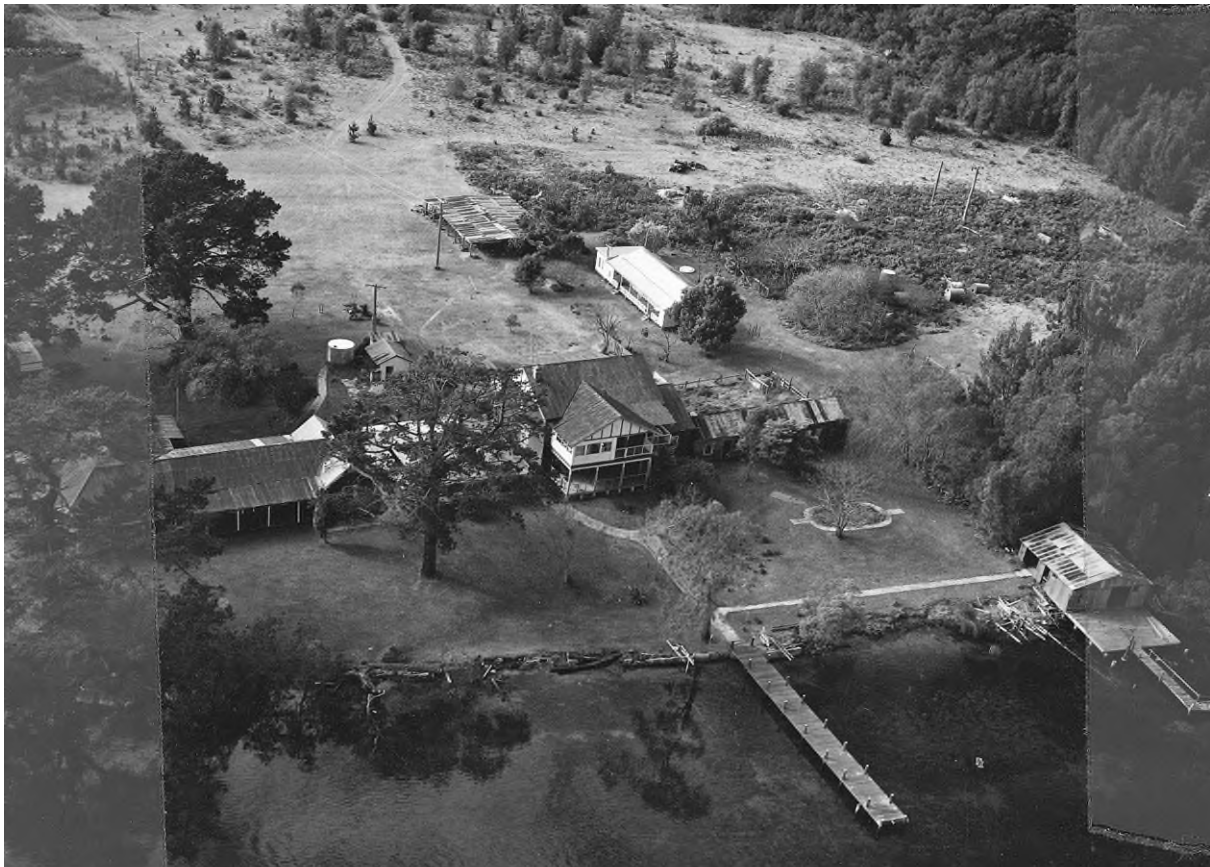
Figure 2.27 Aerial photo of Christian's Minde. Dated 1971, photographer unknown. Note the building on the right is no longer present on the site. It has been replaced by a new single-storey dwelling. (Source: Private collection in Ellmoos family, all rights reserved)

- CM4, a 2016 cottage building directly south of the two-storey guesthouse, which replaced an earlier 1970s cottage that was demolished in 2015. This cottage itself replaced an earlier structure, likely pens or a vegetable garden (visible on Figure 2.27).

There is high potential for the existence of post-settlement historical archaeology within the Christian's Minde Settlement, particularly on Block 14—Christian's Minde. Historical site plans and photographs suggest the original guesthouse accommodation consisted of a continually evolving development of buildings and outbuildings that no longer exist on the site or have been replaced with other buildings. In some cases the exact location, form and date of these buildings have not been well-documented and are unknown. Consultation with lessees indicated Building A1—Ardath's original location and foundations are close to the east of the Block 14—Christian's Minde buildings in the forested area, though these were not able to be accessed due to heavy vegetation. Changes to the form and location of buildings on the site can even be seen from the 1970s onwards, as is evident in Figure 2.27.

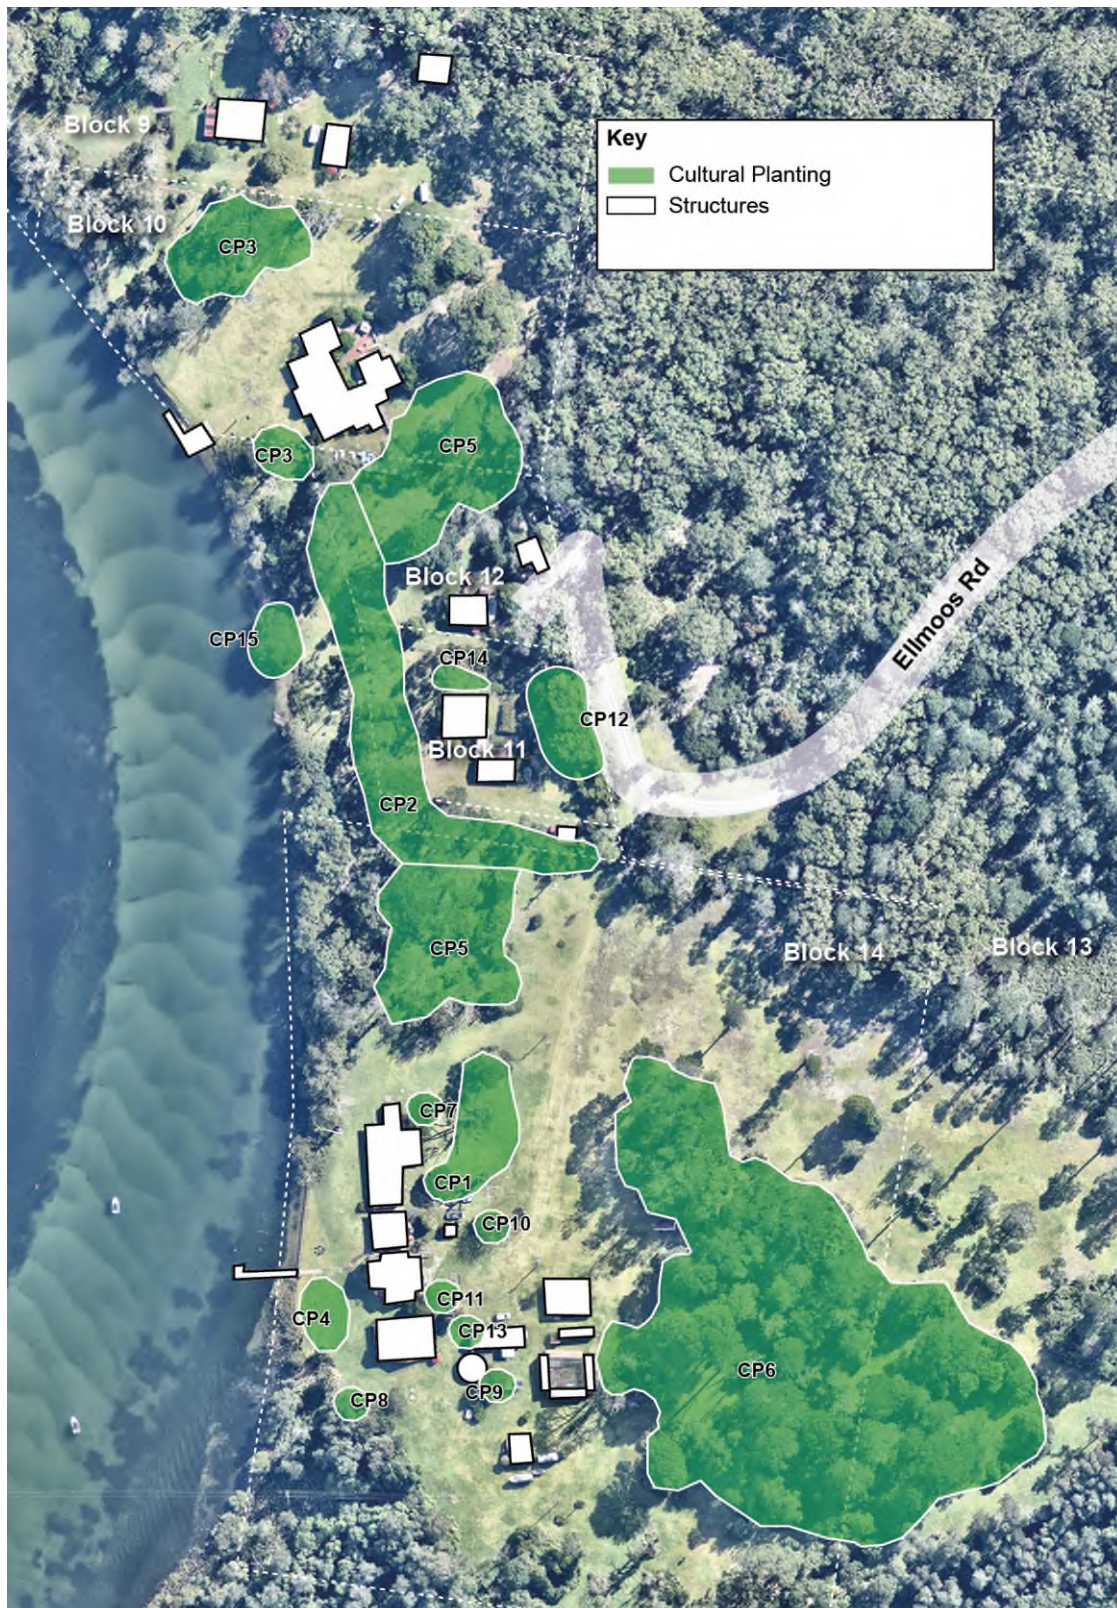
Figure 3.2 Location of surviving cultural plantings at the Christian's Minde Settlement. (Source: Nearmap with GML overlay)

Nonetheless, the surviving cultural plantings constitute a significant part of the Christian’s Minde Settlement, reflecting their use for decorative and practical purposes. A number of individual trees and groups remain as evidence of different phases of cultural planting—they are listed in Table 3.1 below and shown in Figure 3.2.

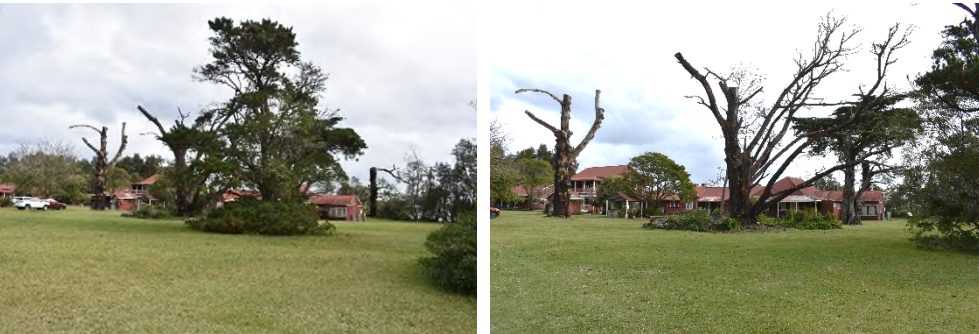
| ID and planting | Attributes, cultural heritage value and photographs |
|---|---|
| CP1<br><b><i>Pinus radiata</i></b><br><b>(Monterey Pine)</b> | <p>A tree 80–100 years old planted behind the complex of Christian's Minde buildings on Block 14. Originally part of a group of three, two of which have died since 2015. These were not planted to act as windbreak trees and appear to be planted as ornamental specimen trees. A <i>Pittosporum</i> is competing with the remaining pine.</p> <div data-bbox="395 651 1378 983"> </div> |

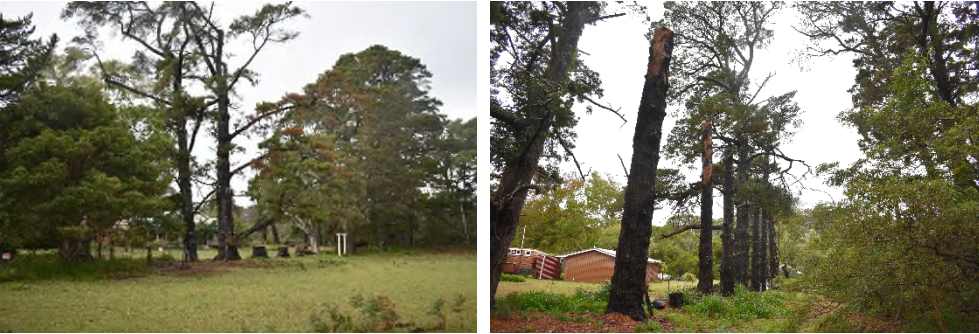
| ID and planting | Attributes, cultural heritage value and photographs |
|---|---|
| CP2<br><b><i>Pinus radiata</i></b><br><b>group</b> | <p>Formal windbreak group planted at 5–10m spacing along the southern and western boundaries of Ardath (Block 11) and Pamir (Block 12). The trees are 80–100 years old.</p> <p>Since 2015, several trees in this group have died or been removed on the boundaries of Ardath (Block 11) (see tree stumps in images below). Several more in this group appear to have dieback.</p> <div data-bbox="395 1218 1378 1550"> </div> |

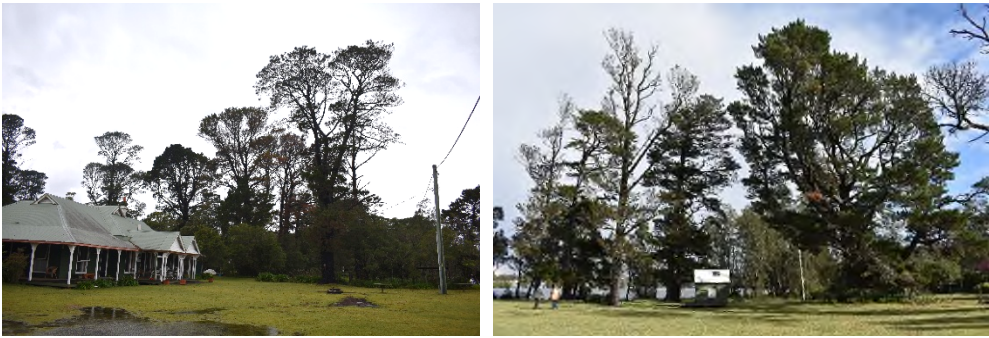
| ID and planting | Attributes, cultural heritage value and photographs |
|---|---|
| CP3<br><b><i>Pinus radiata</i> group</b> | <p>Informal group of pines in the front grounds of Kullindi Homestead (Block 10). There are two individuals more than 100 years old. These are the oldest trees on site. Several older specimens have been removed since 2015, in particular a large <i>Pinus radiata</i> directly to the east of the homestead c2020.</p> |

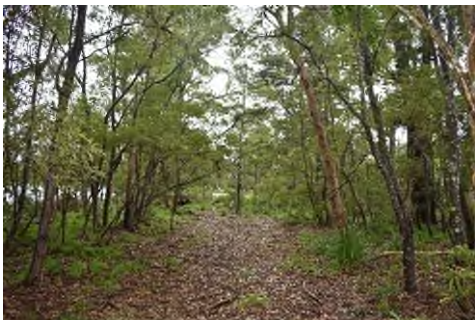
| ID and planting | Attributes, cultural heritage value and photographs |
|---|---|
| CP5<br><b>Mixed <i>Pinus radiata</i> and <i>E. botryoides</i> (Bangalay) stands</b> | <p>These are self-seeded pines and naturally occurring eucalypts growing as tall forest. The pines here are 50–70 years old. They are divided into two key areas:</p> <p>(i) between Block 14—Christian’s Minde and the pine windbreak south of Block 11—Ardath</p> <p>(ii) between Block 12—Pamir and Block 10—Kullindi Homestead.</p> <p>Since 2015 these groups have thinned as several pines have died. Pines in this group appear to have dieback (browning of pine needles), indicating a health issue related to either age or a change in conditions or a combination of factors. Some of these trees are understood to have been aggressively pruned (topping of main trunk) by electrical services contractors in the last several years.</p> |

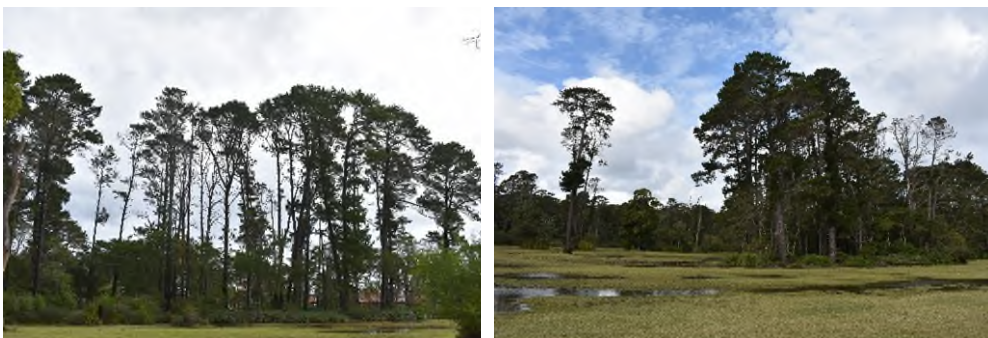
| ID and planting | Attributes, cultural heritage value and photographs |
|---|---|
| CP6<br><b><i>Pinus radiata</i> group</b> | <p>Self-seeded pines on land previously cleared to the southeast of Block 14—Christian’s Minde. These trees have a more spreading form (not being in competition with eucalypt forest). <i>Pittosporum</i> understorey. The trees are 60–80 years old.</p> |

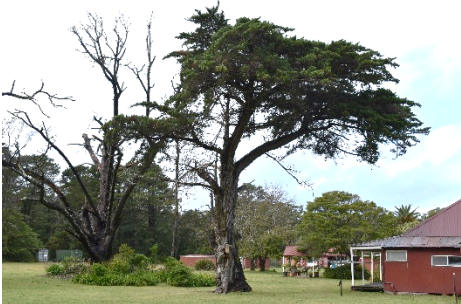
| ID and planting | Attributes, cultural heritage value and photographs |
|---|---|
| CP7<br><b><i>Cupressus macrocarpa</i></b><br><b>(Monterey Cypress)</b><br><b>individual</b> | <p>This tree, behind Building CM1 of Block 14—Christian’s Minde, dates from the 1920s–40s planting phase. The tree is over-mature and has worsened in condition in the past 10 years.</p> <hr/> |

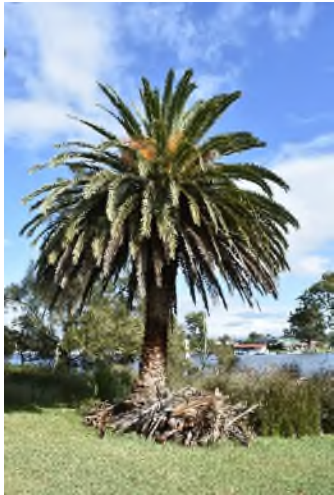
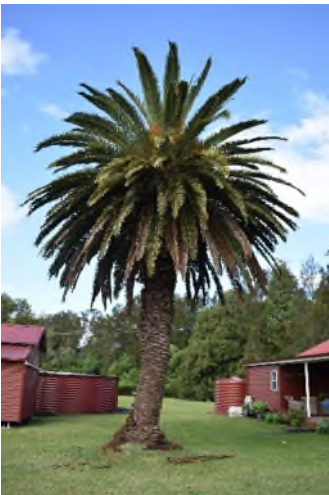
| ID and planting | Attributes, cultural heritage value and photographs |
|---|---|
| CP8<br><b><i>Phoenix canariensis</i></b><br><b>(Canary Island Date Palm)</b><br><b>group</b> | <p>Group of two palms in Block 14—Christian’s Minde that date from the late twentieth century. One is next to the site of the former boathouse (Building CM7) and another is directly east of the 2016 cottage (Building CM11).</p> <hr/> <div style="display: flex; justify-content: space-around;"> </div> |

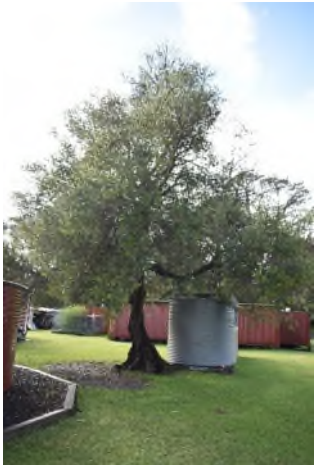
| ID and planting | Attributes, cultural heritage value and photographs |
|---|---|
| CP9<br><i>Olea europaea</i><br>(Olive)<br>individual | <p>A single non-grafted tree on an extensive buttressed root base, in the vegetable garden area north of Building CM10 on Block 14—Christian’s Minde. Planted in the 1930s.</p> |

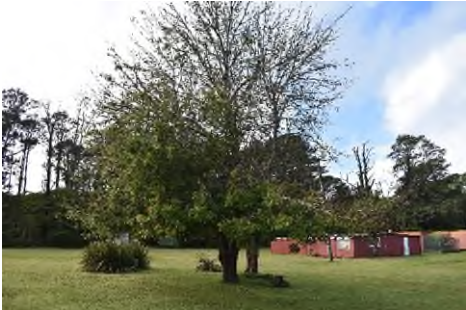
| ID and planting | Attributes, cultural heritage value and photographs |
|---|---|
| CP10<br><i>Pistacia chinensis</i><br>(Chinese Pistachio)<br>individual | <p>Ornamental planting of the late twentieth century to the east of Building CM2 on Block 14—Christian’s Minde. At the time of inspection in April 2025 the tree appeared to be losing foliage.</p> |

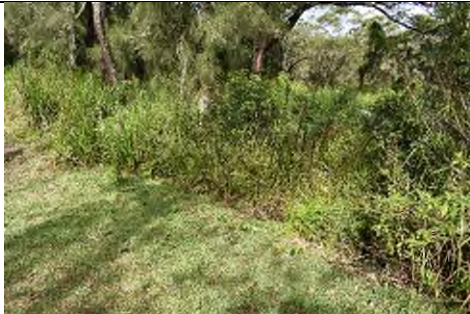
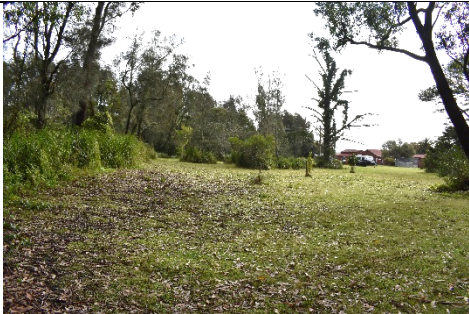
| Contributory elements | Description of the elements that contribute to the cultural landscape of the site |
|---|---|
| Drainage channel and cleared lands | <p data-bbox="411 443 1385 584">The Ellmoos family cleared a substantial amount of land to the east of the guesthouse and other buildings, for animal and crop farming. An extensive drainage channel 2.5m wide and 2m deep was dug by the family following the southern boundary of Block 14 and continuing halfway up the eastern boundary of Block 13 before following the base of the hill behind the Settlement.</p> <p data-bbox="411 600 1358 741">The channel was created to prevent flooding from the higher ground (where livestock were kept) onto the cleared flat below, which was used for the cultivation of vegetables and crops. The cleared areas and evidence of the drainage channel remains on the site. They serve as reminders of the remote nature of the guesthouse and the pioneering lifestyle of the Ellmoos family.</p> <div data-bbox="411 757 882 1070"> </div> <p data-bbox="411 1095 837 1196">Figure 3.13 The drainage channel, now overgrown with reeds and marshy vegetation.</p> <div data-bbox="900 757 1370 1070"> </div> <p data-bbox="900 1095 1385 1196">Figure 3.14 The drainage channel (left) in relation to the buildings of Block 14 (right), looking west.</p> |

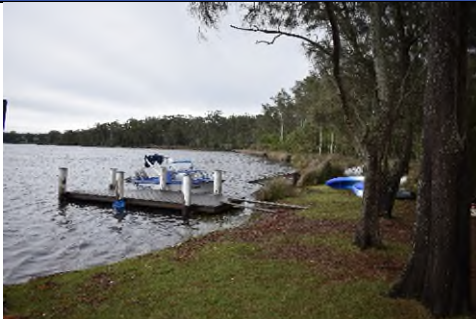
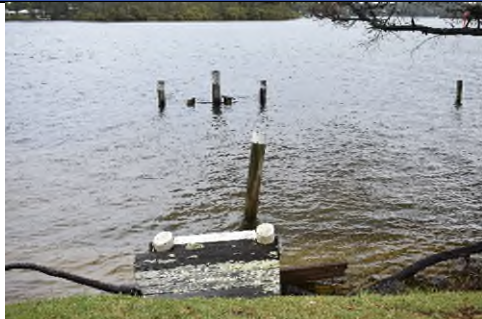
| Contributory elements | Description of the elements that contribute to the cultural landscape of the site | |
|---|---|---|
| | <p>Figure 3.21 The modern jetty in Block 9—Ellmoos.</p> | <p>Figure 3.22 The remains of the jetty in the public reserve.</p> |

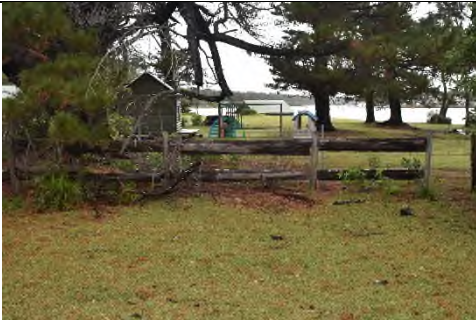
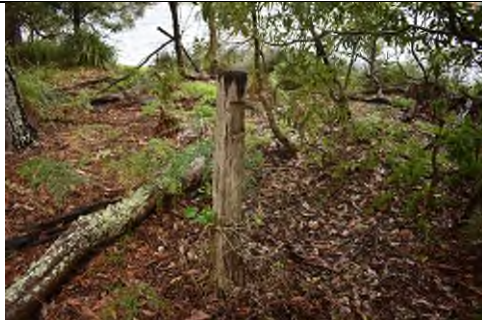
| Contributory elements | Description of the elements that contribute to the cultural landscape of the site | |
|---|---|---|
| | <p>Figure 3.23 A small section of early split-rail fencing between Block 9 and Block 10.</p> | <p>Figure 3.24 A remnant of the early split-rail fencing in the Crown reserve north of Block 14.</p> |

| Contributory elements | Description of the elements that contribute to the cultural landscape of the site | |
|---|---|---|
| <p>Remnant 'rural' elements</p> | <p>The former rural and remote lifestyle of the site is evident by the remnant elements and the historic boundaries defining ownership and animal management.</p> <p>These include remnants of the historic timber split-rail fences and the oven of the original detached kitchen building.</p> | |

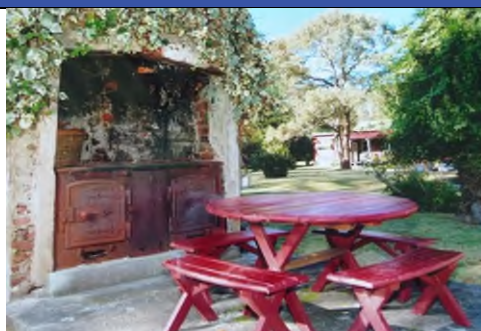
Figure 3.25 The oven of the detached kitchen as it was in the 2000s.  
(Source: Peter and Pam Ellmoos collection)

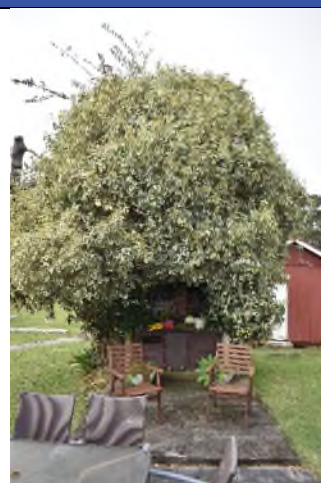
Figure 3.26 The oven is located directly east of building CM2 and is covered in ivy.

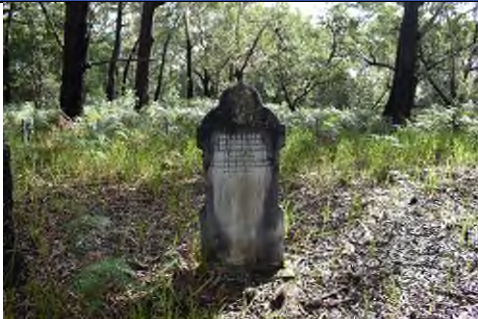
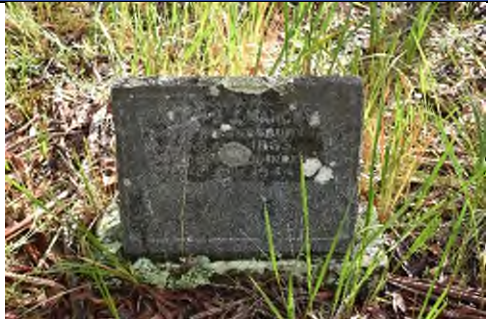
| Contributory elements | Description of the elements that contribute to the cultural landscape of the site |
|---|---|
| | <div data-bbox="411 770 890 949"> <p>Figure 3.29 The original headstone for Louise Ellmoos shows a very multicultural approach with rose, thistle and shamrock symbols around the edge and Danish text.</p> </div> <div data-bbox="911 770 1401 882"> <p>Figure 3.30 A more modern remaining headstone. The text can no longer be distinguished.</p> </div> |

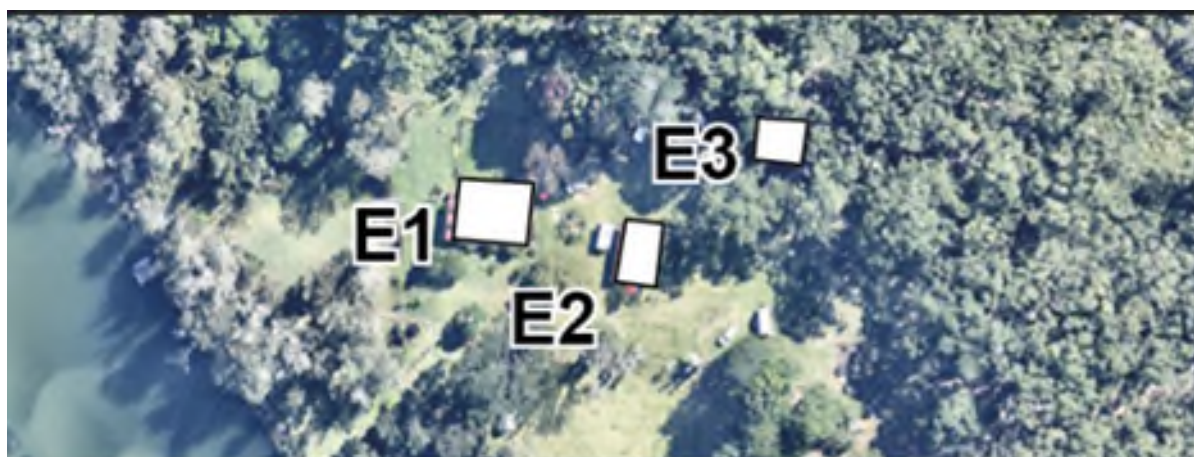
Figure 3.31 Structures in Block 9. (Source: Nearmap with GML overlay, © Nearmap, all rights reserved)

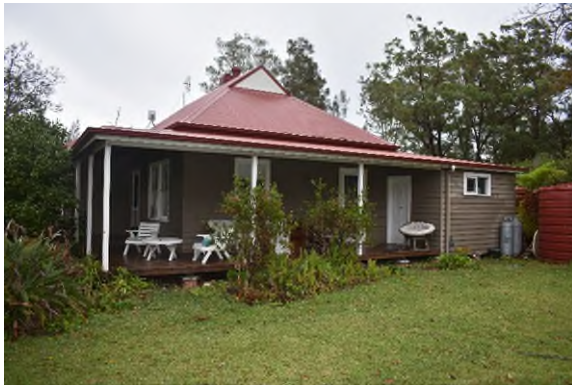
Figure 3.32 Building E1, a weatherboard cottage built in the early 1930s, viewed from the east.

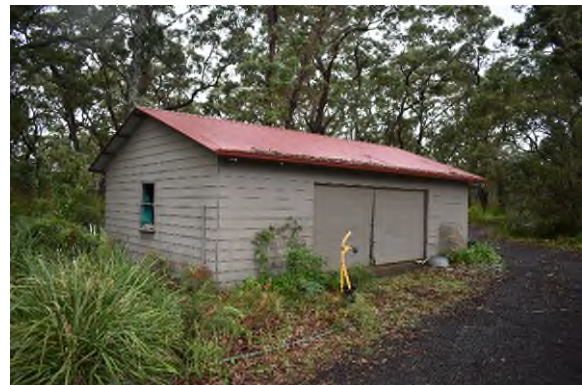
Figure 3.35 Building E3, the c1980 garage.

The second structure, Building E3, is a large garage dating from c1980. It consists of a concrete slab floor, steel frame, fibre cement weatherboards, a corrugated steel roof, sliding steel-framed and clad doors and double-hung timber windows reclaimed from another building, which are missing their glazing.

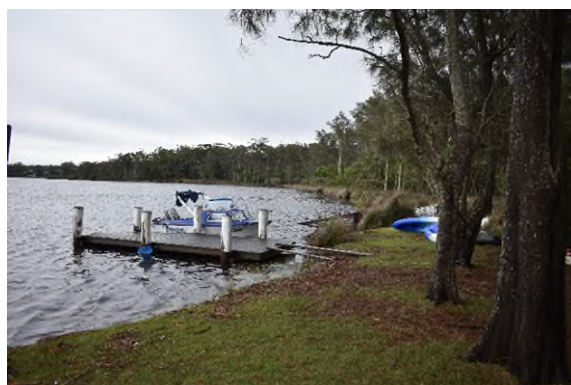
Figure 3.37 The modern jetty to Sussex Inlet.

Other structures include a modern timber jetty built c2013 that sits over the water's edge within the boundary of the block, and disused greenhouses beside the access road.

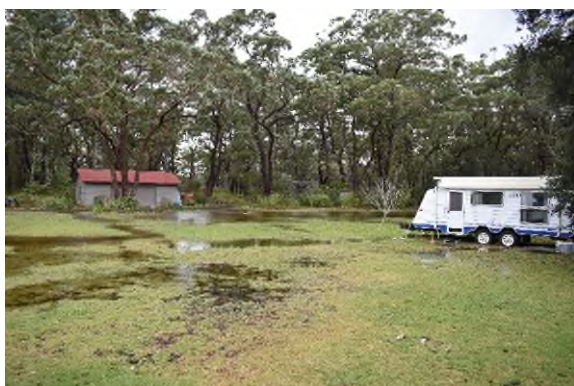
Figure 3.38 Building E3 and the back lawn area, showing the poor drainage at the site.

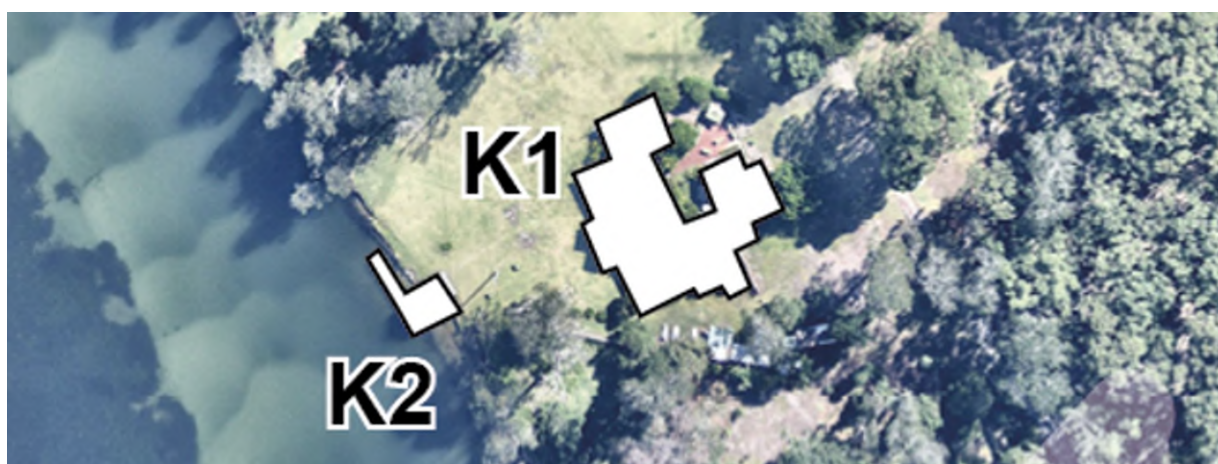
Figure 3.40 Block 10 structures. (Source: Nearmap with GML overlay, © Nearmap, all rights reserved)

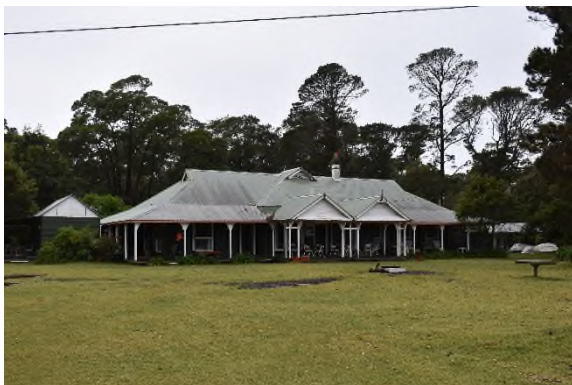
Figure 3.41 Kullindi (Building K1) showing the feature double gables.

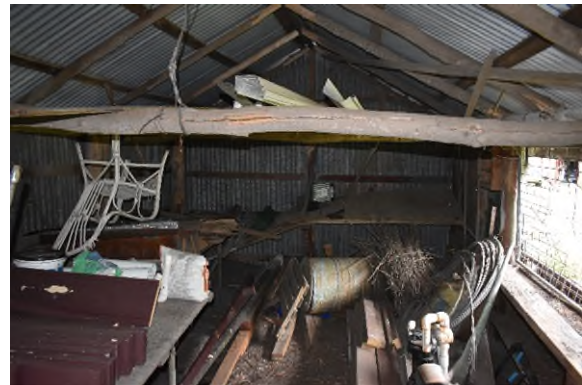
Figure 3.63 The interior of Pop's Shed (Building A3), showing the bush pole framing and simplistic construction.

It is a shed consisting of a dirt floor with a bush pole support structure, sawn Oregon secondary framing, early corrugated galvanised iron cladding and roof sheeting marked 'Lysaght'. Internal fittings include timber shelving and a bench that still shows marks of a century of hammer blows. The old timber panelled door on the northern elevation is likely to have been re-used from elsewhere. Modern fabric includes galvanised steel mesh to gates on the eastern elevation and in the side window opening next to the timber door on the northern elevation.

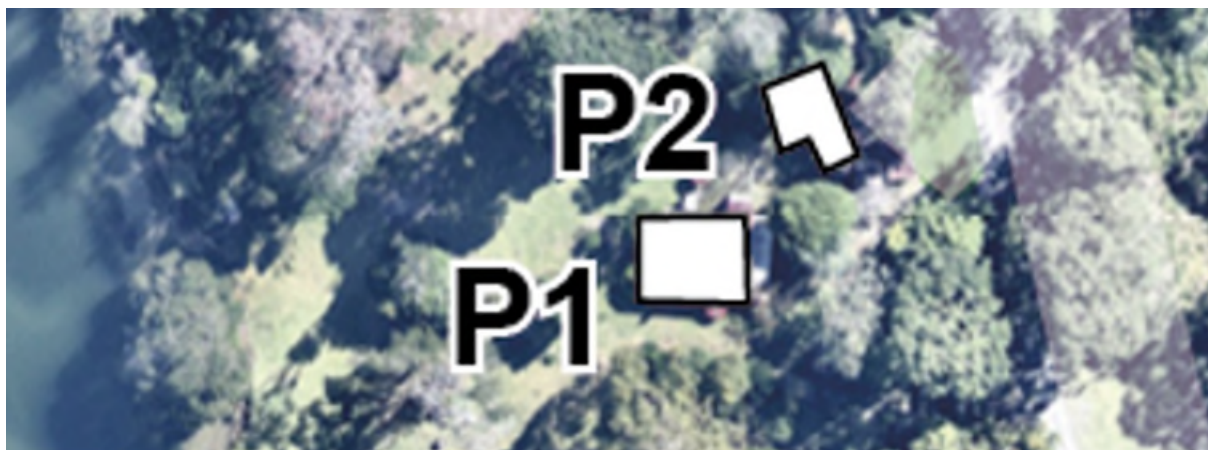
Figure 3.66 Block 12 structures. (Source: Nearmap with GML overlay, © Nearmap, all rights reserved)

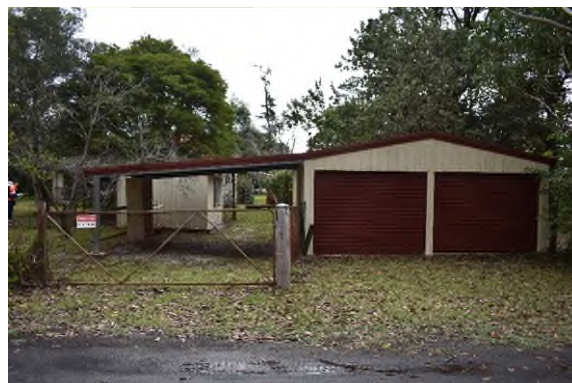
Figure 3.72 The outbuildings of Pamir (collectively referred to as Building P2).

There are several outbuildings on Block 12; they are referenced collectively as Building P2. The most significant of these is the original detached laundry. This is a small building approximately 2.5m by 3.0m consisting of a concrete slab floor, fibre cement cladding on a timber frame, a painted timber window and boarded door and a painted corrugated steel roof. The original brick chimney flue is intact. The whole structure is currently covered in ivy and difficult to distinguish or access.

Other structures include a fernery consisting of a concrete slab floor and a wire-over-steel frame, two Colorbond clad sheds and an open carport.

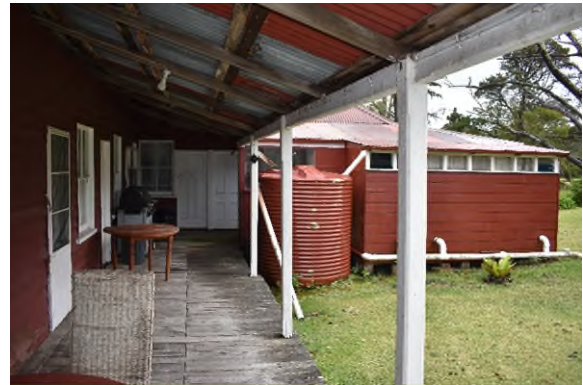
Figure 3.77 The rear verandah of Building CM1, showing the external toilets joined to the building.

The guesthouse rooms are of varying sizes and each opens off the perimeter verandah. Later shower, toilet and laundry facilities were provided in extra skillion-roofed structures, located to the east of the building but attached to the verandah. A new cardroom addition was erected at the northern end of the building in the 1970s with a simple pitched gable roof. This was reportedly known as the Pontey Room after the Pontey family who were frequent guests of Christian's Minde.<sup>17</sup>

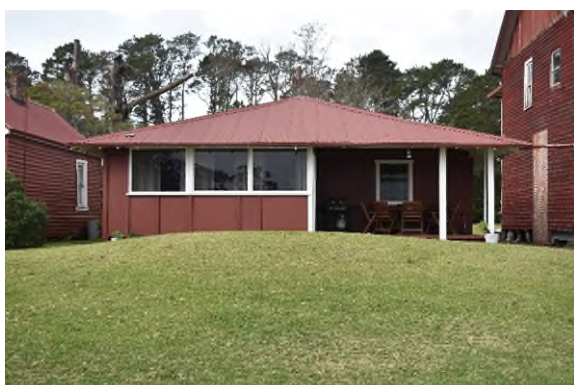
Figure 3.80 Building CM2, showing the height of the midden in front of the building.

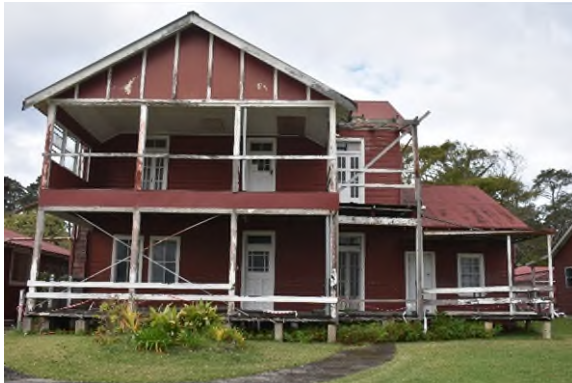
Figure 3.84 The front (western) elevation of Building CM3. Verandah with missing roof sheeting is visible on the upper floor at the right-hand corner.

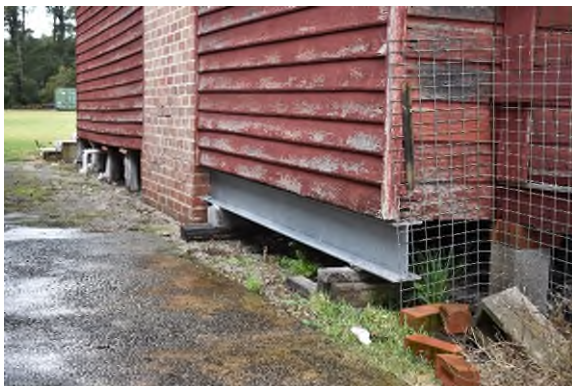
Figure 3.86 Detail of the steel members inserted to shore up the structure of Building CM3.

- Some remediation work was undertaken to CM3, including:
  - installation of a steel chassis beneath the building to shore up the structure's foundation, including raising of verandah floorboards for access; and

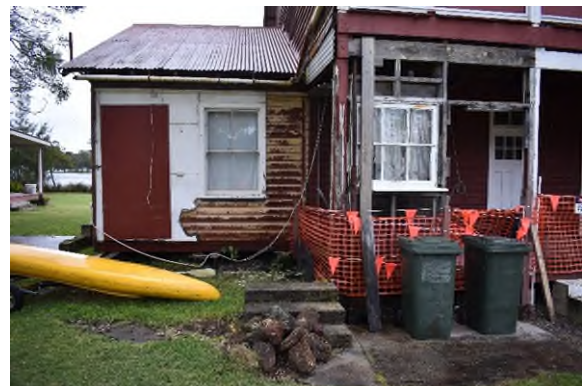
Figure 3.87 Building CM3 on the eastern (rear) elevation showing the decayed and removed fabric from the verandah and single-storey addition. The partially exposed weatherboard around the leftmost window is the location of a removed laundry annexe.

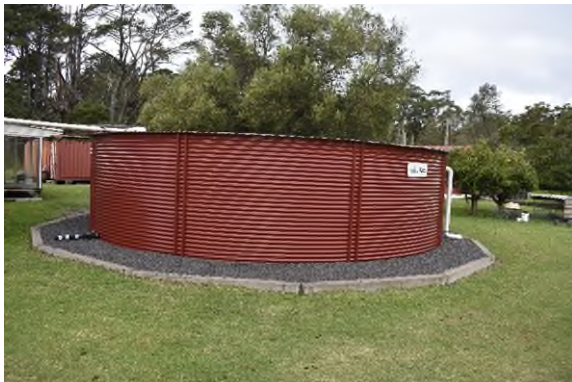
Figure 3.92 The water tank installed southwest of Building CM5.

A large water tank has been installed off the southwestern corner of Building CM5 in around 2017/2018.

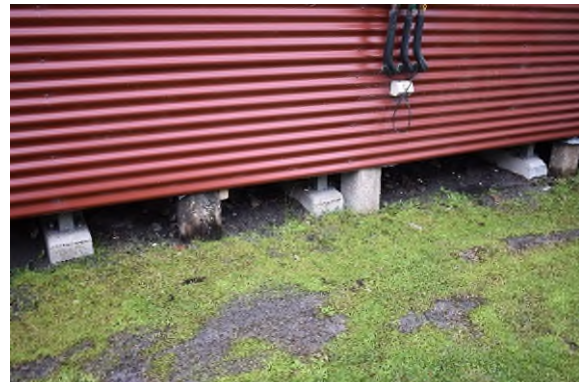
Figure 3.93 New structural footings of Building CM5, using jacks on concrete sleepers.

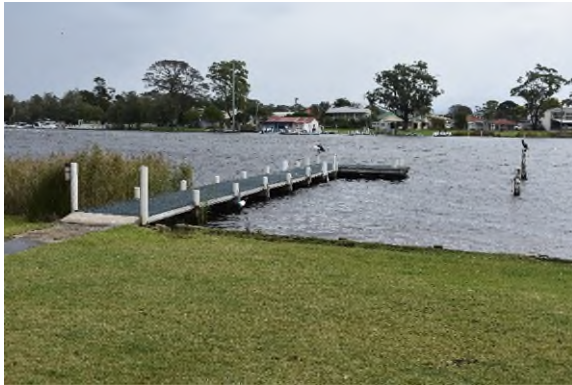
The current jetty (Building CM6) on Block 14 is not the original structure but has been constructed in the same location as the 1890 original. The L-shaped jetty sits over the waters of Sussex Inlet and is constructed from timber piles with a new coated steel deck that was installed by the current lessees in 2020.

Figure 3.94 The jetty—structure CM6.

- The jetty, CM6, was repaired and a coated steel deck installed (2020).
- The jetty in the public reserve collapsed (c2020).
- Maintenance of the main access/entry road has occurred.

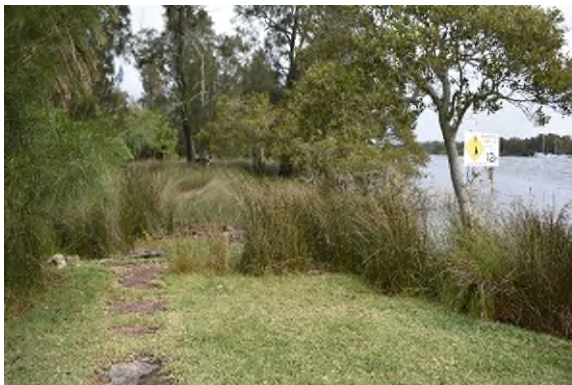
The original boathouse (Building CM7) on Block 14—a remnant indication of the fishing culture and activities so popular at the Christian's Minde Settlement—was destroyed in a severe storm in 2011 that also destroyed many pines and native forest trees to the east of Block 14. The timber base and supports of the boathouse still remain.

Figure 3.96 The location of the former boathouse—structure CM7.

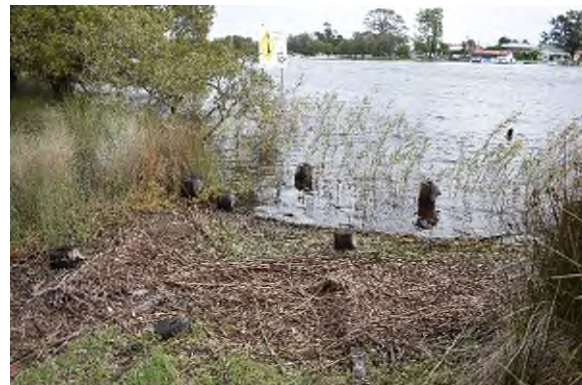
The previous lessees managed to salvage much of the remaining material with the intention of resurrecting the structure, though this is yet to occur.

Figure 3.97 The remaining timber stumps of the boathouse—structure CM7.

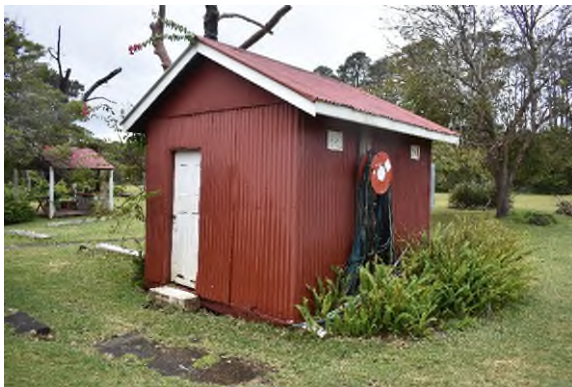
There is a window opening on the eastern elevation with steel mesh infill. The single door on the western elevation is timber planked, ledged and braced and is showing signs of wear. The site's main electrical board is installed on the outside of the building.

Figure 3.98 The western elevation of Building CM8, the site's pumphouse.

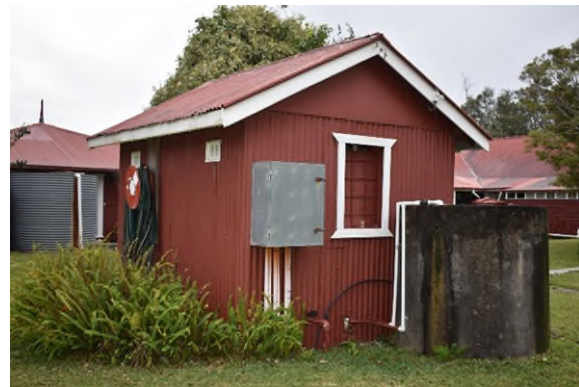
Figure 3.99 The eastern elevation of Building CM8.

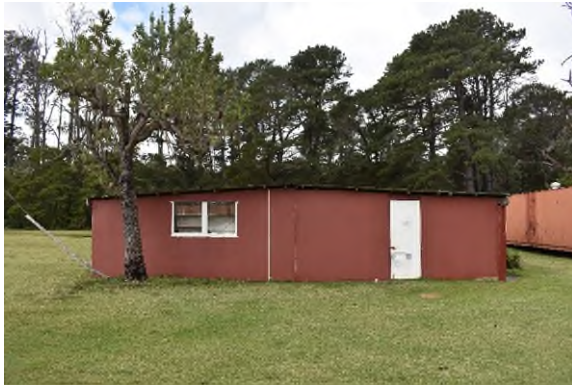
Building CM9, the large garage and shed structure, is a substantial building located to the east of Building CM3. An open garage is listed in the 1952 inventory of the site as being 30' by 30' with an iron roof and in good condition.<sup>19</sup> The current structure appears to be consistent with this, though demonstrates various alterations and additions over the years. Names of former residents from when Christian's Minde was used as flats remain painted on beams on the eastern elevation.

The building has a dirt floor, steel and timber framing, and corrugated steel cladding and roof sheeting. Its form, materials and colour are sympathetic to the character of the historical buildings on the site.

Figure 3.100 The 1950s garage and shed (Building CM9).

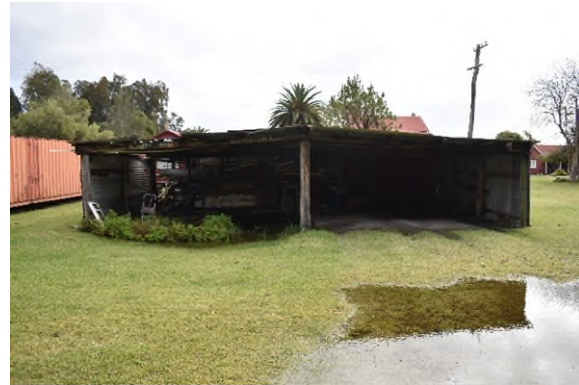
Figure 3.101 The open eastern elevation of the garage and shed, Building CM9.
