# Christian's Minde Settlement, Jervis Bay Territory

Historic Heritage Management Plan

June 2025

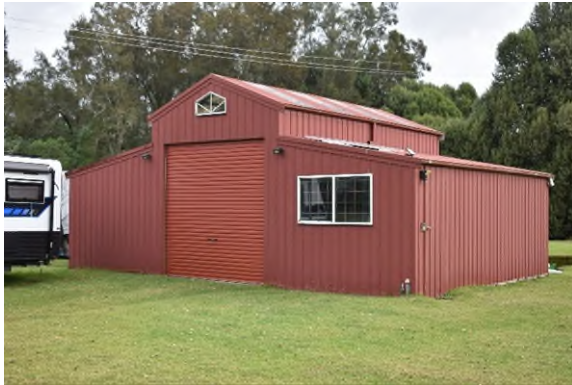
Building CM10, a firefighting garage, is located to the southeast of Building CM4 and purposefully set back at a distance from the main complex of buildings. It is a kit-form structure in the 'American Barn' style, with a taller gabled central section and a lower skillion roofed wing on each side. It is constructed of a concrete slab floor, steel framing, Colorbond steel deck cladding and corrugated Colorbond roof sheeting. Its form, materials and colour scheme are sympathetic to the character of the historical buildings on the site.

Building CM10 is approximately 20–25 years old and is constructed on an easement for a fire depot.

Figure 3.103 The fire depot, Building CM10.

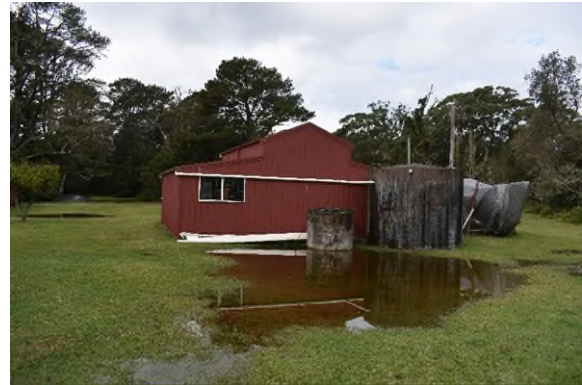
Figure 3.104 The rear of the fire depot shed, Building CM10.

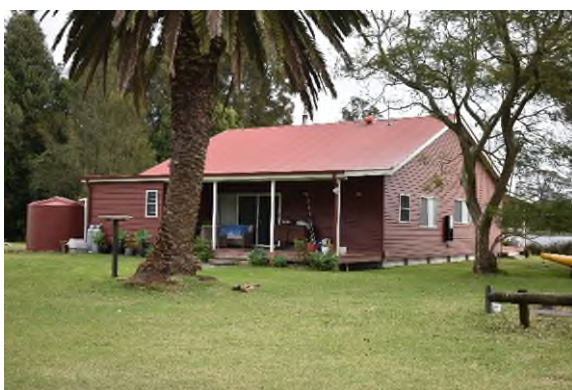
The building is a single-storey weatherboard cottage with a rectangular floor plan, low-pitched roof clad in Colorbond, and two skillion verandahs. It has timber flooring over joists and galvanised piers. Like the rest of the buildings, it has a red and white paint scheme. Although a modern building and larger than previous structures, the form, materials and colour scheme are sympathetic to the character of the historical buildings on the site.

Figure 3.105 The rear (eastern) elevation of the 2016 cottage, Building CM11.

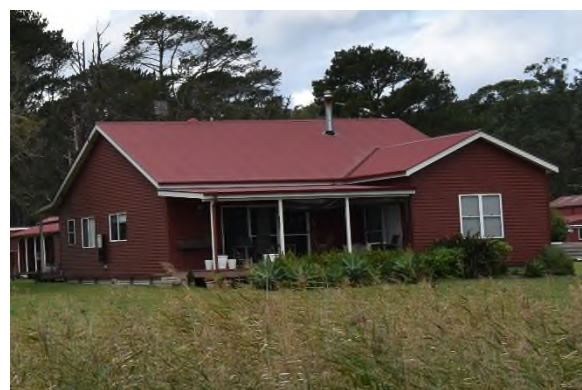
Figure 3.106 The front (western) elevation of Building CM11.

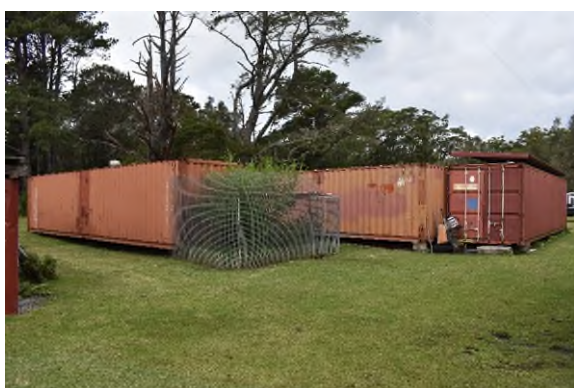
To the south of Building CM9 are several shipping containers (CM9a) that have been used to create a temporary square structure with a mesh covered courtyard. This was previously used for bird breeding and storage but is now unused.

Figure 3.107 Shipping containers adjacent to Building CM9, formerly used for bird breeding.

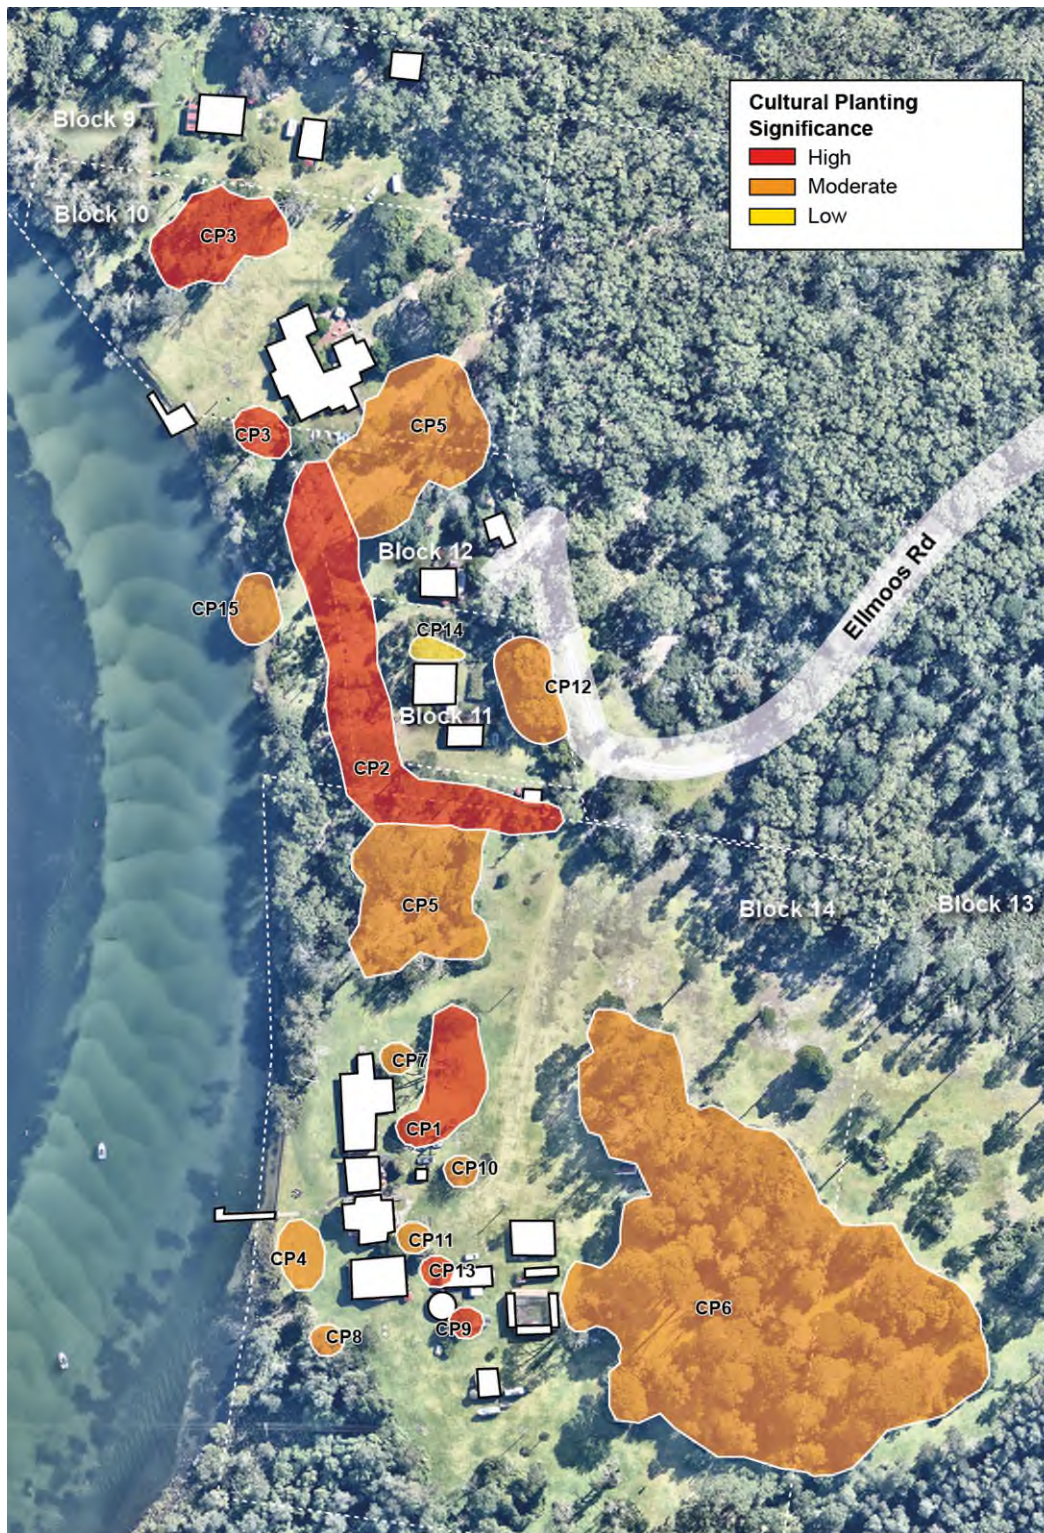
Figure 4.2 Heritage significance rankings of the cultural plantings. (Source: Nearmap with GML overlay, © Nearmap, all rights reserved)
