# Cascade Reserve, Norfolk Island

## Heritage Management Plan

2 April 2026

0794338

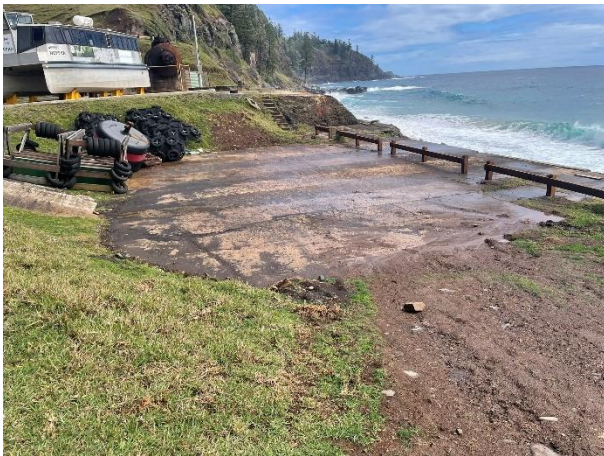
PHOTOGRAPH 2-9 LOWER PLATFORM WITH RAMP AND STAIRS (ERM 2025)

The remains of the whaling station include two platforms to the north of Cascade Road consisting of a reasonably unmodified concrete lower platform with a concrete ramp to the road and a set of concrete stairs in a rocky retaining wall leading to the higher platform (*Photograph 2-9*). The upper platform has been modified through works such as resurfacing, kerbing, installation of a public toilet (*Photograph 2-10*) and the desalination plant (*Photograph 2-11*), and slope stabilisation (*Photograph 2-12*). Between this platform and the foreshore there is a low octagonal concrete tank and the remains of two circular concrete tanks, now filled with grass (*Photograph 2-13*). Above the platform where the road rises is a small circular concrete tank and the buried remains of a former concrete staircase (*Photograph 2-14*) which led to a third platform that once contained steel tanks but is now a bitumen parking spot. The steel boiler or digester from the whaling station is still located on the remaining upper platform, having been put on raised concrete rests and surrounded by temporary fencing (*Photograph 2-15*). It is severely degraded as a result of long-term exposure to the weather (*Photograph 2-16*).

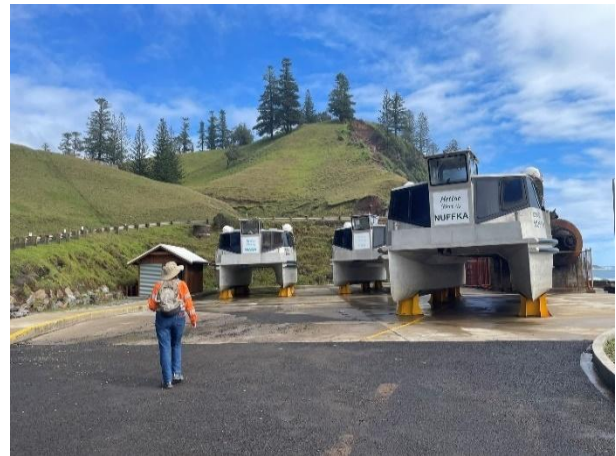
PHOTOGRAPH 2-10 UPPER PLATFORM WITH RESURFACING, KERBING, PUBLIC TOILET (ERM 2025)

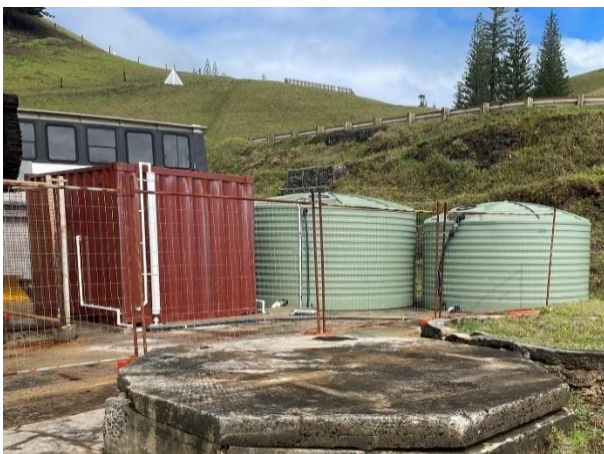
PHOTOGRAPH 2-11 UPPER PLATFORM WITH DESALINATION PLANT (ERM 2025)

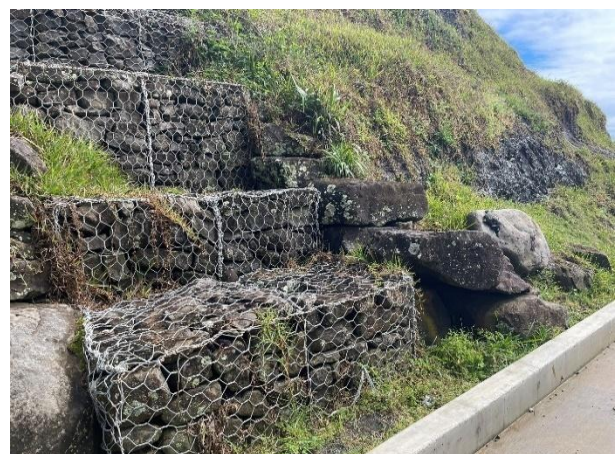
PHOTOGRAPH 2-12 UPPER PLATFORM WITH SLOPE STABILISATION (ERM 2025)

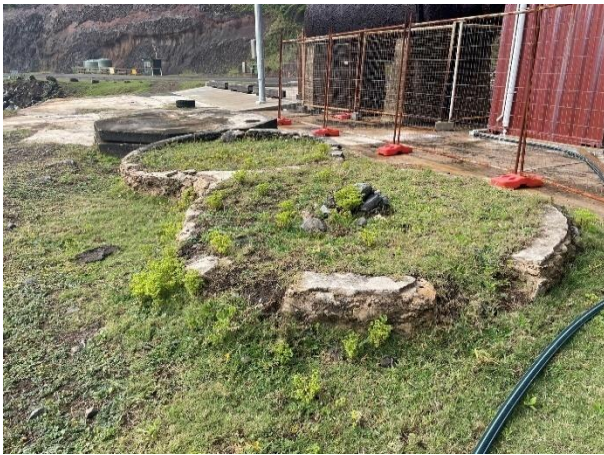
PHOTOGRAPH 2-13 UPPER PLATFORM WITH FORMER CONCRETE TANKS (ERM 2025)

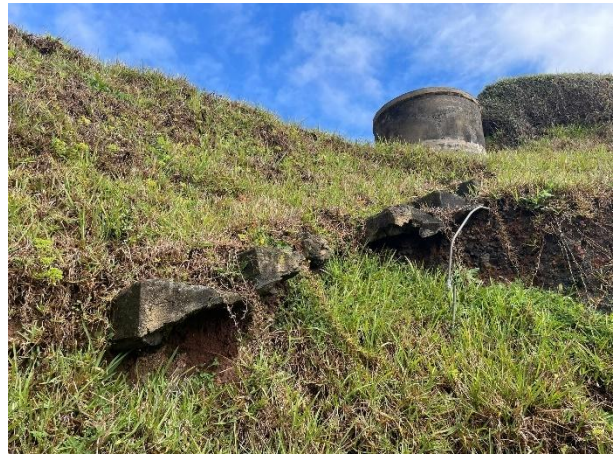
PHOTOGRAPH 2-14 UPPER PLATFORM WITH CONCRETE TANK AND STAIRS (ERM 2025)

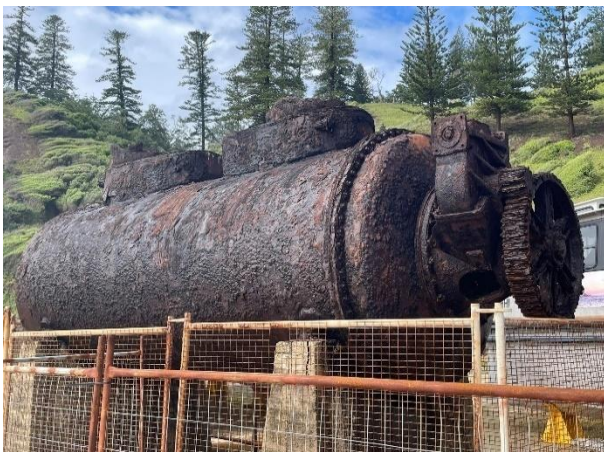
PHOTOGRAPH 2-15 UPPER PLATFORM WITH STEEL BOILER OR DIGESTER (ERM 2025)

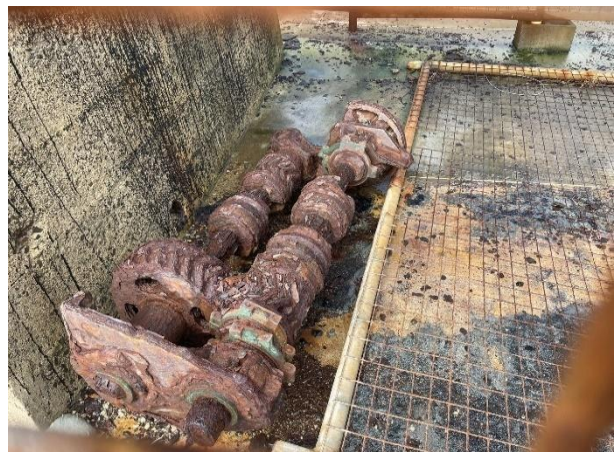
PHOTOGRAPH 2-16 UNDER THE BOILER WITH FLAKES FROM SURFACE (ERM 2025)

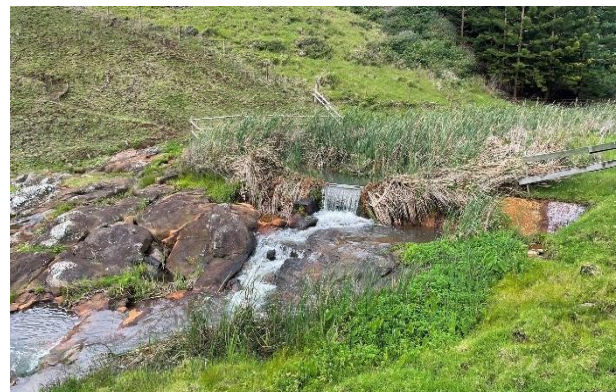
PHOTOGRAPH 2-33 WEIR (ERM 2025)

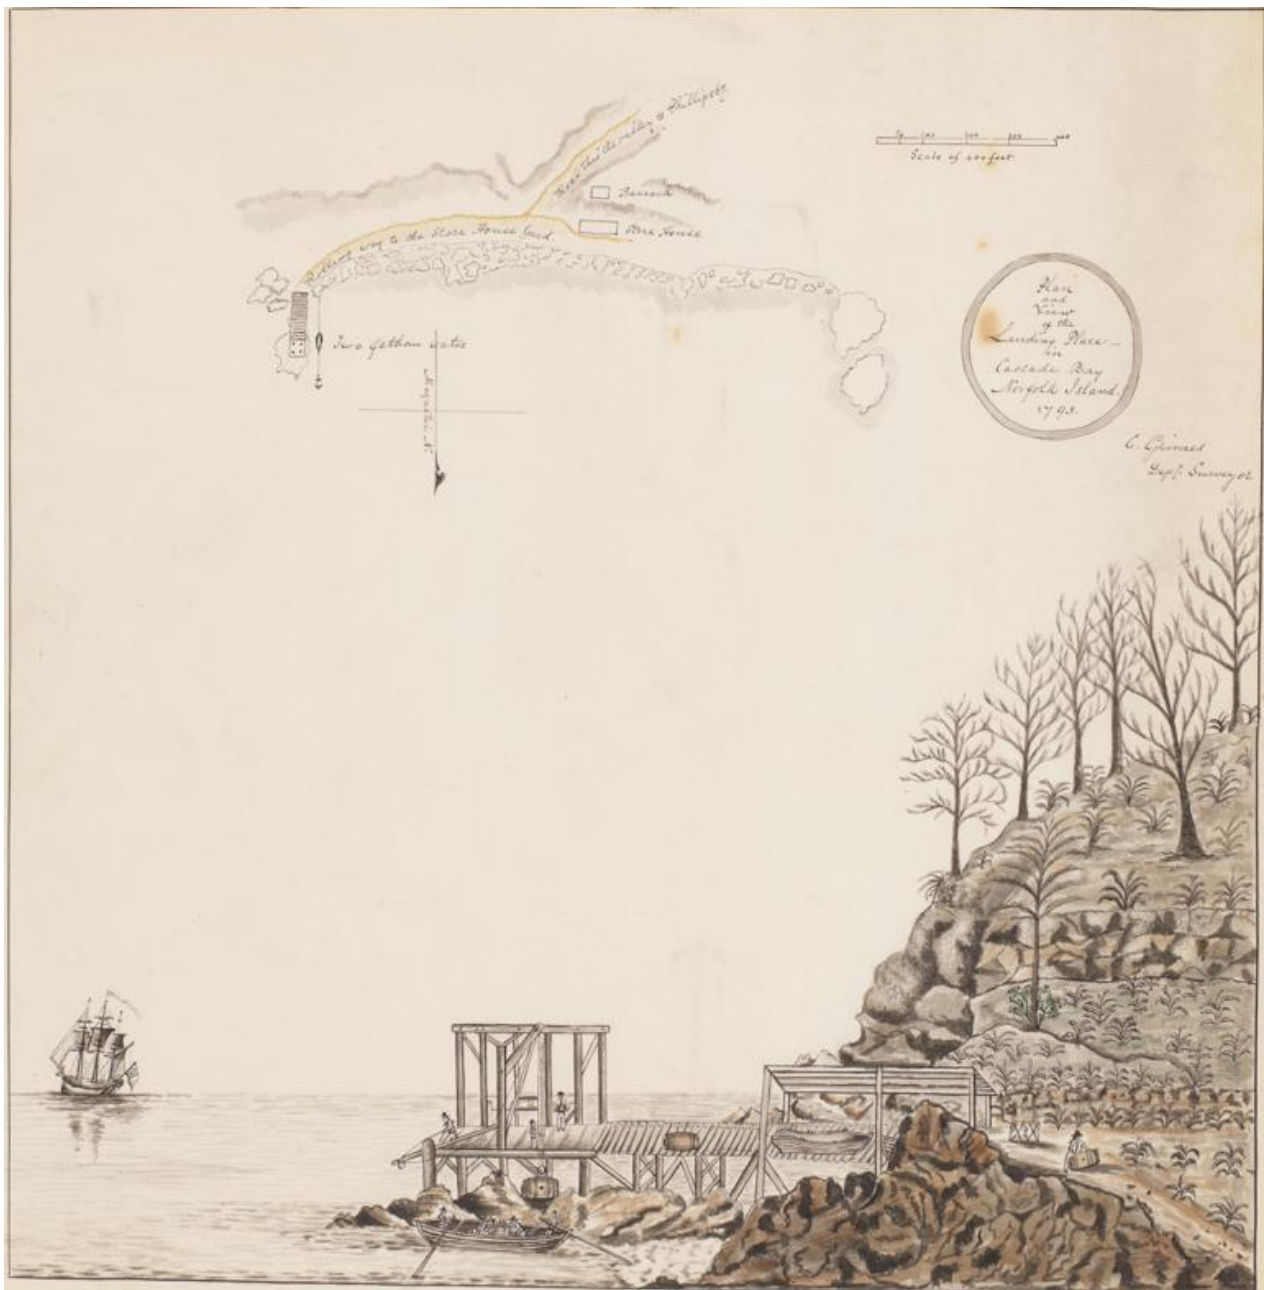
FIGURE 2-5 PLAN AND VIEW OF THE LANDING PLACE SHOWING THE WOODEN PIER, 1793  
(C. GRIMES, SLNSW#Z/CB 79/12)

The rocky outcrop at the foot of the hills at Cascade Bay was originally known as the Cascade Landing Place; it formed a natural jetty from which boats were hauled out of the sea if they were unable to land at the Kingston side of the Island. By October 1792, King made improvements to the landing place and a wooden pier with bridge was constructed over the rocky outcrop, but was later destroyed by a storm (*Figure 2-5*). A store was constructed to the west of the landing place by 1794 and by 1796 a flagstaff was installed on a low hill above the store (Varman 1998:2/52; visible in *Figure 2-8*) and a strong wharf (126 feet in length) had been established between the landing place and the shore (Varman 1998:1/74-75).

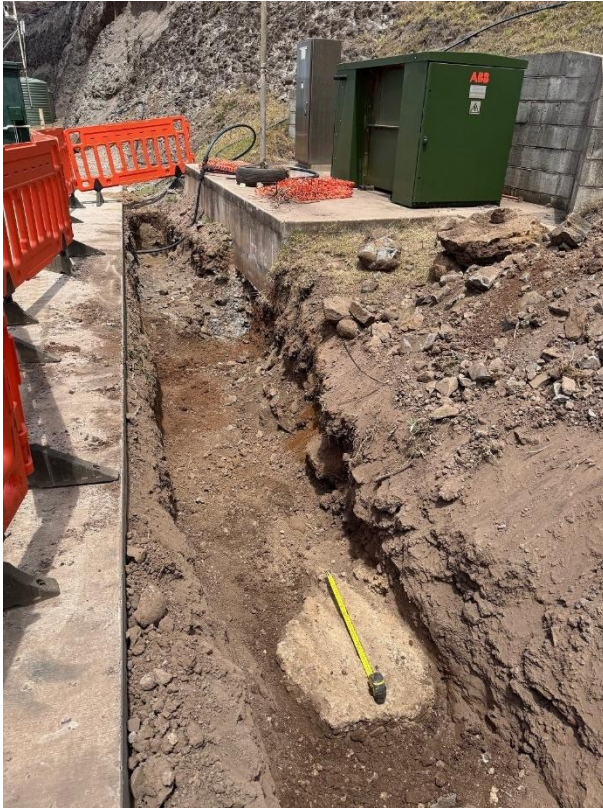
PHOTOGRAPH 5-1 CALCARENITE SLAB IN  
DESALINATION PLANT TRENCH  
(DITRDCA)

The likelihood of remaining archaeological material at this general location is supported by the discovery of large slabs of calcarenite, which only occurs naturally on Norfolk Island in Kingston, during trenching for the desalination plant reservoir on the south side of Cascade Road (*Photograph 5-1* and *Photograph 5-2*). These slabs were laid in a linear fashion and were not found in the vicinity of any post-war structures but were in the general area of many earlier structures and align to the orientation shown in historic photographs.

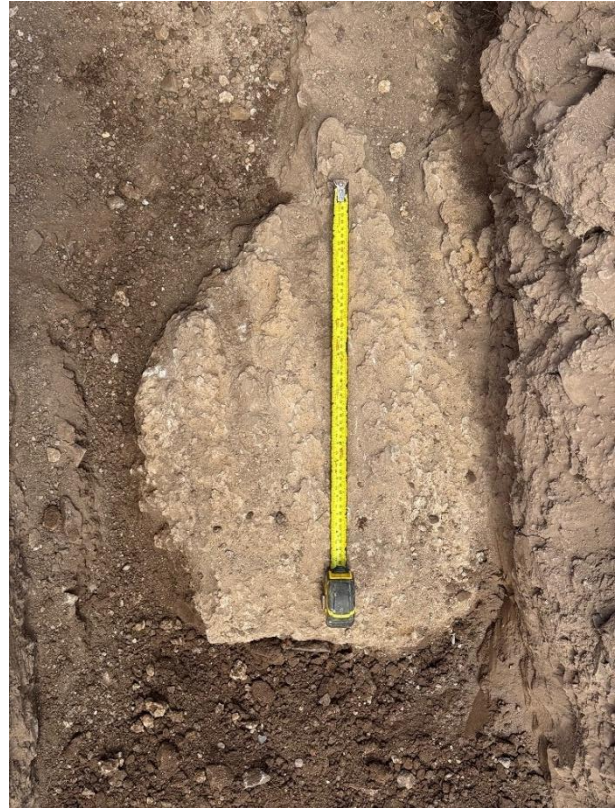
PHOTOGRAPH 5-2 CLOSE-UP OF  
CALCARENITE SLAB (DITRDCA)

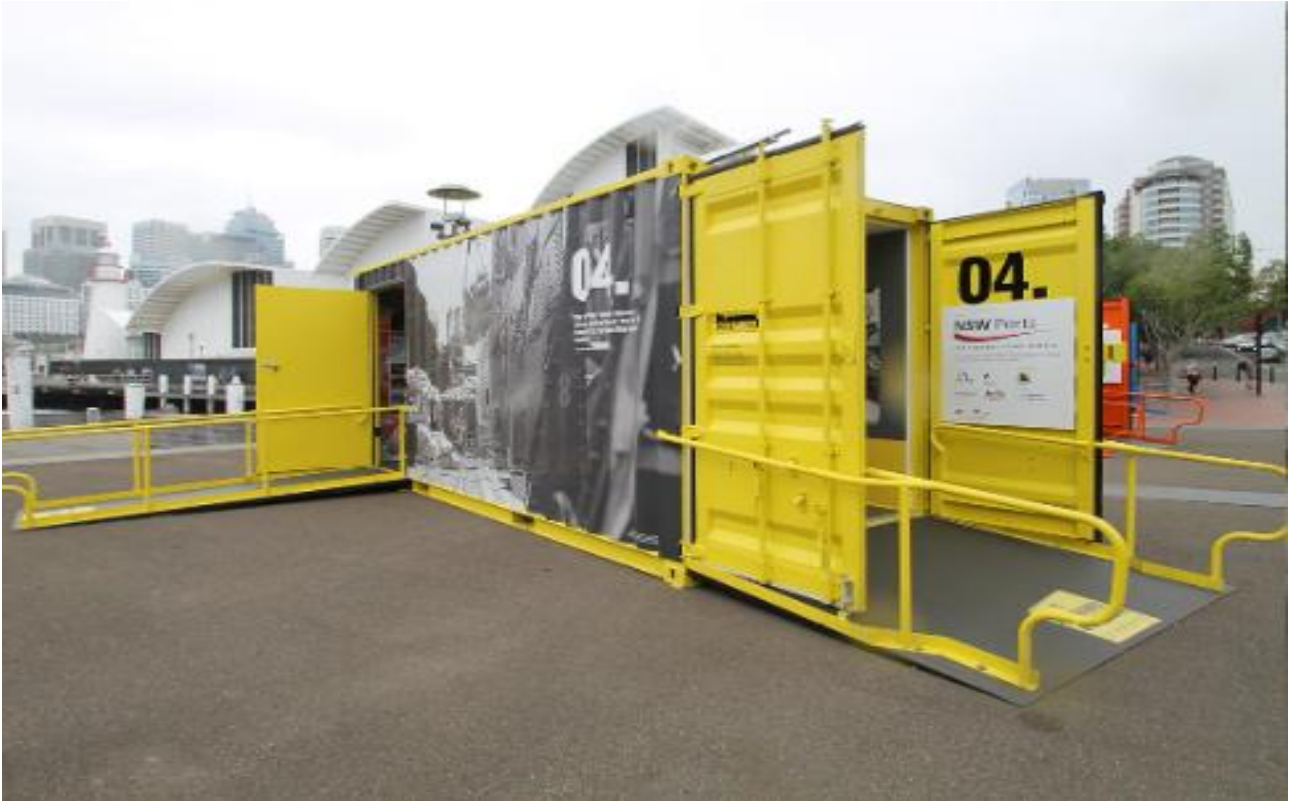
**PHOTOGRAPH 6-1 EXAMPLE OF A HERITAGE INTERPRETATION CENTRE USING A SHIPPING CONTAINER (ROYAL WOLF 2017)**

The public reserve management plan identified in 2003 that the location of the former whaling station would be an excellent venue for a museum or interpretation centre and stated that the public consultation process indicated strong support for this idea. Stakeholder consultation for the development of this HMP recorded continued support, and included suggestions such as signage, conservation and preservation of the whaling station boiler/digester, and a shipping container converted into a mini-interpretation centre (*Photograph 6-1*).

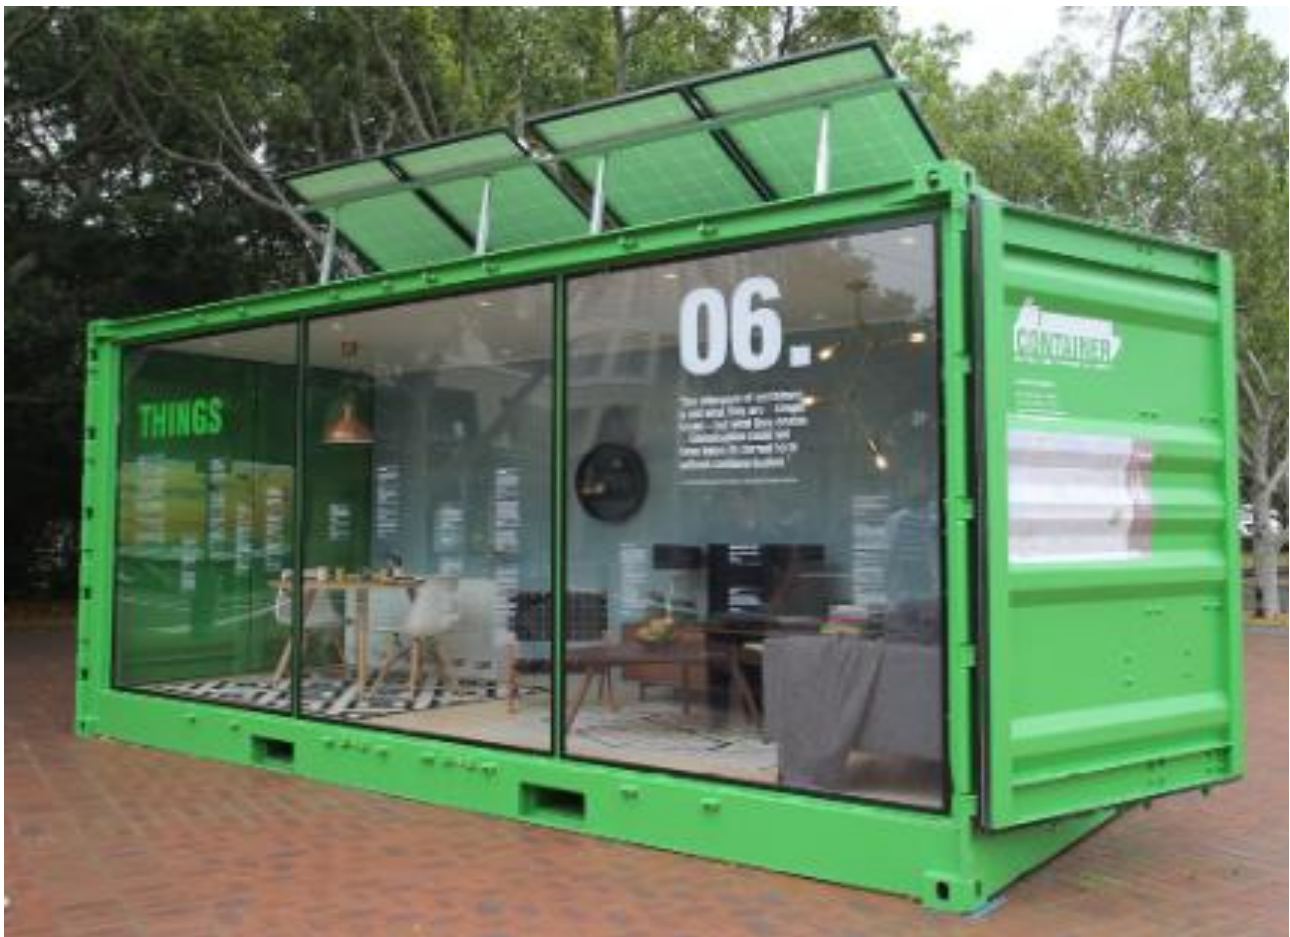
PHOTOGRAPH 6-2 POTENTIAL FUTURE STORAGE AND DISPLAY CONCEPT USING A SHIPPING CONTAINER (ROYAL WOLF 2017)

Should conservation be recommended, the preferred outcome would involve incorporation of the feature into the heritage interpretation of Cascade Reserve (see *Photograph 6-2* for an example of how this could be done); however, transfer to an off-site interpretation site or museum collection is also an option.
