Detailed Site Investigation into Per- and Polyfluoroalkyl Substances (PFAS)

Norfolk Island Airport

12 November 2021

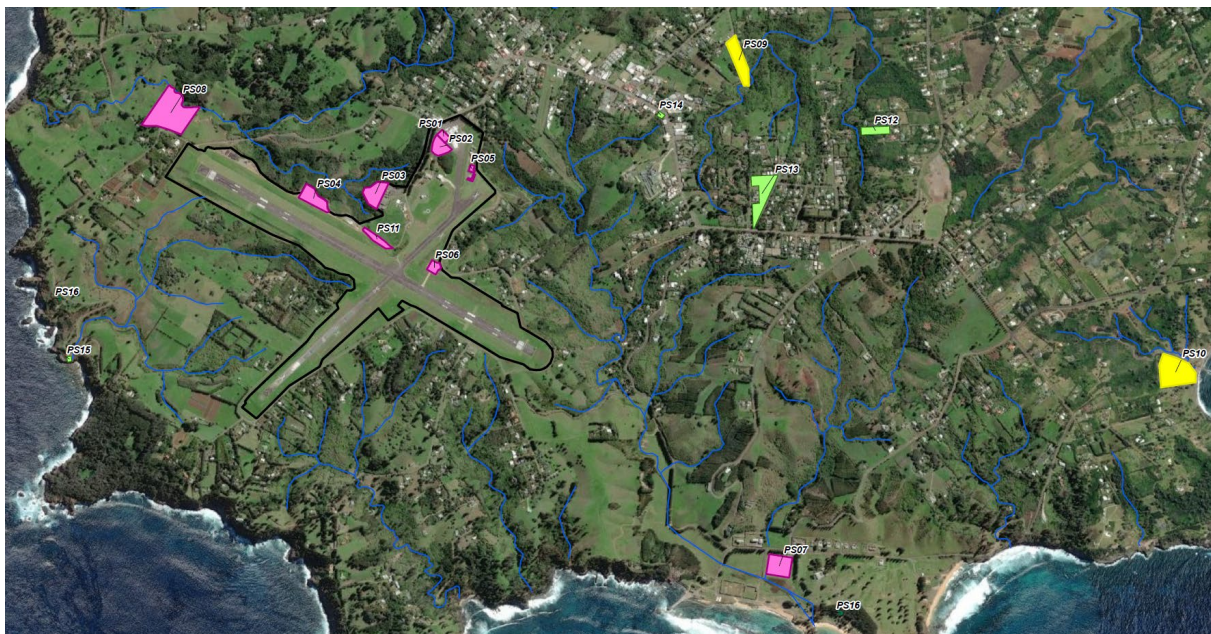
A total of 17 different types of confirmed and potential PFAS source areas were identified across the wider Norfolk Island within the PSI. The location of these source areas is provided in **Figure 4** below, with further information provided in **Table 2-1** and **Figure A3**.

Figure 4: Confirmed and Potential PFAS Source Areas

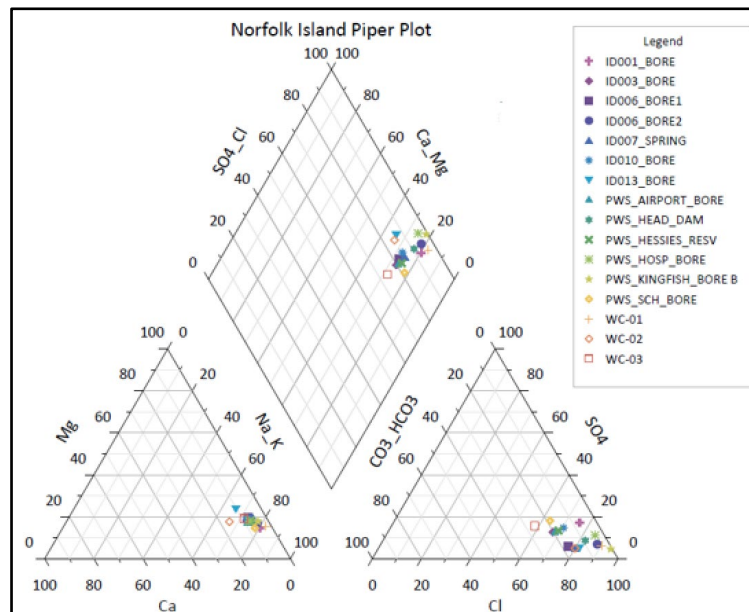
Senversa undertook further assessment into groundwater provenance during the PSI, with a piper plot produced from 16 groundwater samples spread across the island. The piper plot (see **Figure 8**) found sodium and potassium to be the dominant cations, with chloride as the dominant anion. This indicates groundwater on Norfolk Island falls within the sodium chloride type, which is expected for the dominant rainfall / freshwater recharge of the island.

Figure 8: Piper plot detailing ionic balance of groundwater across Norfolk island

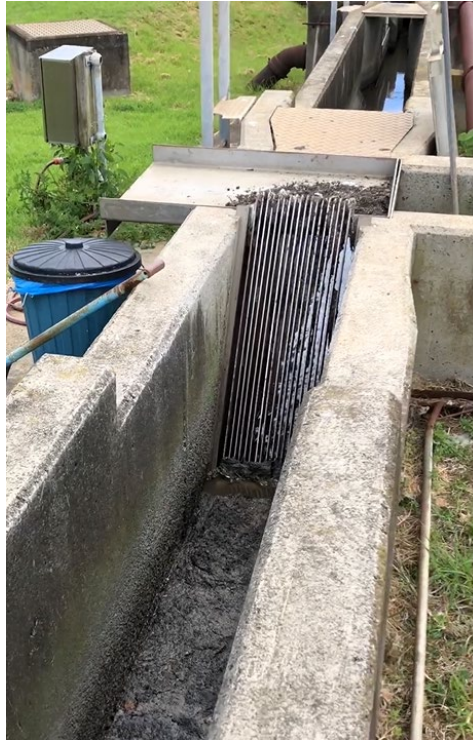
The inlet works for the WWTP are shown on **Figure 12** below, with the soils sampled around the WWTP presented in **Figure A6G**.

Figure 12: Wastewater Treatment Plant Inlet

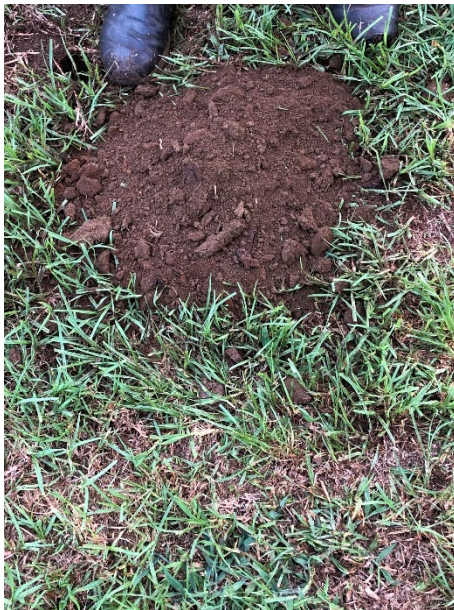
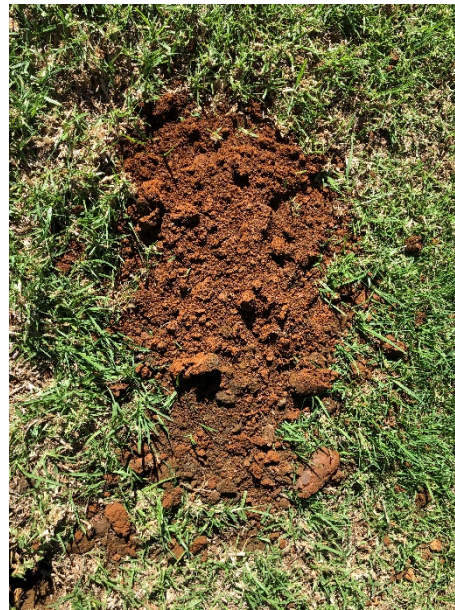
The typical fill and natural soils encountered are shown in **Plate 1** below.

Plate 1: Typical soil profile encountered showing brown silty sand topsoil (left) and natural red brown silty clay (right)

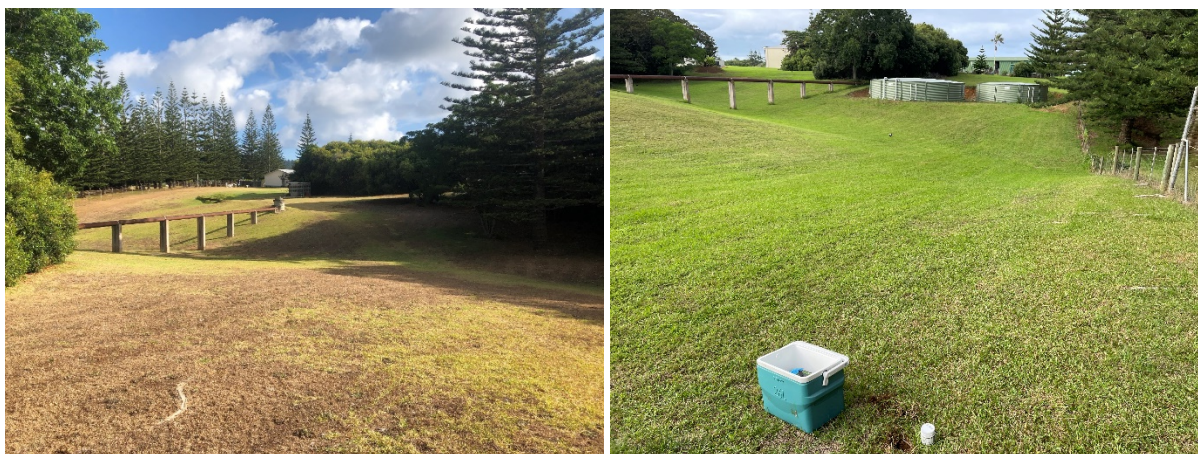
Rainfall conditions and the presence of surface water at the site varied significantly between the PSI sampling in January 2020 and the DSI sampling conducted in March 2021, as illustrated by PFAS Source Area 1 looking west in both January 2020 (left) and March 2021 (right) in **Figure 23** below. The condition and colour of grass in area clearly demonstrates the difference in rainfall at the airport during this time.

Figure 23: PS01 looking west in January 2020 (left) and March 2021 (right)

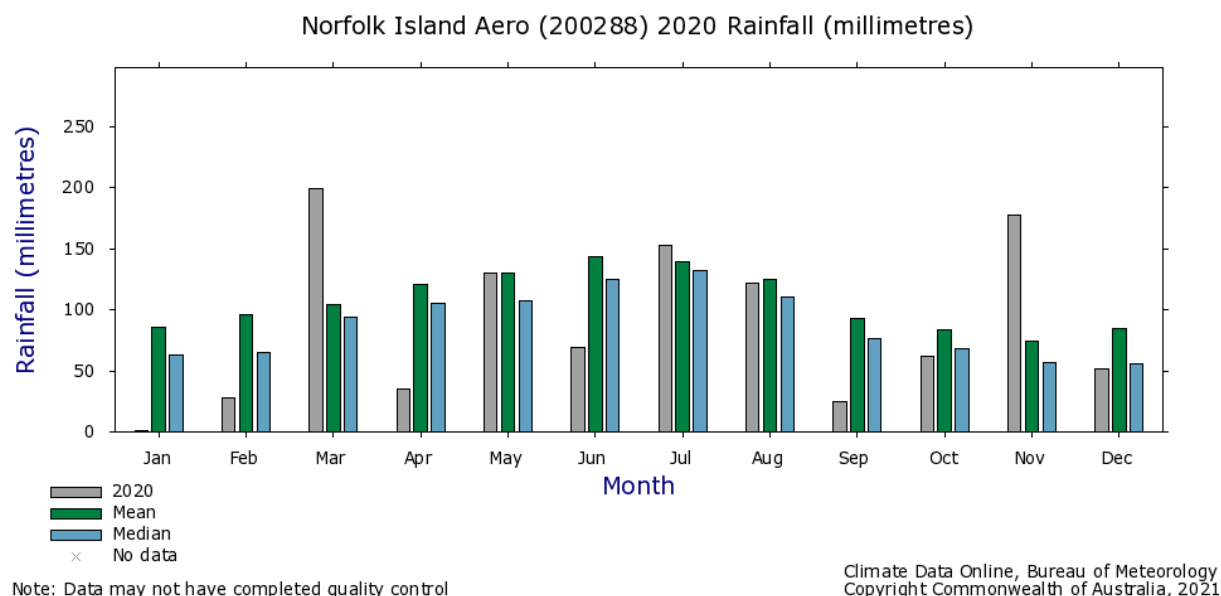
During the DSI, Norfolk Island was observed to be green and lush and is understood to have had reasonable recent rainfall leading up to the sampling works; this is shown in the 2020 month of November, which shows much higher than average rainfall, and this was also confirmed by anecdotal evidence from residents. Despite the recent rainfall, there remained limited surface water presence in the ephemeral creeks and streams. **Figure 25** provides a summary of the previous 12 months of rainfall (2020) prior to the DSI sampling being undertaken.

Figure 25: Graph of Mean and Median Monthly Rainfall Data vs 2020 Data for Norfolk Island Aerodrome (BoM, 2021a)

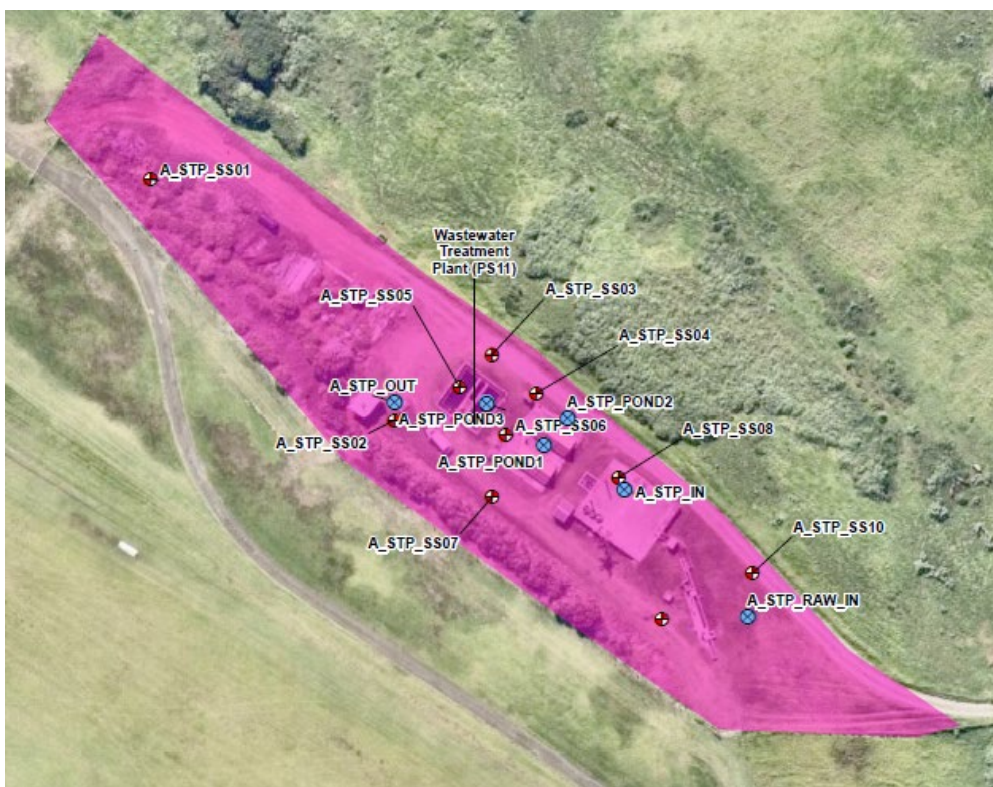
Figure 30 below shows the sample locations taken from around the WWTP with the with further information provided in **Figure A6G** (in **Appendix A**).

Figure 30: Wastewater Treatment Plant – Sample locations
