**Re: Norfolk Island Airport Repair and Resurfacing Project (SPT1718NIRC)
Cascade Cliff and Alternative Site Review**

Investigation into Cascade Cliff & Review of Alternative Sites

Document Number: BORAL-NIRC-PLN-0001

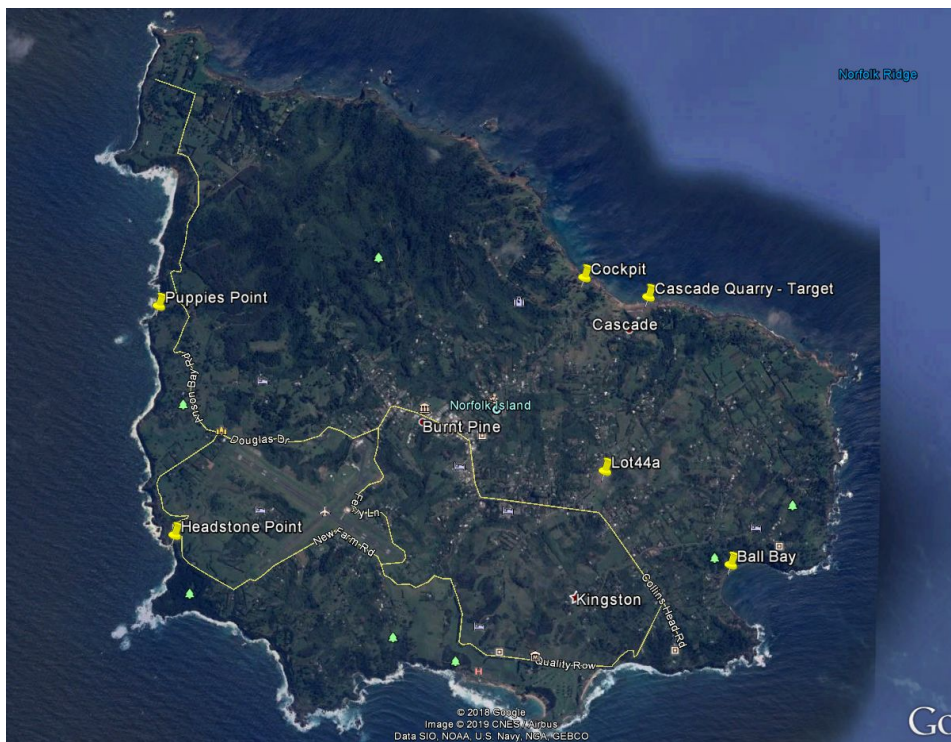
Figure 1: Norfolk Island primary targets for quarry locations

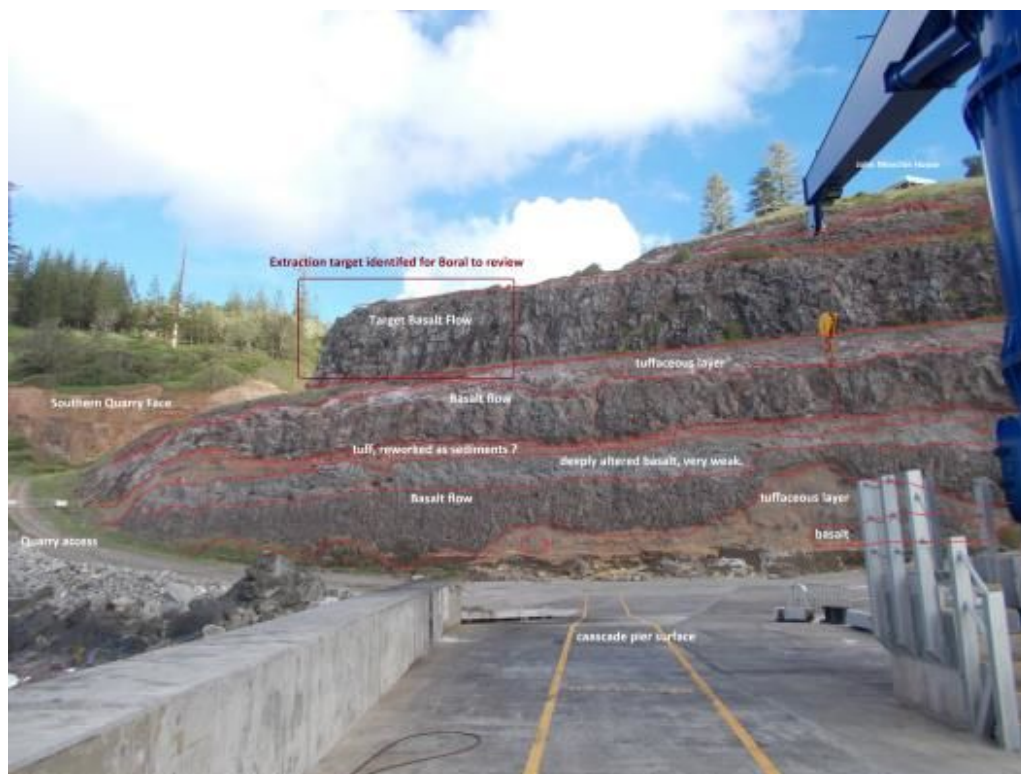
Figure 4 - Cascade Cliff from Cascade Pier

It was observed that the full face had many flows within it, from strongly weathered (becoming clay) to relatively fresh, but also weathered. The fresher flow has less obvious weathering, however weathering does exist. During drilling of the target, observations of the operating drill (penetration rate, size of rock chips, type and tone of drilling noise) indicated the rock was of a higher quality than the testing confirmed. The small light drill rig was working toward its limit to drill the test holes and this resulted in an incorrect interpretation of this information.

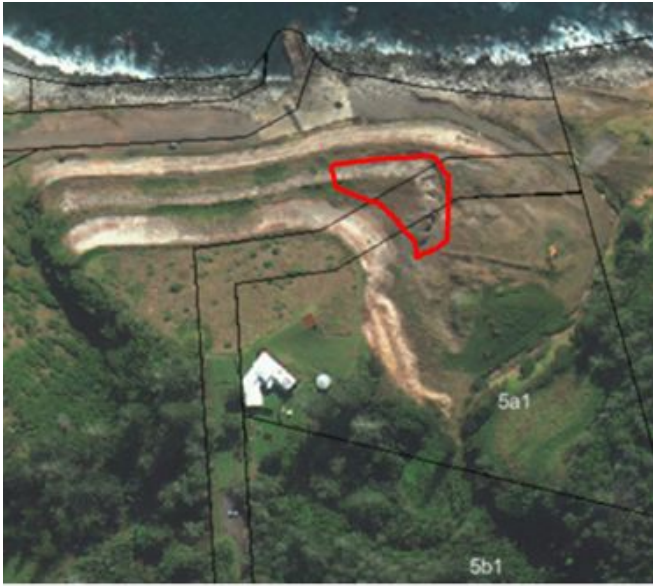
Figure 2 - Norfolk Island Map Resource - Potential Extraction Area marked in Red, March 2019

The three locations are identified as Hole 1, Hole 2, Hole 3 as shown on Figure 1 and 2. These locations were identified by Boral's Geologist as the best representation from visual inspection this resource and would offer adequate sample information sufficient for analysis.

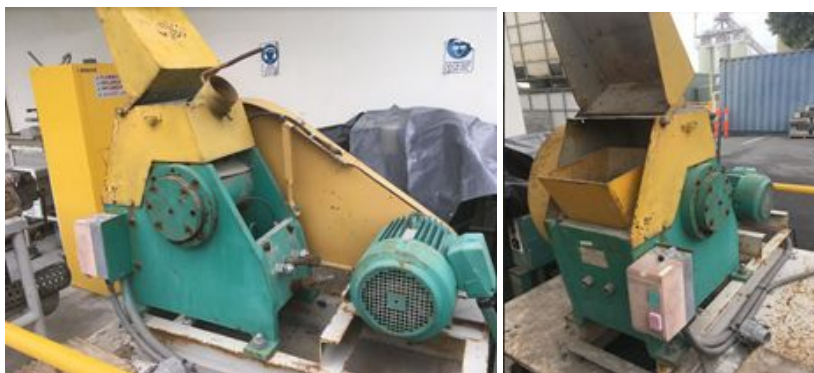
Figure 4 - Boral Whinstanes - Jaw Crusher

At Boral's Technical Testing facility the testing process involves the replication of typical crushing process to assess the practical manufacturing properties of the resource and the resultant outcomes achieved through this process.

The jaw crusher used is a forward-move with jaw opening of 100-30mm size.
