Arthurs Vale Creek Fencing and Rehabilitation Project 2020

Summary of project methodology and delivery

Design Report

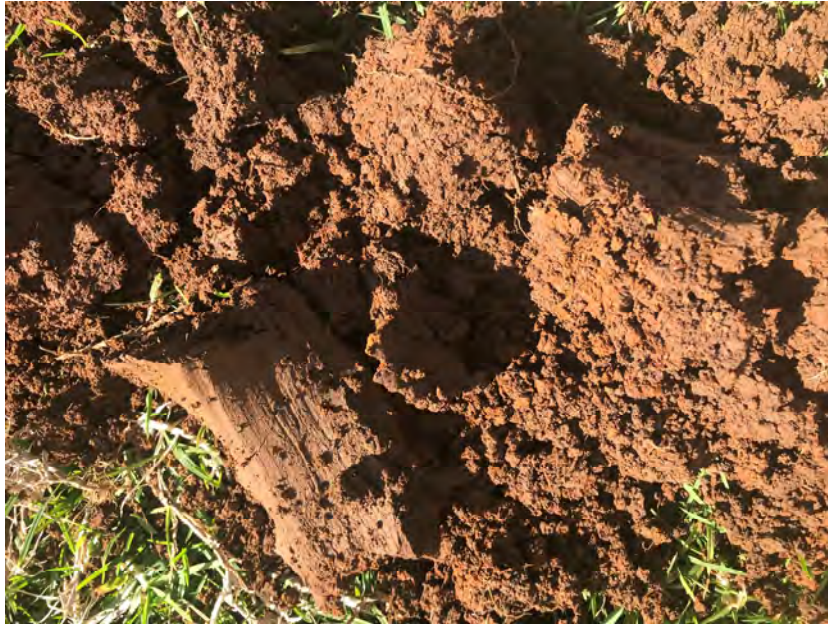
4. Uniform alluvial soil with clay like constituency when compressed

Post holes were all dug mechanically due to the known soil conditions and depth of deposited soil over earlier archaeological layers. The soil uncovered through to 500mm at every excavation point is friable alluvial sediment and clays deposited in a uniform layer as a result of regular flooding events in the valley.

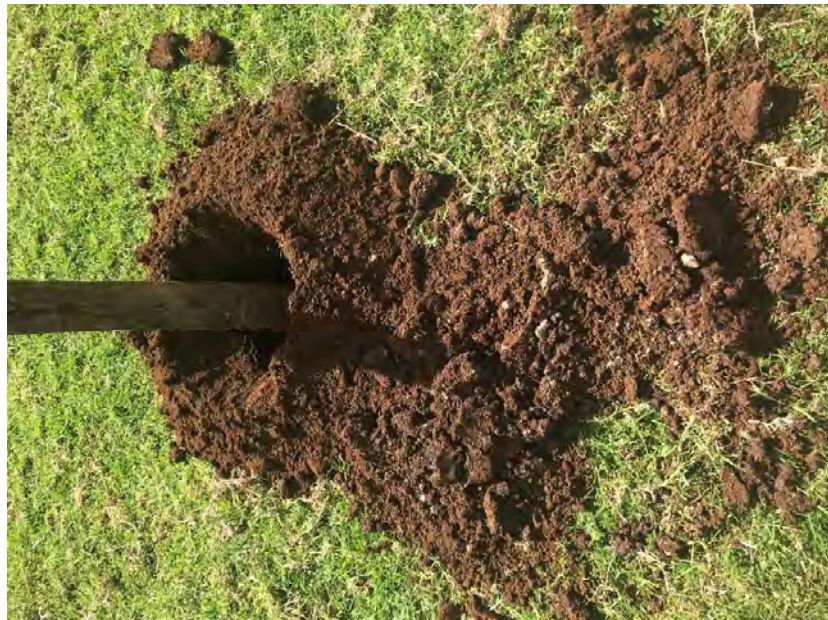
5. Post 5 lower creek west showing very small mortar stone, bedding over old causeway crossing

The only exceptions were the two post holes at the midpoint of the valley adjacent to the old convict road crossing from south to north, post four and post five from the middle concrete bridge parapet to the west, at David (Didds) Evans access road. These two holes carried no finds, but the soil did contain some small loose stone and aggregate material consistent with the causeway although in no discernible layers. (see image This was all that was the most that was uncovered in the post holes.

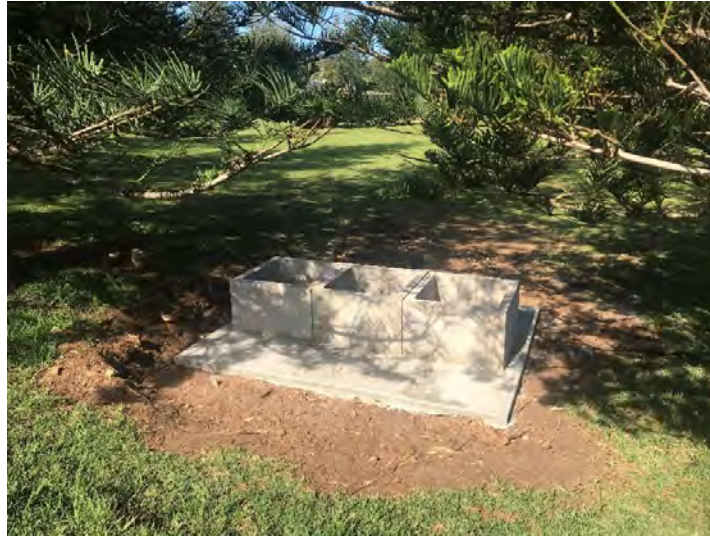
10. Cattle Trough at Pier Street on caste base

A shallow depression was created to take a caste 4m x 3m concrete slab located on the edge of the common behind the pier Street causeway stone parapet.

Excavation was minimal encountering surface tree roots and turf sward and no finds were recorded. The slab was reinforced and can be lifted and removed if required. Tanks are pre-caste and can also be removed. Water connection was supervised by the SDA manager to an existing water supply on Pier Road.

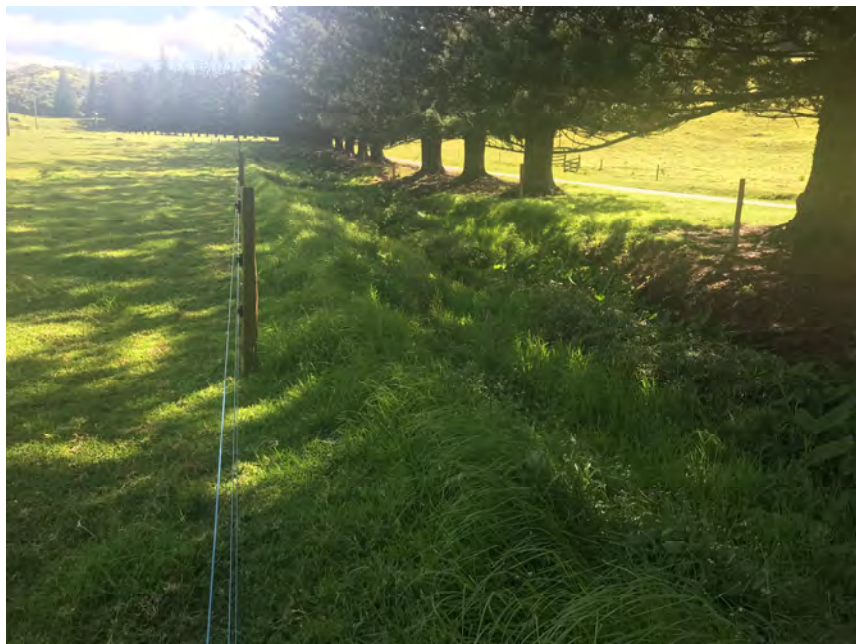
11. At the midpoint of the Valley adjacent to the bridge and roadway to David (Didds) Evans farm, the Creek Boundary is already showing evidence of growth with the restriction of grazing.

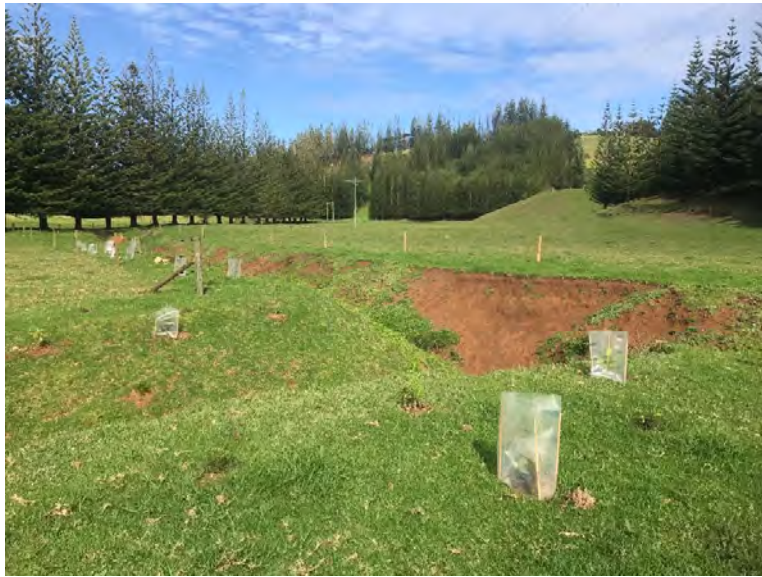
14. Ongoing erosion of banks by cattle accessing the creek for water, damage exacerbated by storm water flow scour, increasing the depth of the creek bed and further eroding its banks

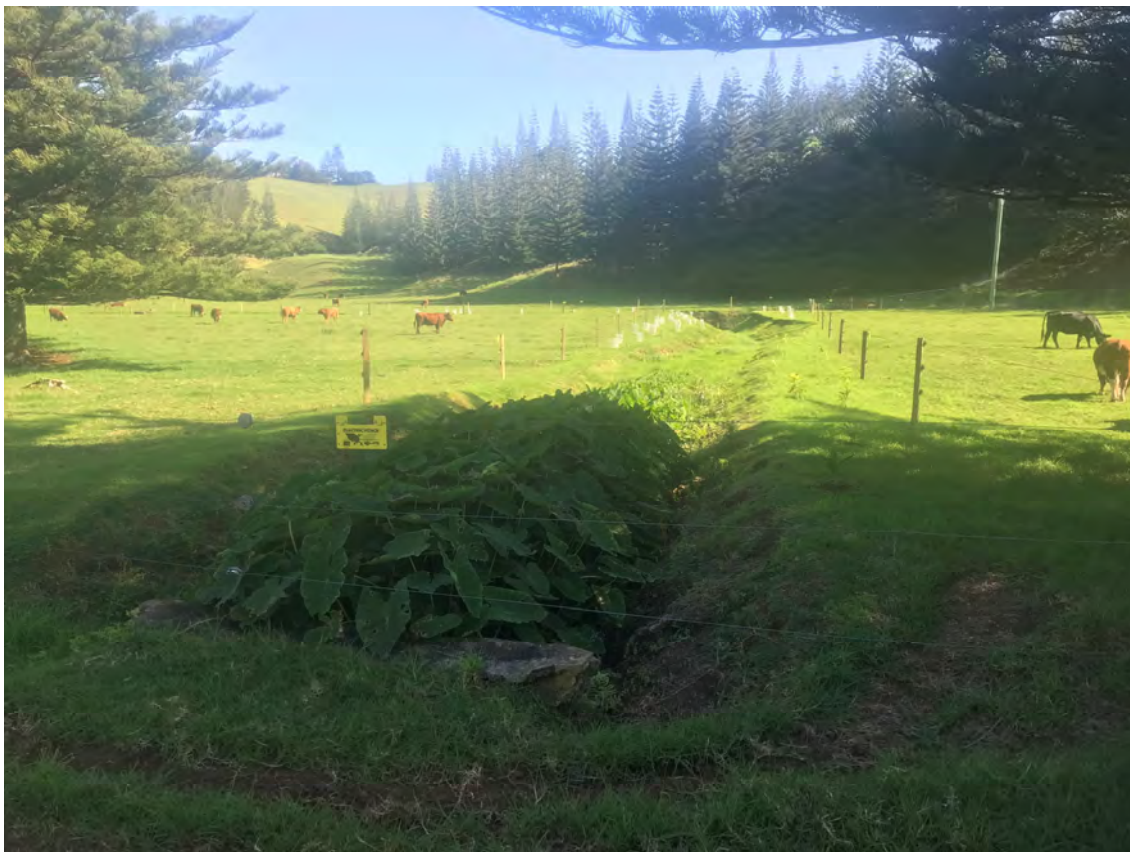
15. Fencing of drainage tributary upper area of creek near dam showing native planting

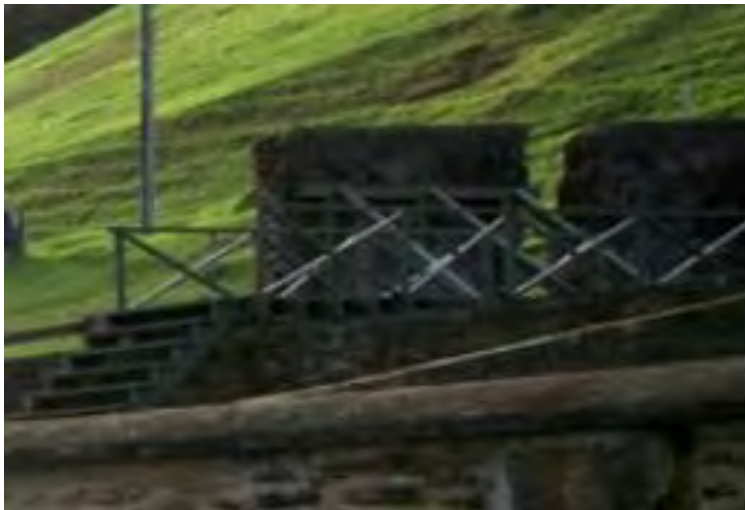
Figure 2 Existing timber braces on Quality Row.

The construction uses large format timber sections and galvanised steel connector plates. The plates would be supplied from the mainland but the timbers could be locally sourced subject to value management of cost versus life span. Any eventual timber replacement would involve unbolting and replacement without the need for temporary propping or specialist skills.

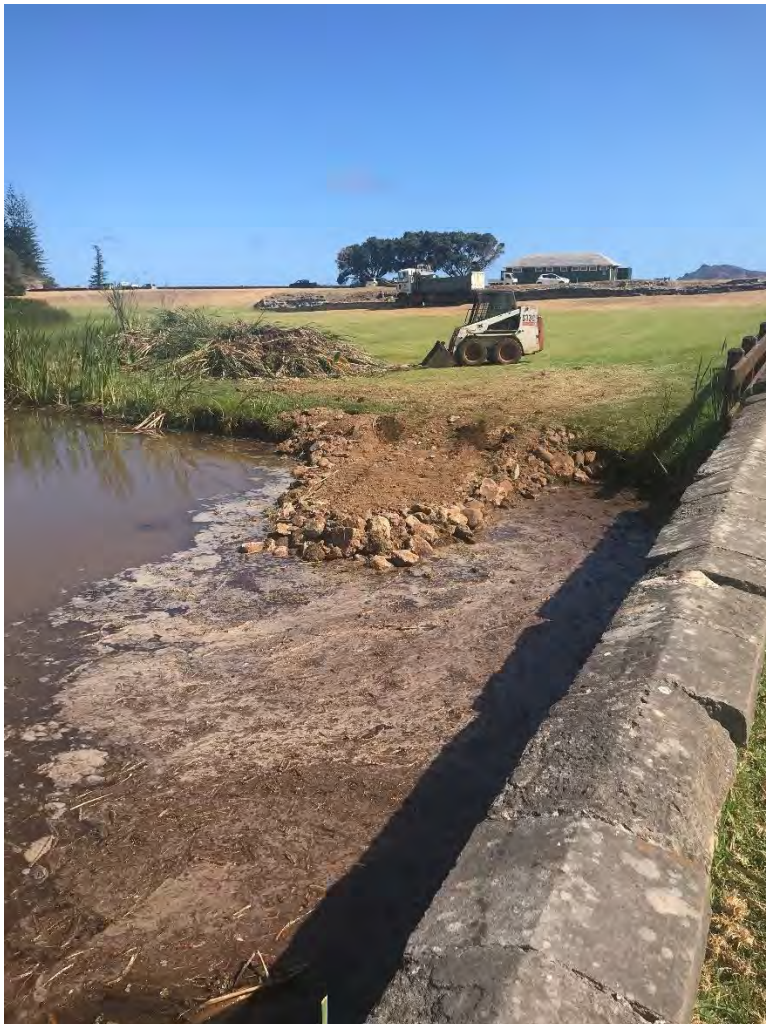
Figure 5 Construction of Coffier Dam

The works undertaken for the inspection phase consisted of the construction of an earth fill coffer dam immediately downstream of the bridge and dewatering to provide access to the bridge soffit and areas that are normally below the waterline and geotechnical investigations of the bridge foundation material.

These works were undertaken at the end of January 2020 and are shown in Figure 5 and Figure 6.

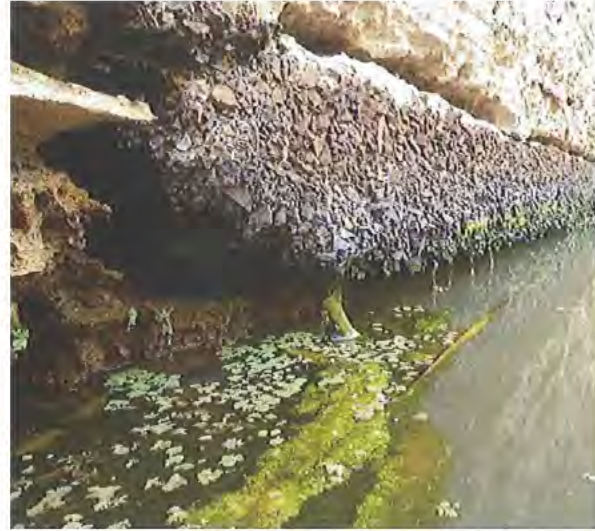
Figure 9 2010 Photo from Hughes Trueman

This degree of stone erosion, in combination with the approximate 1.2m foundation settlement on the northern side, has significantly reduced the capacity of the bridge to safely support loads, and in particular, vehicular traffic. The condition of the bridge is such that we are unable to provide it with a load rating or expected remaining design life.

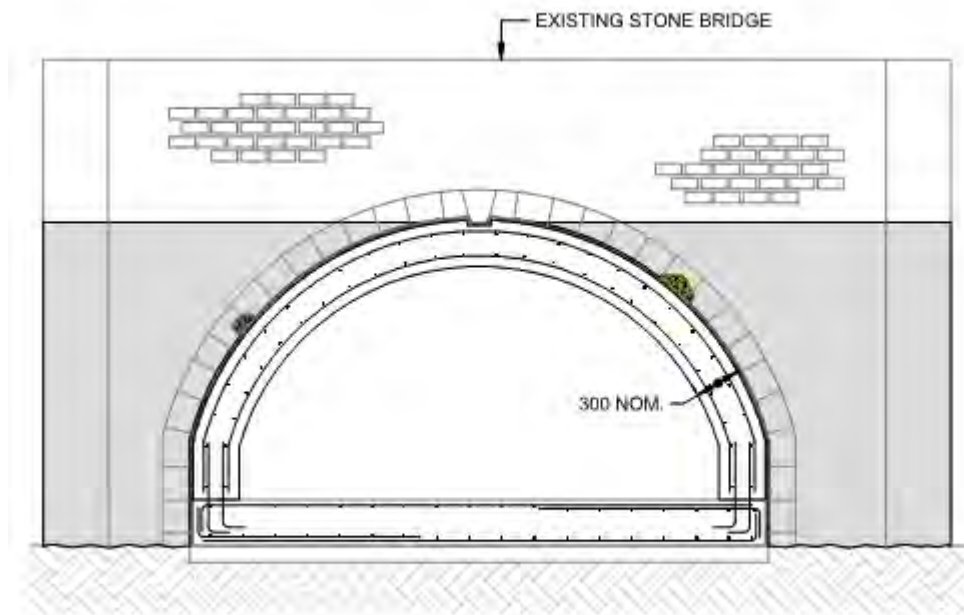
Figure 10 New Concrete Arch Option

It is proposed that the reinforced concrete arch option be adopted for further design development and a concept for this option is shown below in Figure 10 and in Appendix C

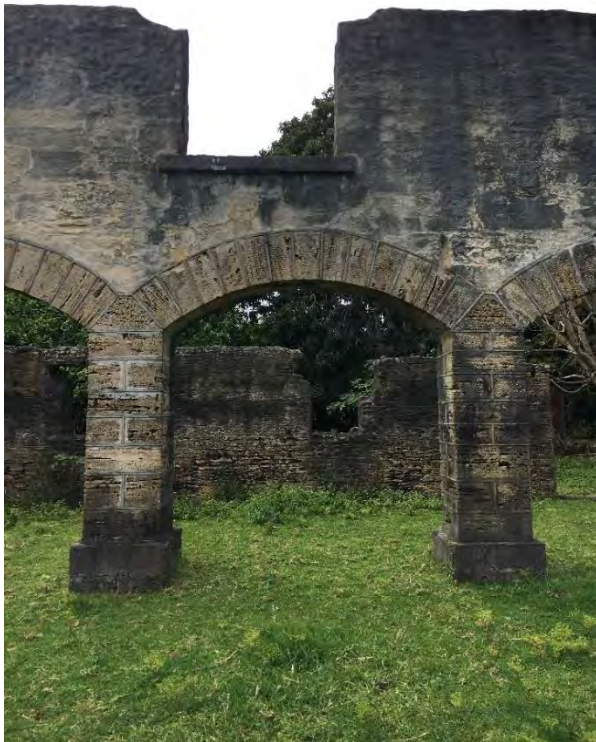
Figure 11 Arch and window misalignment

The arches currently have a lean towards the south of approximately 200mm and previous engineering investigations have identified stability issues under wind and seismic loading as well as excessive rotation of the foundations that is probably the result of overstressing of the foundation material.

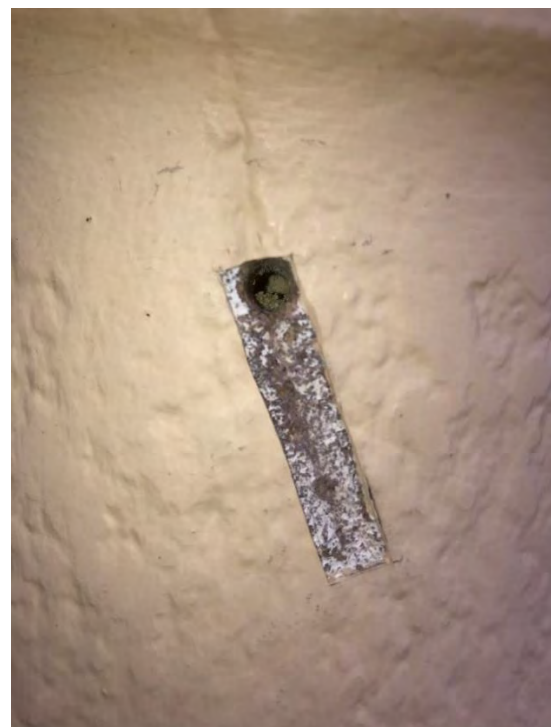
Figure 15 Upper Groove with Drill Hole

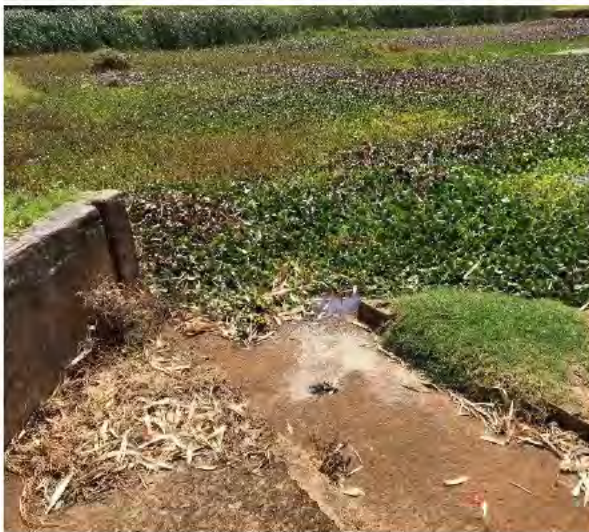
Figure 16 Upstream end of spillway

It was not possible to determine the depth of any erosion under the spillway slab but given the potential for erosion to the dam wall it is recommended that works be undertaken to remedy the spillway.

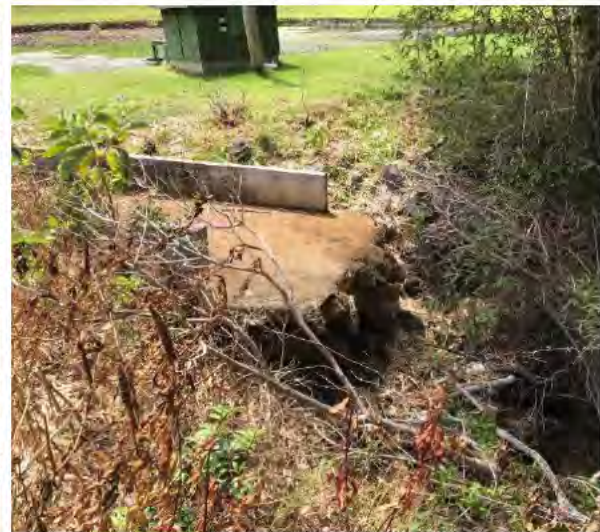
Figure 17 Downstream end of spillway

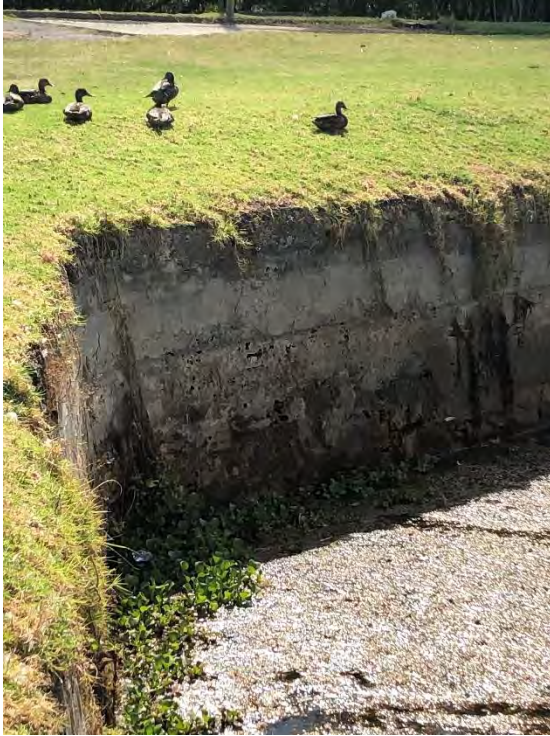
Figure 18 Eroded dam lining

During the spillway investigations it was noted that the render lining to the upstream face of the dam wall has been eroded by contact with the dam water. Refer to Figure 18. It is understood that the wall lining has been regularly reapplied to prevent water seeping through the relatively porous soil that forms the dam wall. At the time of inspection there was no sign of water seeping through the dam, so the render appears to be still effective, but it is due for a fresh render coat to maintain the watertightness of the wall.

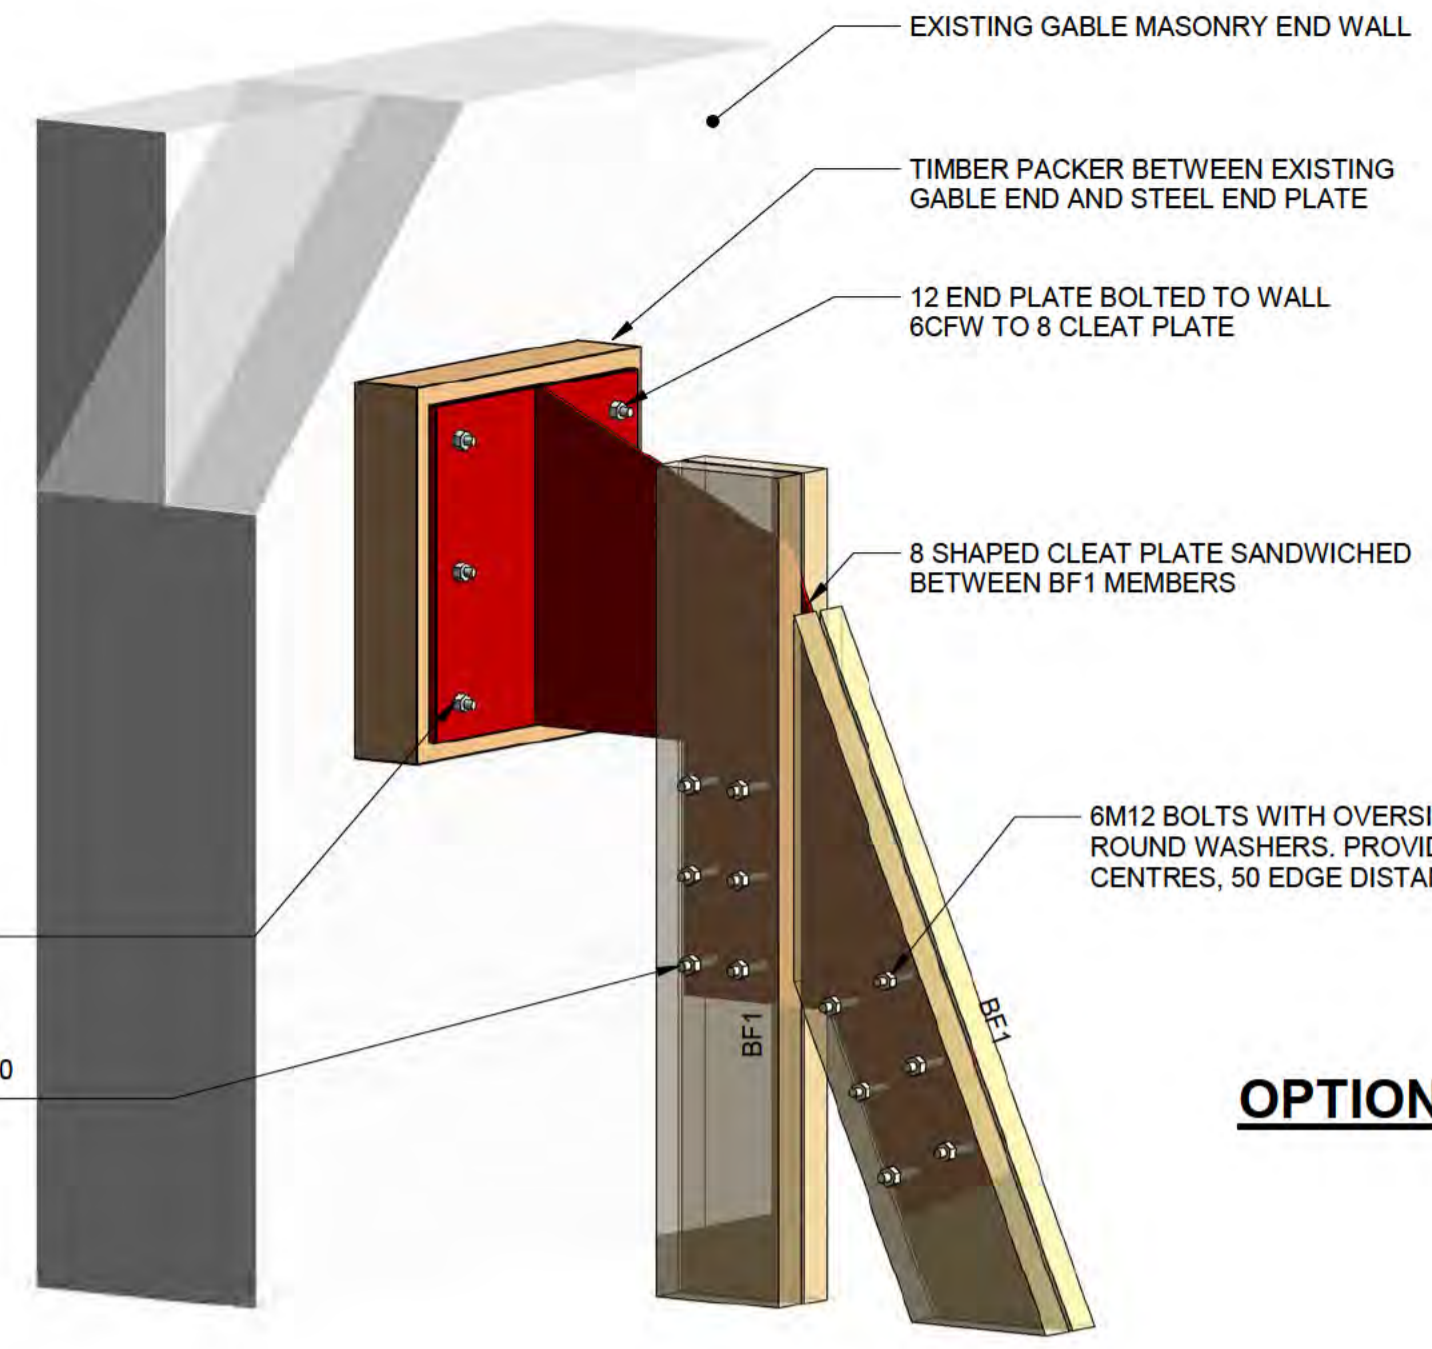
OPTION 01 - CONNECTION TYPE CN1

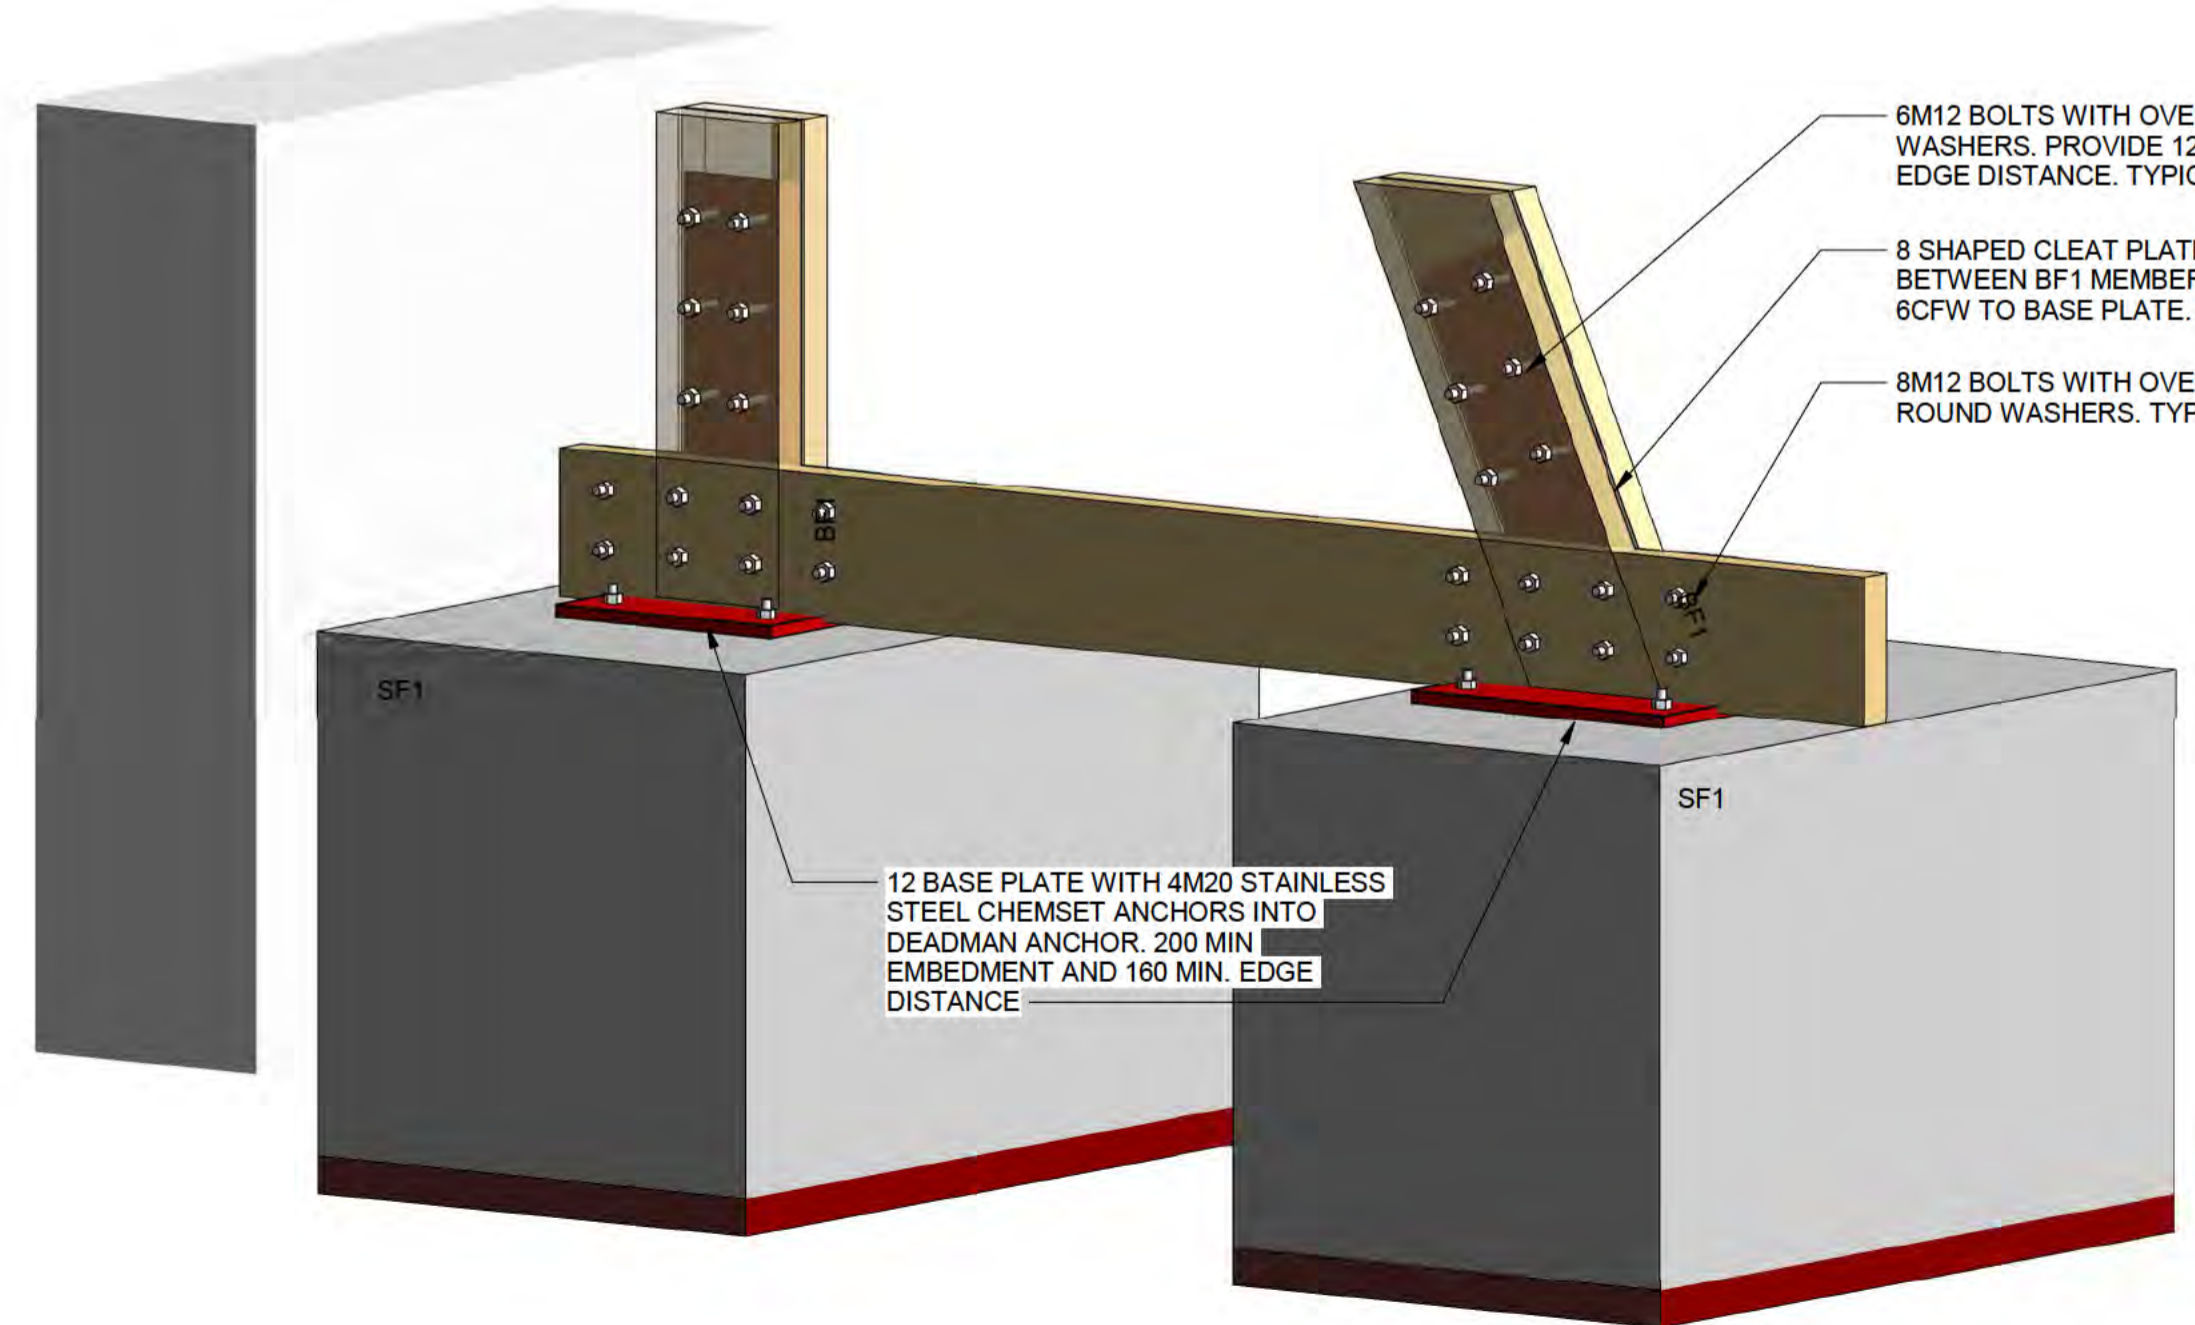
OPTION 01- CONNECTION TYPE CN3

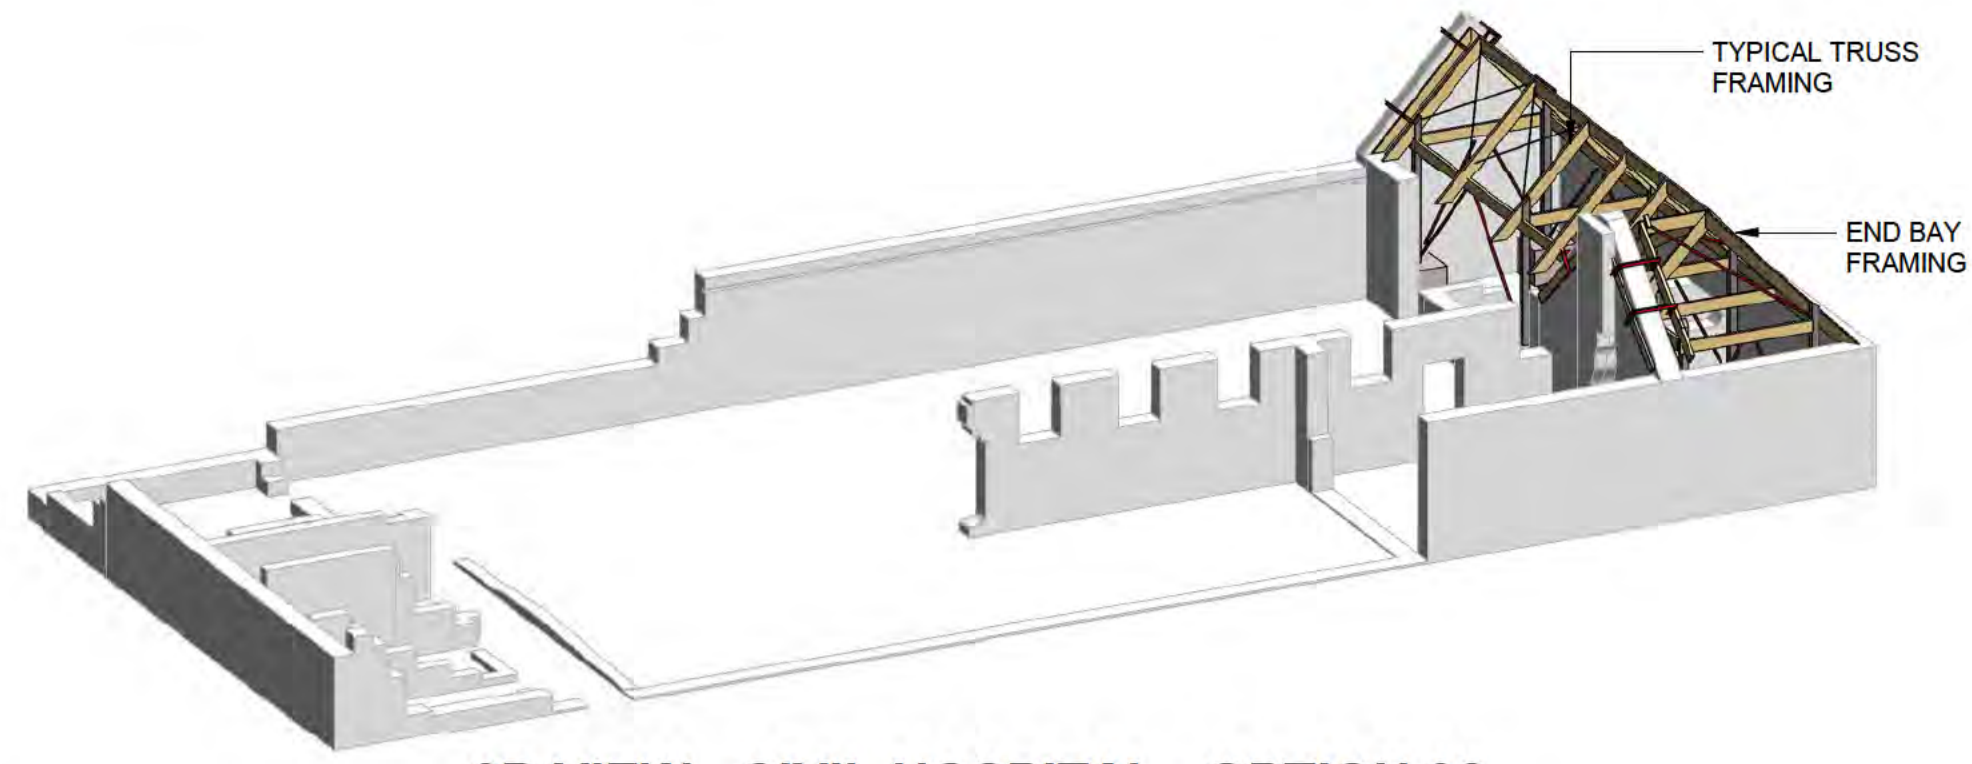
3D VIEW - CIVIL HOSPITAL - OPTION 02

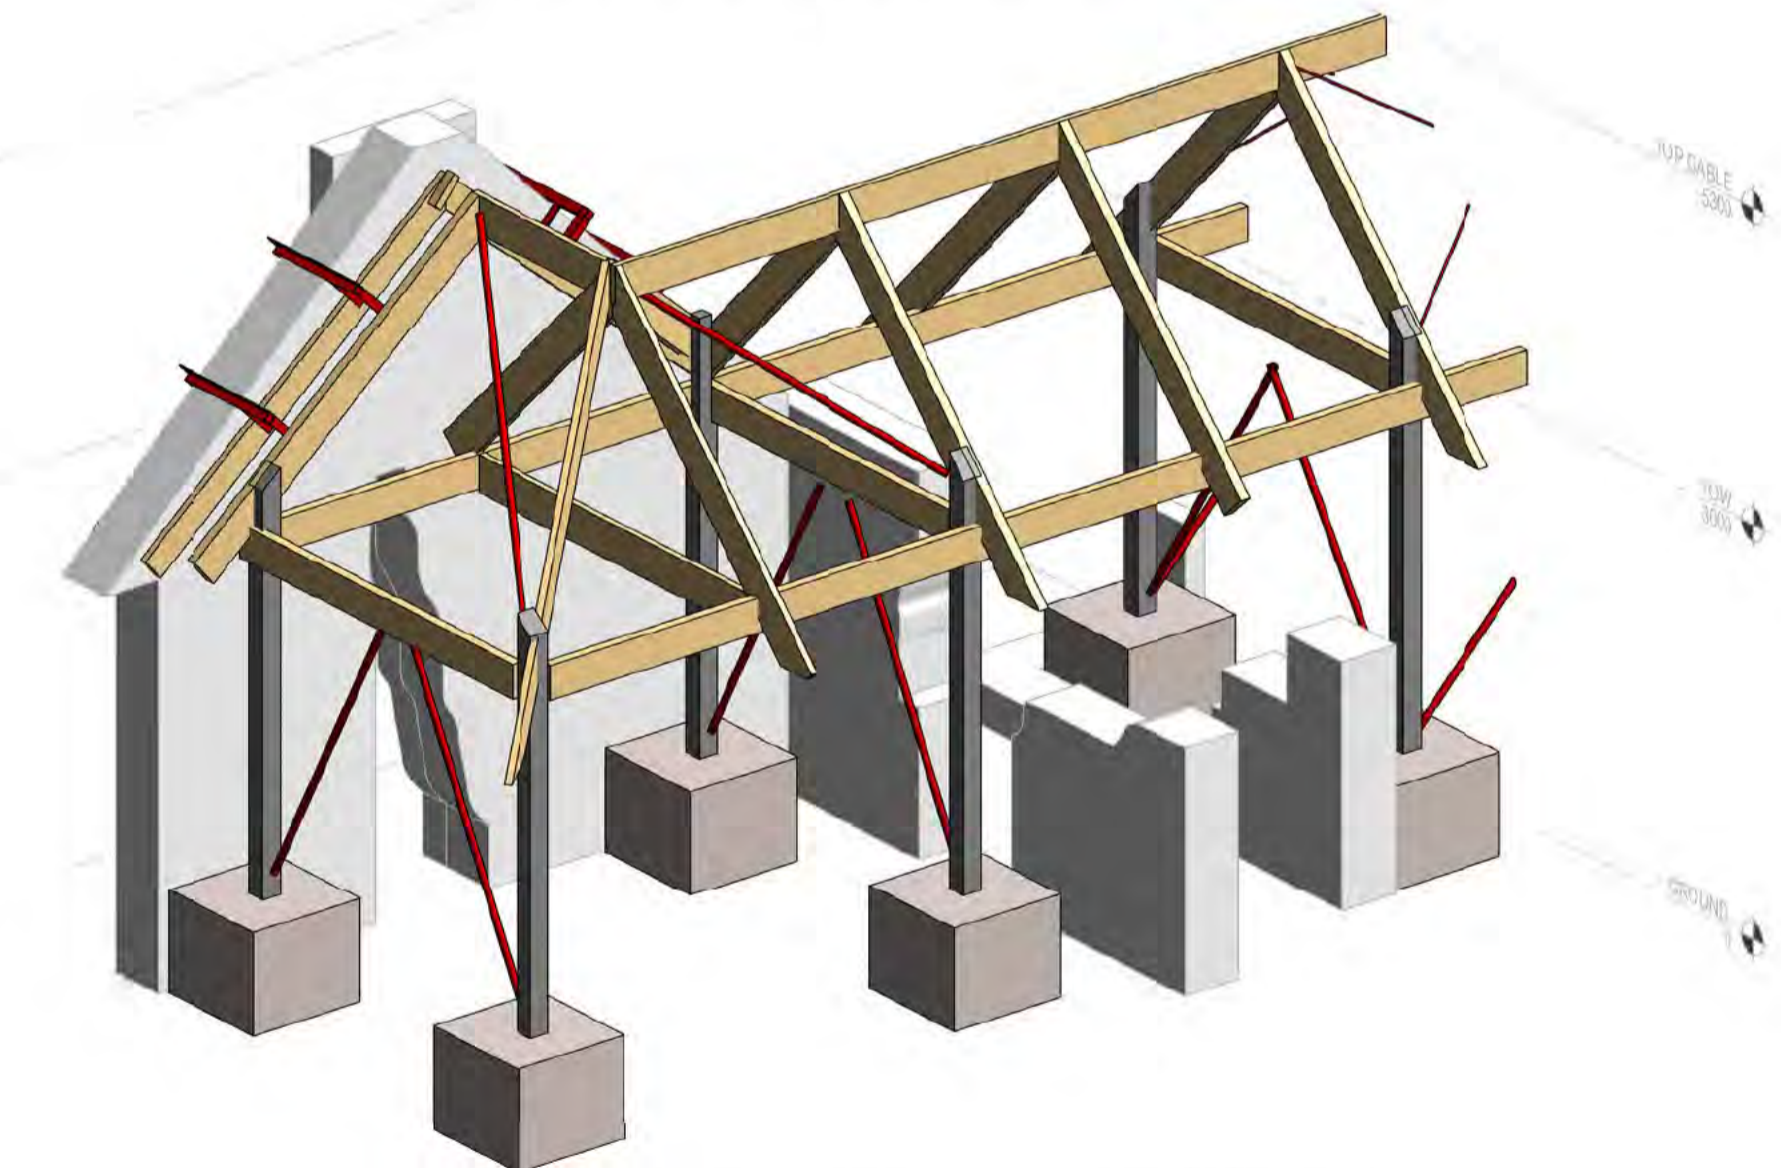
3D VIEW - TYPICAL TRUSS FRAME

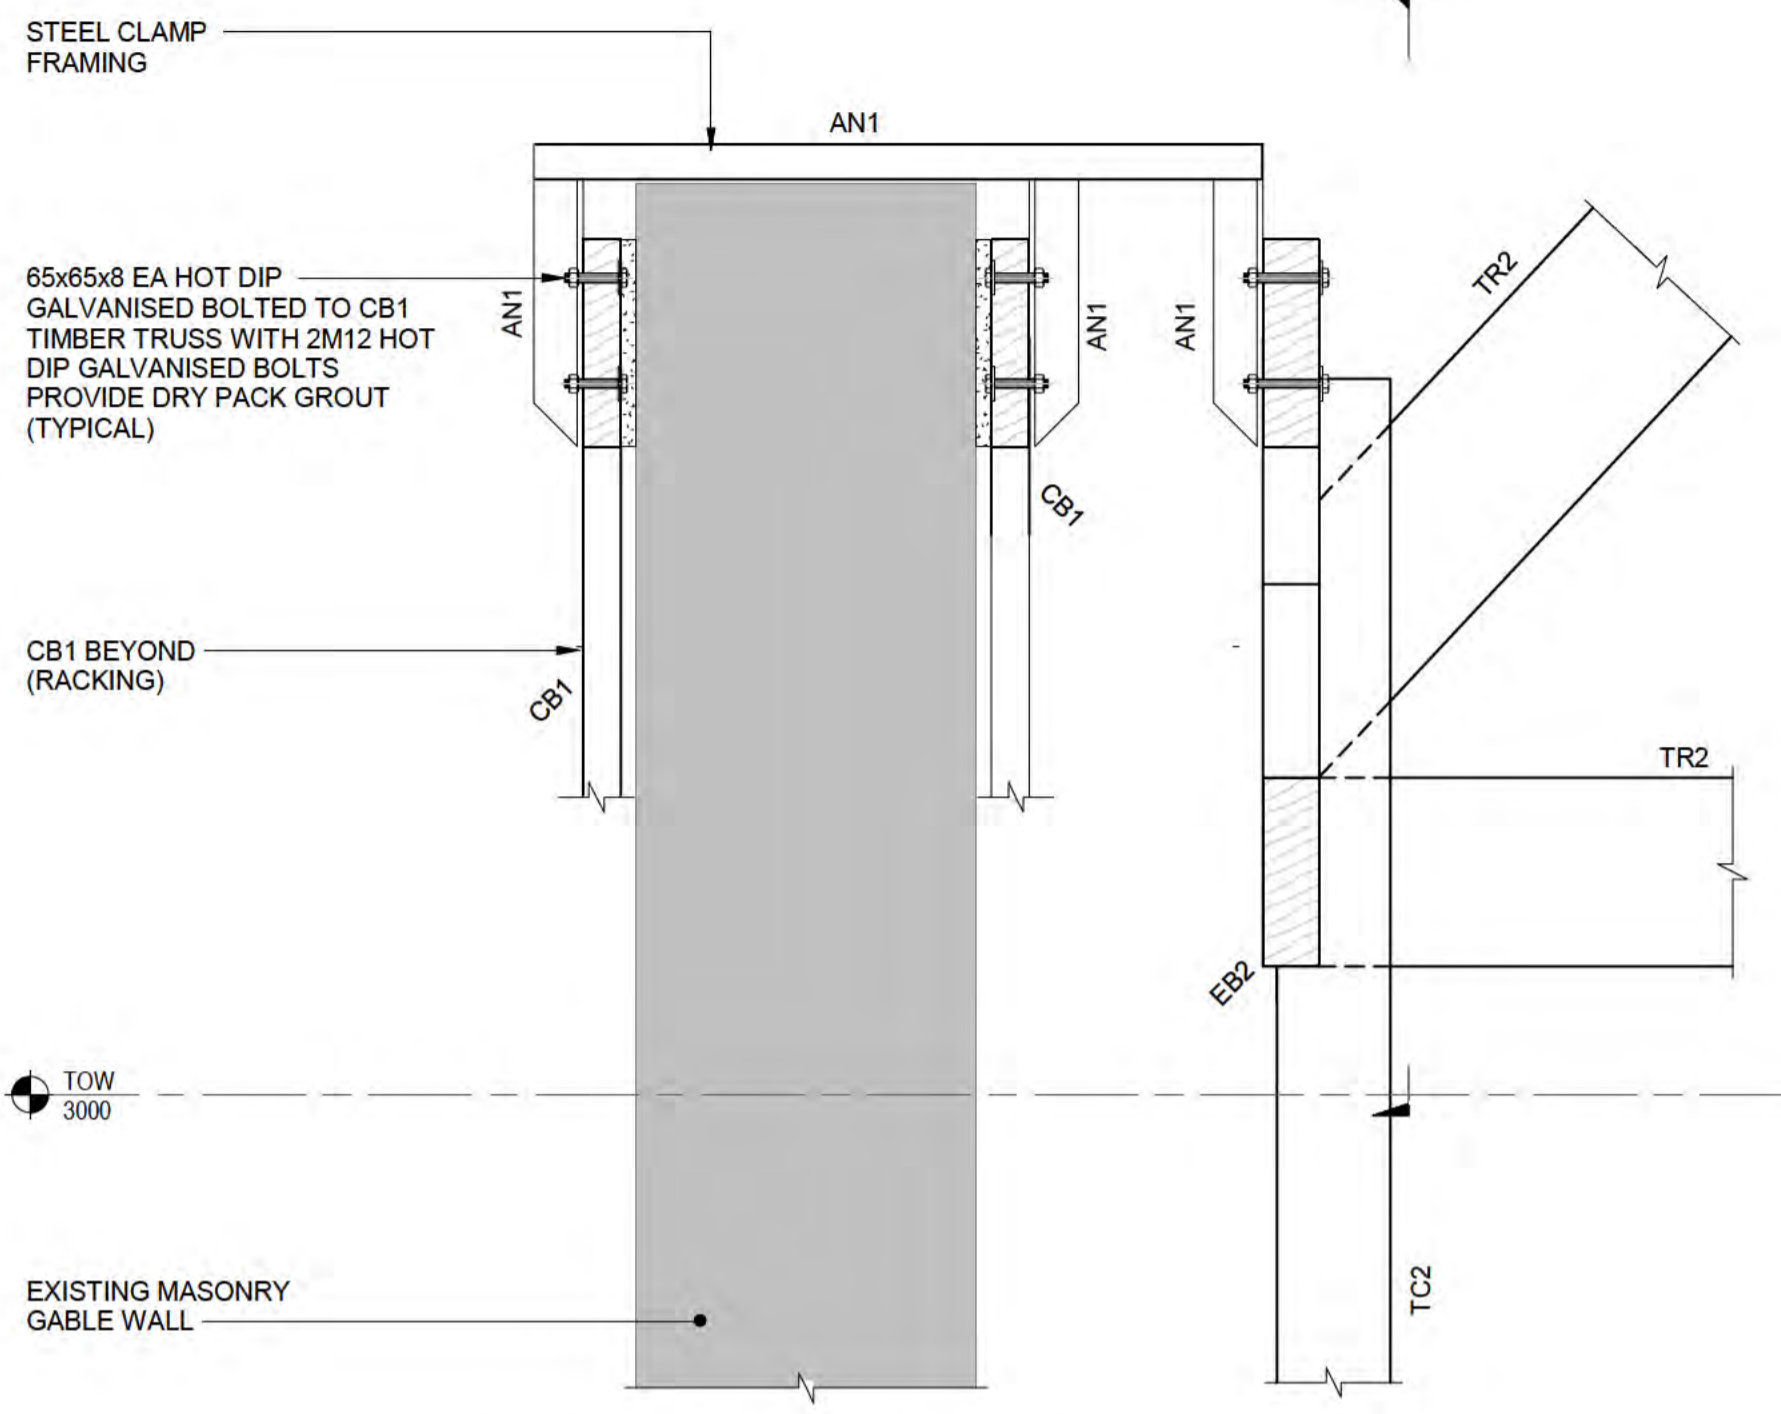
TYPICAL CLAMPING DETAIL ALONG RAKING GABLE EDGE

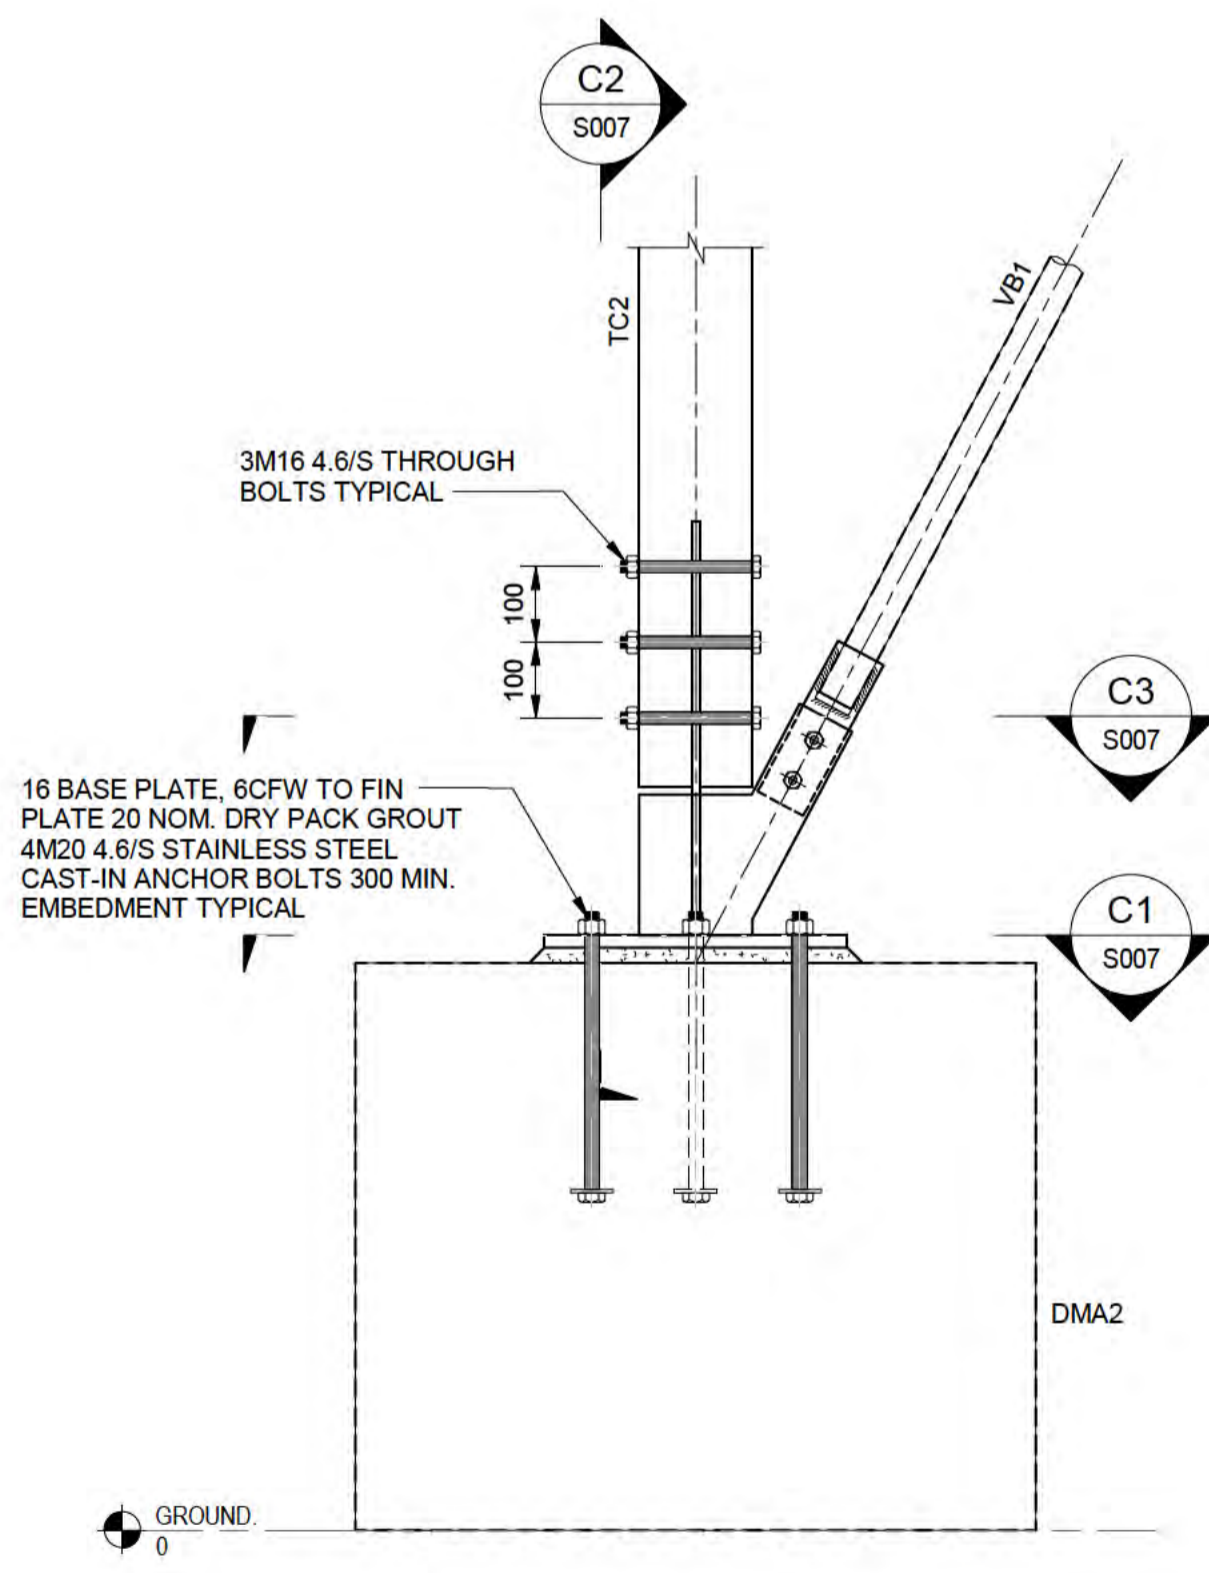
TC2 TO DMA2 BASEPLATE DETAIL
