Arthurs Vale Creek Fencing and Rehabilitation Project 2020

Summary of project methodology and delivery

Design Report

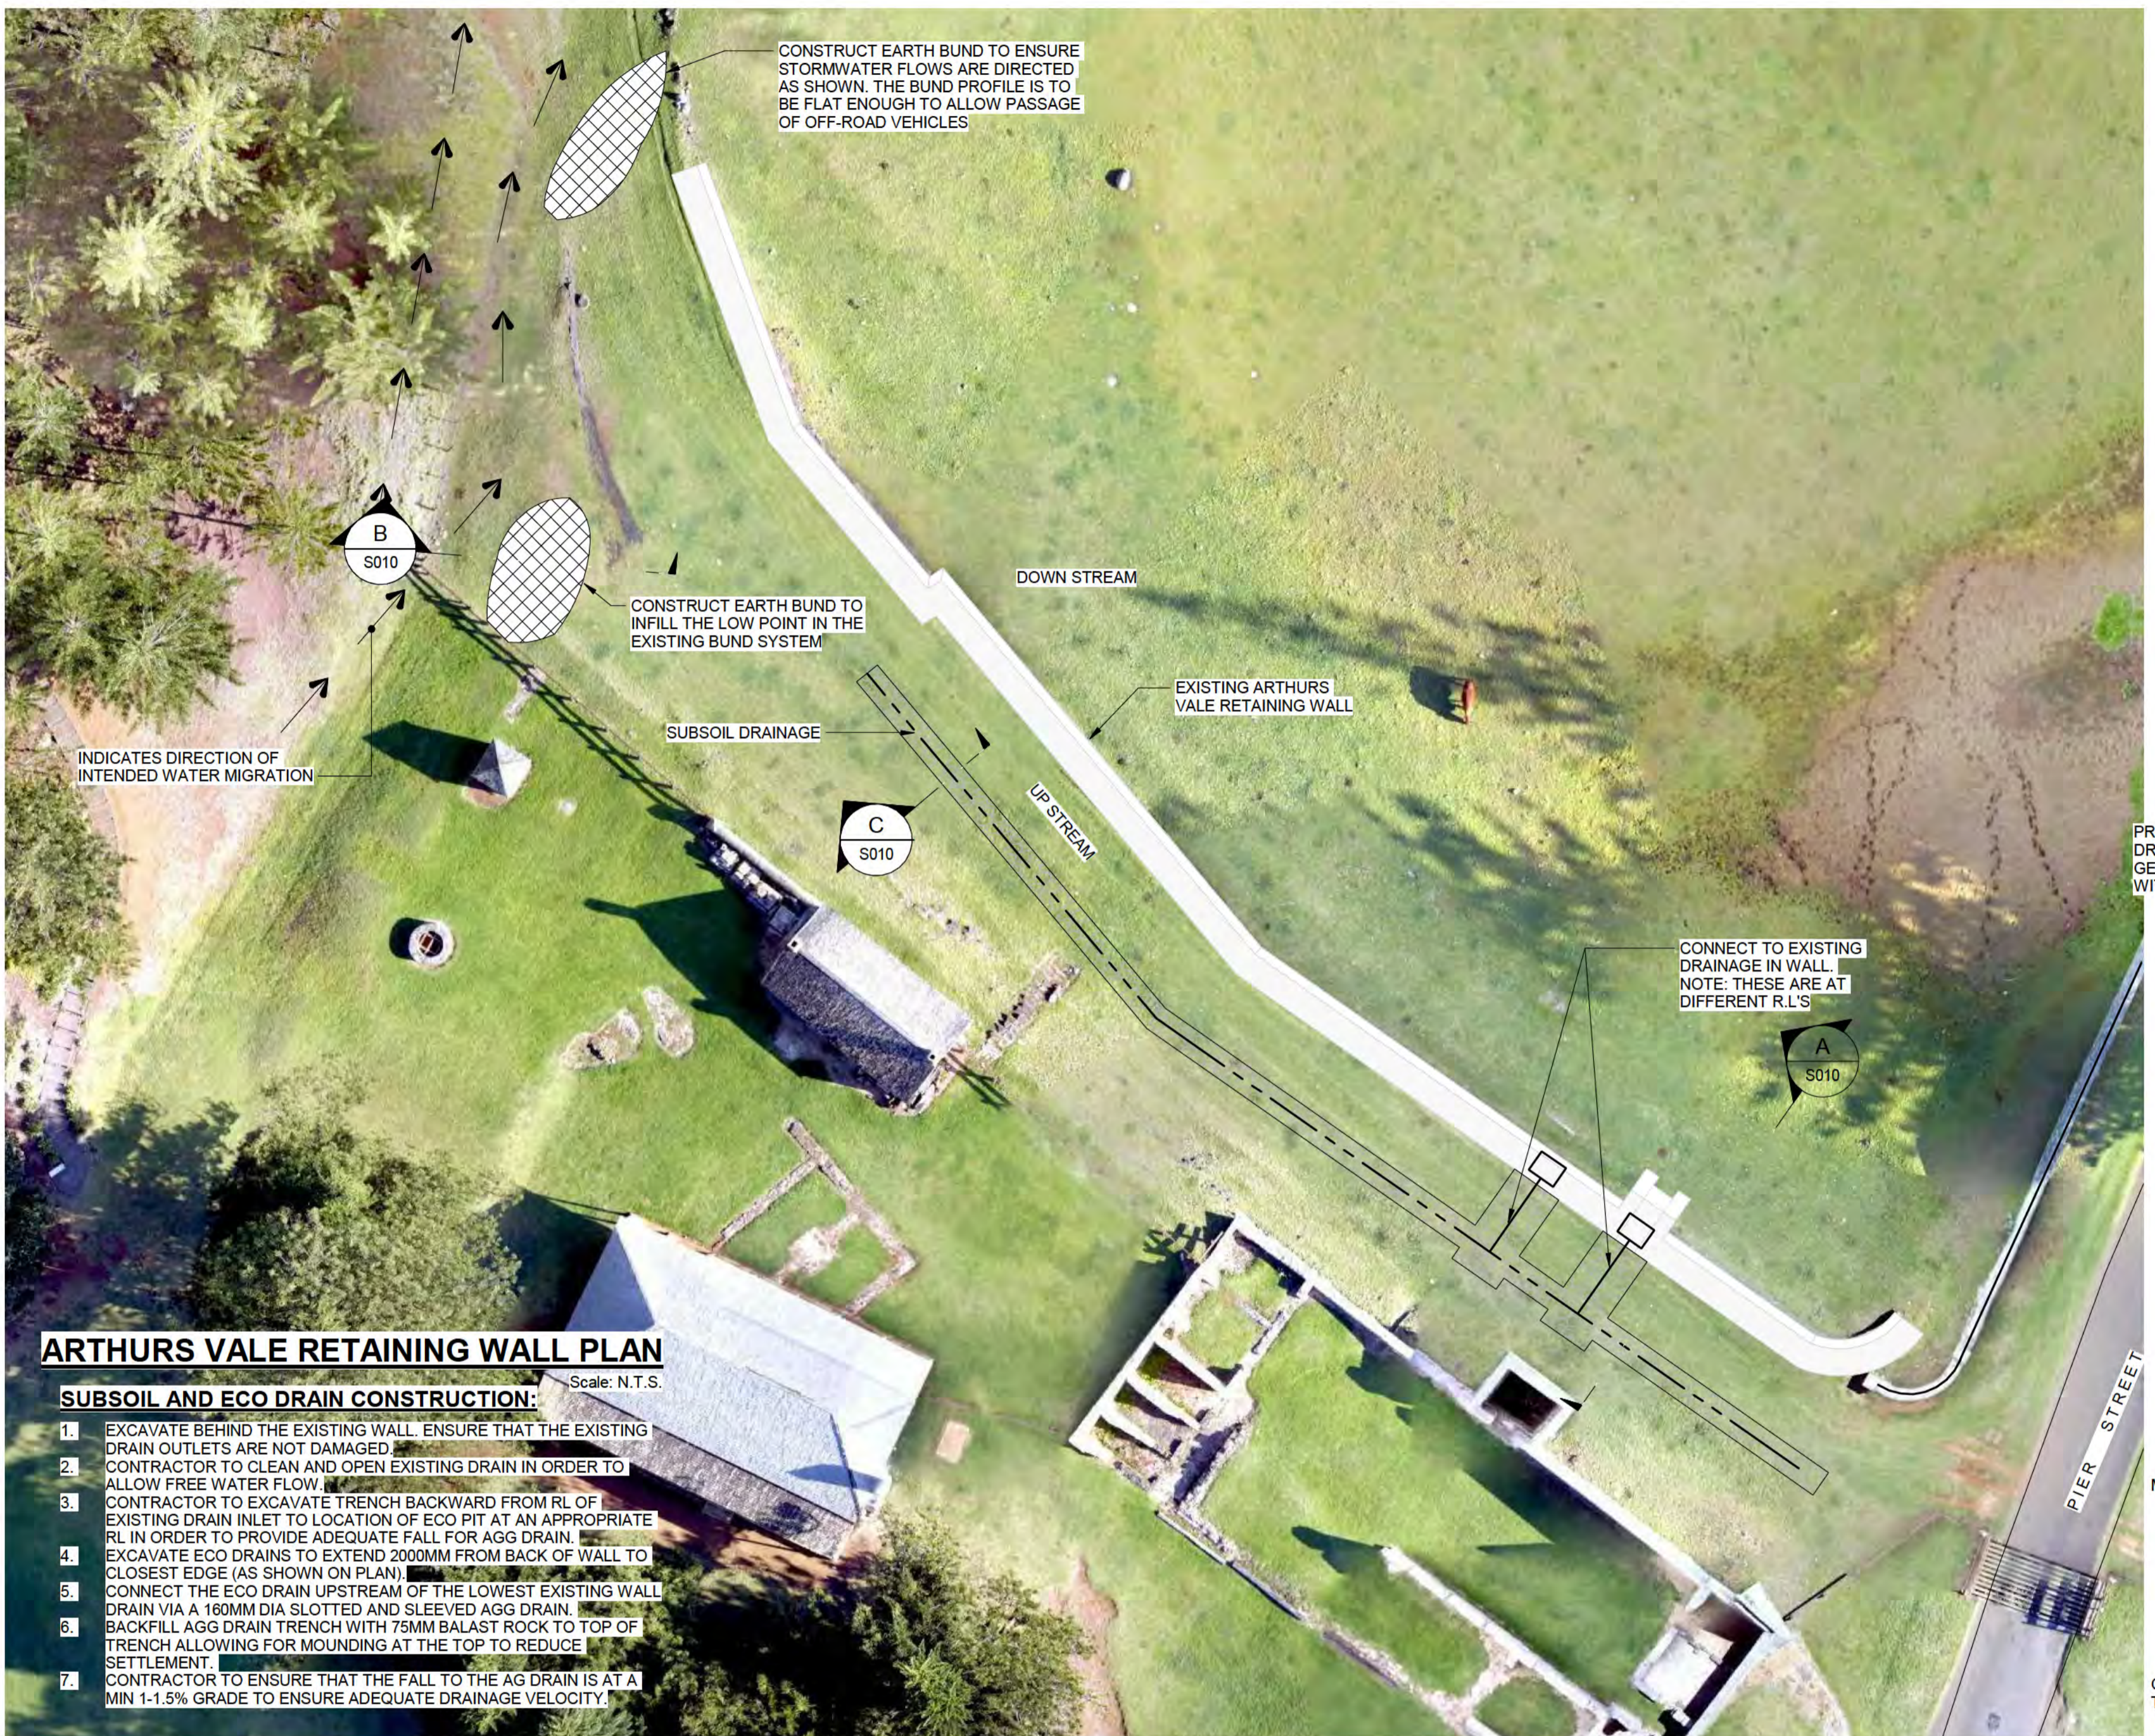
ARTHURS VALE RETAINING WALL PLAN

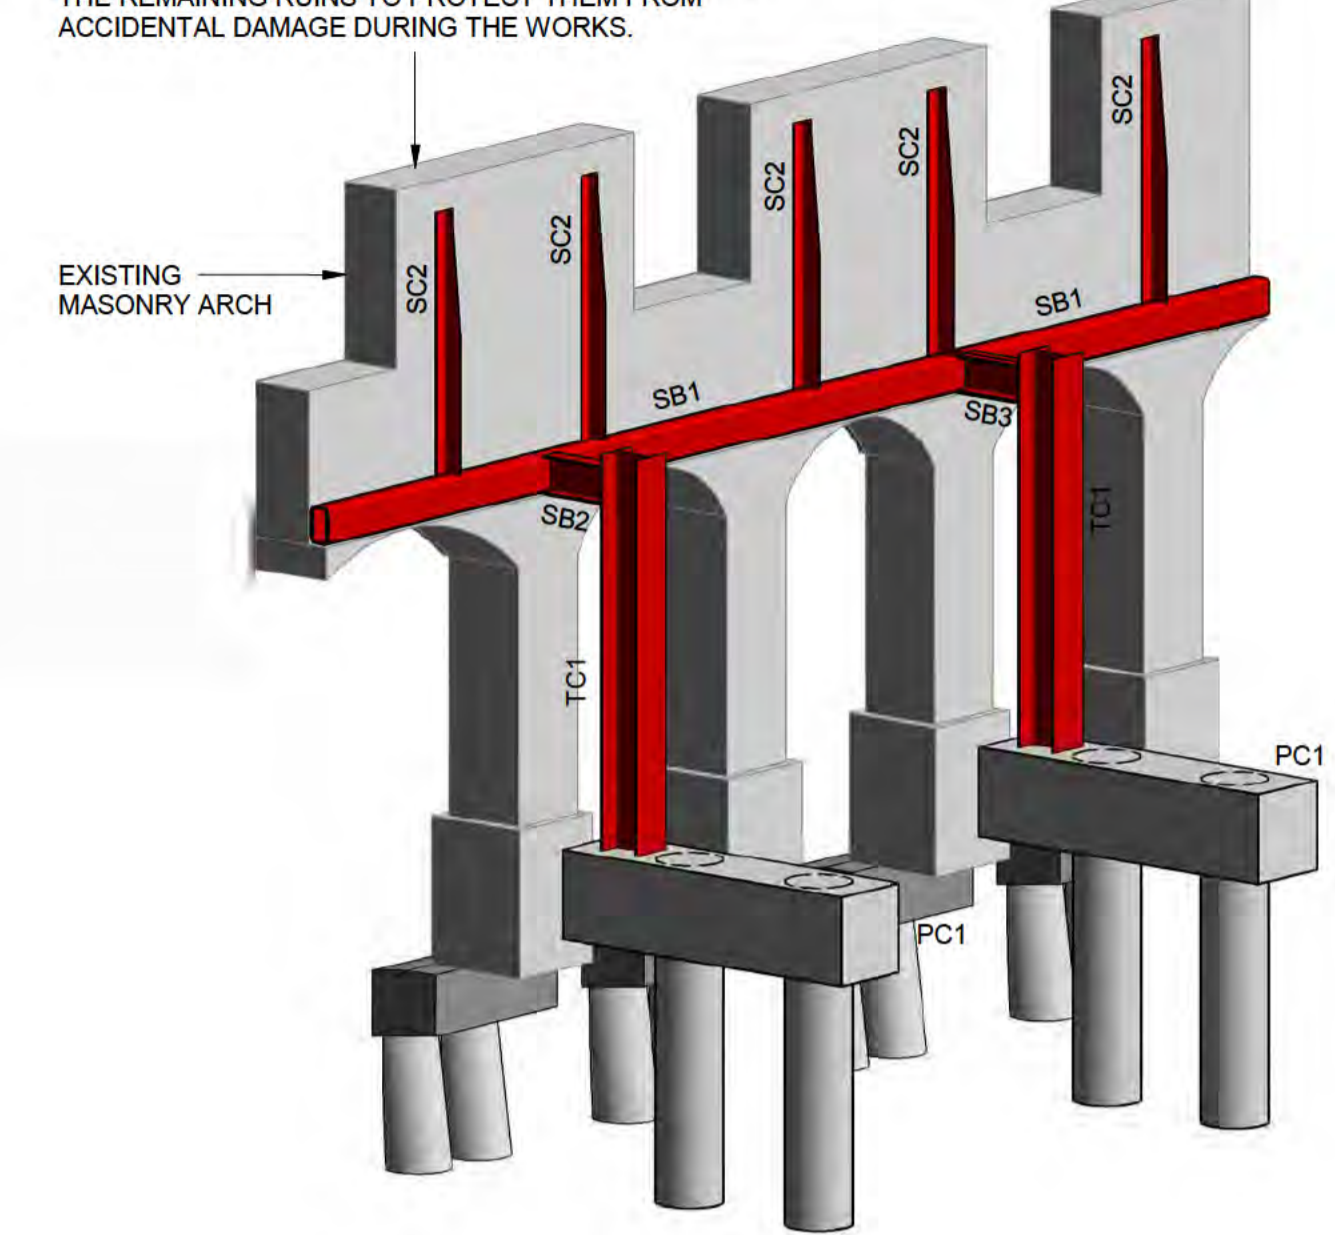
3D VIEW - TYPICAL SUPPORT STEELWORK FRAMING

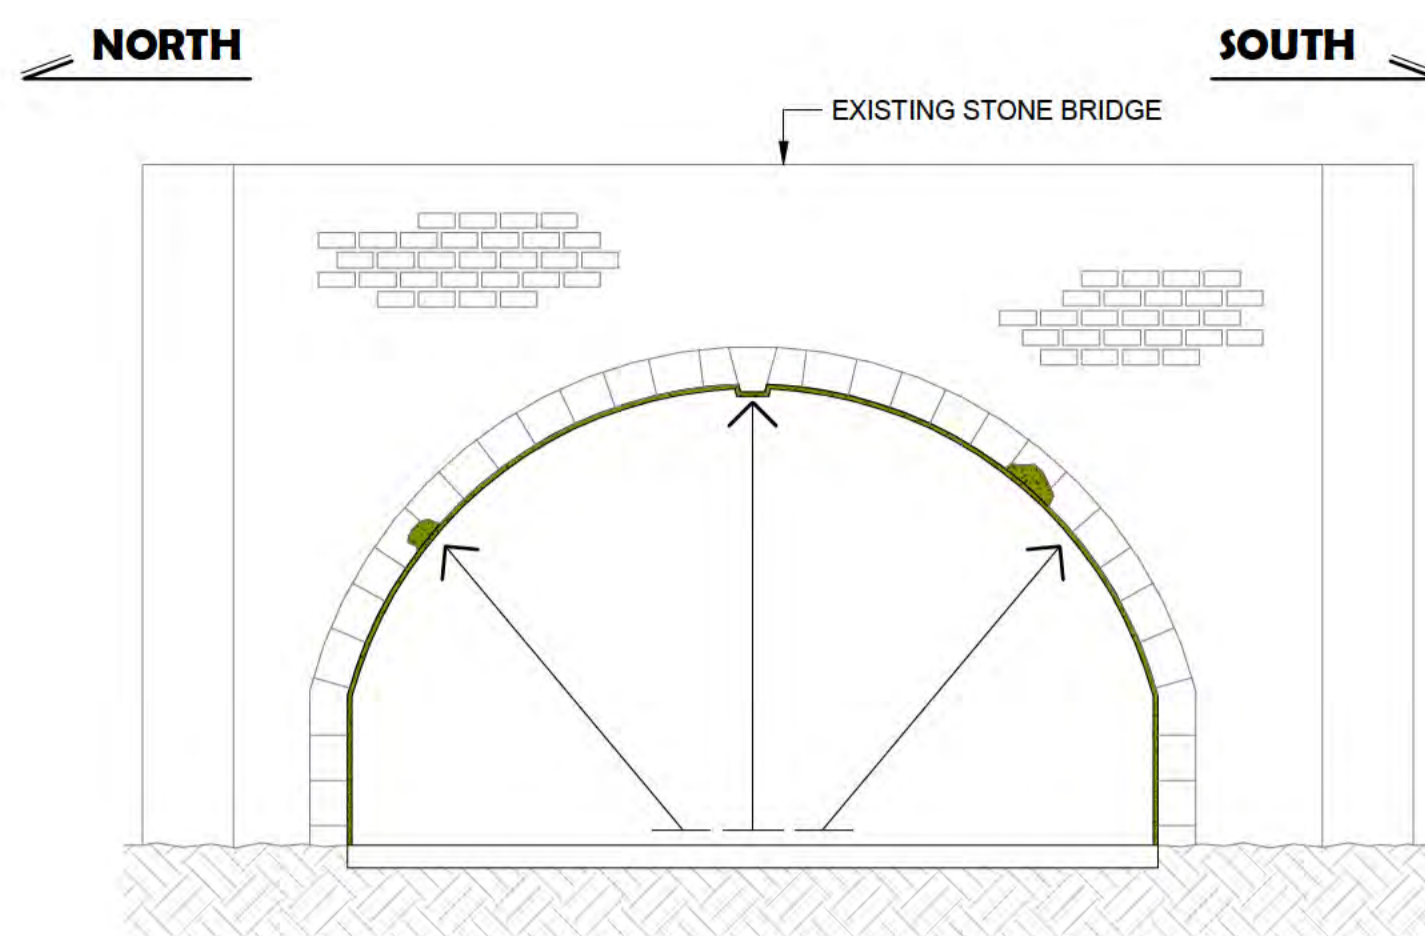
- EXCAVATE TO A FIRM SOUND BASE UNDER THE ARCH. THIS IS EXPECTED TO BE ALLUVIAL SOILS AND NOT ROCK. DISPOSE OF SOIL TO AUTHORITY APPROVALS.
- THE BASE IS TO MATCH THE R.L. OF THE BRIDGE FOUNDATIONS. R.L. UNKNOWN.
- OVER EXCAVATE AND INSTALL A NOMINAL 100 THICK CONCRETE BLINDING LAYER AS A WORKING PLATFORM.
- THE WORKS MAY NEED TO PROGRESS IN STAGES FROM THE UPSTREAM TO DOWNSTREAM TO SUIT CONTRACTORS SWMS AND/OR CONSTRUCTION METHODOLOGY.
- ALLOW TO PROP AS REQUIRED BY SWMS.

CONSTRUCTION SEQUENCE - STAGE 2

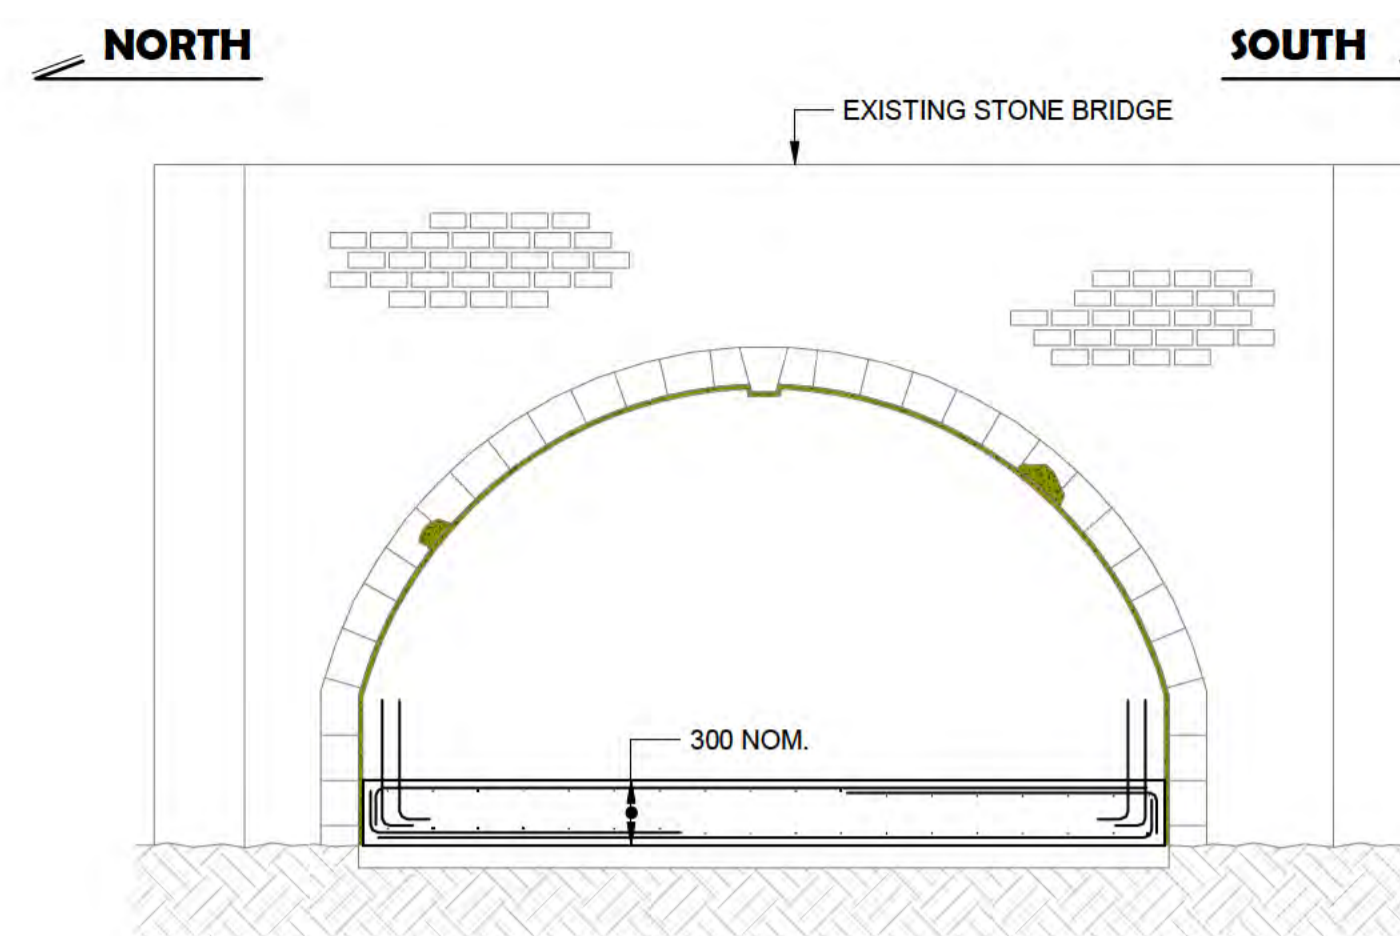
- CLEAN MUD FROM STONE WITH POTABLE WATER.
- FILL ERODED STONE WITH HYDRAULIC LIME MORTAR.
- TO BE CONFIRMED:
 - STONE SEALING SURFACE TREATMENT
 - MORTAR COMPOSITION
 - MORTAR APPLICATION LIMITATIONS/METHODOLOGY
- APPLY A 50 THICK HYDRAULIC LIME MORTAR RENDER TO THE ARCH SOFFIT.

CONSTRUCTION SEQUENCE - STAGE 3

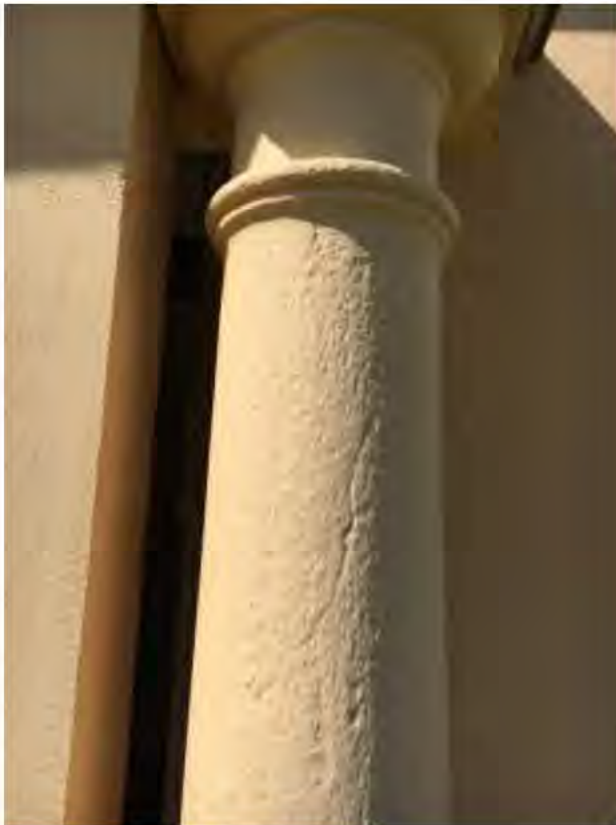
Figure 5 Column defect (top)

The rod has been sized at nominally 33mm diameter stainless steel and this will require a nominal 50mm diameter core hole through the column to provide for an 8mm grout annulus. The final rod size, grade and grouting methodology is to be resolved via detailed discussions with the contractor as it will be influenced by the available tools and methodologies.

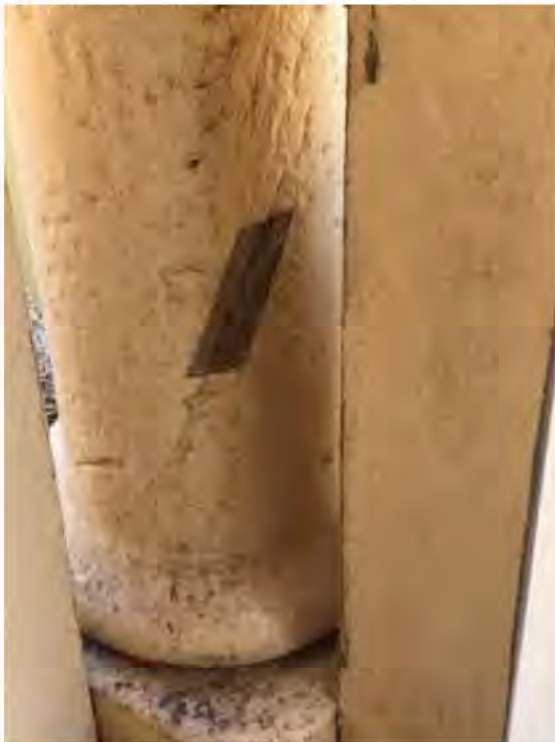
Figure 6 Column defect (bottom)

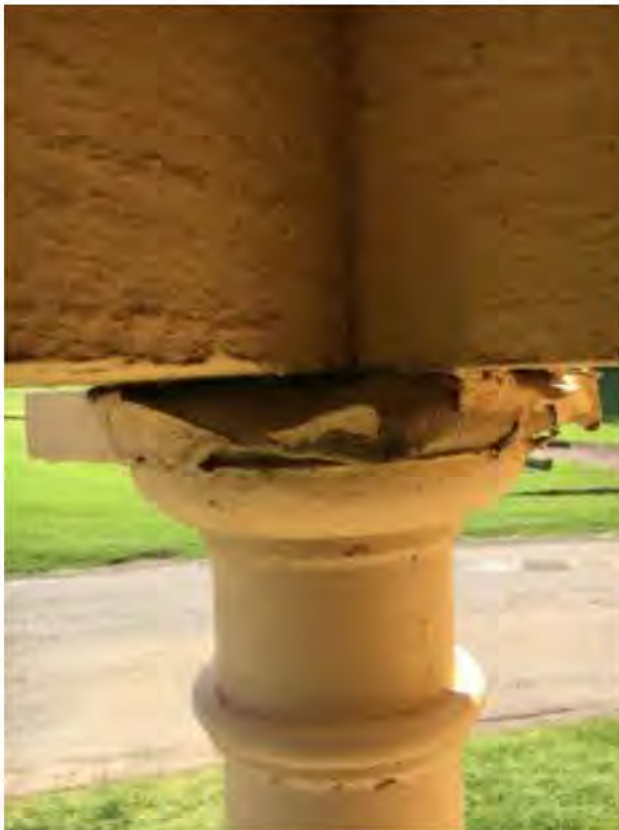
Figure 7 Eroded capping stone

The replacement stone is to be approved by the KAVHA Commonwealth Heritage Manager before installation and the completed works are to be to their satisfaction.

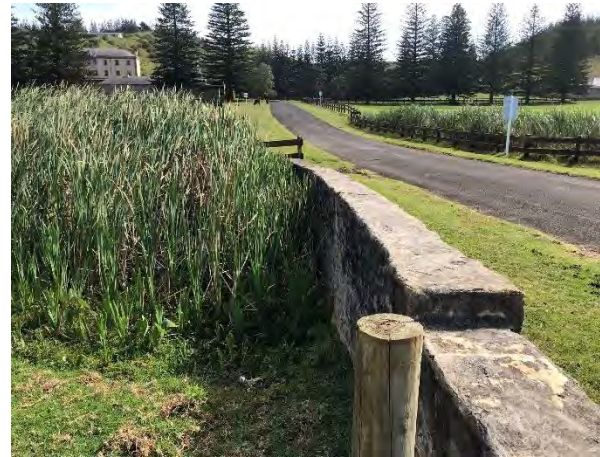
Plate 3 View north along the western side of the Bounty Street Bridge. Note coping stones are missing.

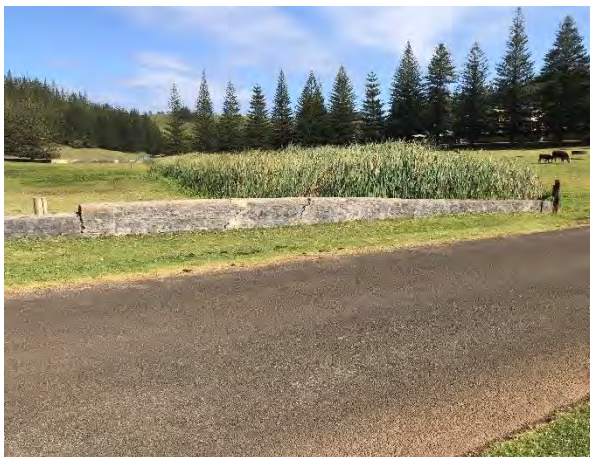
Plate 4 View west showing western wall of the Bounty Street Bridge. Note crack in parapet wall. AECOM 2020.

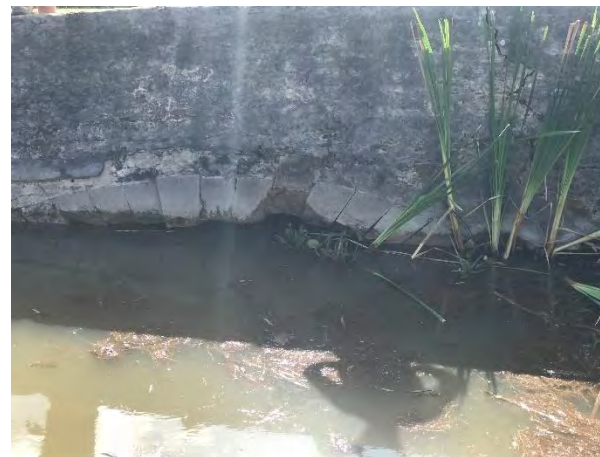
Plate 5 Detail of western arch of the Bounty Street Bridge prior to dewatering. AECOM 2020.

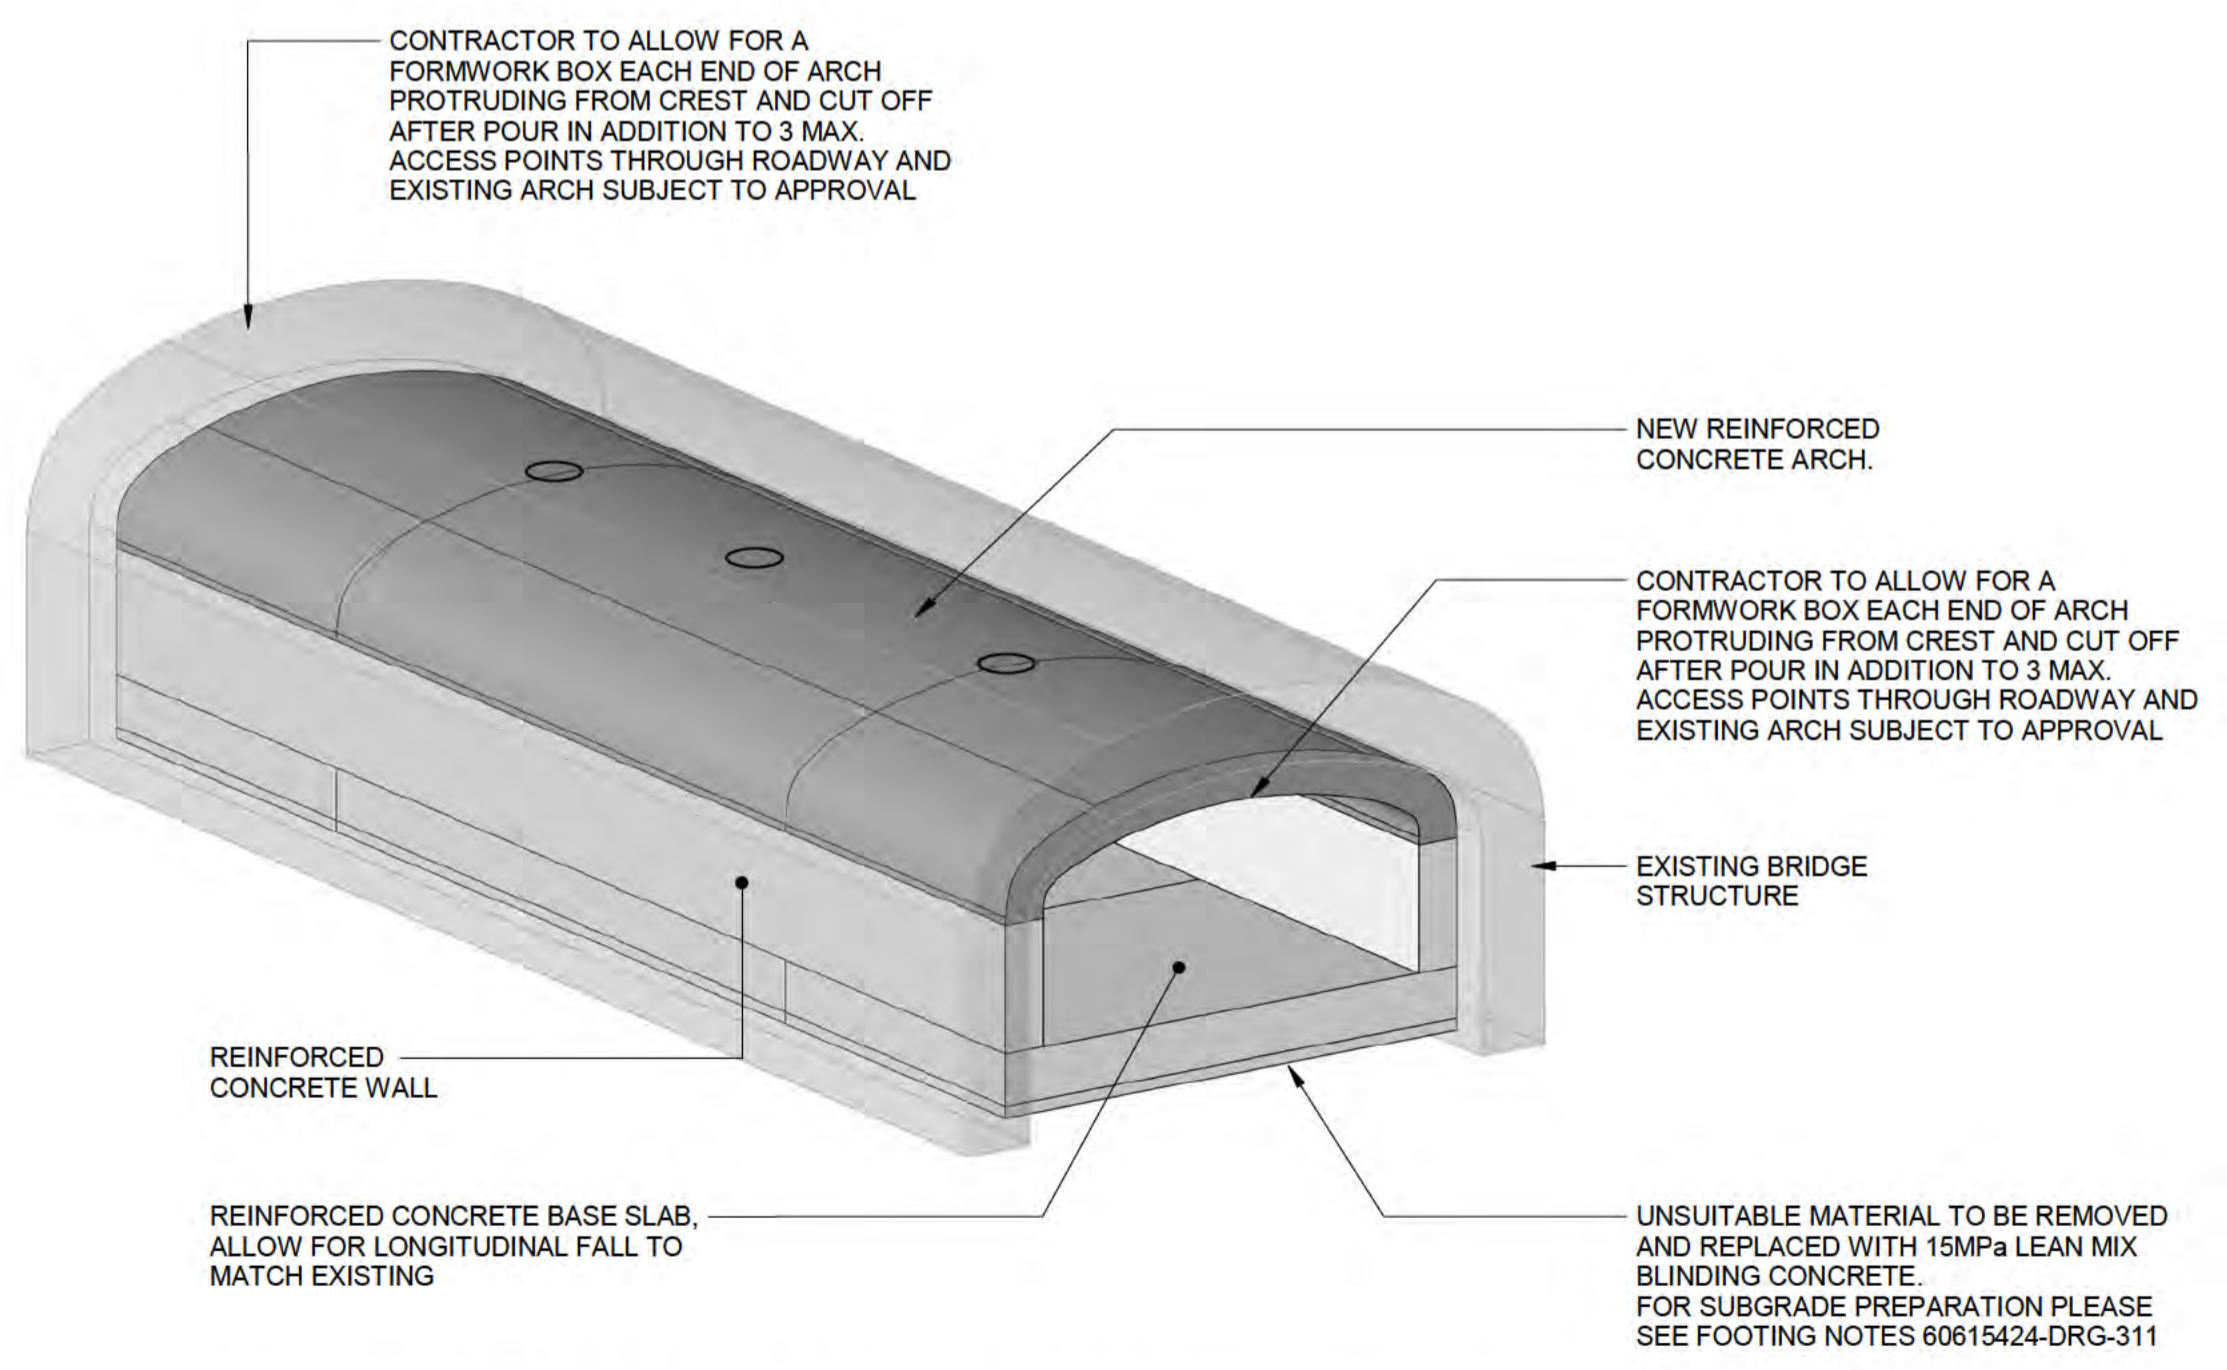
BOUNTY STREET BRIDGE SUPPORT STRUCTURE

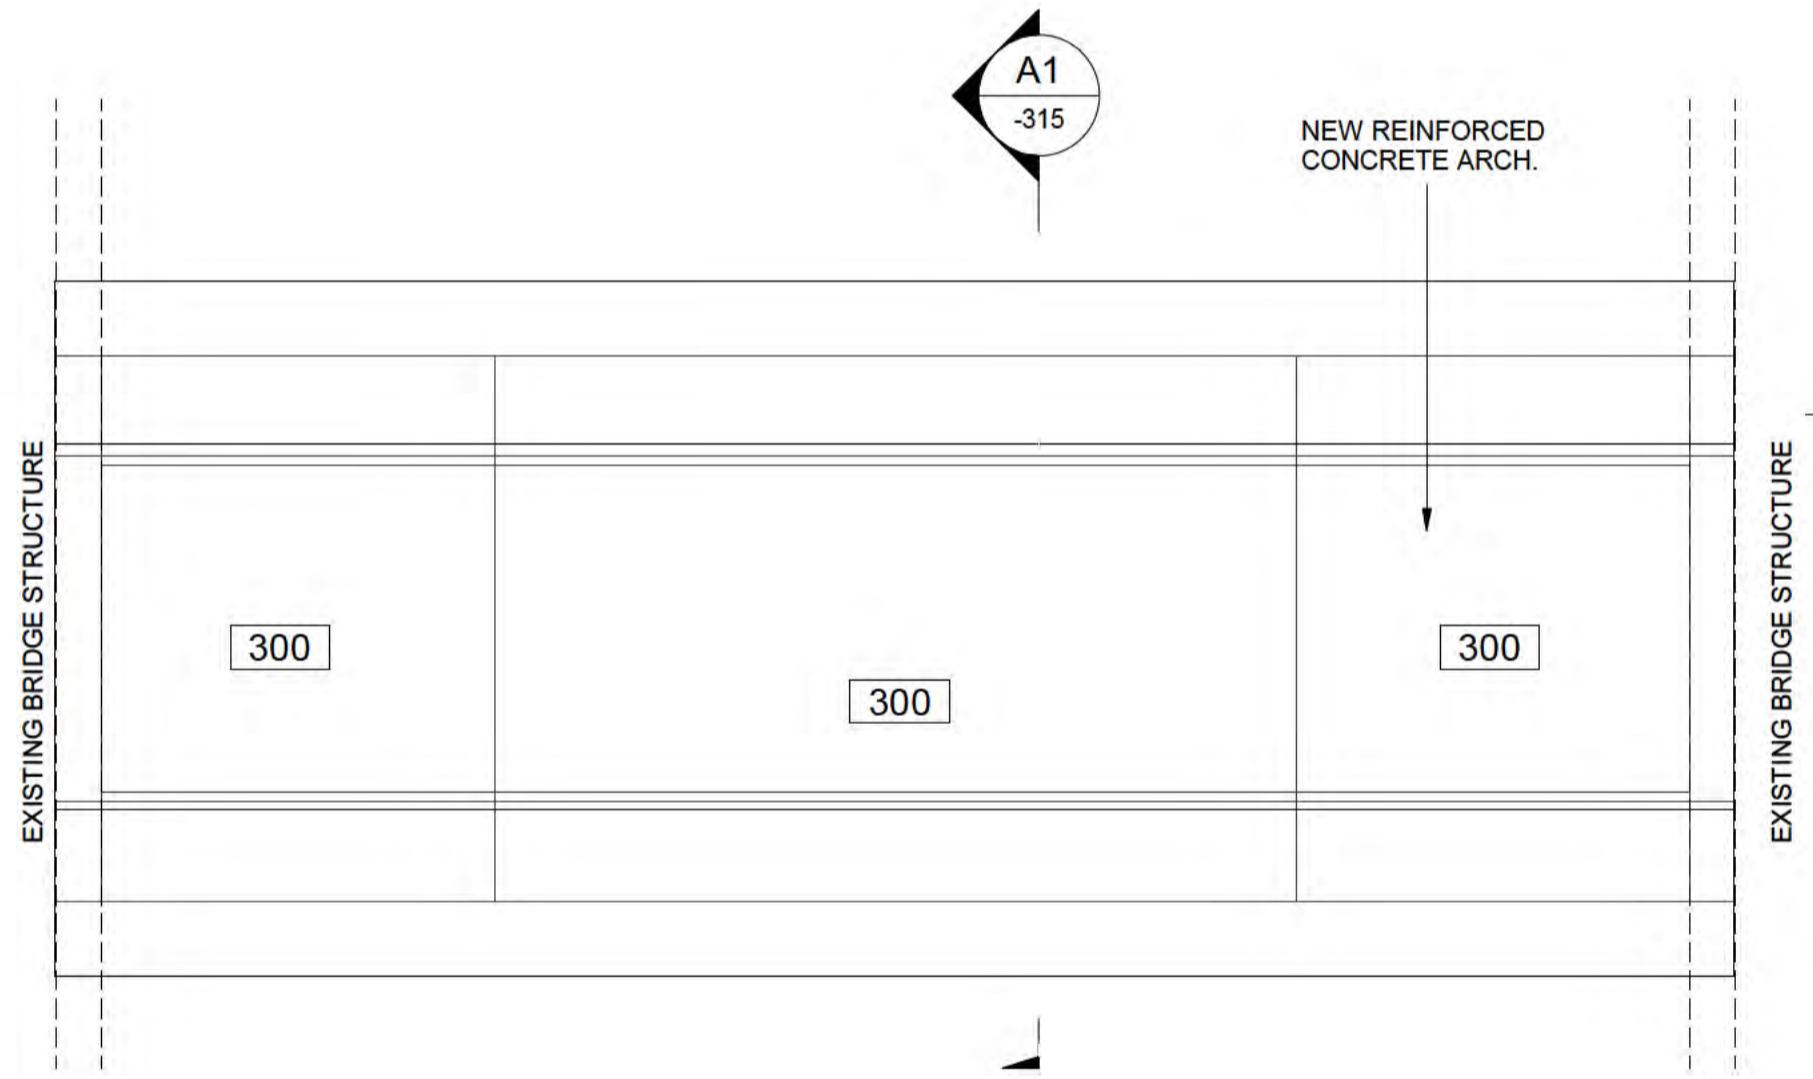
GENERAL ARRANGEMENT PLAN - BOUNTY STREET BRIDGE ARCH
 Scale: 1 : 50

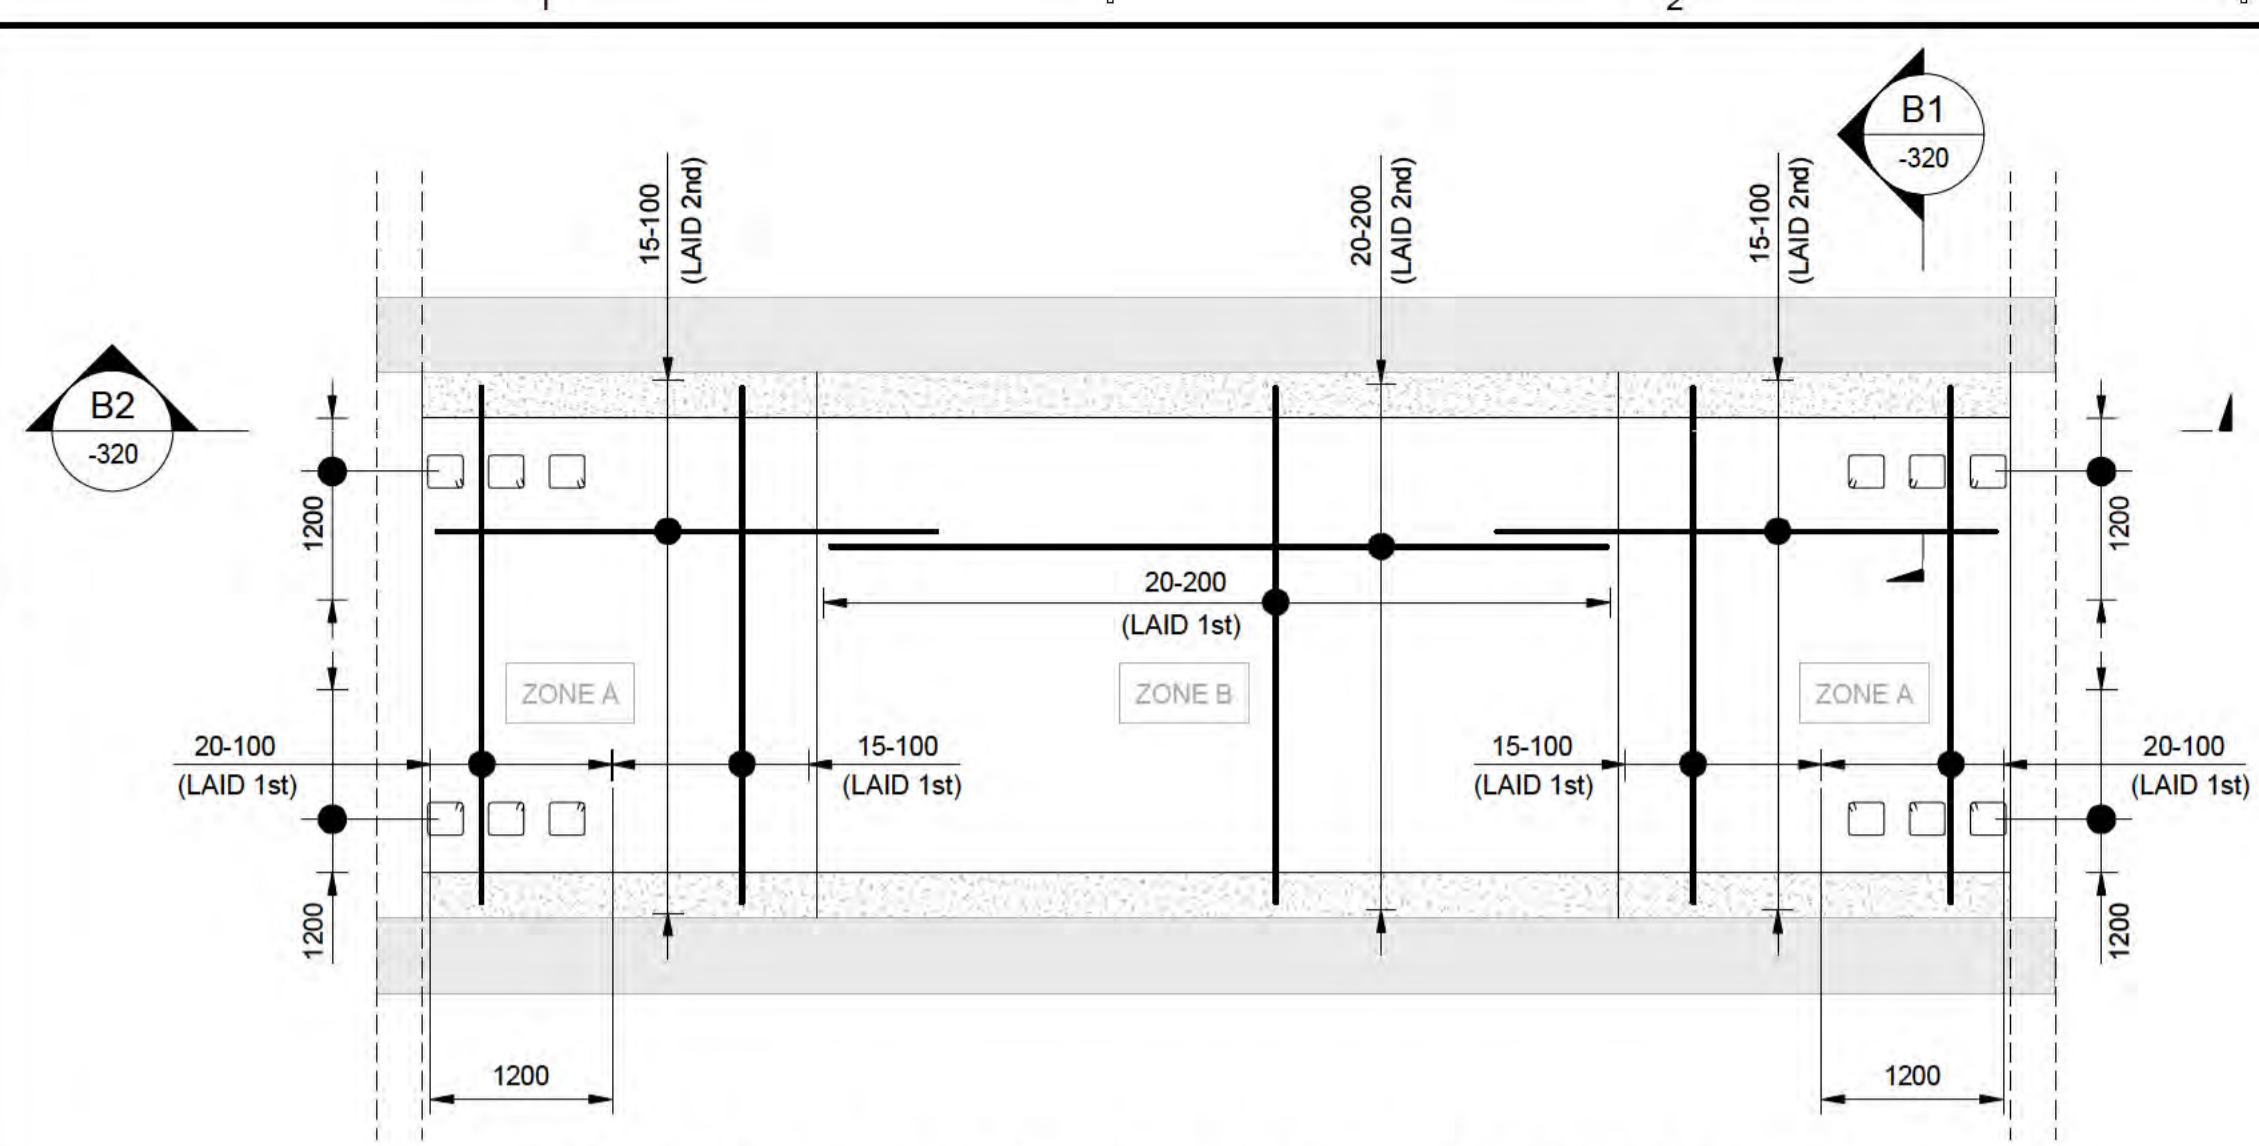
BASE SLAB - BOTTOM REINFORCEMENT LAYOUT
 Scale: 1 : 50

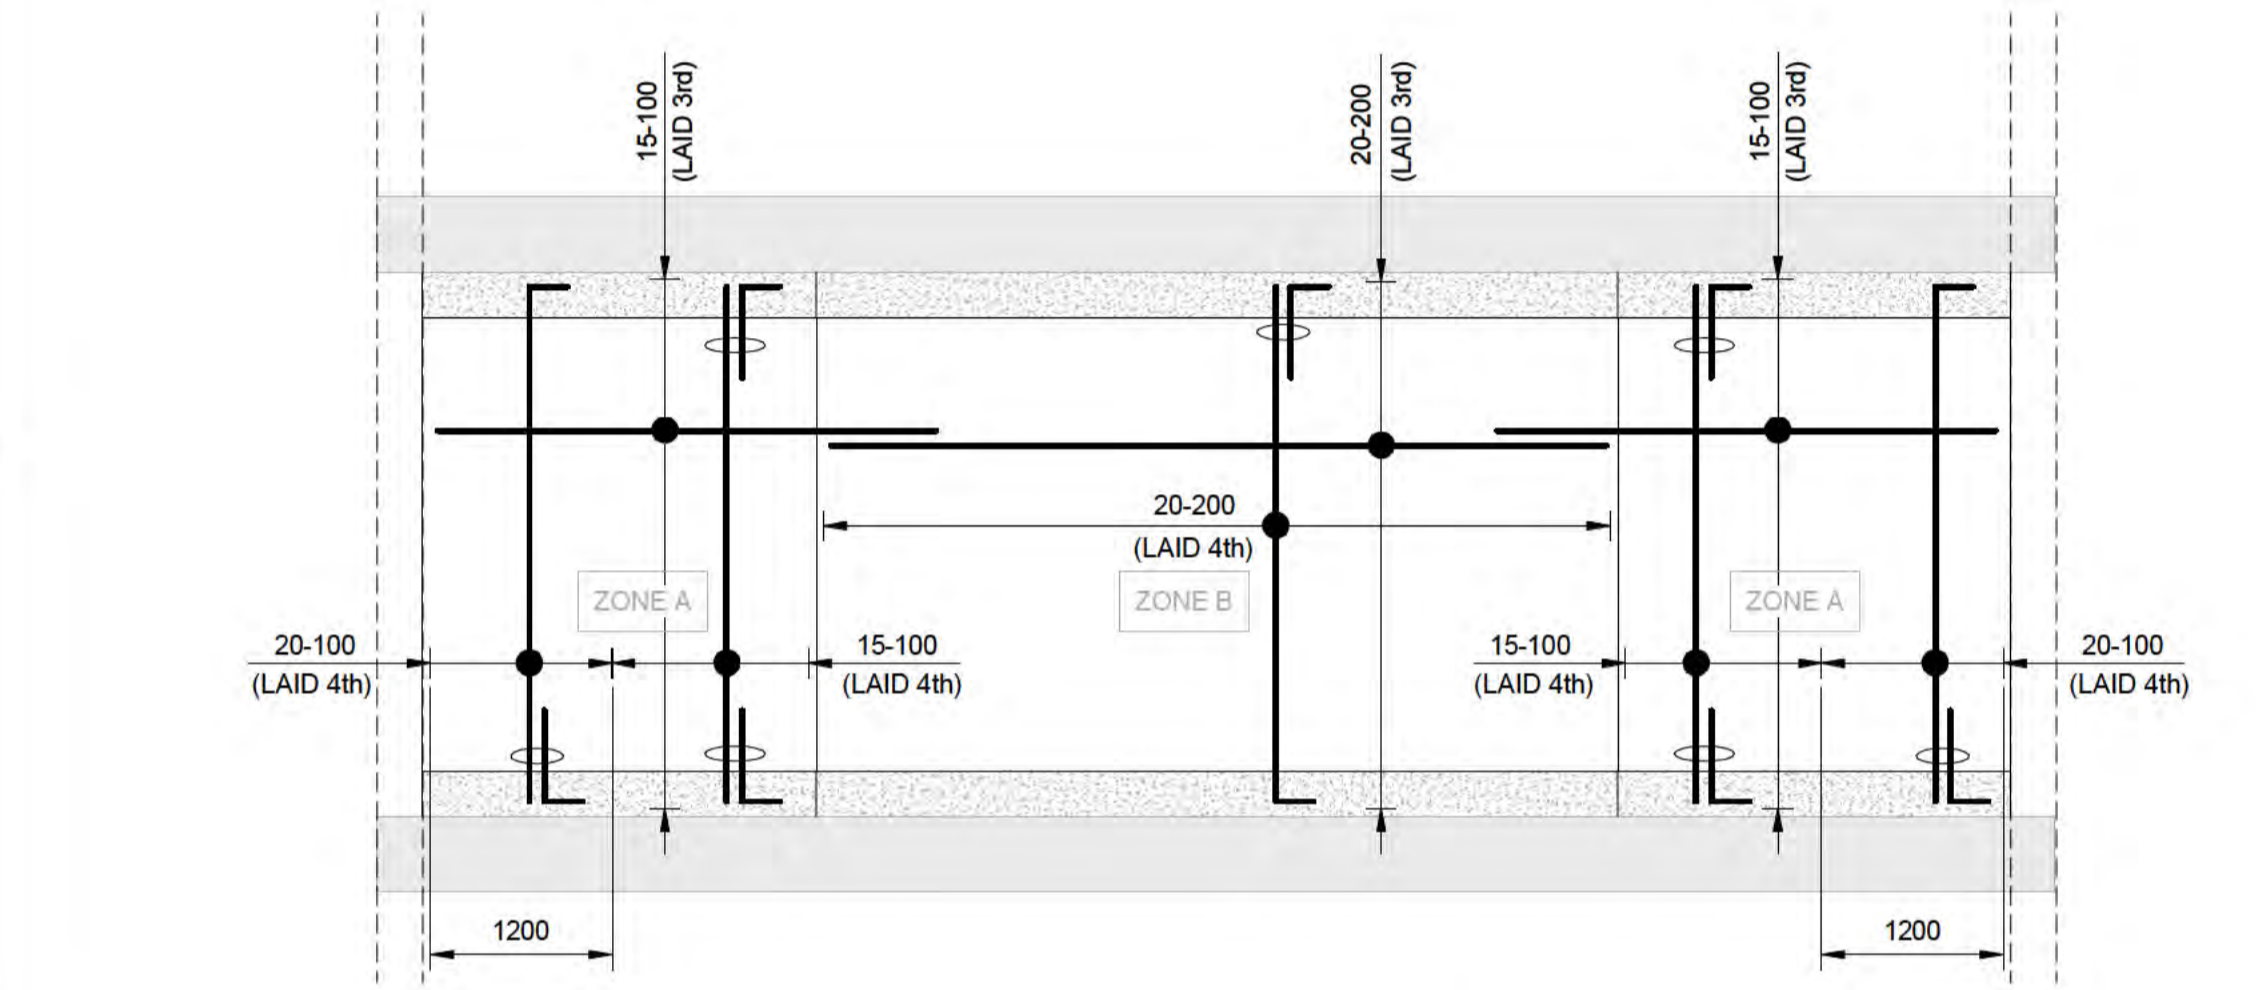
BASE SLAB - TOP REINFORCEMENT LAYOUT
 Scale: 1 : 50

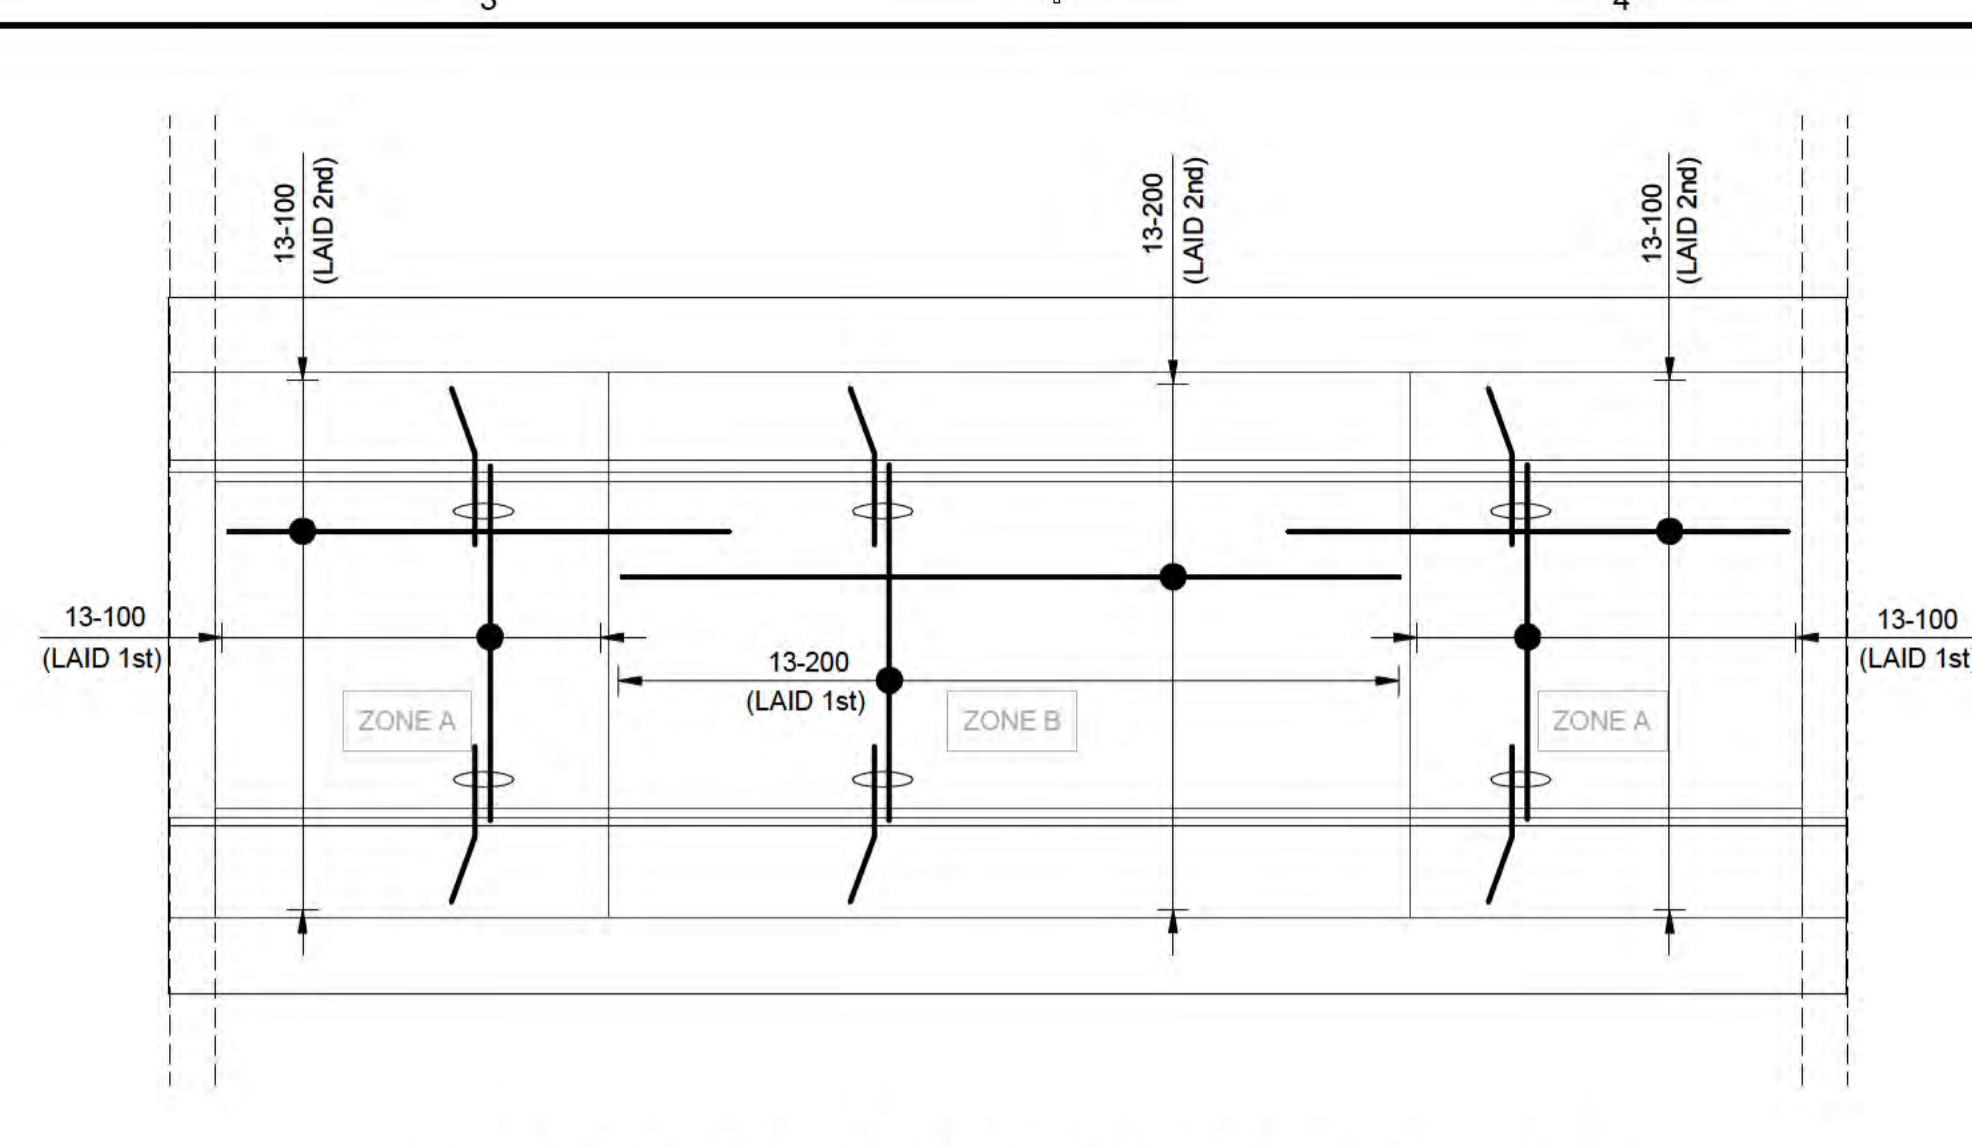
ARCH - BOTTOM REINFORCEMENT LAYOUT
 Scale: 1 : 50
