Arthurs Vale Creek Fencing and Rehabilitation Project 2020

Summary of project methodology and delivery

Design Report

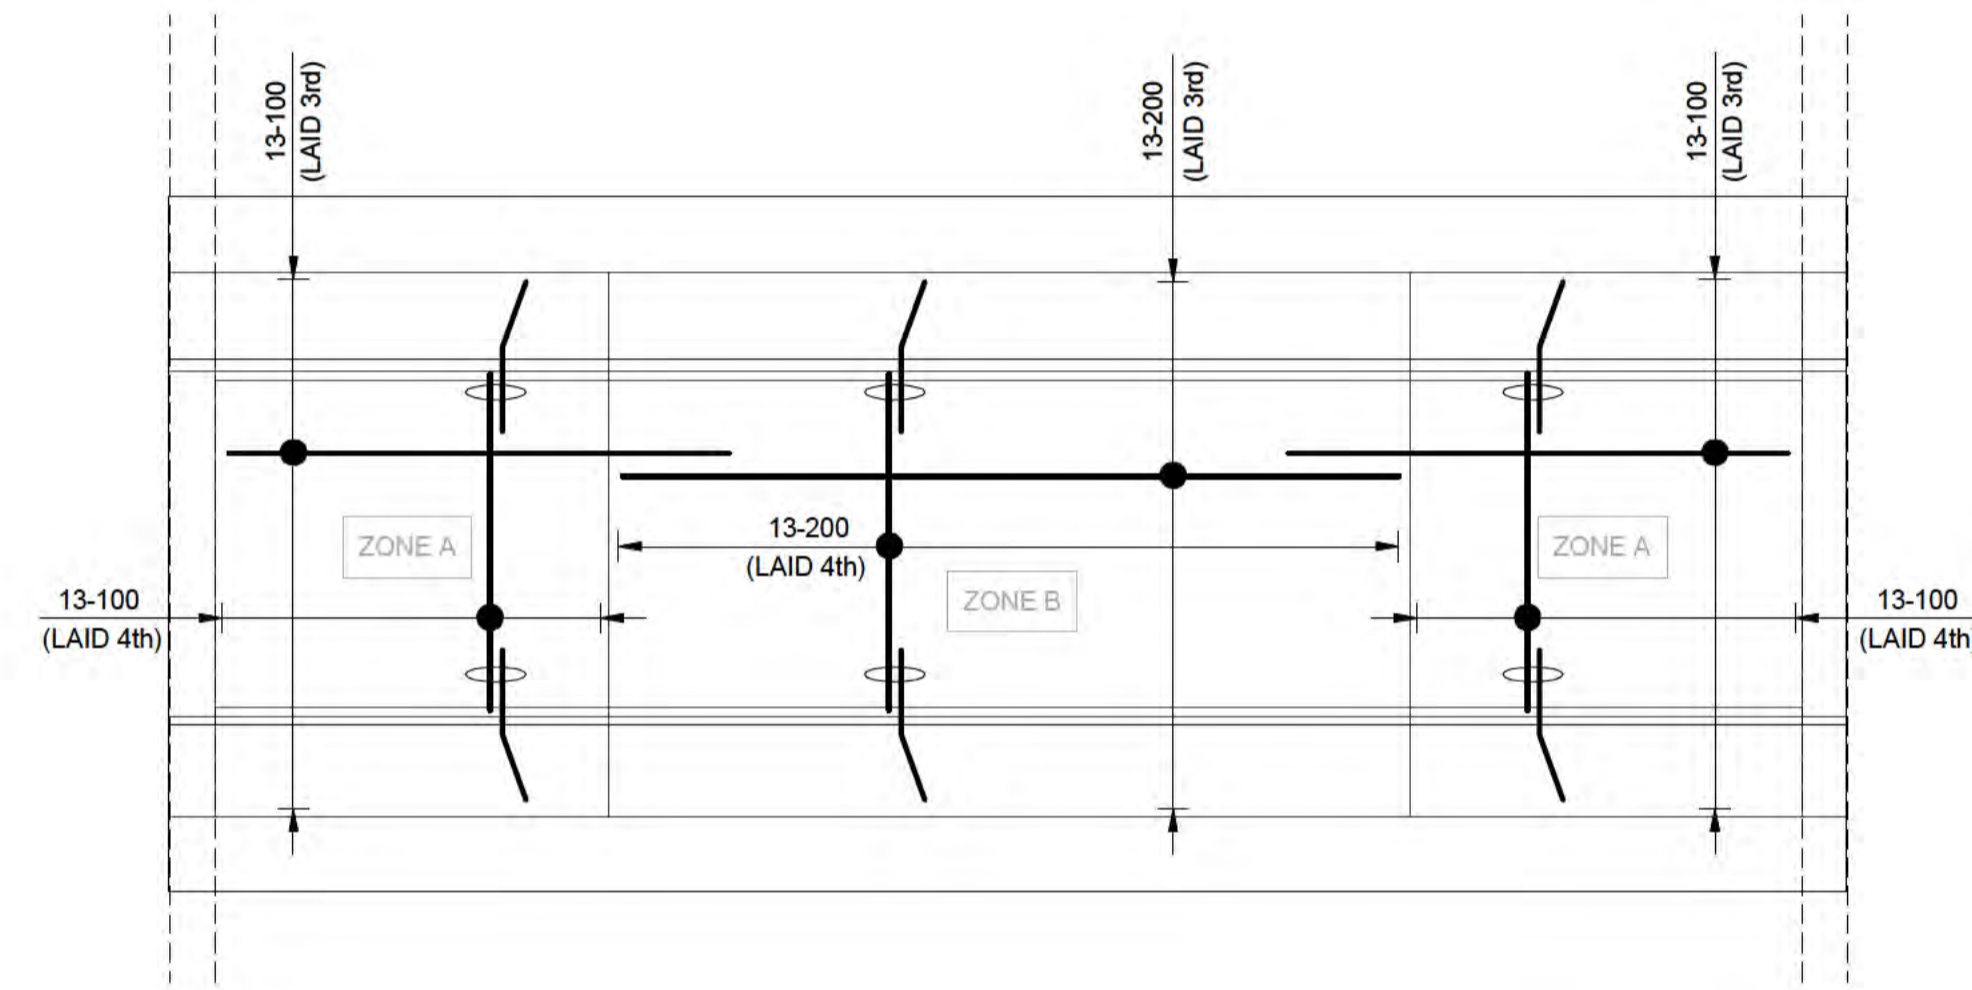
ARCH - TOP REINFORCEMENT LAYOUT
 Scale: 1 : 50

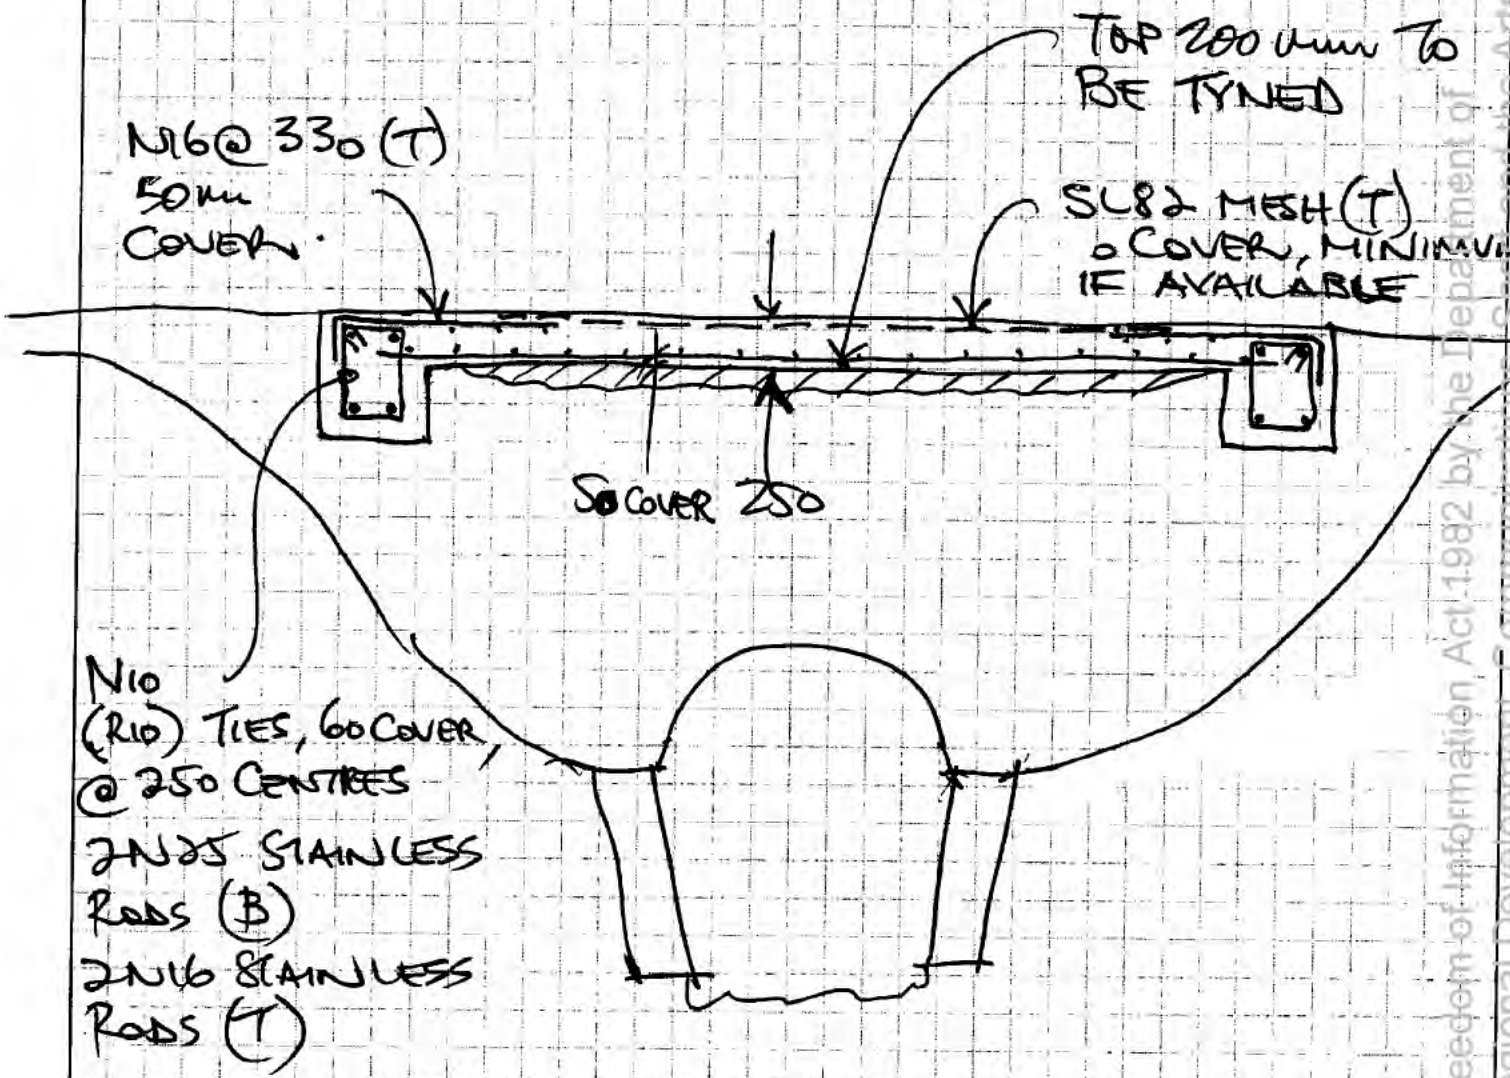
N10
(R10) TIES, 60 COVER,
@ 250 CENTRES
2N25 STAINLESS
RODS (B)
2N16 STAINLESS
RODS (T)
