Water Quality Improvements in Emily Bay

Options Analysis Report

Stormwater Mitigation Works on Norfolk Island
 Water Quality Improvements in Emily Bay
 Commercial-in-Confidence

25-Mar-2021

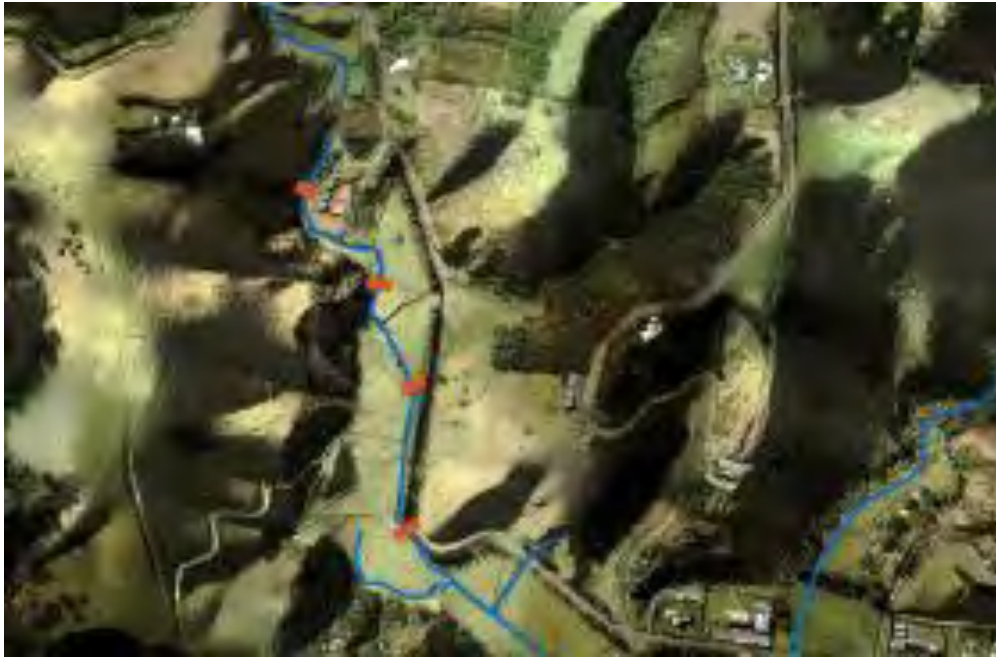
Figure 5: Leaky weir locations (Bligh Tanner, Figure 7, 2020)

It should be noted that alternate locations may also be suitable, subject to land tenure, access and constructability considerations. Alternative locations would need further investigation in relation to the topography of the existing flow path and potential impacts on increased afflux on private property.

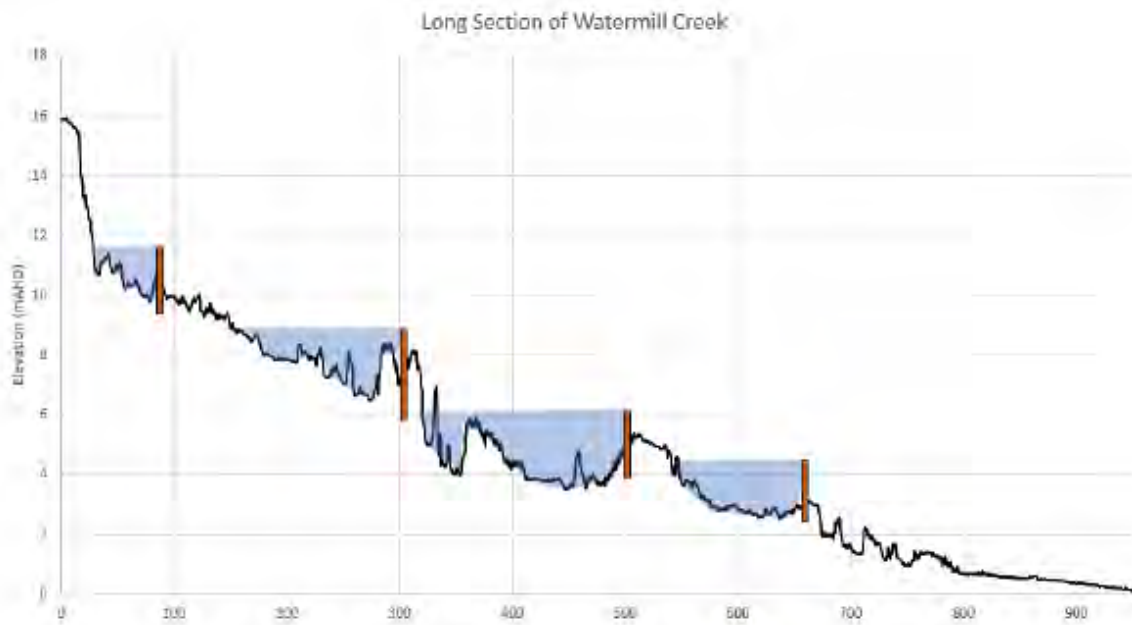
Figure 6: Long sections at weir locations (Bligh Tanner, Figure 8, 2020)

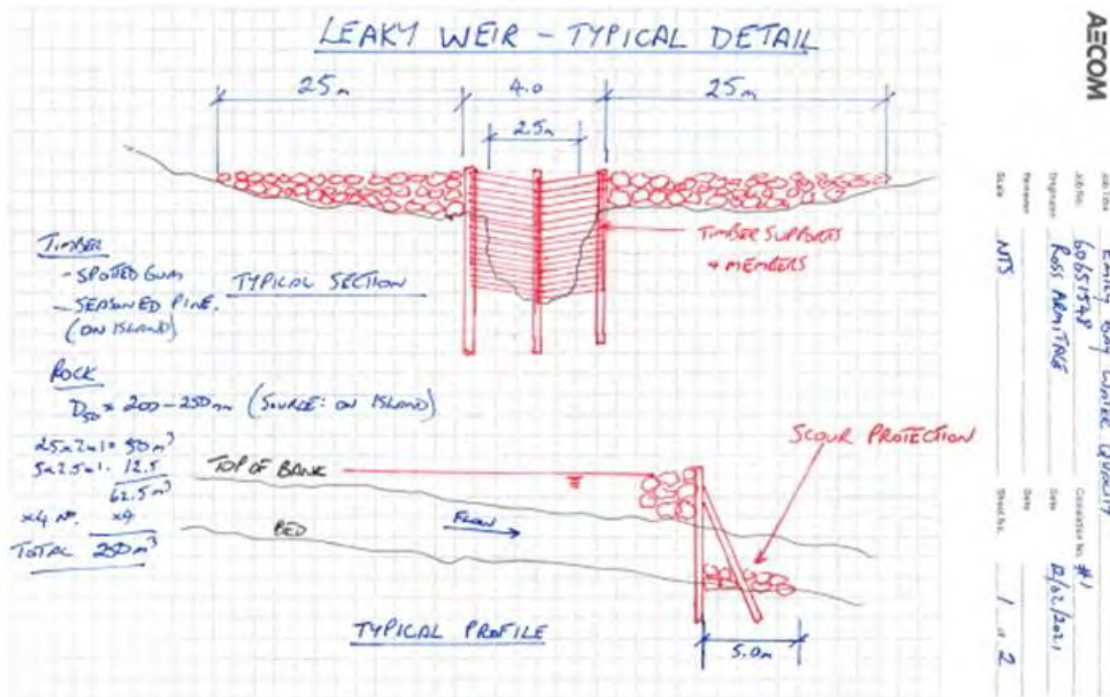
Figure 7: Concept leaky weir for costing purposes

Advice from the Norfolk Island team on island has indicated that sufficient rock is available and local timber (spotted gum) is available for use. Further advice suggested that fill, topsoil and turf is also available. It has been assumed that geofabric layers required to line the rock aprons, will be available.

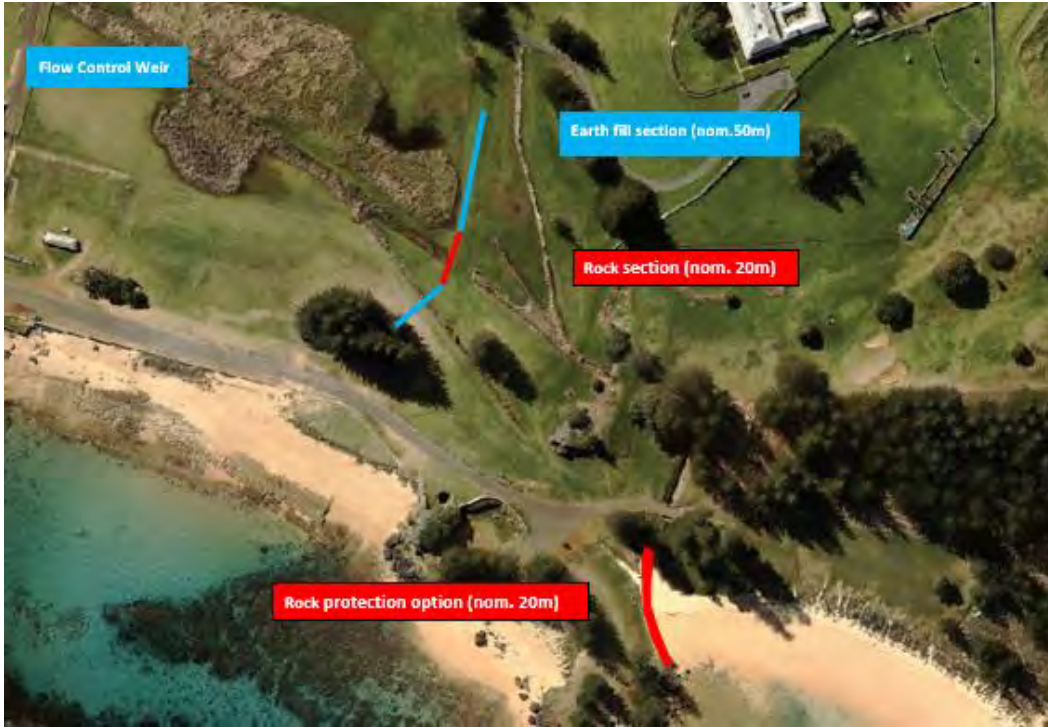
Figure 8: Flow control weir location

It should be noted that a weir height of 1.0 m has been used. However, the impact of any ponding has not been modelled, but will need to be considered during the detailed design, if this option is selected for the next stage of the project. It is noted that alternate locations have been suggested by the on-island team including upstream of Pier St Bridge or at the entrance to rock tunnel at Chimney. These locations, or alternatives, may be suitable for the final siting of the weir - subject to the effects of upstream detention as well as land tenure, access and constructability considerations.

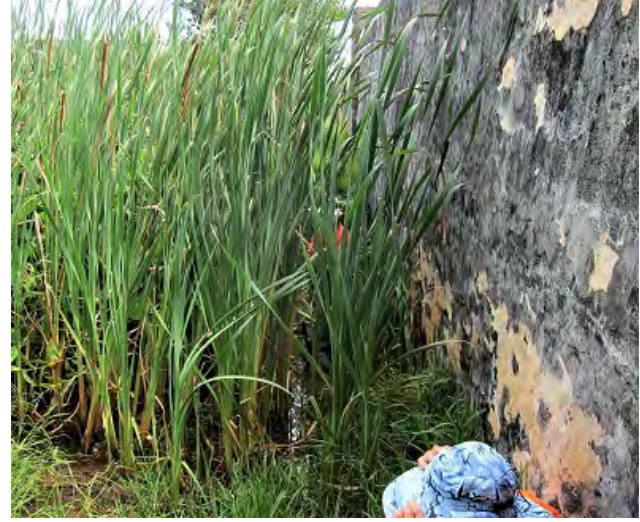
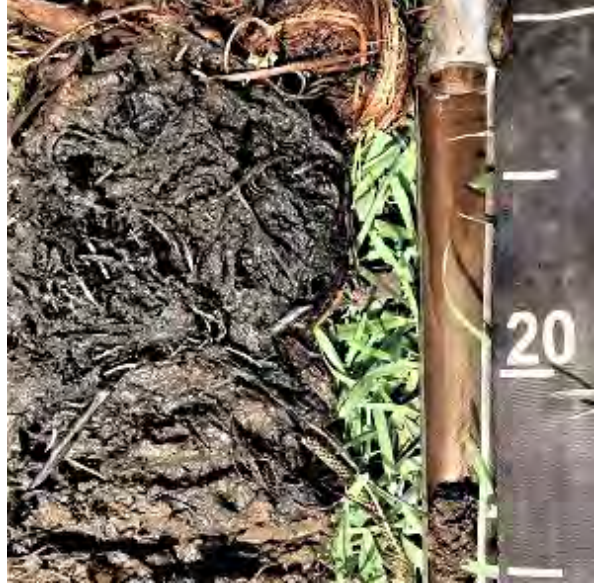
<p>Figure 1 (a) Pier street bridge wall (right hand side) and adjacent abundant 6 metre high reeds in December 2021 (the rewetting of this wetland was caused by 18 months of “just below” average rainfall).</p>	<p>Figure 1 (b) Photograph of the saturated surface soil horizons (0 to 30 cm depth) of the Monosulfidic-Hypersulfidic organic Acid Sulfate Soil taken within the 6 metre high reeds at street bridge (see adjacent photograph) in December 2021 (the rewetting of the wetland was caused by 18 months of “just below” average rainfall)</p>

The sampling campaign conducted by CSIRO in December 2021 in the KAVHA wetlands with abundant 6 m high reeds following rewetting, which resulted from 18 months of “just below” average rainfall and the laboratory analyses of samples confirmed the occurrence of deep (> 1.5 m) organic rich acid sulfate soils with both monosulfidic and hypersulfidic materials (i.e. Monosulfidic-Hypersulfidic organic soils) [See Figures 1 (a) & (b)].

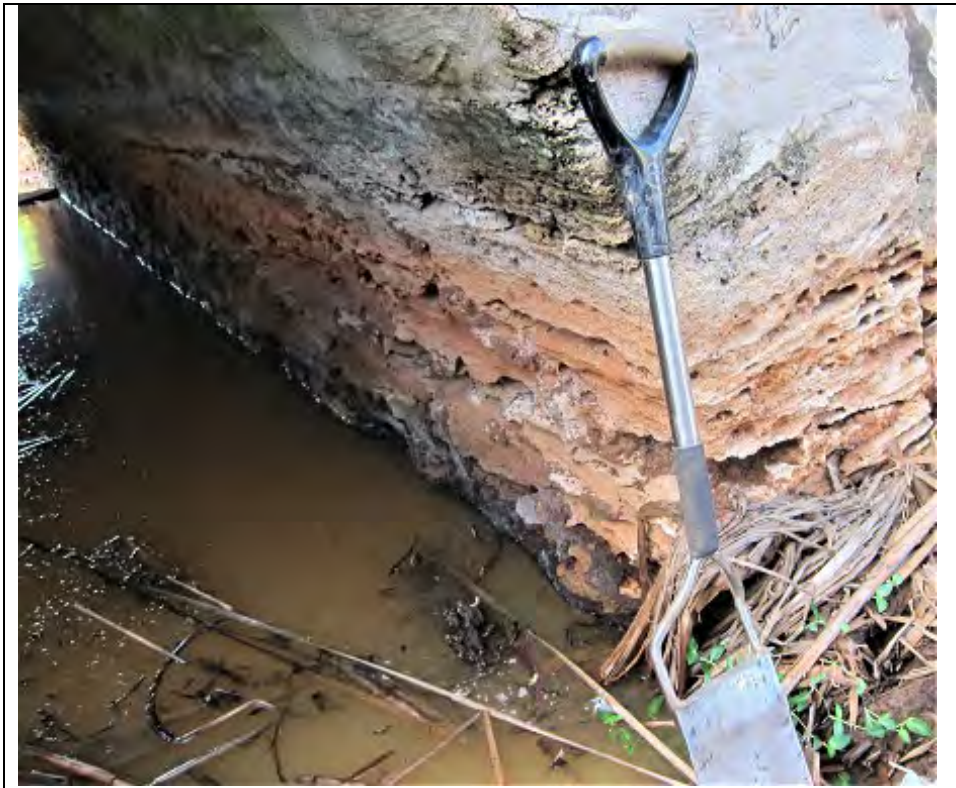
Figure 2. Pier street bridge showing exposed corrosion / dissolution of cement mortar and calcarenite used in the construction of the Pier street bridge – photograph taken in February 2020 during the drought/ dry period.

Monosulfidic materials in these soils can also cause strong odours. Significantly, these acid sulfate soils damage calcarenite building blocks by dissolution of calcium carbonate (calcite) as shown in Figure 2 for the Pier street bridge but also for several heritage structures, such as the Watermill dam within the Kingston and Arthurs Vale Historic Area (KAVHA).

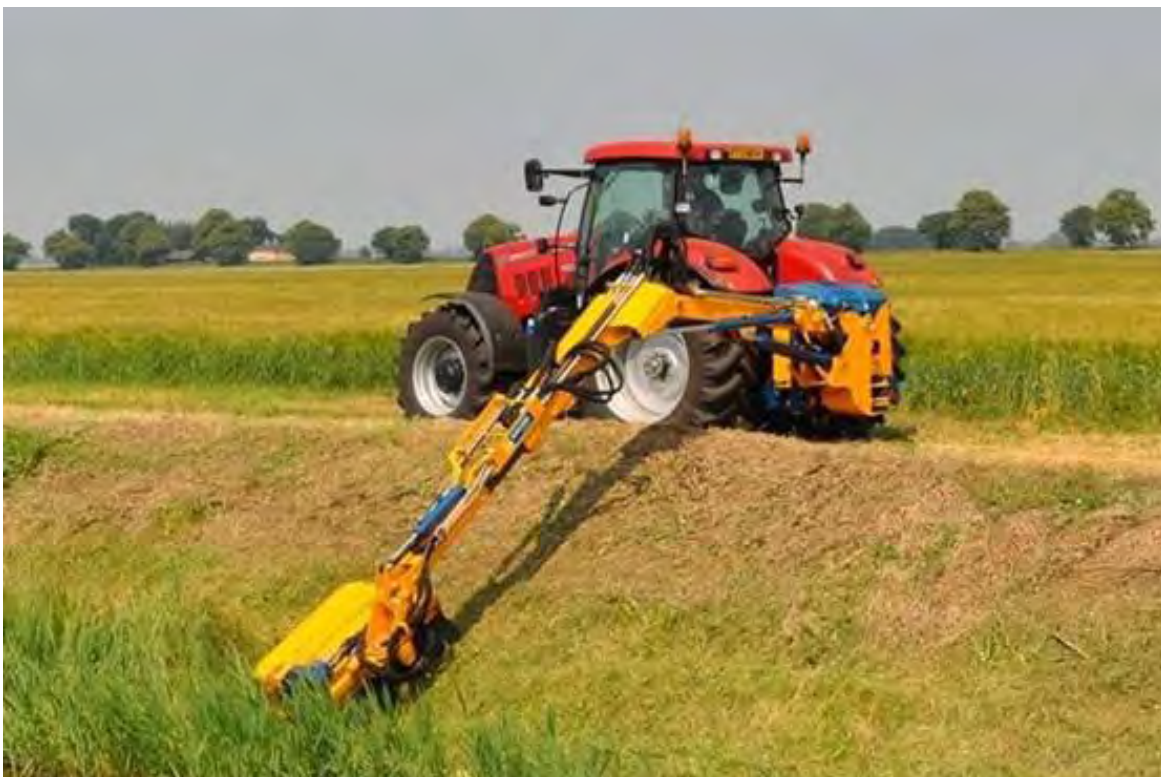
Figure 3: Side cut long reach flail mower example

Using a side cut long reach flail mower (see Figure 3 example) would enable the vegetation to be slashed without disturbing the acid sulfate soils. The flail mower would cut the reeds near the base to enable the trash to be more easily raked and removed, which would then be more suitable as stock feed. If a flail mower is not available then a slasher would certainly work.

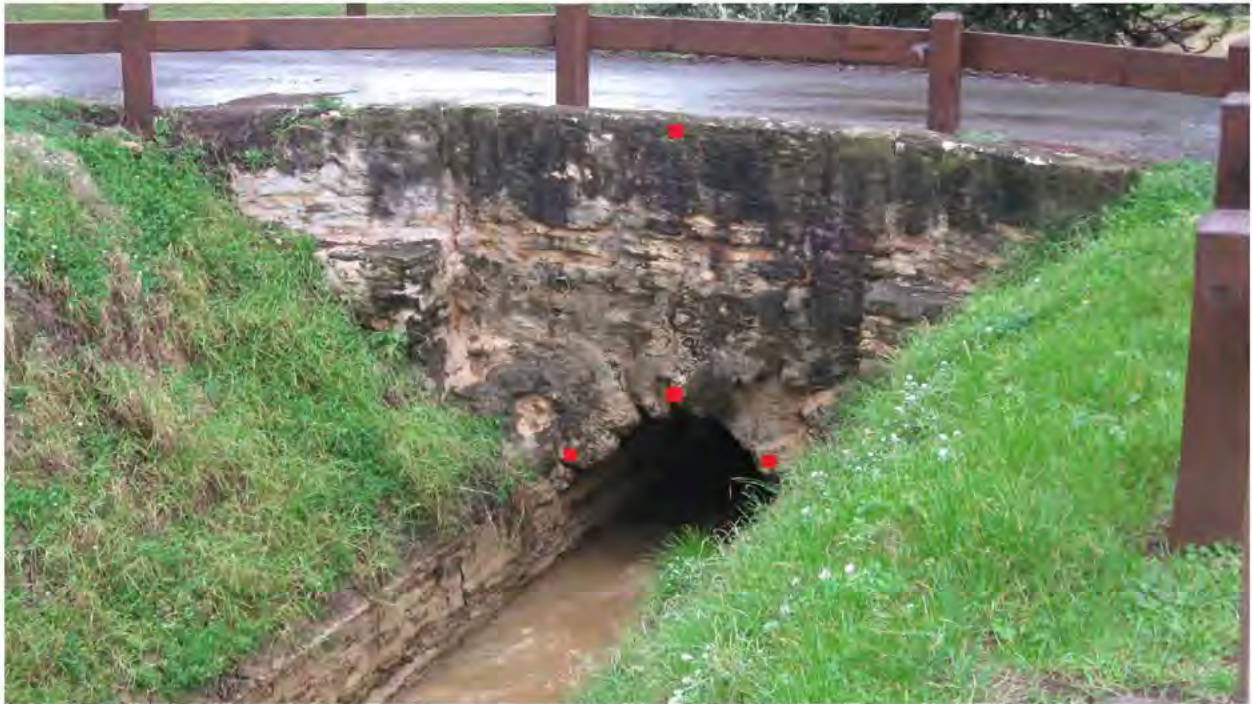
Four (4) monitoring targets were placed on each side of the structure as per the images below. The Pier Street bridge structure was only accessible with waders, so the image below is another localised bridge and used only as a diagram to display the monitoring locations and layout.

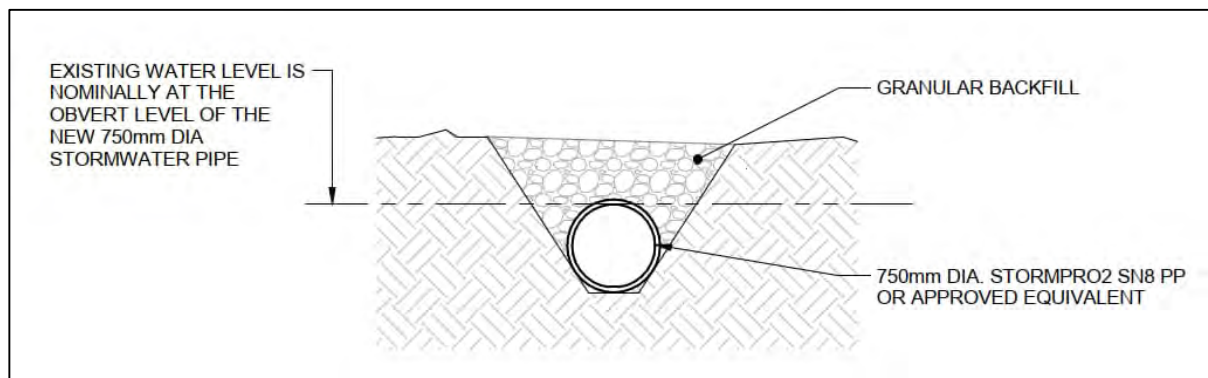
Figure 3 Typical diversion trench cross section

Whilst the earth bunds are being installed, dewatering of the works area would be required to allow for access to clean the bridge and install formwork. Due to the current water level elevation being at or below sea level, as well as the continuous flow from the hydraulic head in the upper Watermill catchment, it is anticipated there would be the requirement to continuously dewater each 24 hours during the conservation works, as water slowly seeps back into the works area between the earth bunds. This water would be pumped out into Watermill Creek, downstream of the works area. Water quality discharge standards would be set to comply with the ANZG 2018.

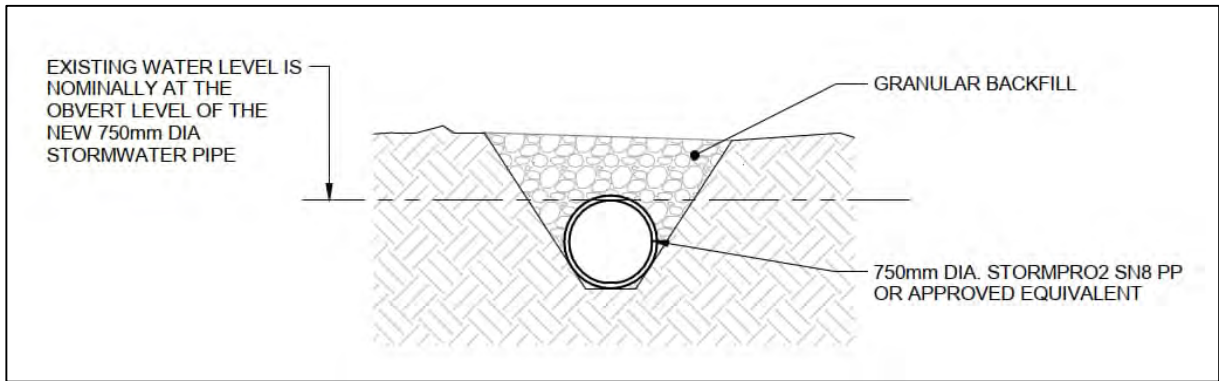
Figure 5 Typical diversion trench cross section

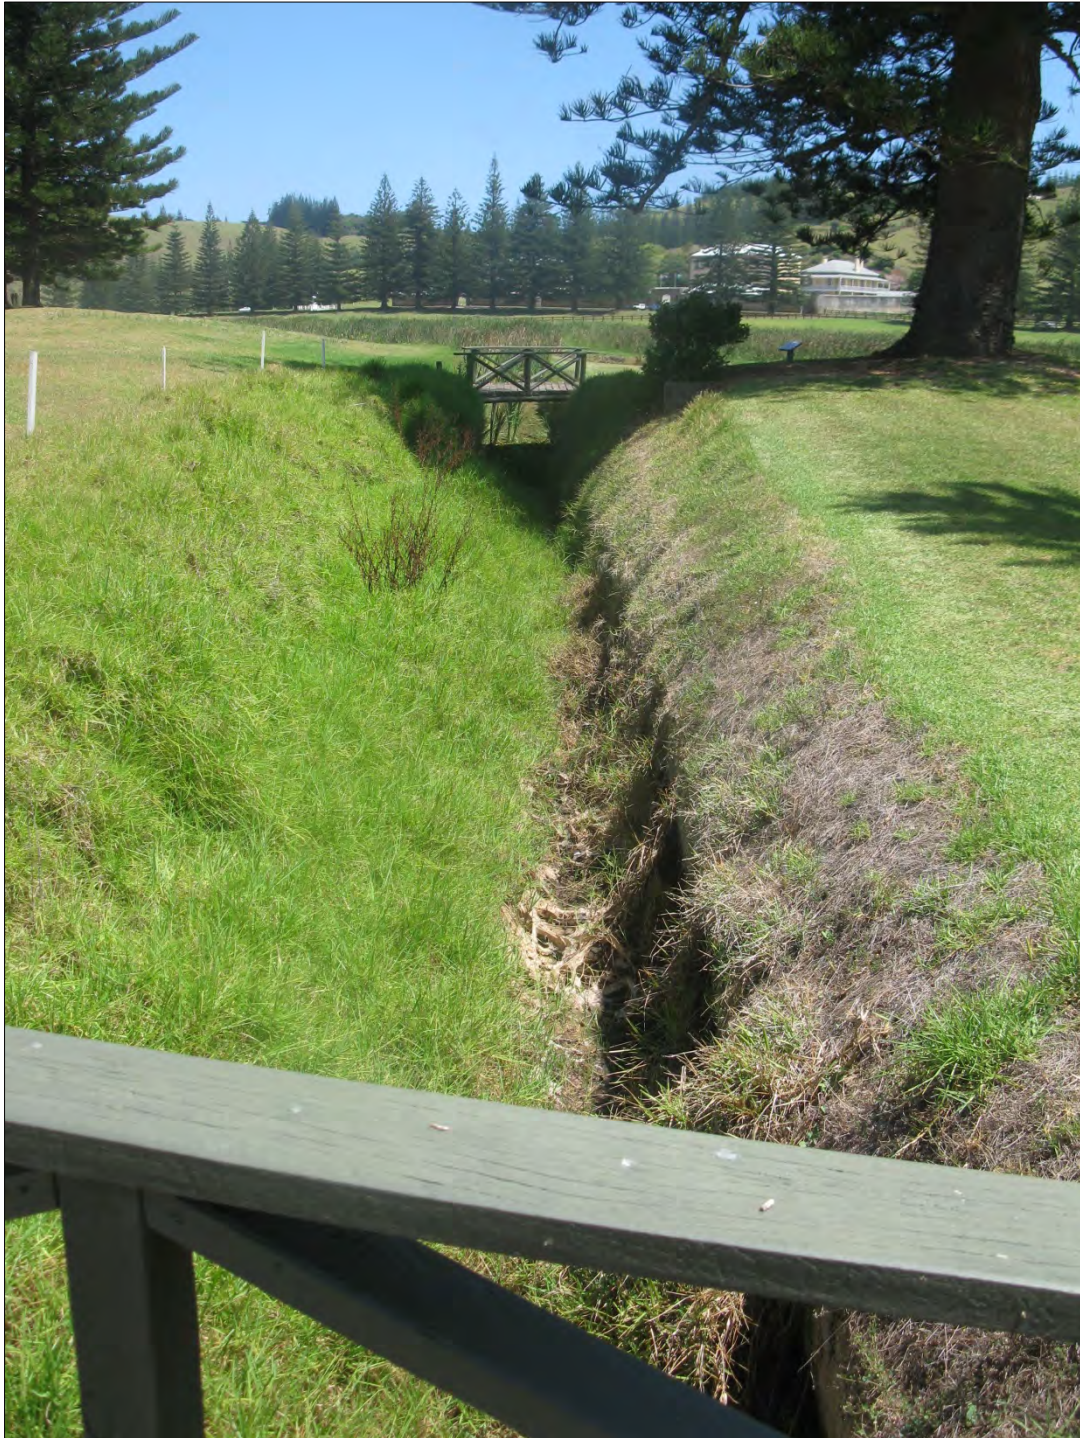
View of channel from Bay Street Bridge – January 2014

The existing open channel is of low significance and its infill and installation of two 600mm diameter plastic stormwater pipes will have minimal impact on the heritage values of the area.

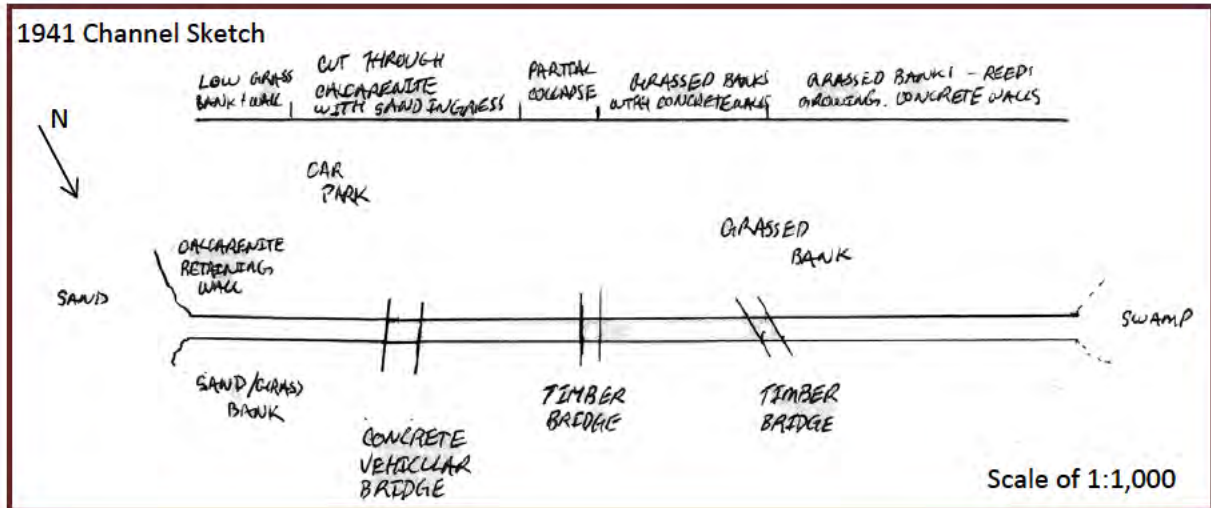
Figure 2: Structure of Channel

The 1941 Channel is a 2.5metre wide, up to 3 meter deep and approximately 200 metre long channel that connects the existing lowland swamp area of KAVHA to Emily Bay, in concert with the 1840's channel north east of it. Figure 2 and the photographs in the attachment provide details on the channel's structure. The channel cuts through former swamp and calcarenite bedrock before discharging to Emily Bay.

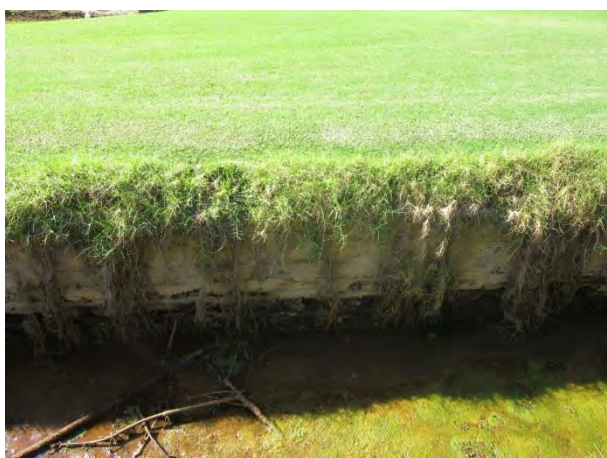
Figure 15: Concrete lining at West end of the 1941 channel

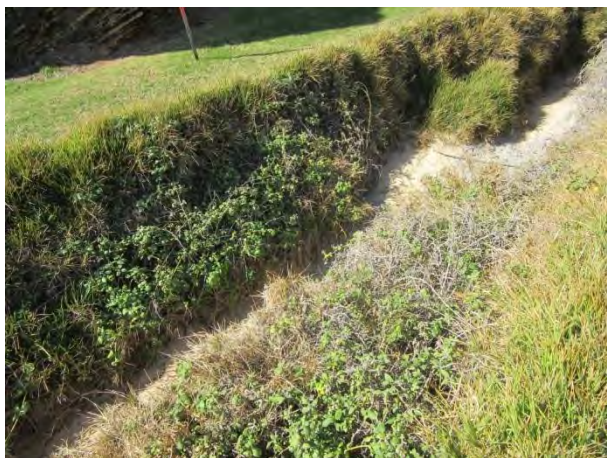
Figure 19: Sand and vegetation in centre section of 1941 channel

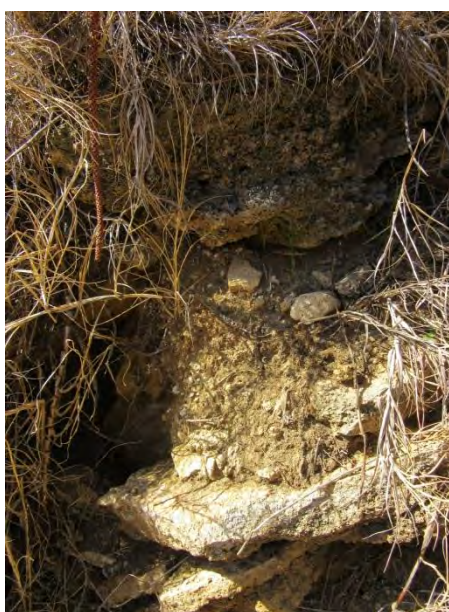
Figure 21: East end of the 1941 channel walls showing bedding

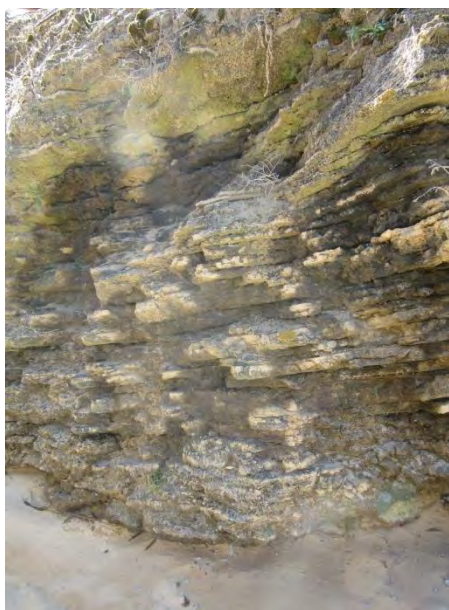
Figure 22: Bedding on South wall of 1941 channel near bridge

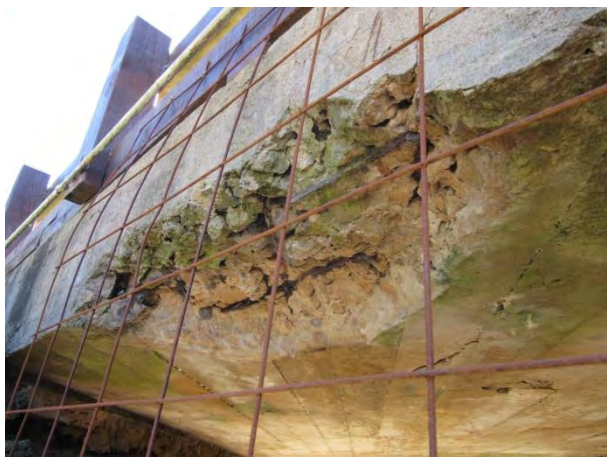
Figure 24: Bridge deck concrete cancer

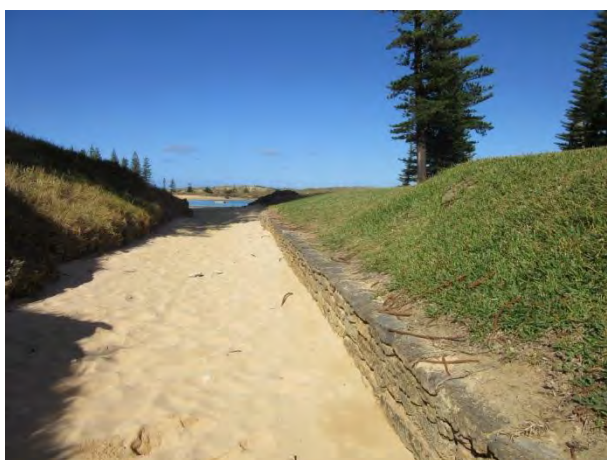
Figure 25: Looking east showing early 2000s calcarenite retaining wall

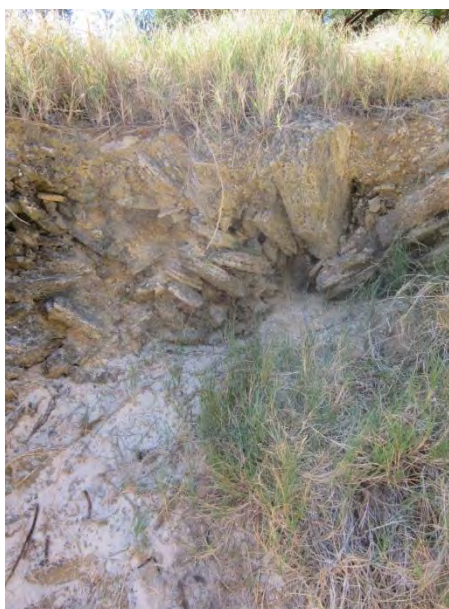
Figure 26: Waste calcarenite near surface, potentially from Dove Hill quarry. Such deposits are evident across KAVHA.
