Appendix D. Project Specific Geotechnical Investigation Factual Report

1. Introduction

Jacobs Group Australia (Jacobs) has completed the geotechnical investigation for the detailed business case of the Stage 2 Haughton Pipeline Project. This report contains the findings of the geotechnical testing undertaken along the proposed pipeline alignment and associated infrastructure.

Client	Department of Infrastructure, Regional Development and Cities
Project Title	Stage 2 – Haughton Pipeline Project
Project No.	IH175200

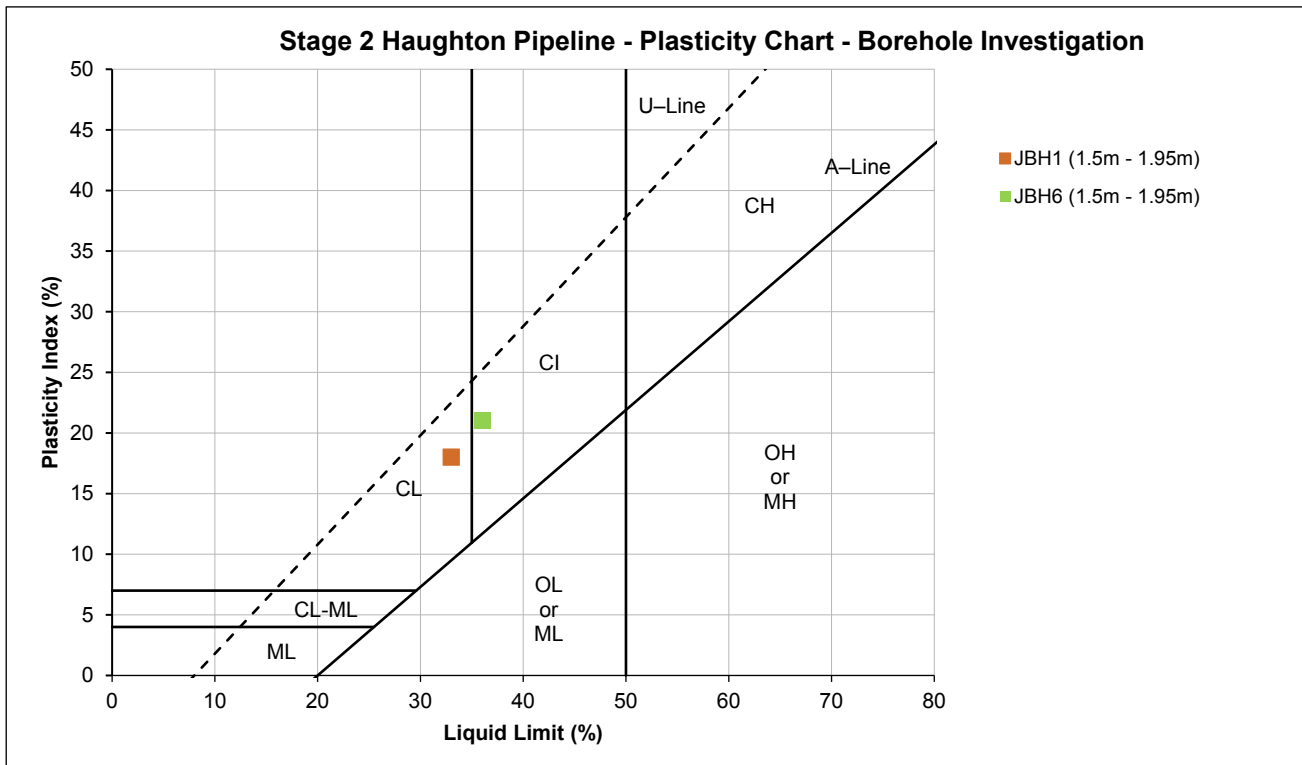
Figure 6. Atterberg Limit Test Results – Borehole Investigation.

Atterberg limit testing was undertaken on representative material samples from the test pits and the borehole. The test results are summarised in Table 4 and graphically illustrated in Figures 6, 7, 8 and 9. Laboratory test results are included in Appendix D.

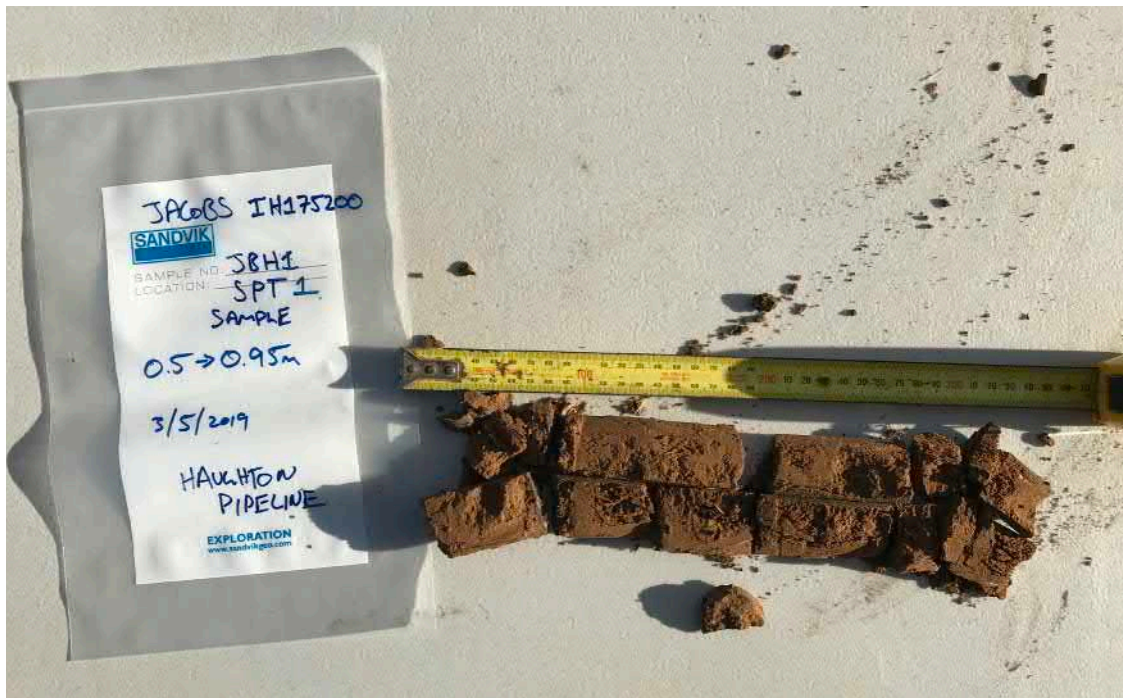
Photograph 3 - JBH1 SPT Sample from 0.5 - 0.95m.

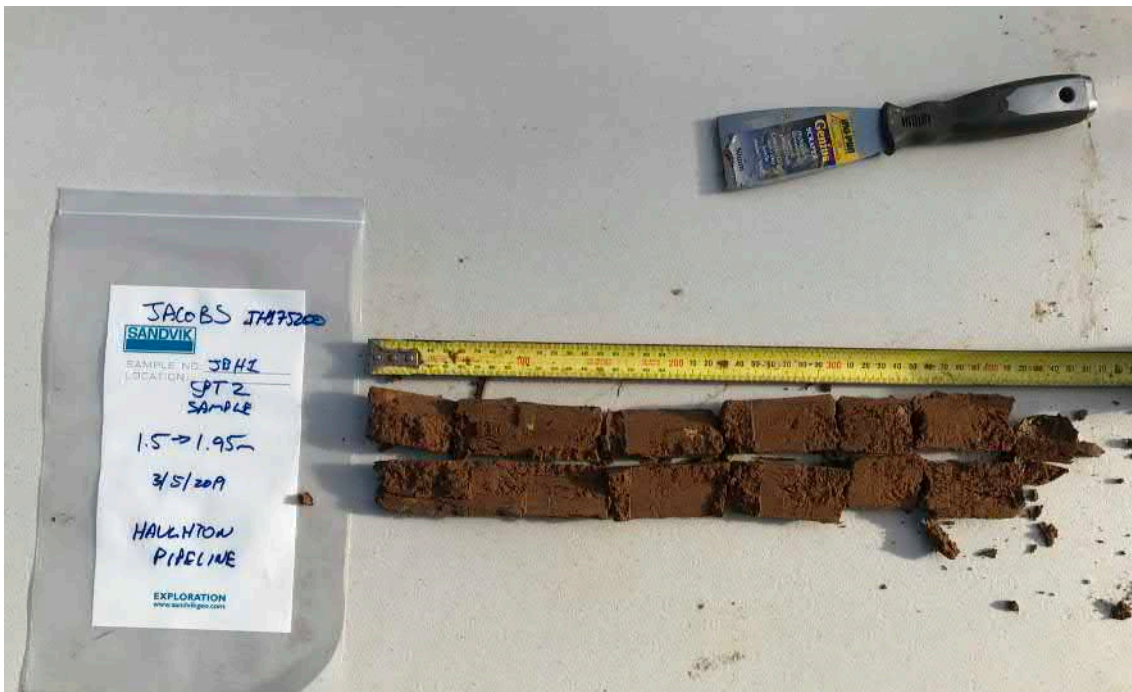
Photograph 4 - JBH1 SPT Sample from 1.5 - 1.95m.

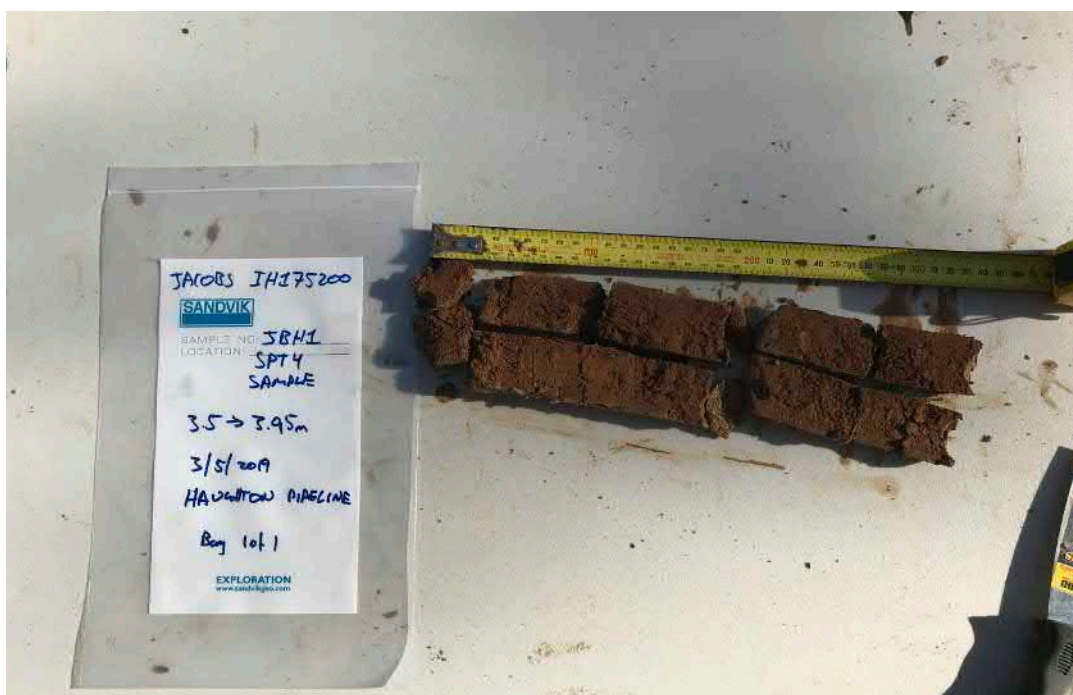
Photograph 6 - JBH1 SPT Sample from 3.5 - 3.95m.

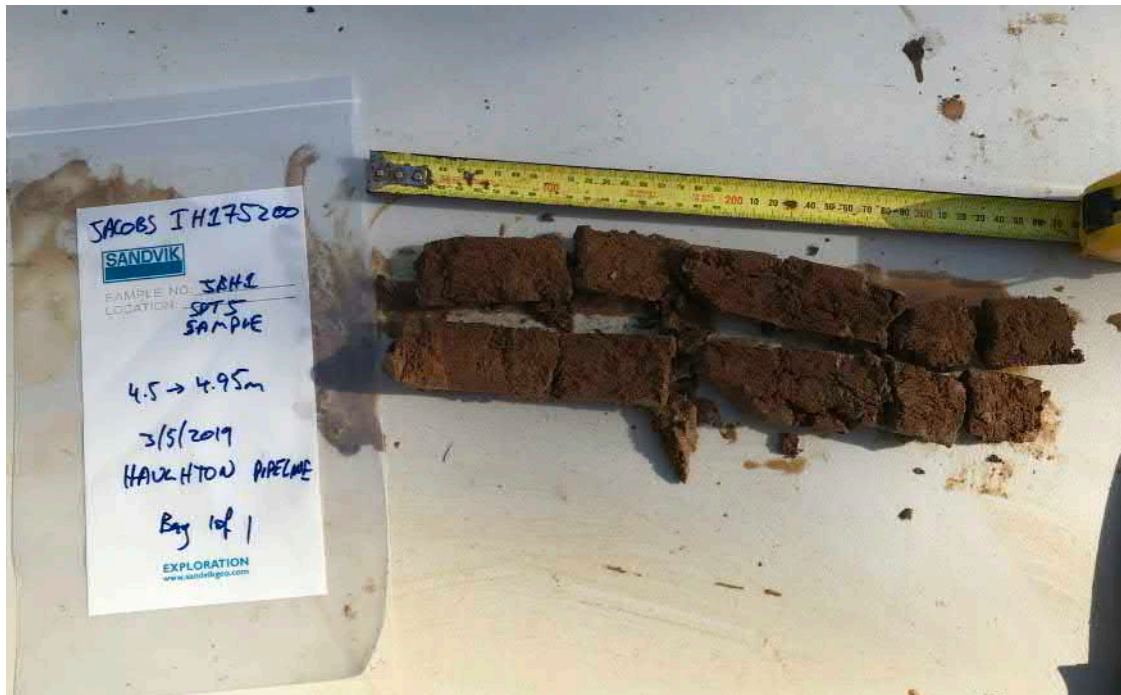
Photograph 7 - JBH1 SPT Sample from 4.5 - 4.95m.

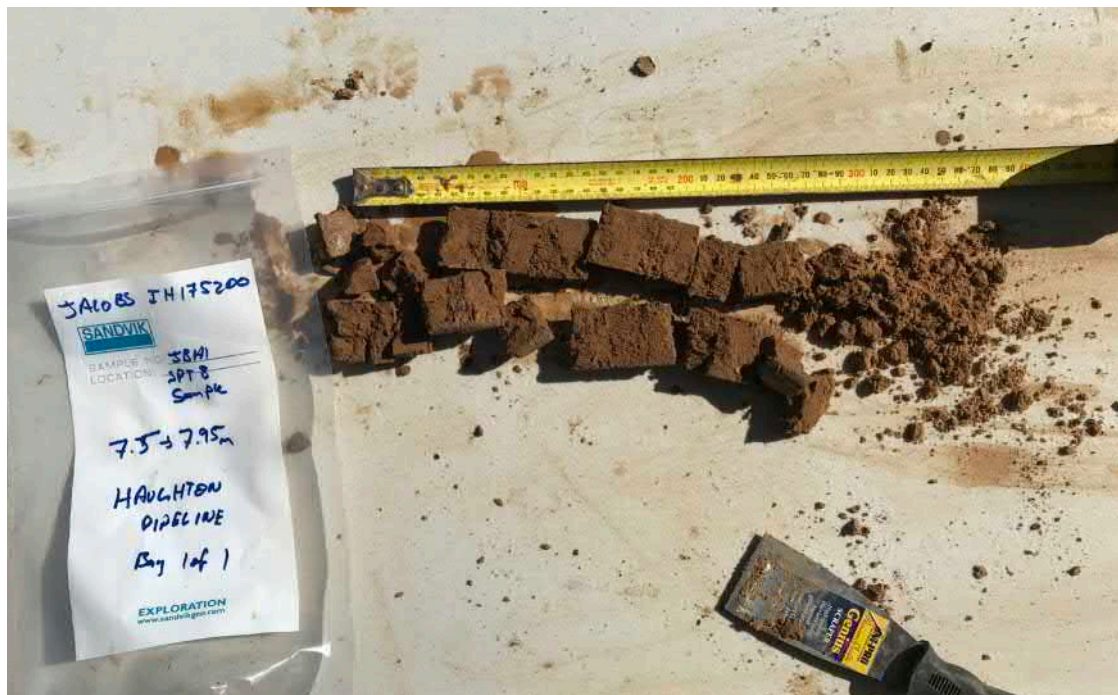
Photograph 8 - JBH1 SPT Sample from 7.5 - 7.95m.

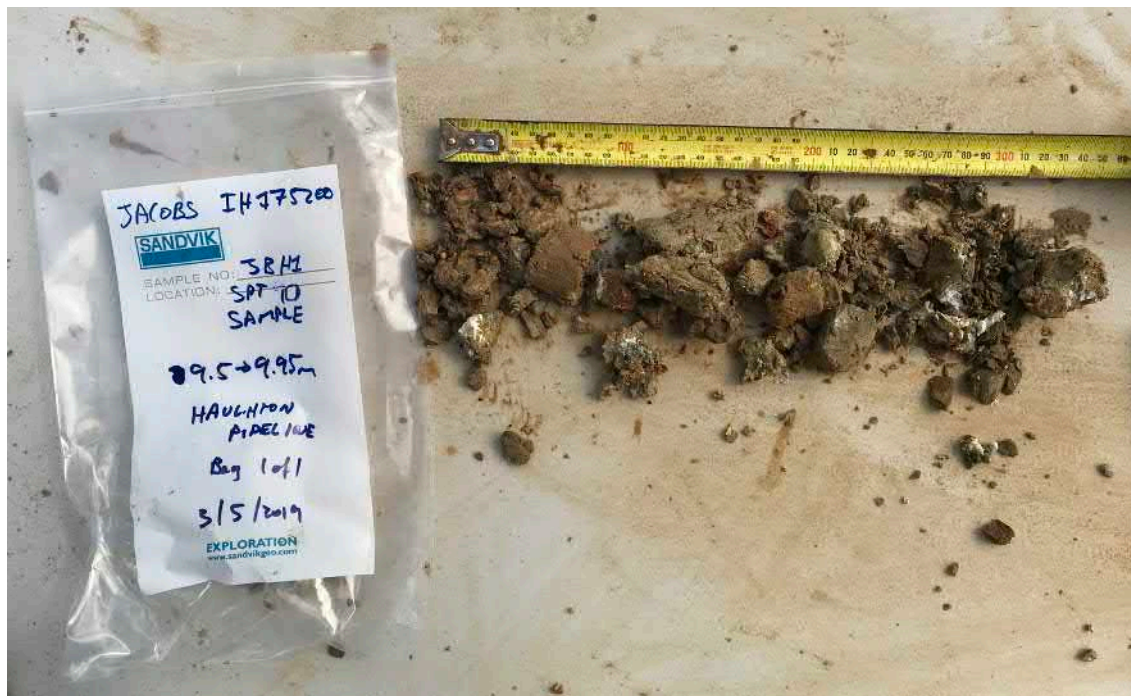
Photograph 9 - JBH1 Sample from 9.5 - 9.95m.

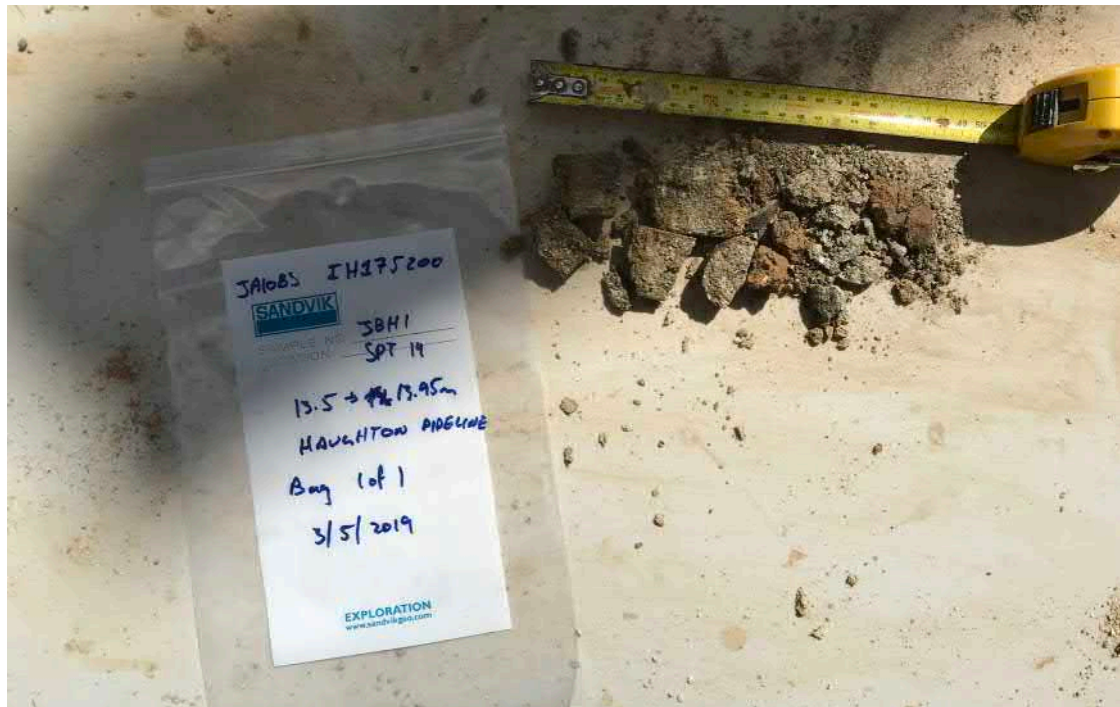
Photograph 13 JBH1 SPT Sample from 13.5 - 13.95m

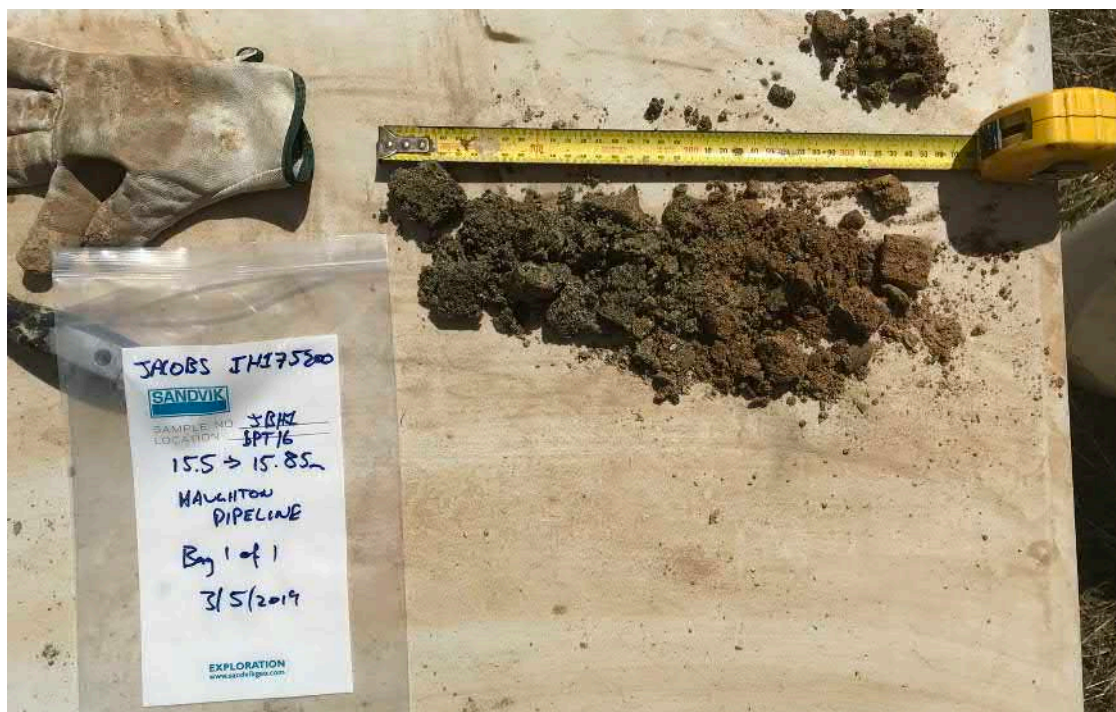
Photograph 15 - BH1 SPT Sample from 15.5 - 15.85m.
