Preliminary PFAS Risk Assessment for Camden Airport

Sydney Metro Airports

IA115500 | FINAL

4 April, 2017

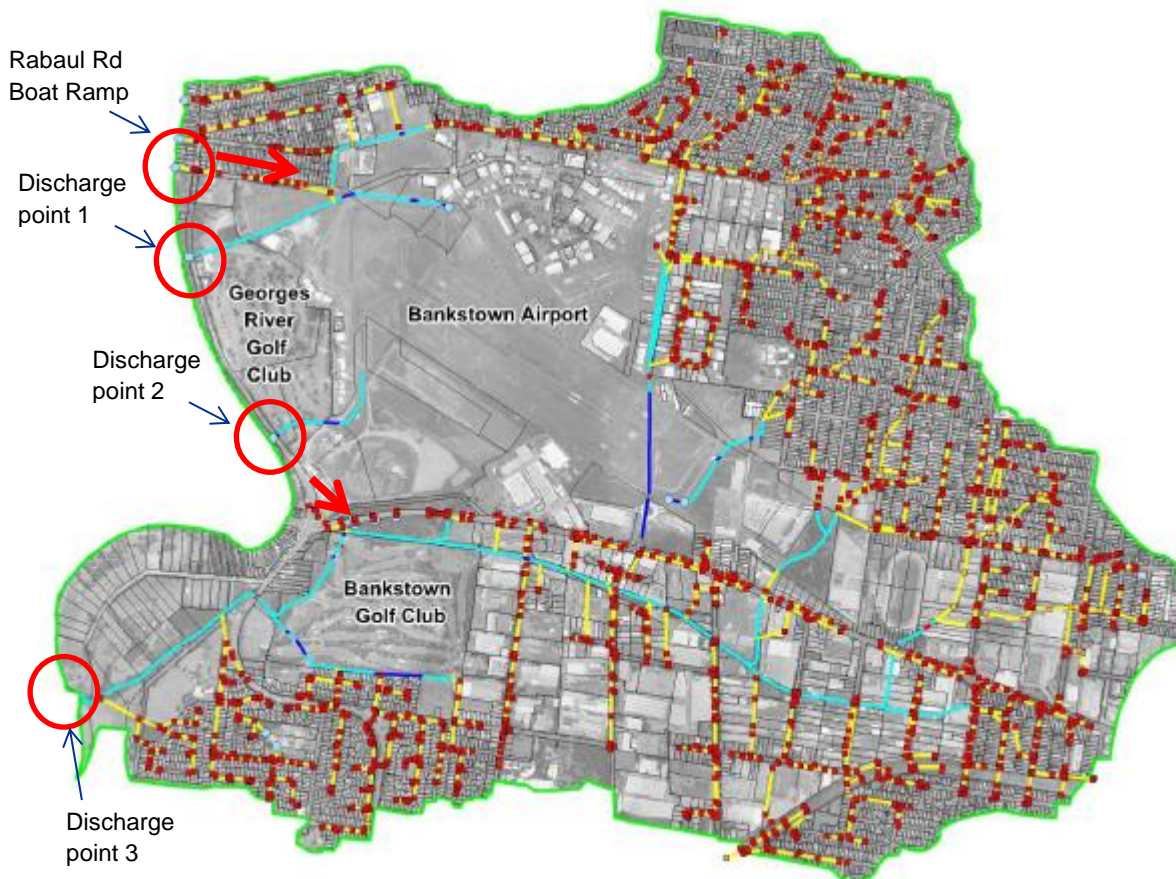
Figure 1 : Stormwater drainage network for the Milperra Catchment. Note red arrows indicate assumed flow direction (BMT WBM, 2013 with mark-ups by Jacobs)

The Airport is part of the Milperra Catchment which drains surface water to the Georges River. Stormwater from higher areas north east of the Airport as well as from the Airport property is directed to the Georges River through underground pipes, open channels and culverts as indicated in **Figure 1** below.

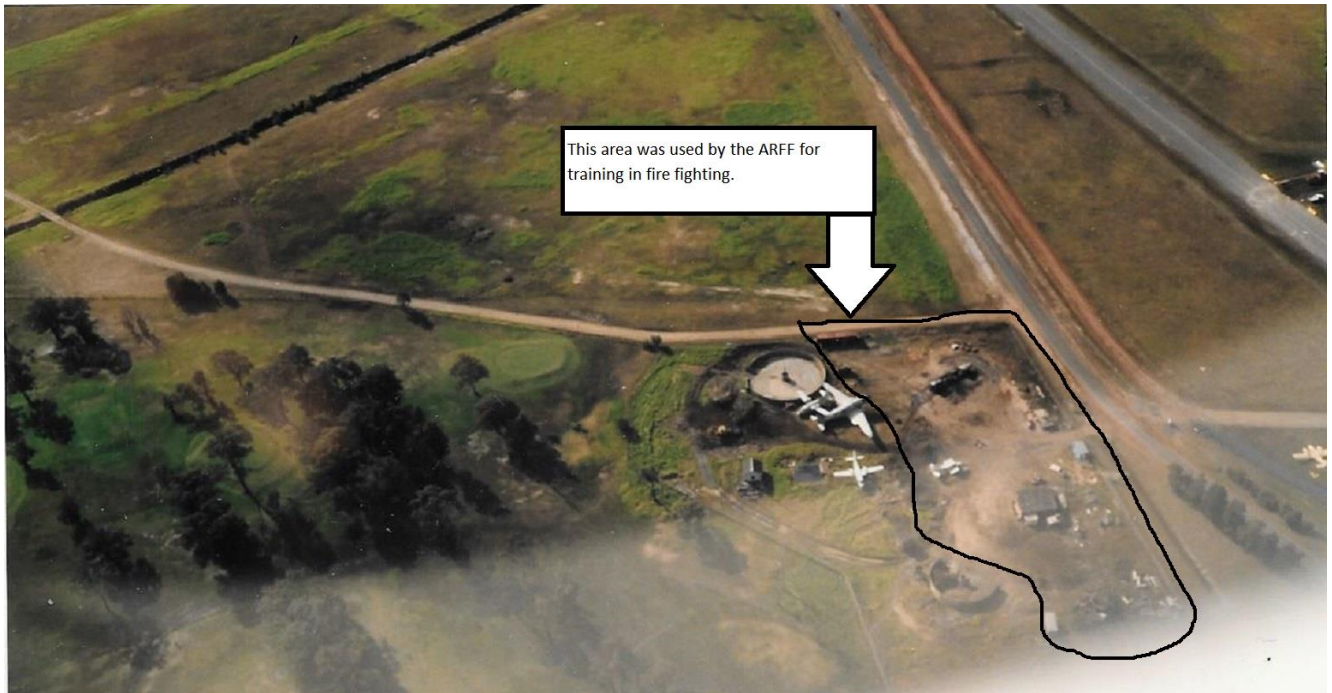
Figure 3 : Photo of the former fire training area (supplied by SMA)

Figure 3 below is a photo of the former fire training ground provided by SMA. The approximate boundary of the area has been marked on the photo by SMA.

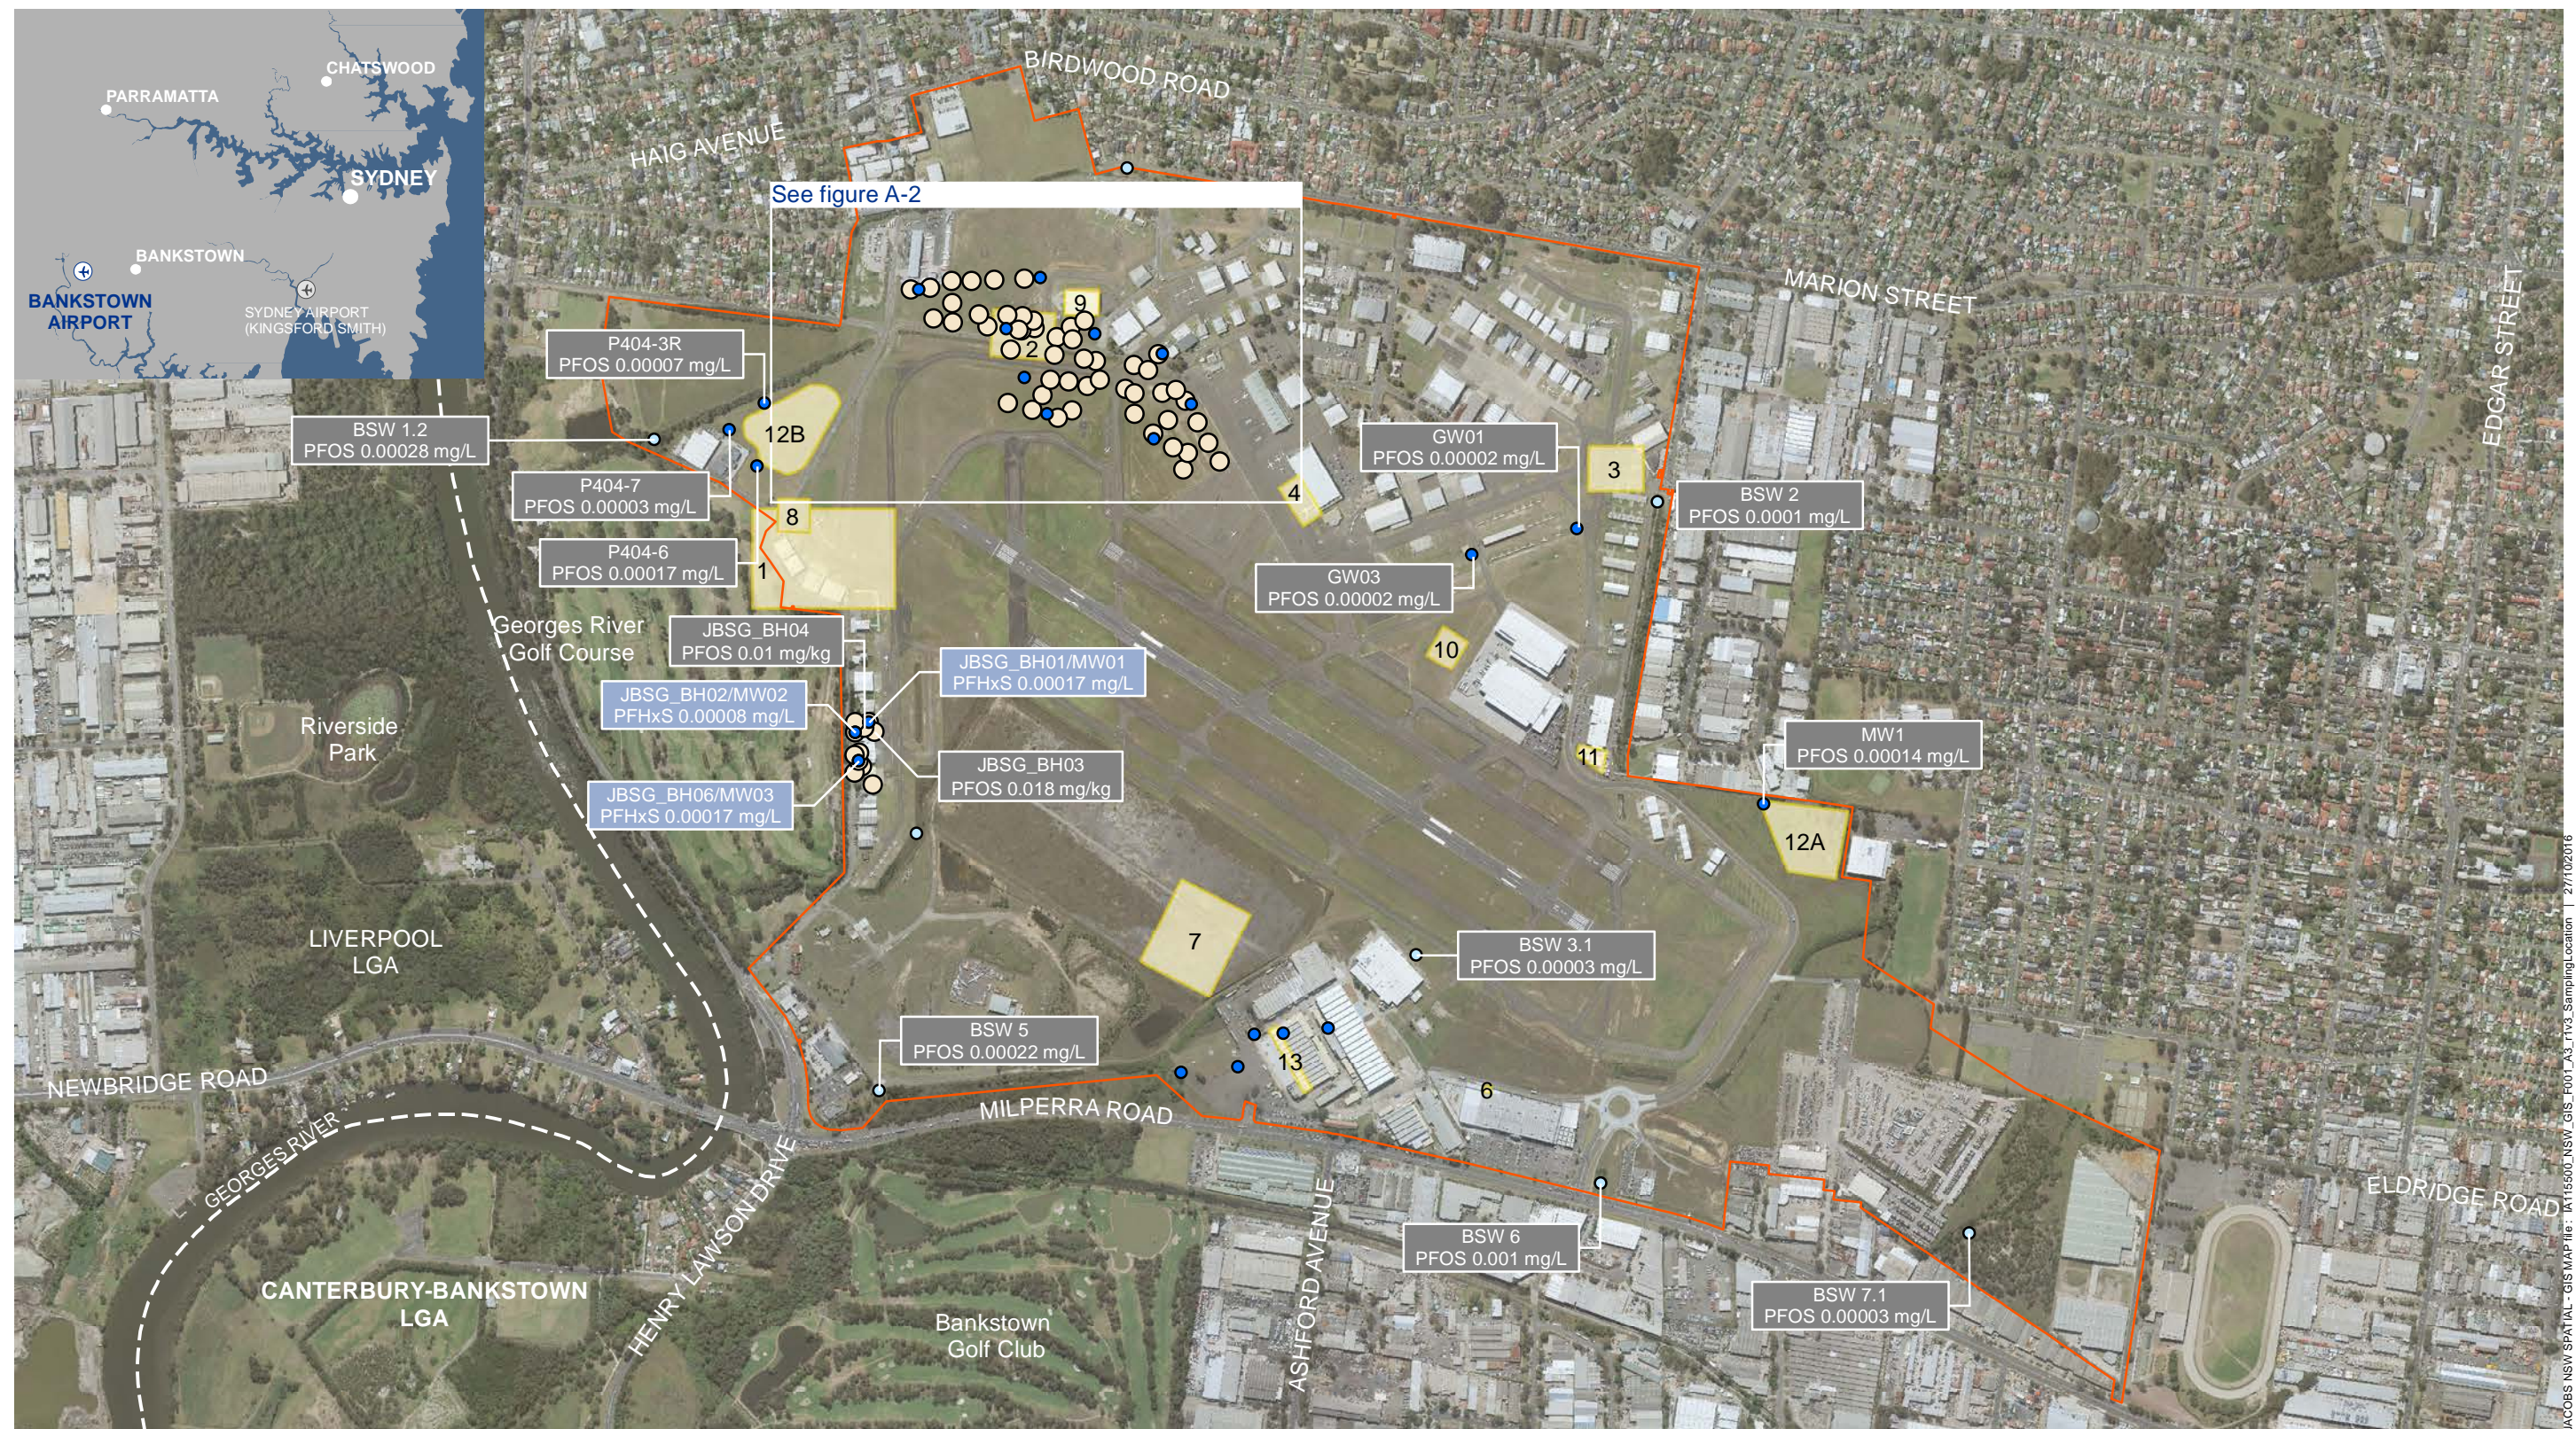
Figure A-1

- Bankstown airport
- PFOS sampling location
- Groundwater sampling
- Surface water sampling
- Soil sampling

- Site ID PFOS mg/L PFOS detected (label)
- Site ID PFHxS mg/L PFHxS detected (label)

| Potential PFAS sources and historical PFOS sampling results

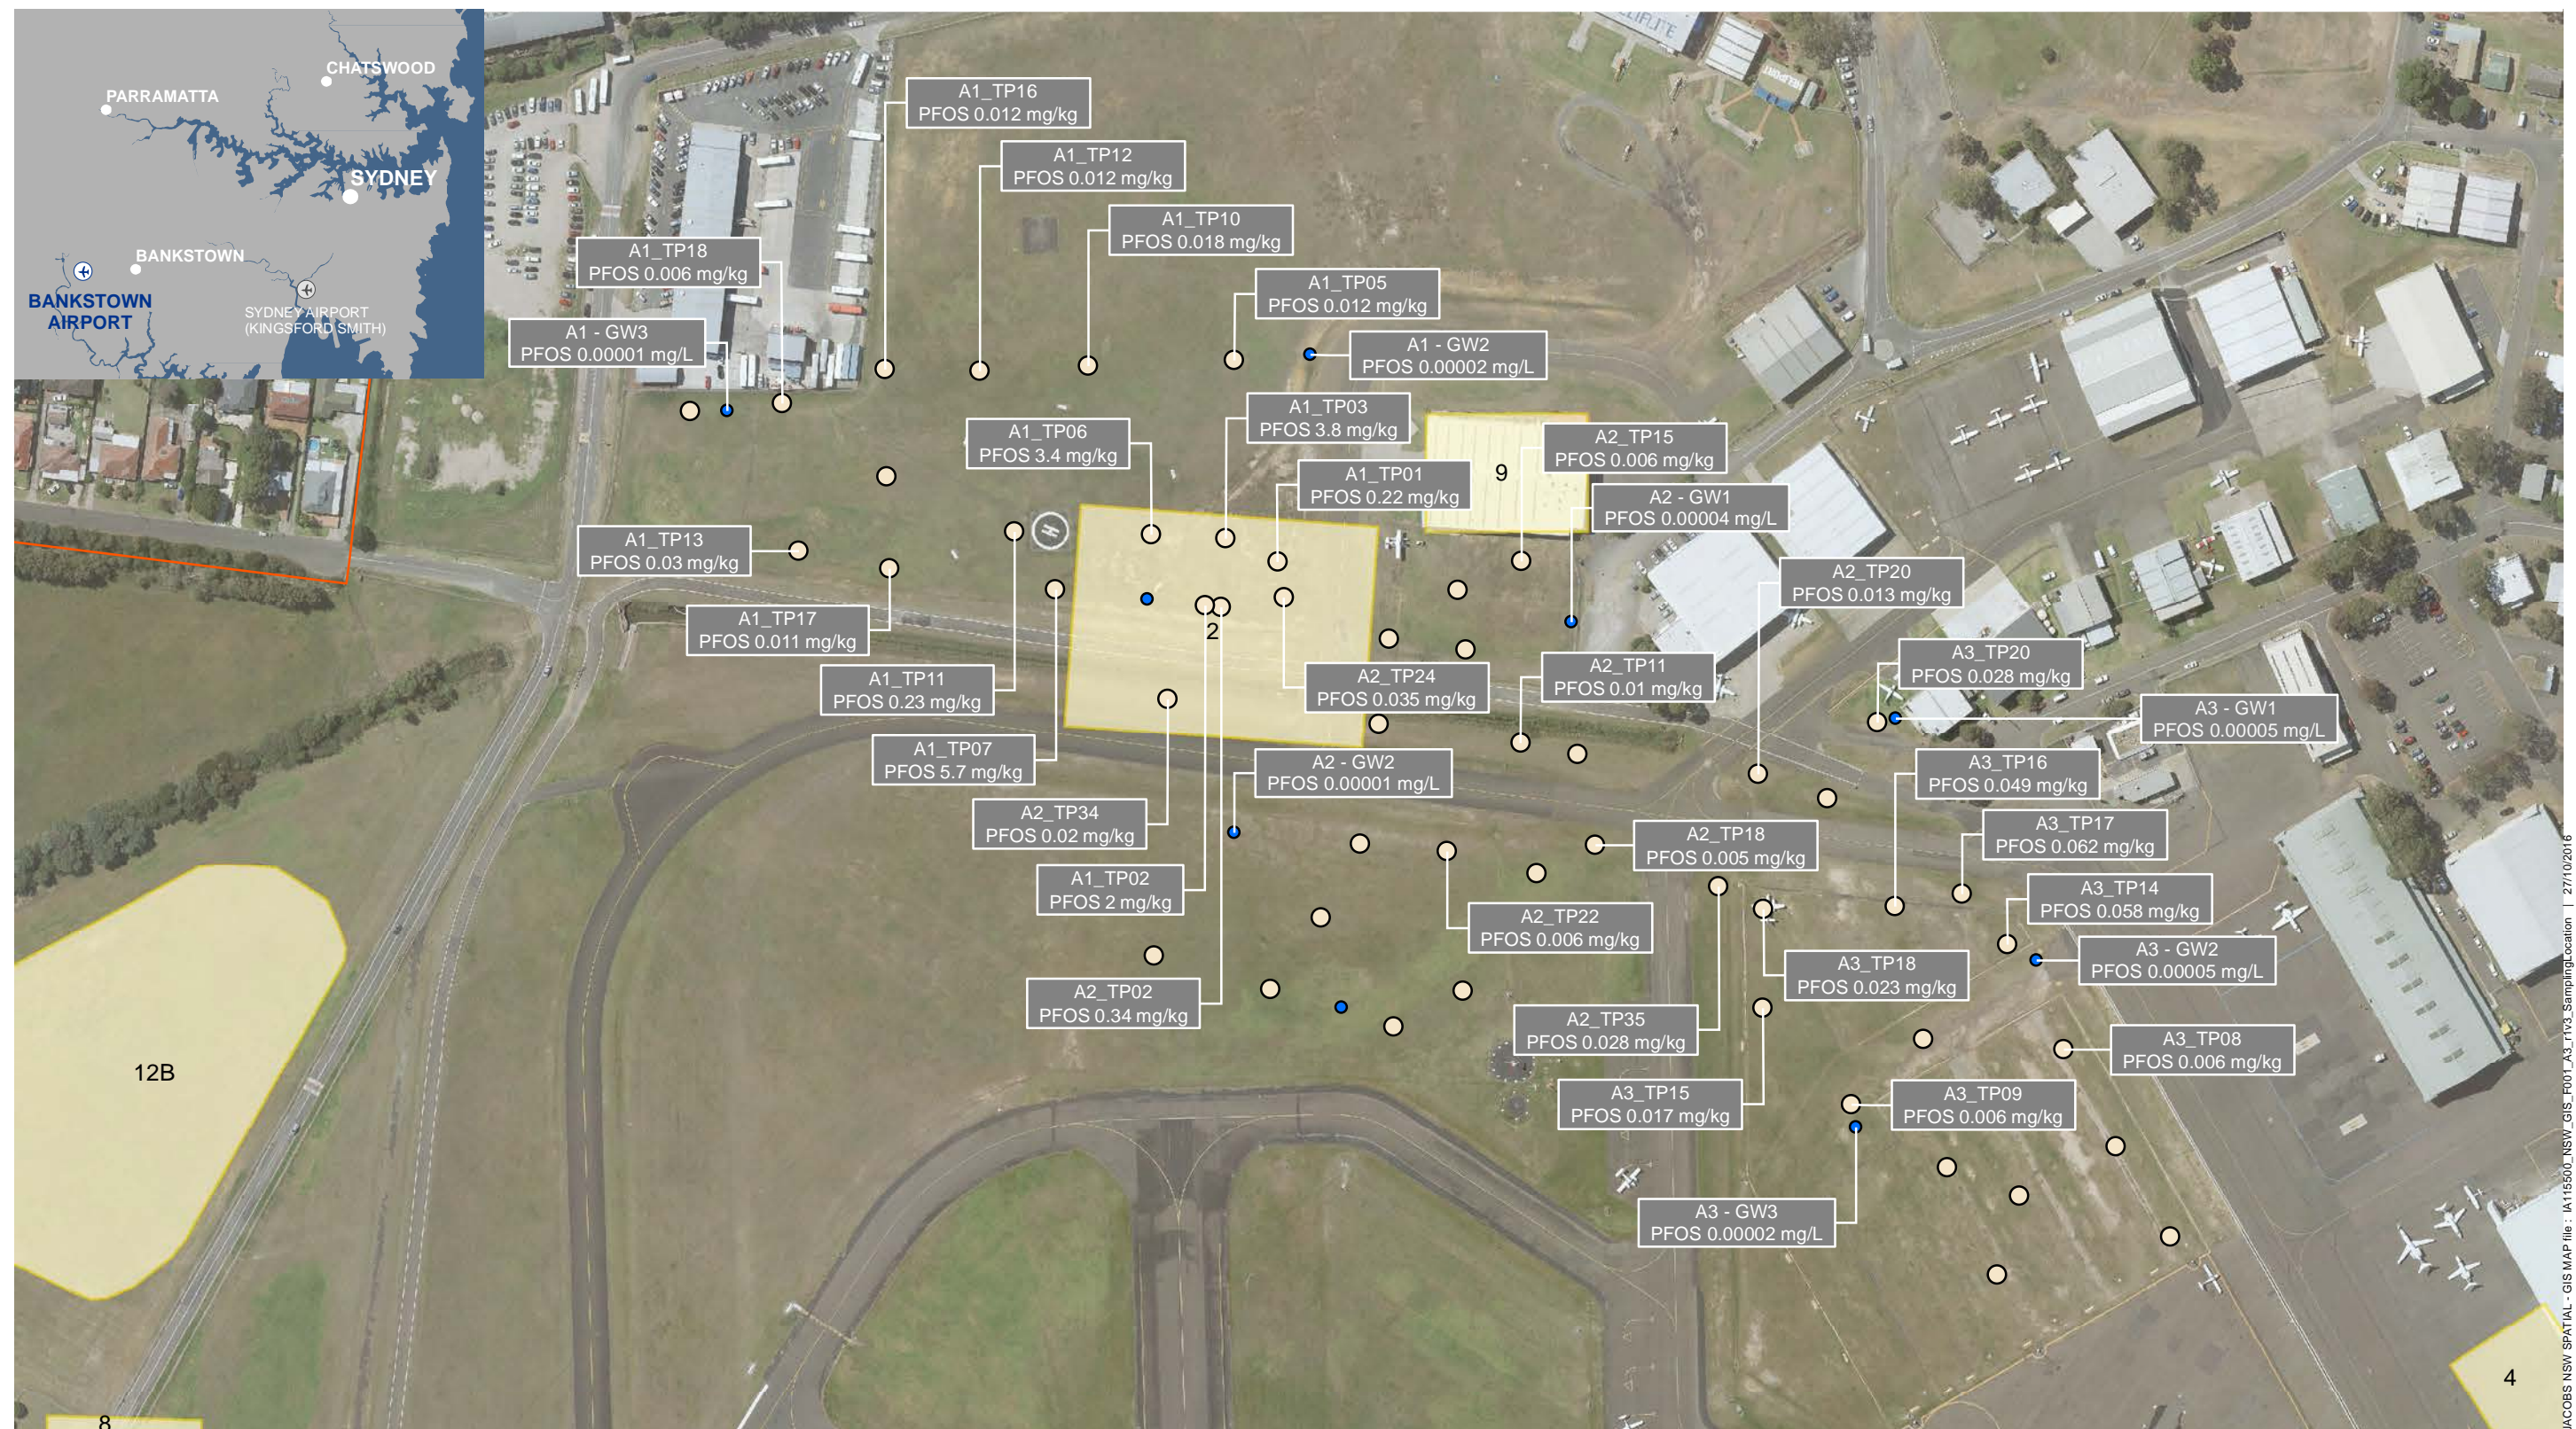
Figure A-2

| Potential PFAS sources and historical PFOS sampling results
