DEPARTMENT OF TRANSPORT
OFFICE OF ROAD SAFETY
DOCUMENT RETRIEVAL INFORMATION

| Report No. | Date | ISBN | Pages |
|---|---|---|---|
| C R 1 3 | October, 1980 | 0 642 S 11306 | 84 + V |

Investigation of the effect of bull-bars on vehicle-pedestrian
collision dynamics

Department of Mechanical and Production Engineering,
Royal Melbourne Institute of Technology,
124 La Trobe Street, Melbourne, Victoria, Australia.

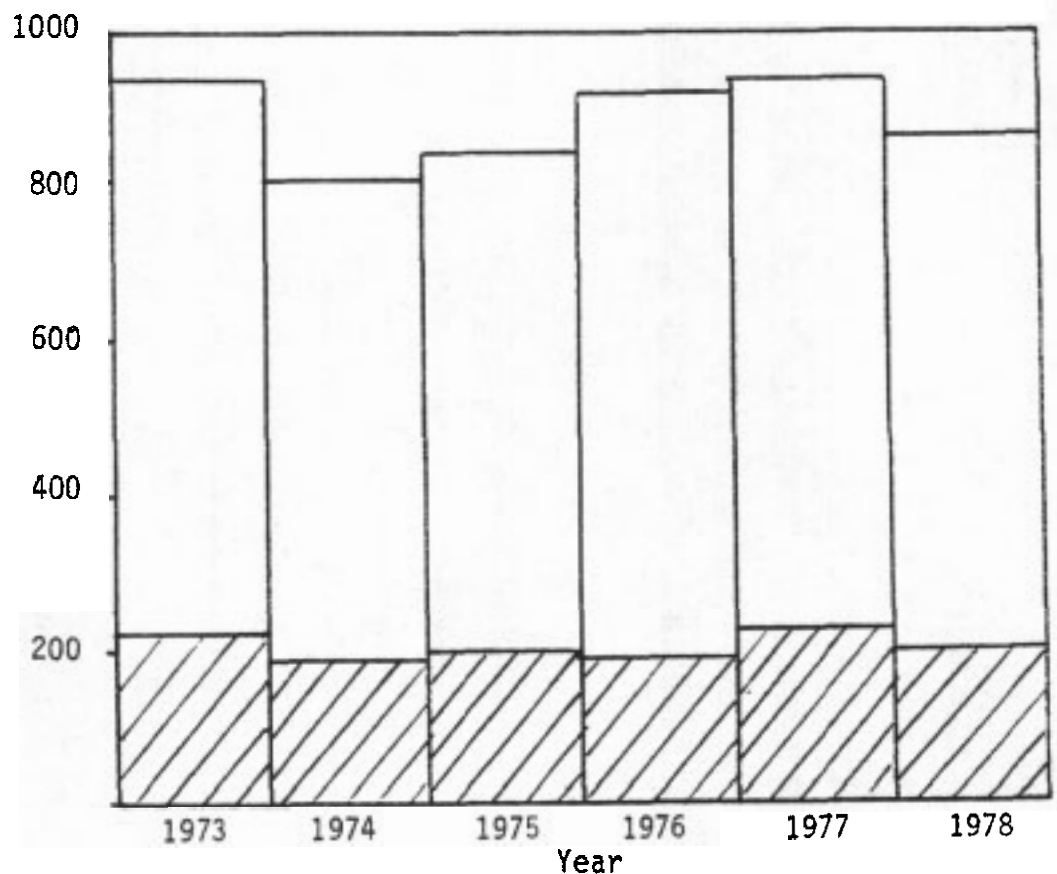
FIGURE 2.1 Road traffic fatalities for Victoria from 1973 to 1978

Victoria's road traffic accidents involving casualties from 1973 to 1978 are summarized in Figures 2.1 and 2.2 (ABS, 1979). Pedestrian casualties for the same period are superimposed for comparison purposes.

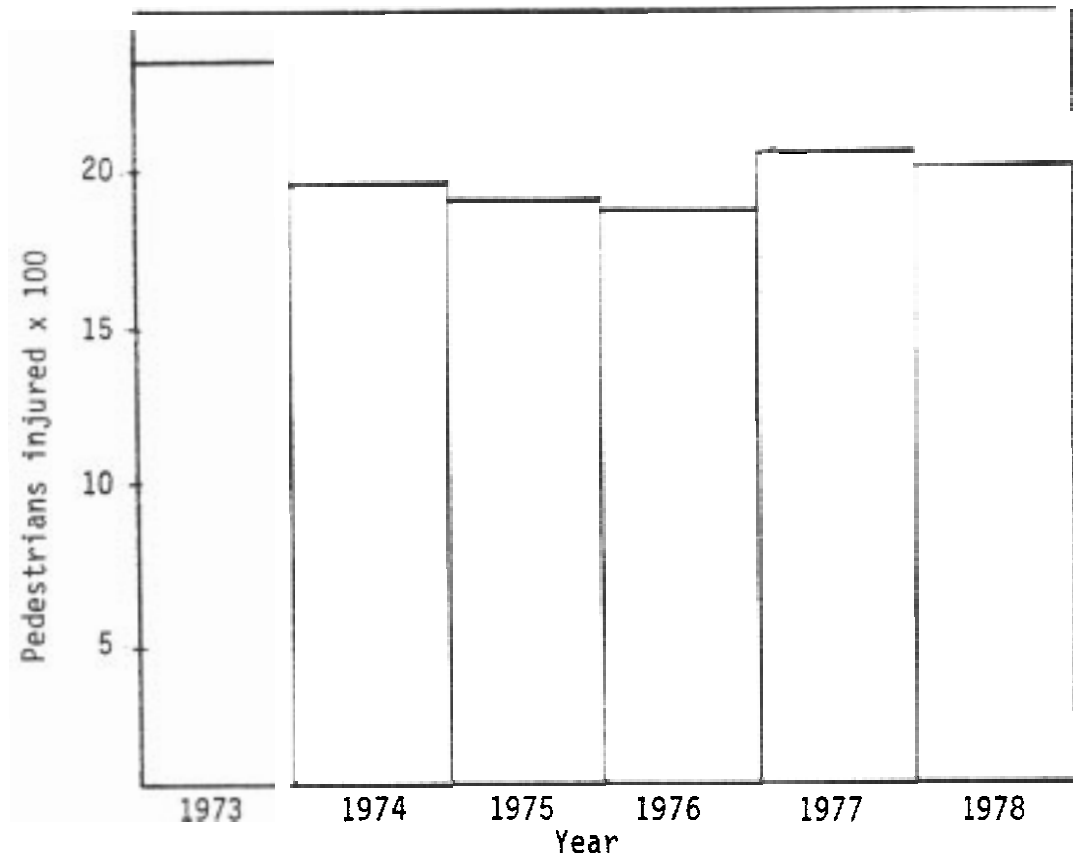
FIGURE 2.2 Pedestrians injured on Victorian roads between 1973 and 1978

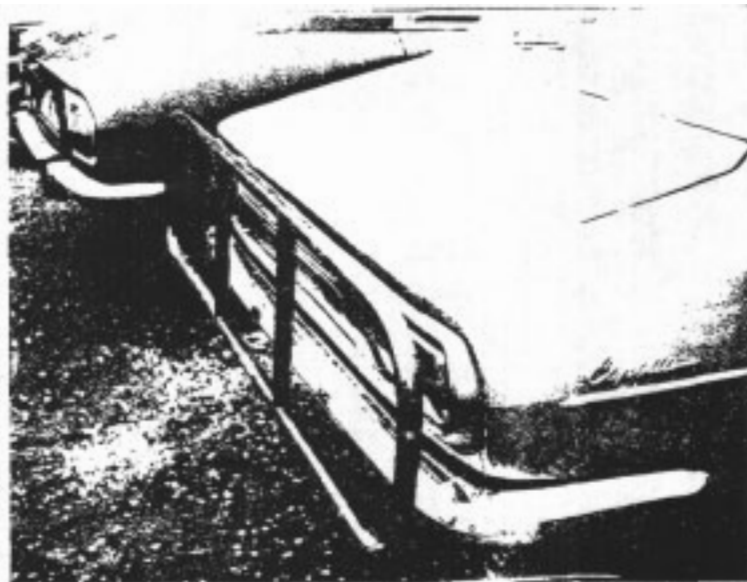
FIGURE 2.3 A bull-bar mounted to the rear of a car

To all intents and purposes, the bull-bar is peculiar only to Australia and similar fittings have been observed on the rear (Fig. 2.3) and the side of vehicles (Fig. 2.4). Nowhere in Europe or the USA are cars equipped with similar fittings.

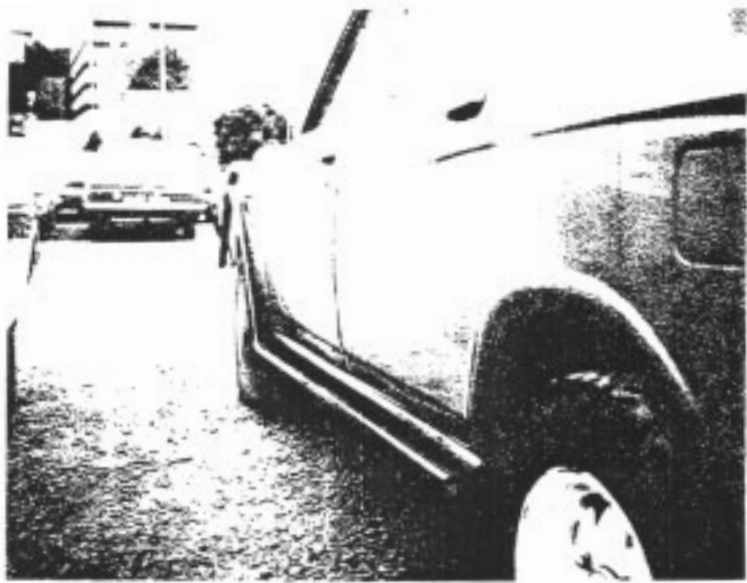
FIGURE 2.4 The mounting of a bull-bar or a similar structure on the side of a car

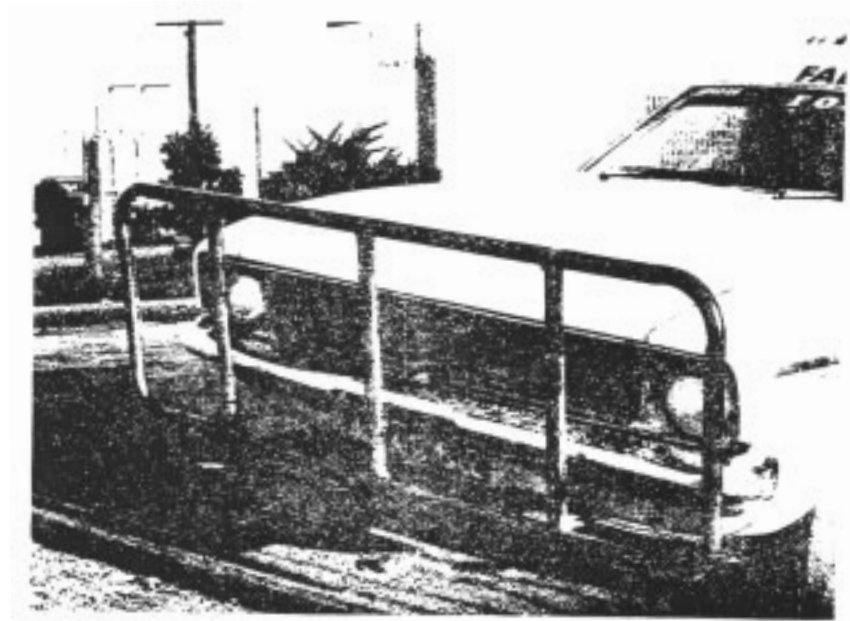
FIGURE 3.1 Example of the top edge of a bull-bar exceeding the leading bonnet edge by approximately 150 mm

Whilst the top edge of most bull-bars do not exceed the bonnet height, usually 760 mm - 860 mm for passenger cars, there are some that clearly protrude above the leading edge of the bonnet. This difference in height can be as much as 150 mm above the bonnet's leading edge (Fig. 3.1).

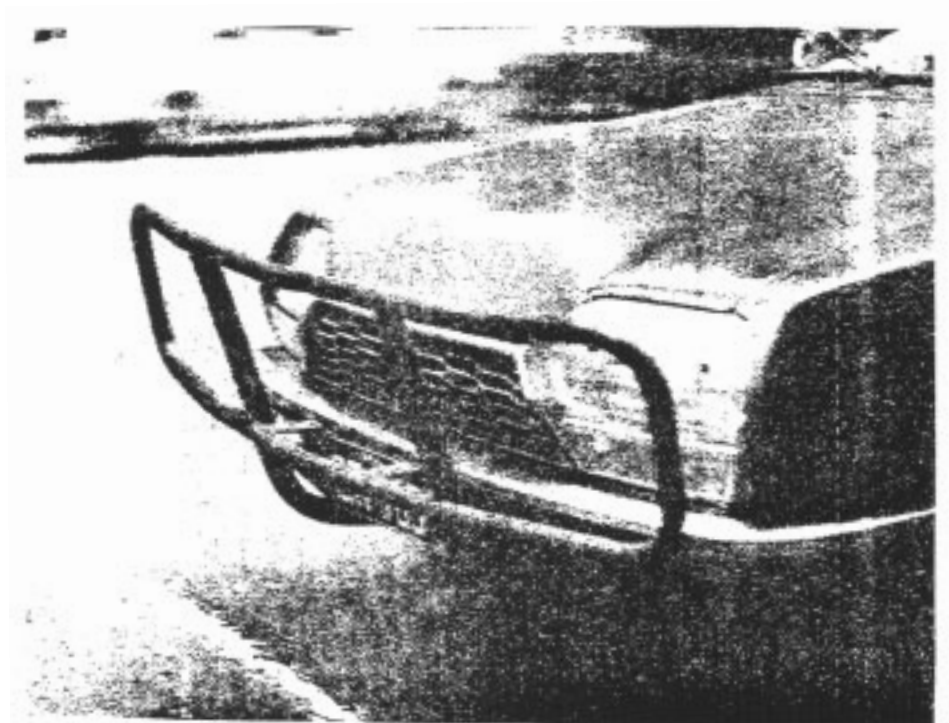
FIGURE 3.2 The bull-bar on the vehicle slopes forward at an angle of 20°

The majority of bull-bars are vertical frames. Some, however, slope forward by as much as 20° from the vertical so that the leading edge is some 18 inches ahead of the bonnet edge (Fig. 3.2). Other bull-bars display elements which protrude at an angle at leg and hip

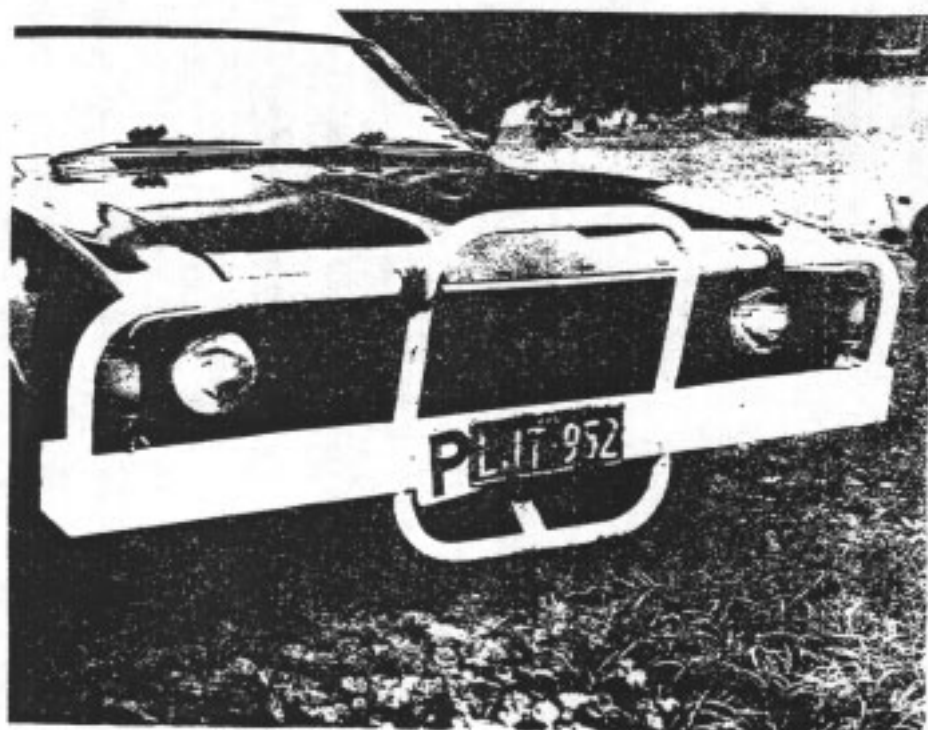
FIGURE 3.3 Elements of some bull-bars protrude at hip and lower leg heights

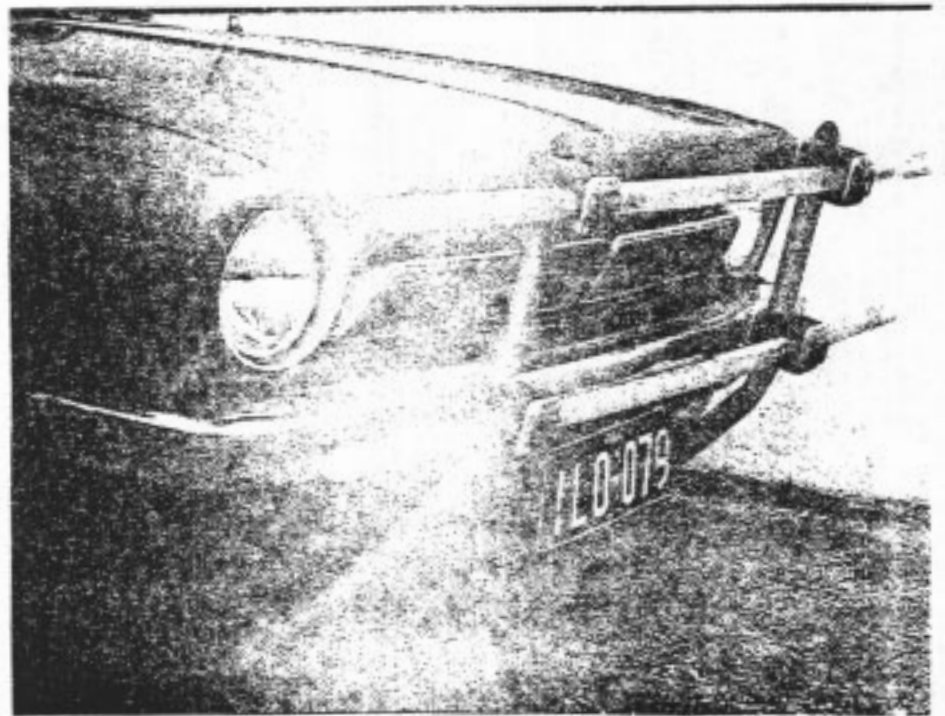
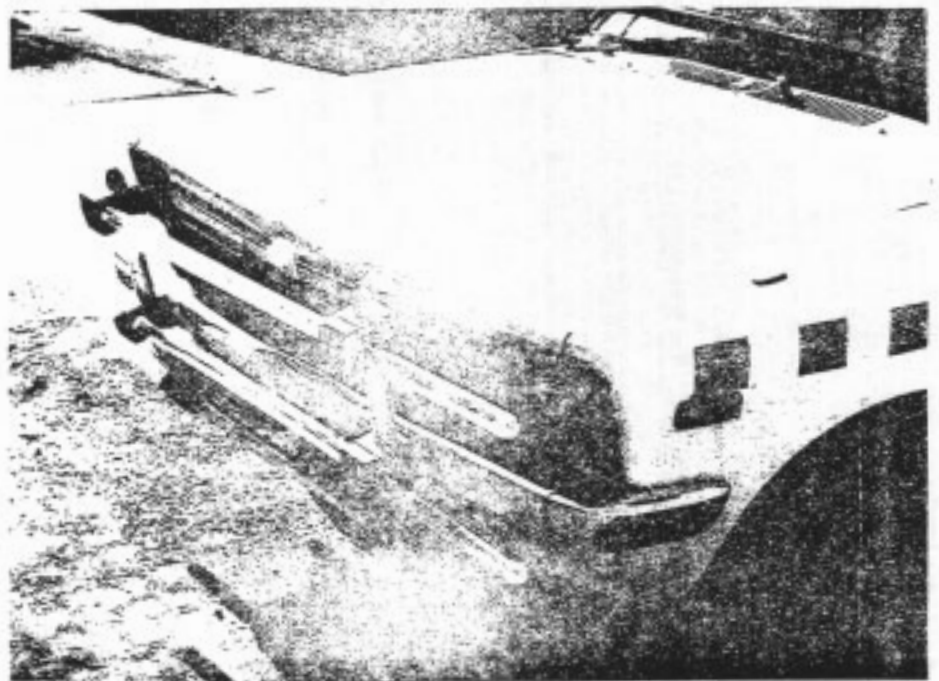
FIGURE 3.4 Thermoplastic bull-bars may have two or three polycarbonate members supported by metal tubes

Samples of bull-bars belonging to each of the above categories and sub-group are presented in Figures 3.4 to 3.9.

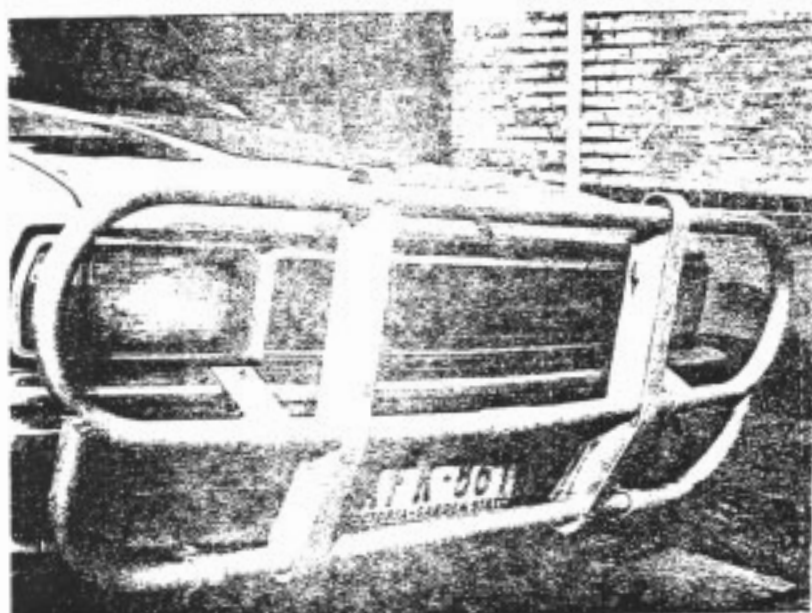
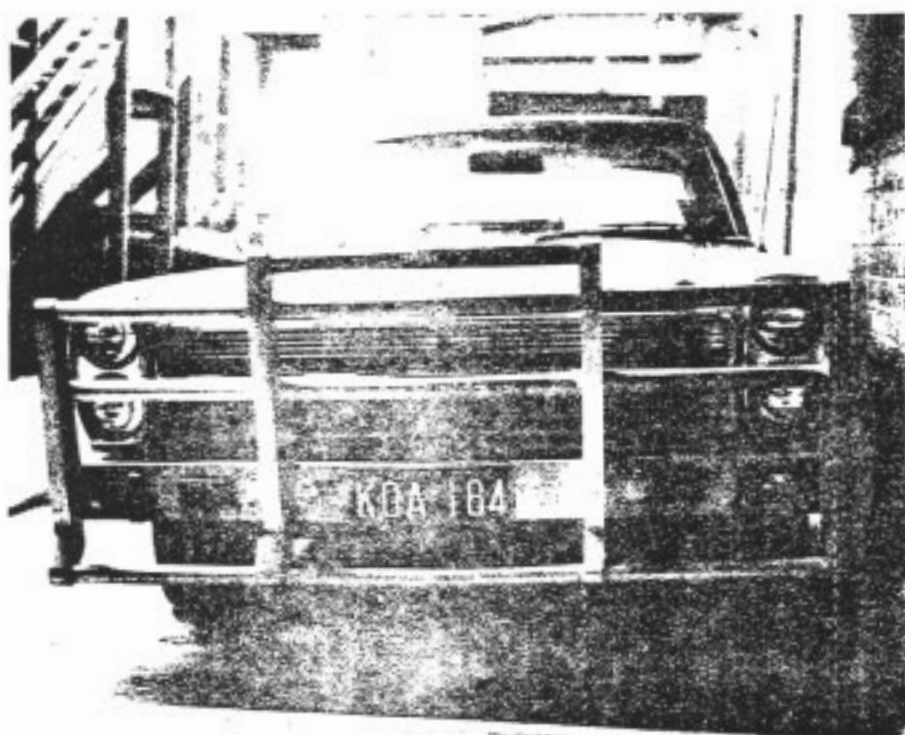
FIGURE 3.5 Aluminium structures. Note the secondary supports (top) and the removal of the bumper (bottom)

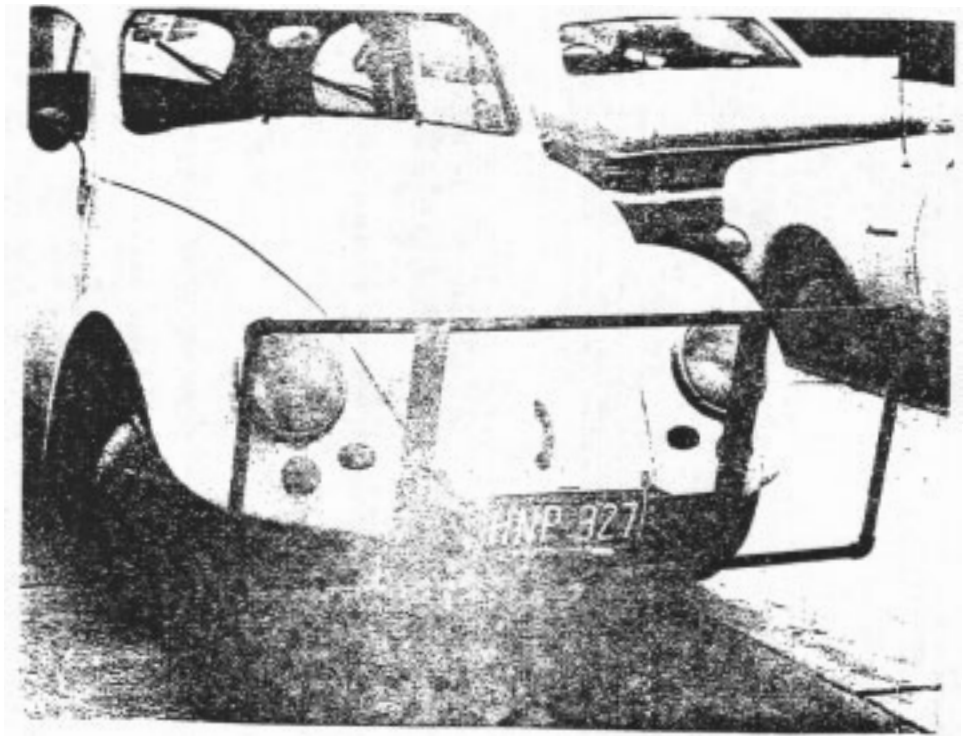
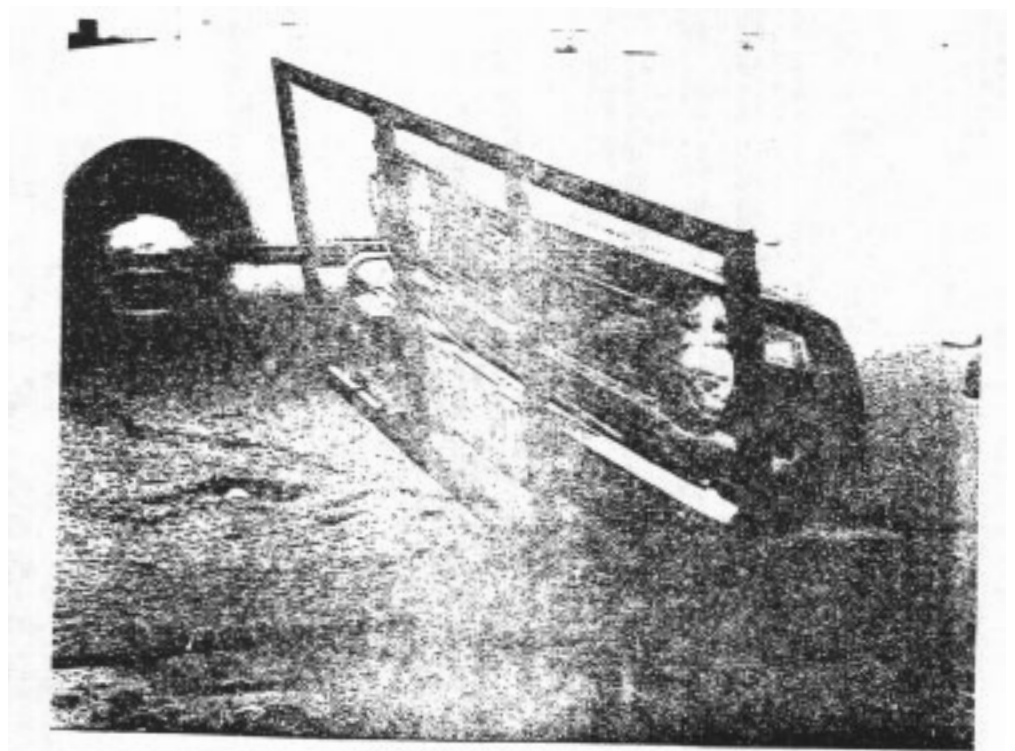
FIGURE 3.6 Steel bull-bars such as these are of arbitrary design.

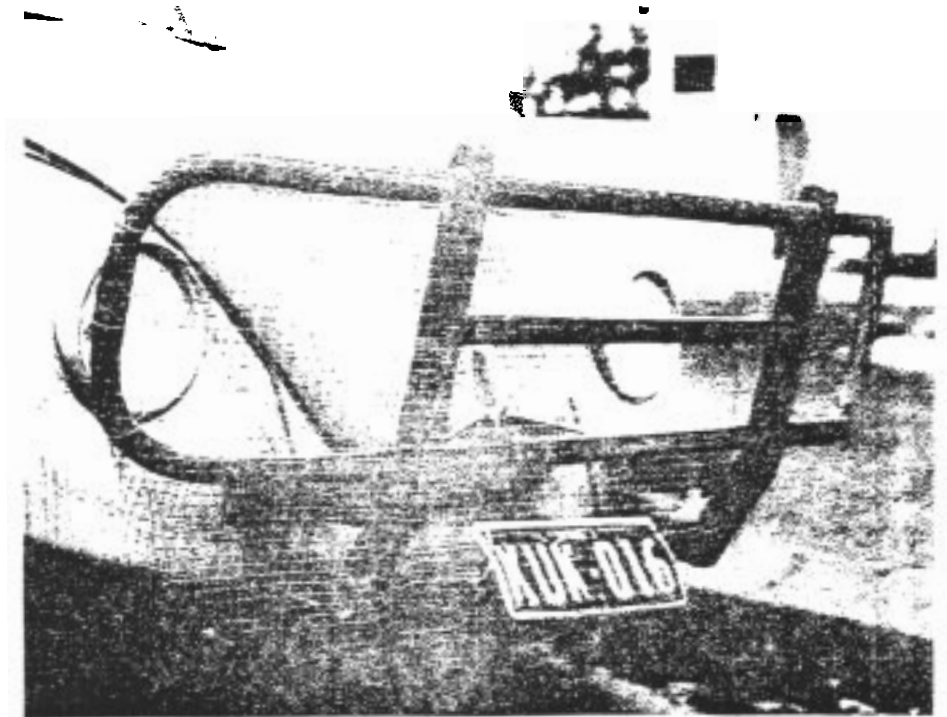
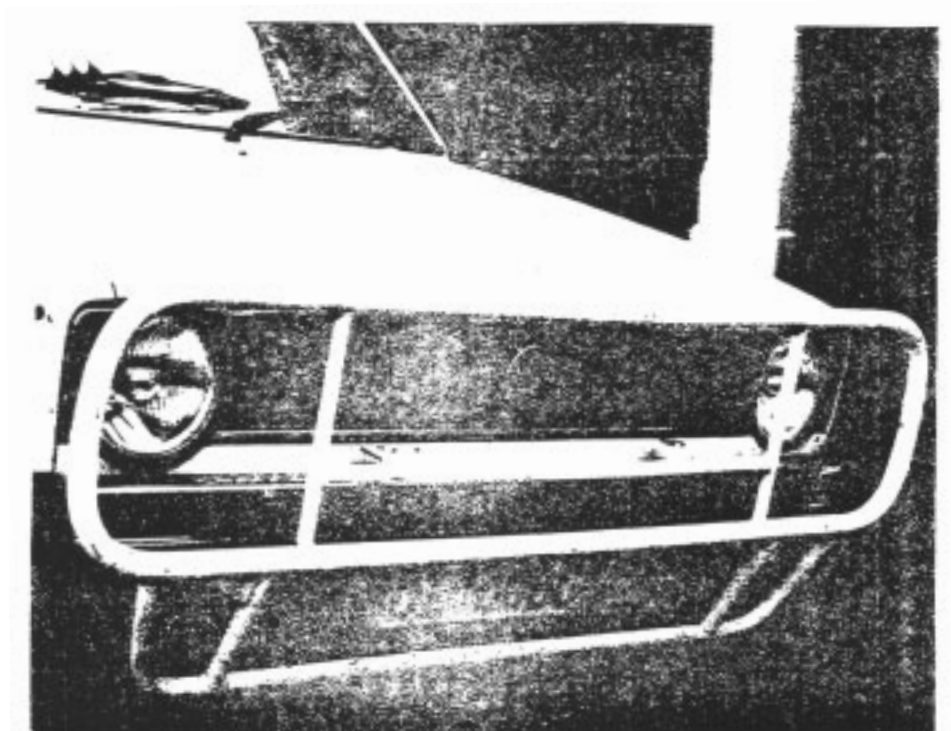
FIGURE 3.7 Tubular steel bull-bars were by far the most common structures found on motor cars in the Melbourne metropolitan area.

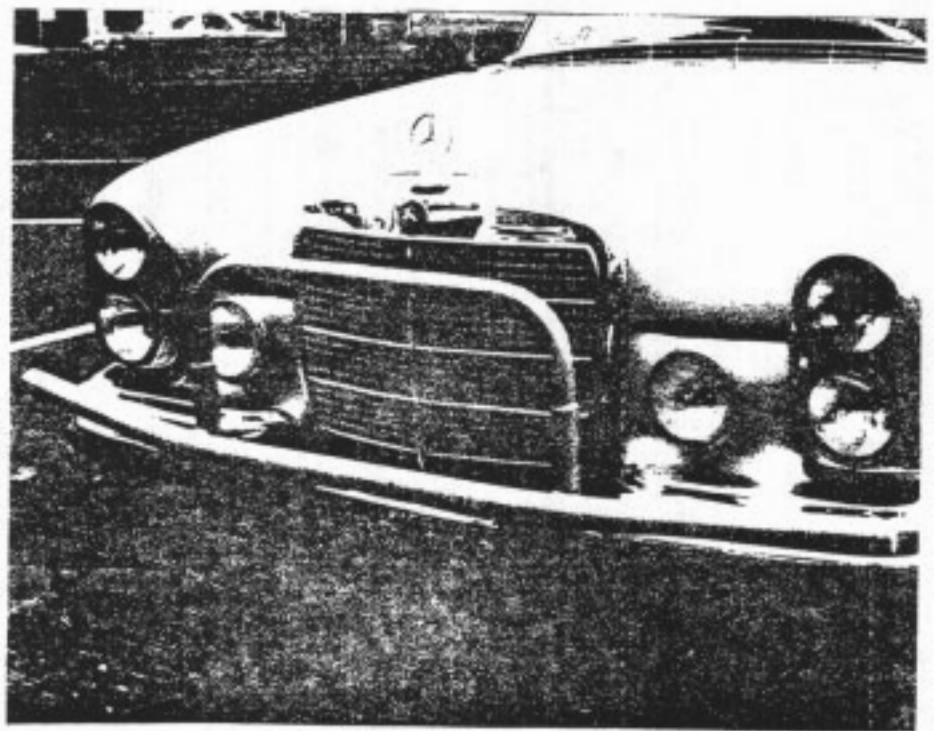
FIGURE 3.8 Small tubular steel bar

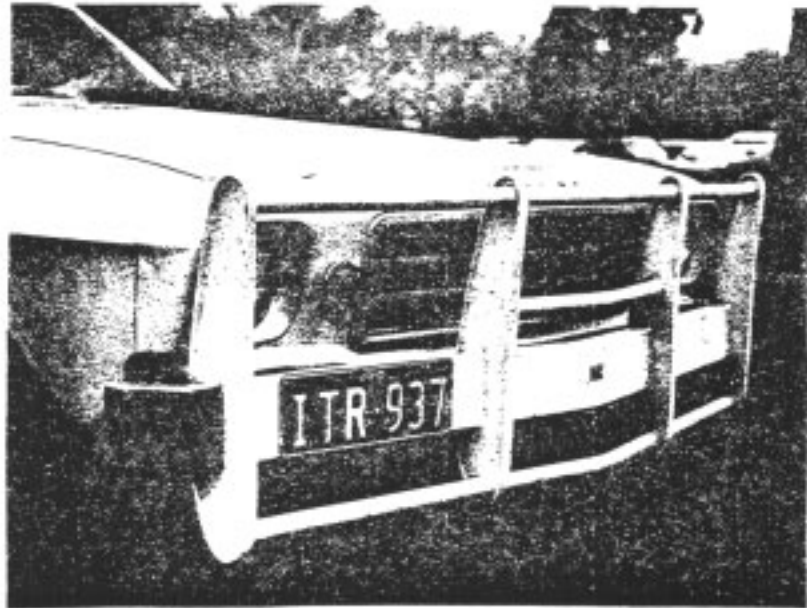
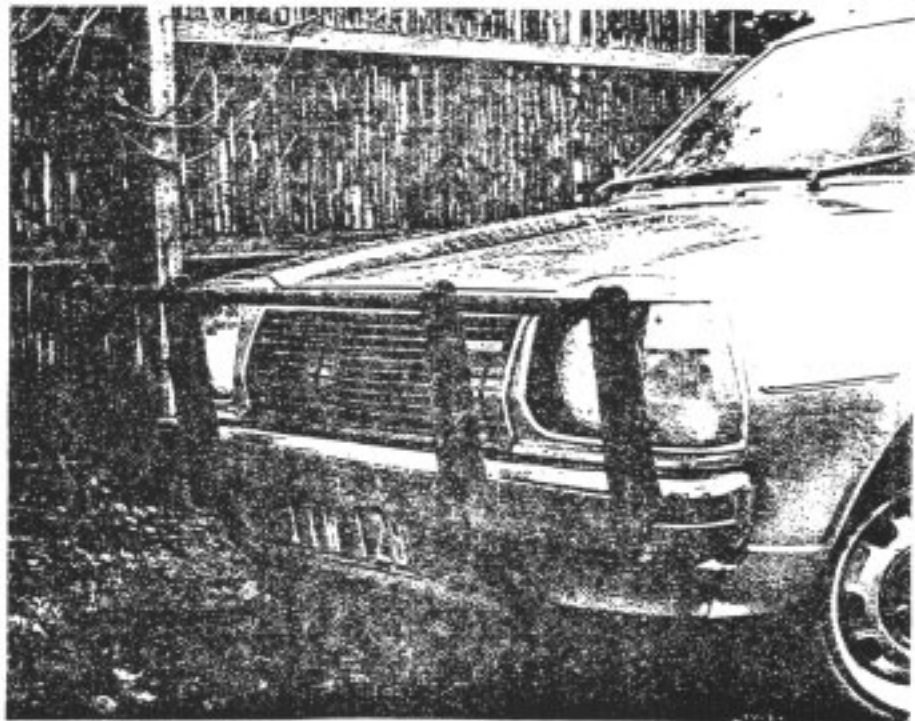
FIGURE 3.9 Truck-type structures are the heaviest group of bull-bars

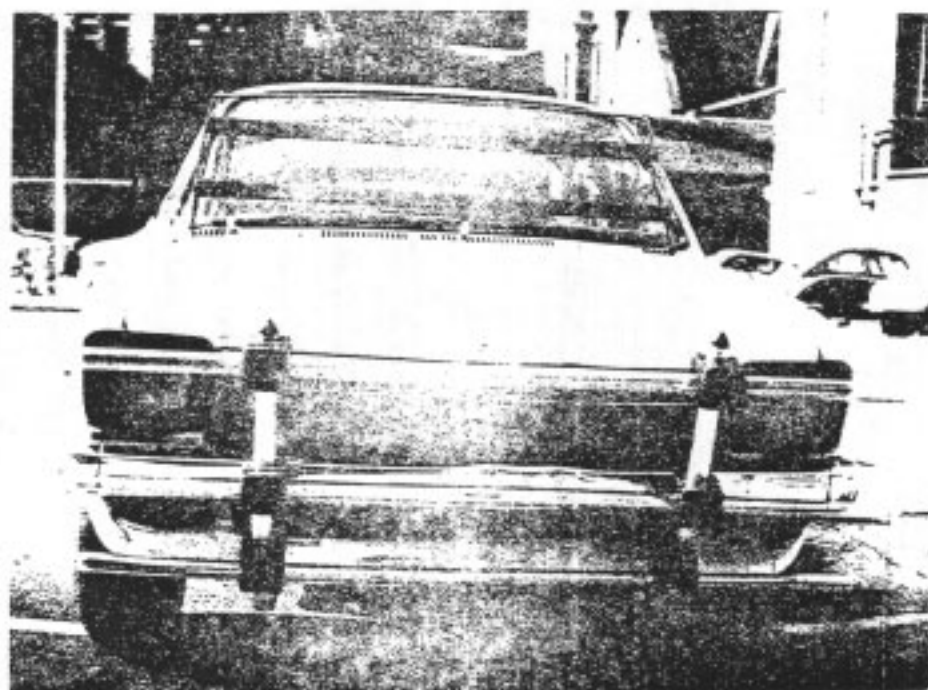
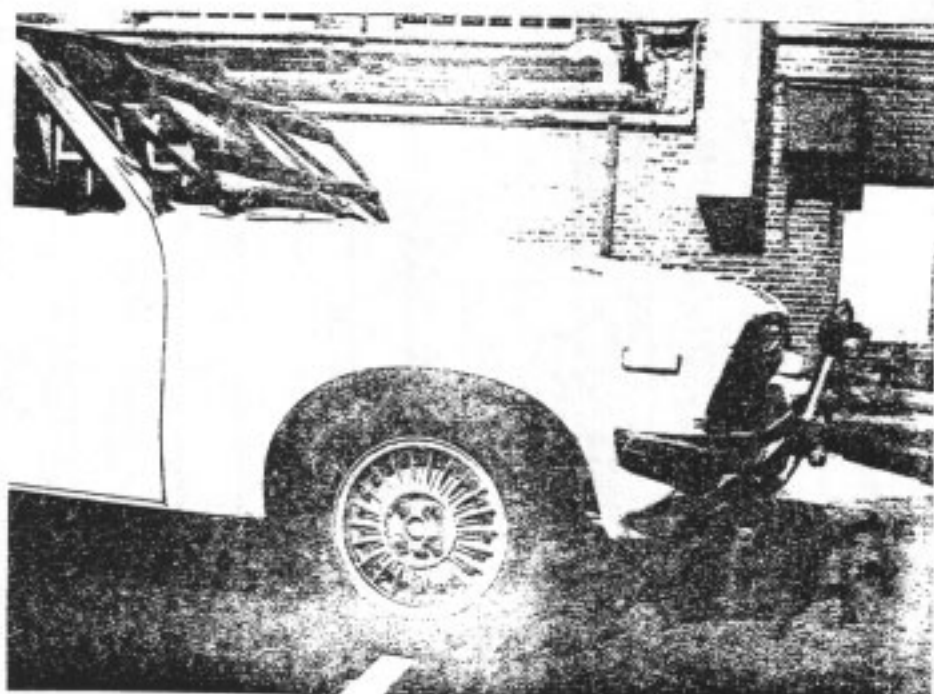
FIGURE 4.1 Thermoplastic bull-bar used in experiments with Genfini

The spacial configuration of the bull-bars with respect to the test car can be seen from figures 4.1 and 4.2.

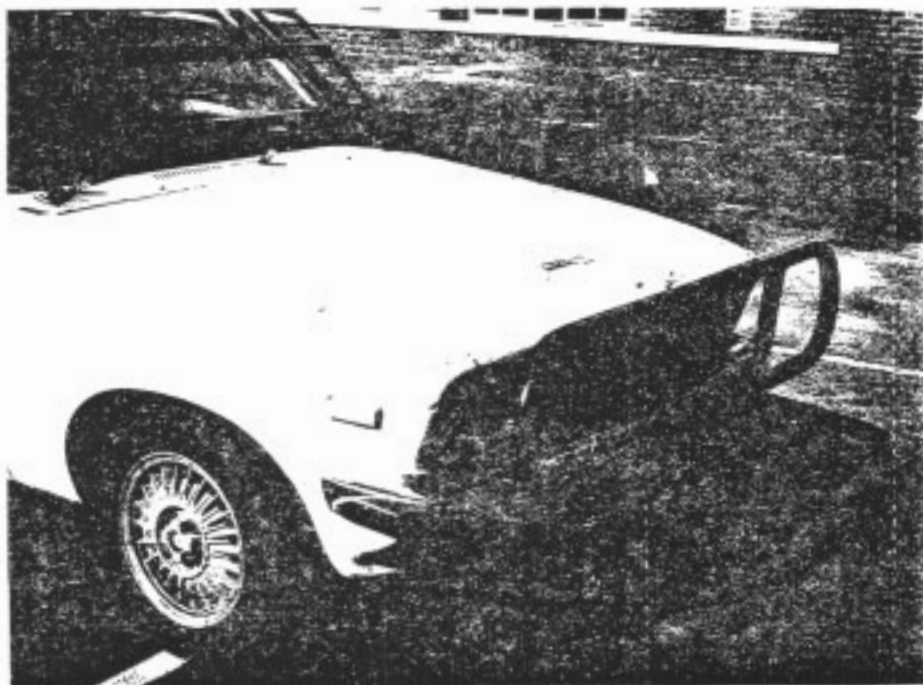
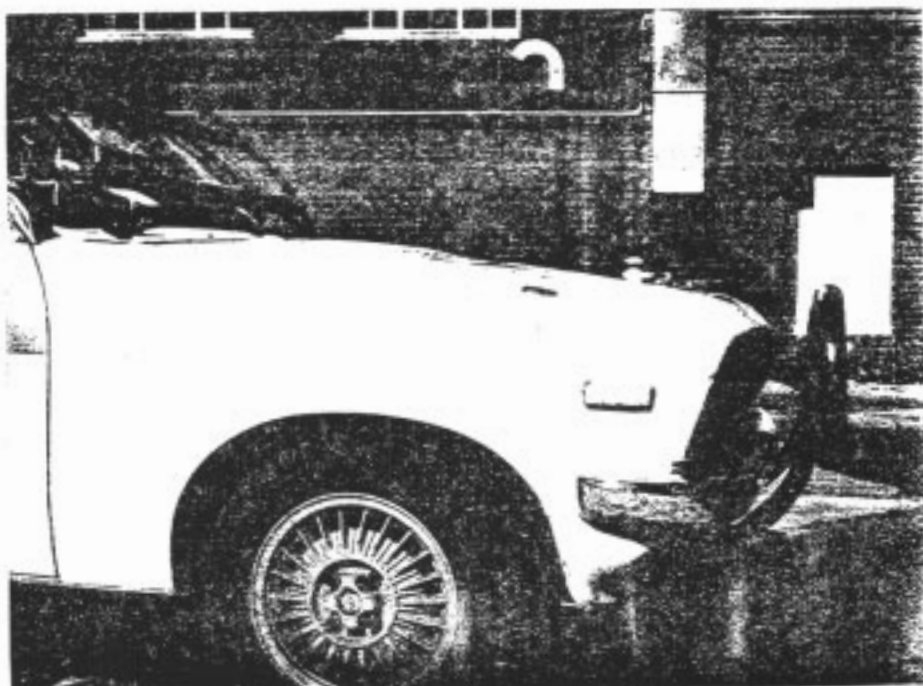
FIGURE 4.2 Tubular steel bull-bar used in experiments with Gemini

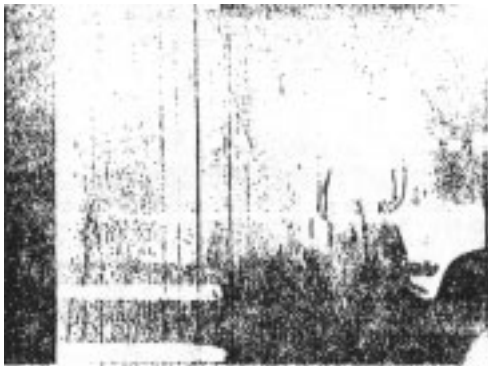
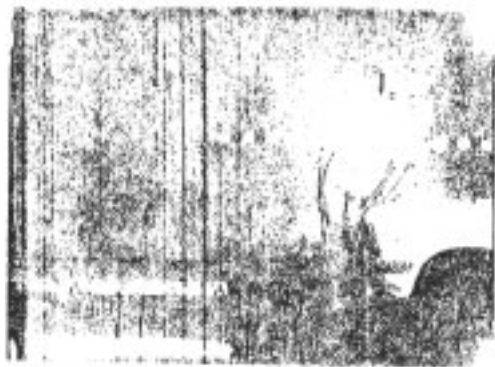
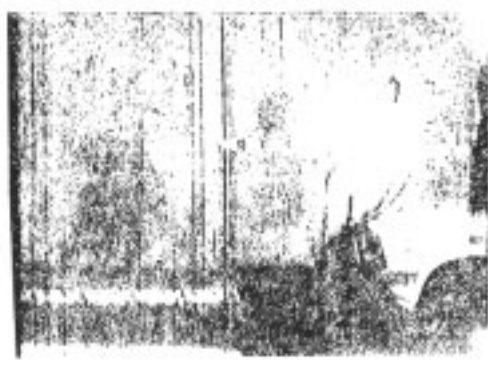
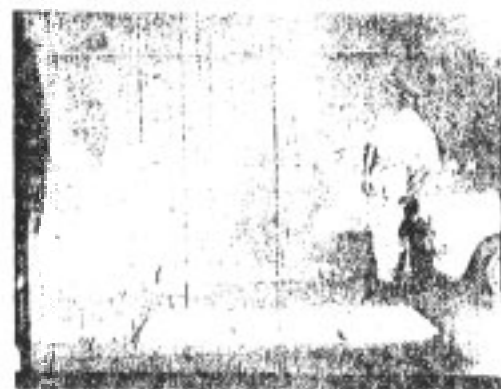
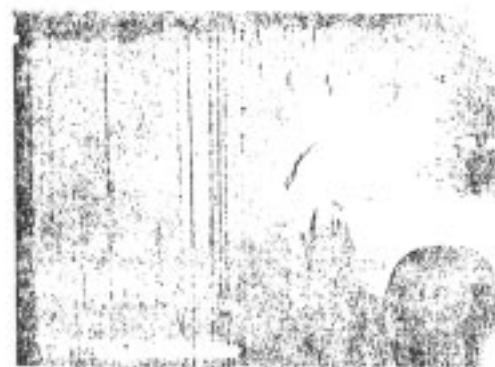
FIGURE 4.3 (Continued)

TEST G 2
thermoplastic bull-bar

TEST G 5
Tubular steel bull-bar

no bull-bar

thermoplastic bull-bar

The plastic bull-bar demonstrates the problem caused by an extremely 'soft' bumper. The almost negligible rigidity of the lower bar results in rotation of the body about the road contact point (the right foot being locked) during the first 50 ms. Compare the position of the right lower leg at 40 ms for the car without a bull-bar and that with the plastic bull-bar. In the first case the foot has slid on the road; in the second case it is still not moving. The photograph at 150 ms shows that the knee has fractured (the ankle had been stiffened after the previous test).

The effect of the elasticity of the upper bar can be seen from the frames at 300 and 360 ms. The rebound of the bar causes larger angular acceleration and a harder impact with the bonnet.

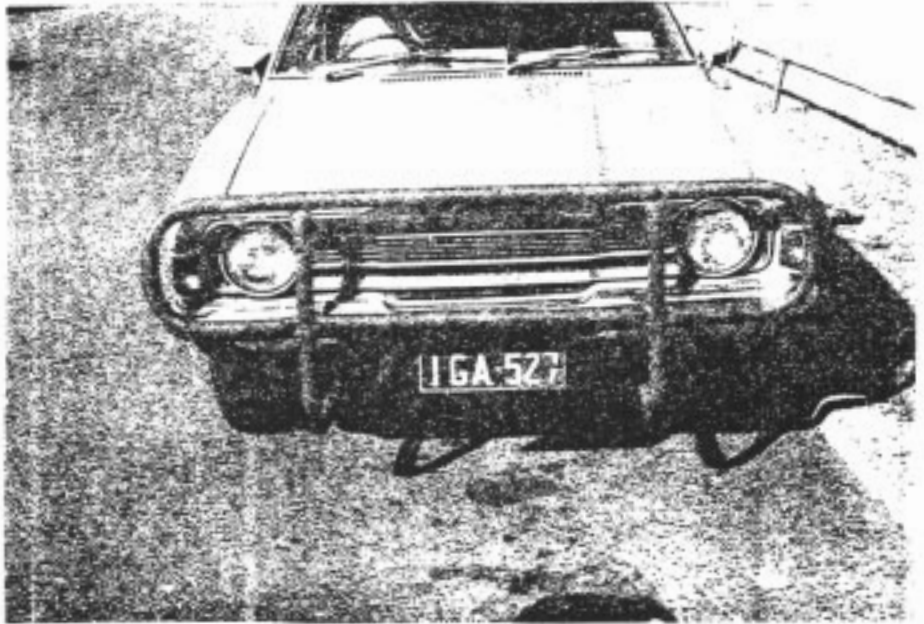
FIGURE 4.4 Tubular steel bull-bar used in experiments with HZ sedan

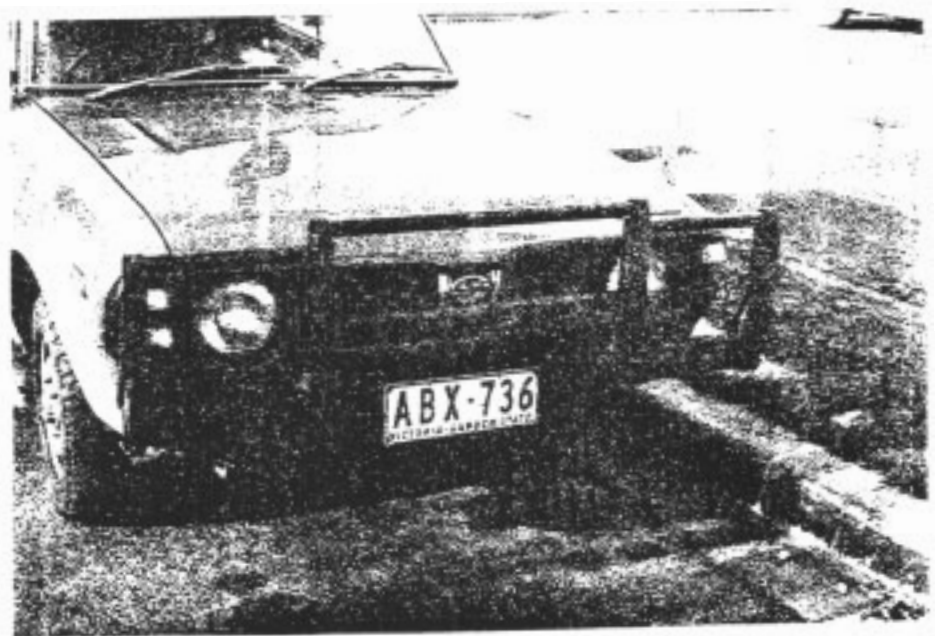
FIGURE 4.5 Truck-type bull-bar used in experiments with HZ sedan

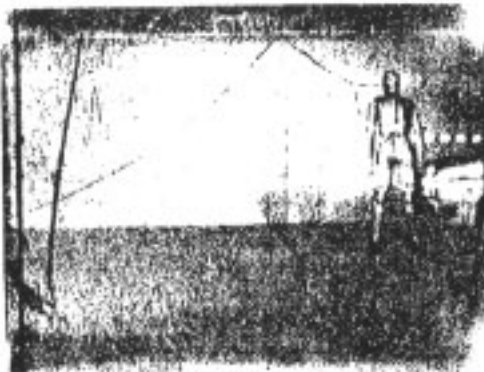
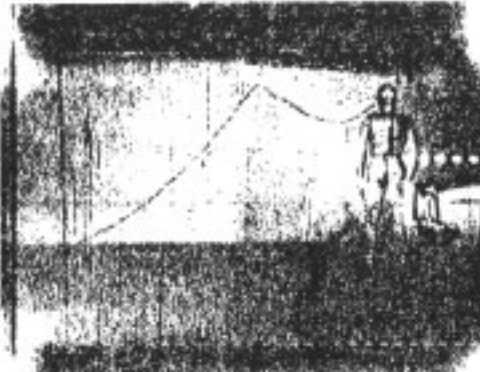
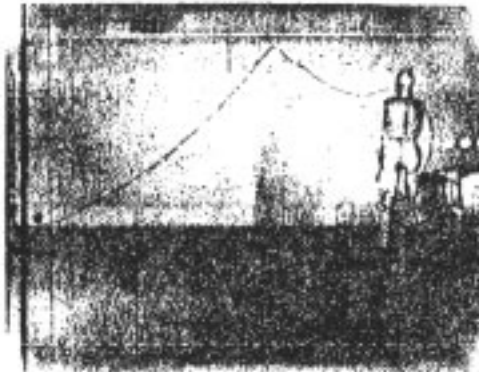
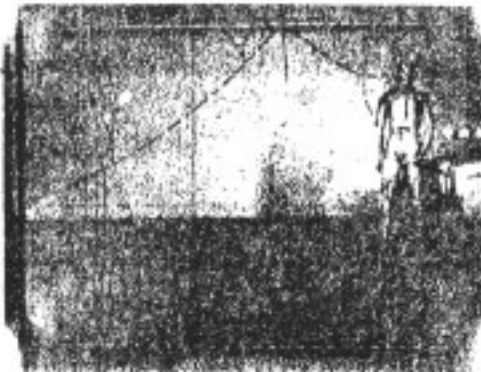
Car: Holden HZ Sedan automatic, curb weight 1370 kg, wheelbase 2819 mm

Test K 4
no bull-bar

Test K 1
aluminium bull-bar

Test K 3
Tubular steel bull bar

Test K 5
truck type bull-bar

The feet of the dummy in the test without a bull-bar are forced from the road after 90 ms. The aluminium bull-bar caused the right foot to be locked throughout the accident, the other two bull-bars effected release after 180 ms. The right ankle would have fractured in all the experiments with the bull-bars. (Note: The ankle and knee of the right leg had been stiffened after repeated damage had been experienced in tests with bull-bars, to save repair time).

The effect of the bonnet edge on the severity of the secondary impact with the road is demonstrated by the last frames and by the final position of the dummy. The head severity index from Table 4. for the truck type bull-bar would cause a severe injury to a pedestrian at impact of 20 km/h when there would be no injury if the car had no bull-bar.

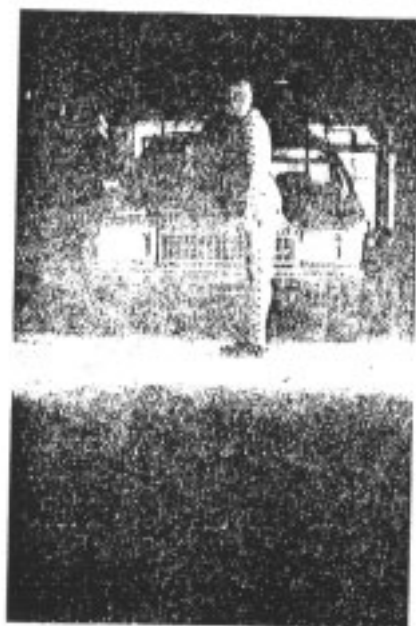
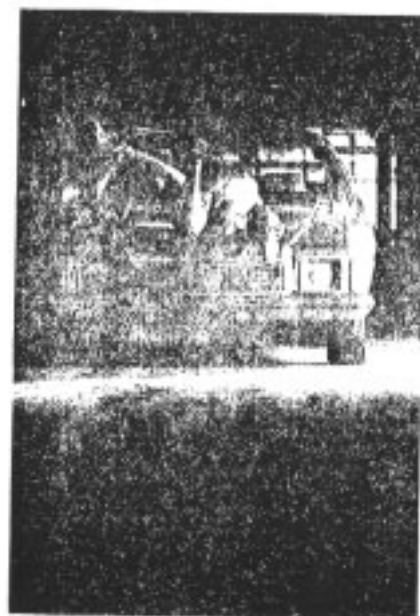
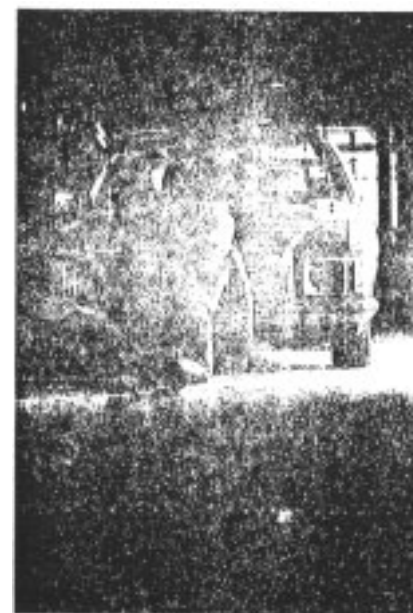
FIGURE 4.7 - 20 km/h impact - no bull-bar

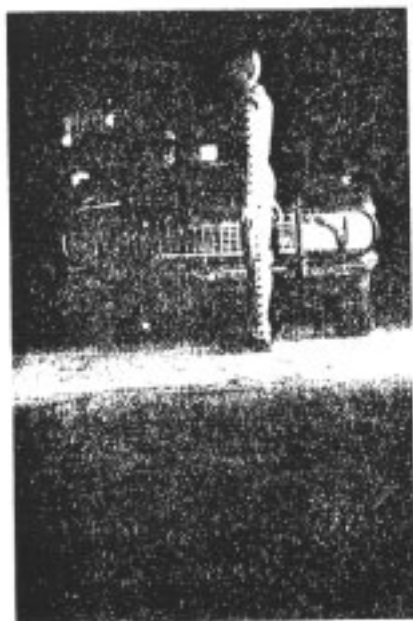
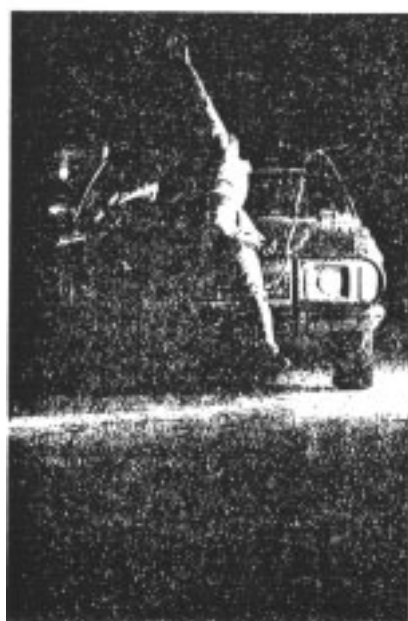
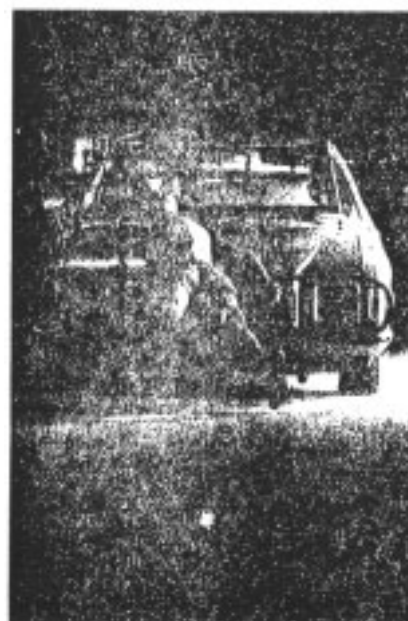
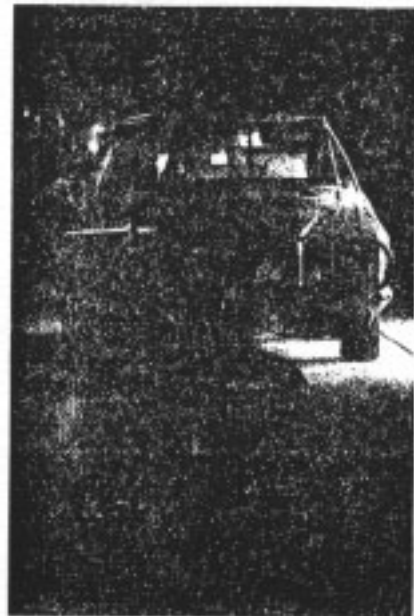
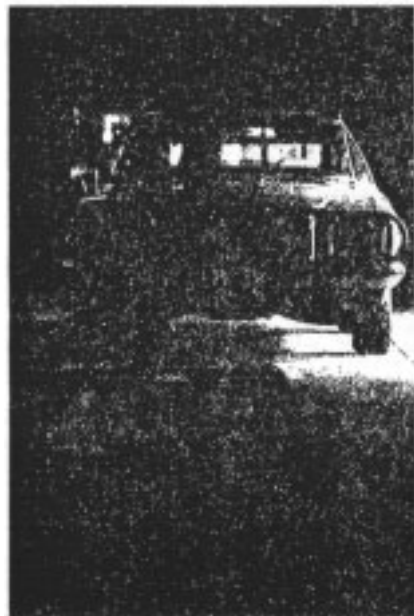
FIGURE 4.8 20 km/h impact - Tubular steel bull-bar

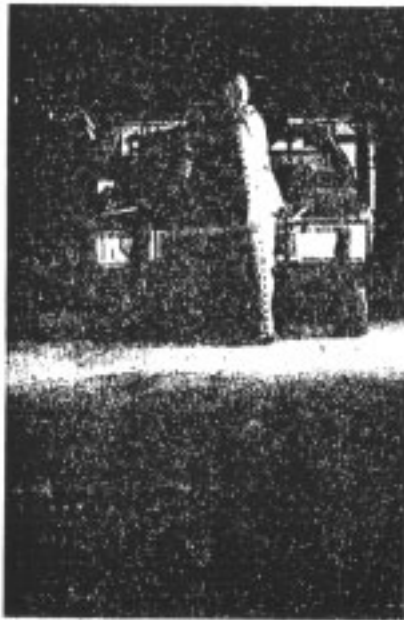
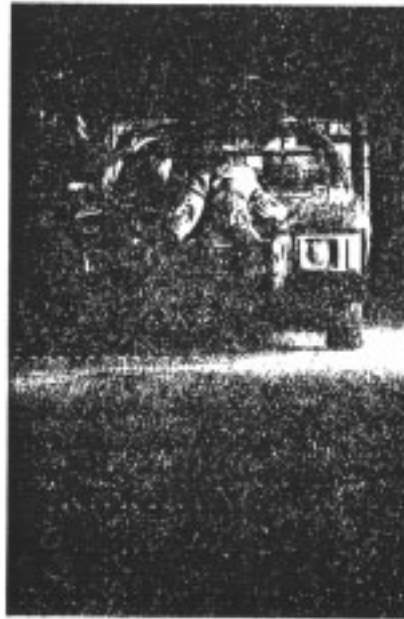
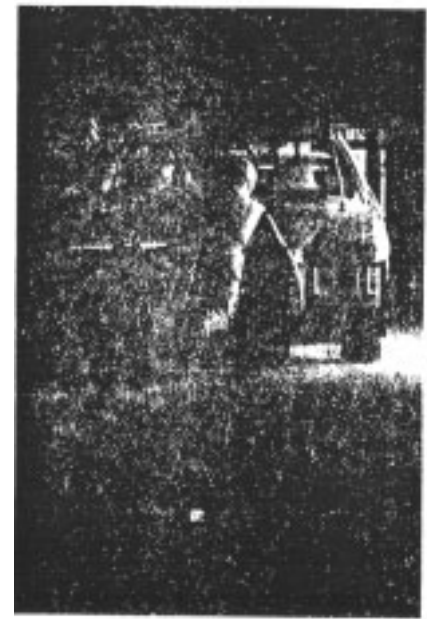
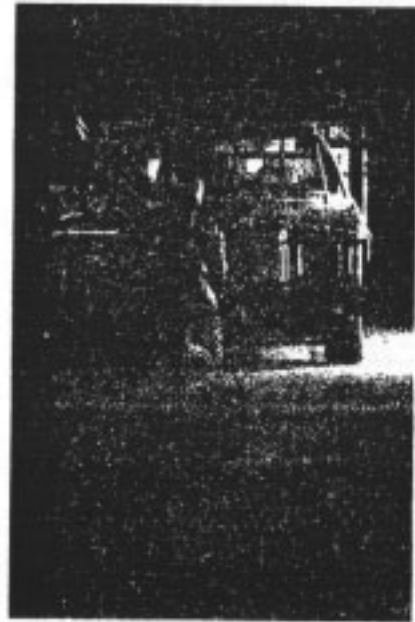
FIGURE 4.9 - 20 km/h impact - Truck type bull-bar
