SAFETY REQUIREMENTS OF BUS
SEATS AND SEAT ANCHORAGES

A. H. DIXON
J. F. WILLIAMS
P. N. JOUBERT

DEPARTMENT OF MECHANICAL ENGINEERING
UNIVERSITY OF MELBOURNE
PARKVILLE VICT.

SEPTEMBER, 1981

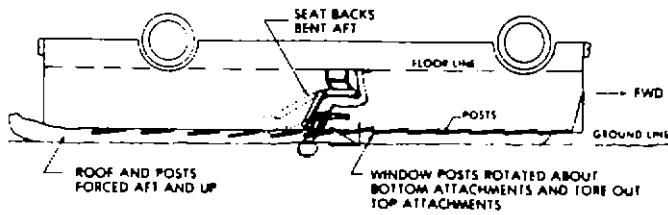
Fig.1.1 Bus position after impact, showing collapse of roof to bottom of windows.
(Ref.15)

In a paper entitled "Autopsy of a Disaster: The Martinez Bus Accident" ¹⁵, the investigation of a bus accident which resulted in the vehicle landing on its roof is outlined. Twenty-nine of the fifty-one passengers died. In the opening paragraph of the report, the authors noted that the passengers who remained in their seats during the roll and impact, or those who were thrown into the space between the seat backs and the roof, suffered severe crushing injuries from the collapse of the roof (Fig.1.1 and 1.2). Those, however, who were thrown out of their seats into the spaces between the seats were somewhat protected as most of the seats remained attached to the floor and did not collapse. The combination of forward and downward impact forces applied to the roof resulted in the folding of the window pillars at the waist rail (bottom of the windows). Those passengers who were still sitting in their seats or who had been thrown between the seats and the roof were subjected to severe crushing blows.

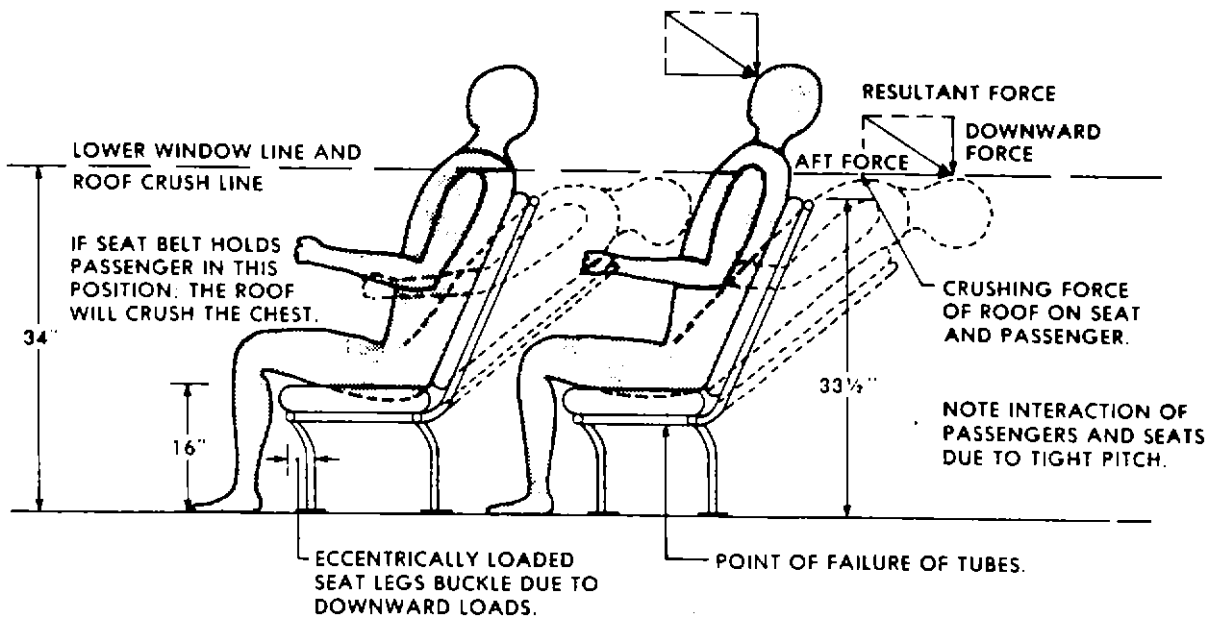
Fig.1.2 Diagram showing relation of collapsed roof to seat backs, and crushing forces likely to be produced on passengers.
(Ref.15)

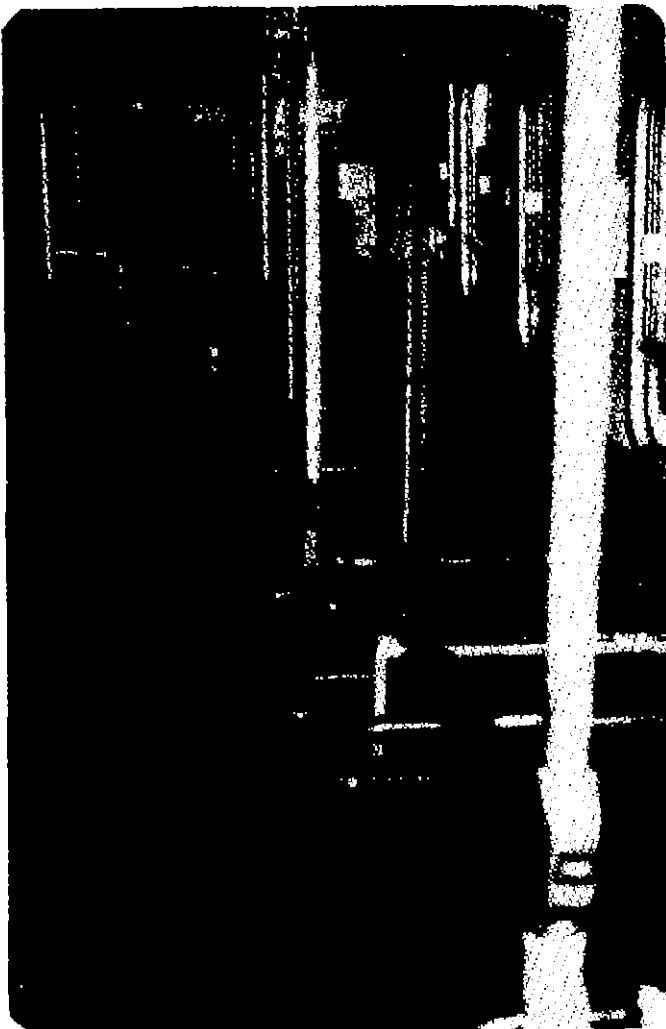
Photograph 1.1

A new transit bus interior. Note the large number of stanchions and the integration of stop buttons into the stanchions. These stop buttons help to keep seated passengers in their seat until the vehicle has stopped. The two stanchions shown on the far left near the entrance to the vehicle also have elevated stop buttons for standee passengers. Note also the prominent grab rails near the entrance area and the roll top seat backs.

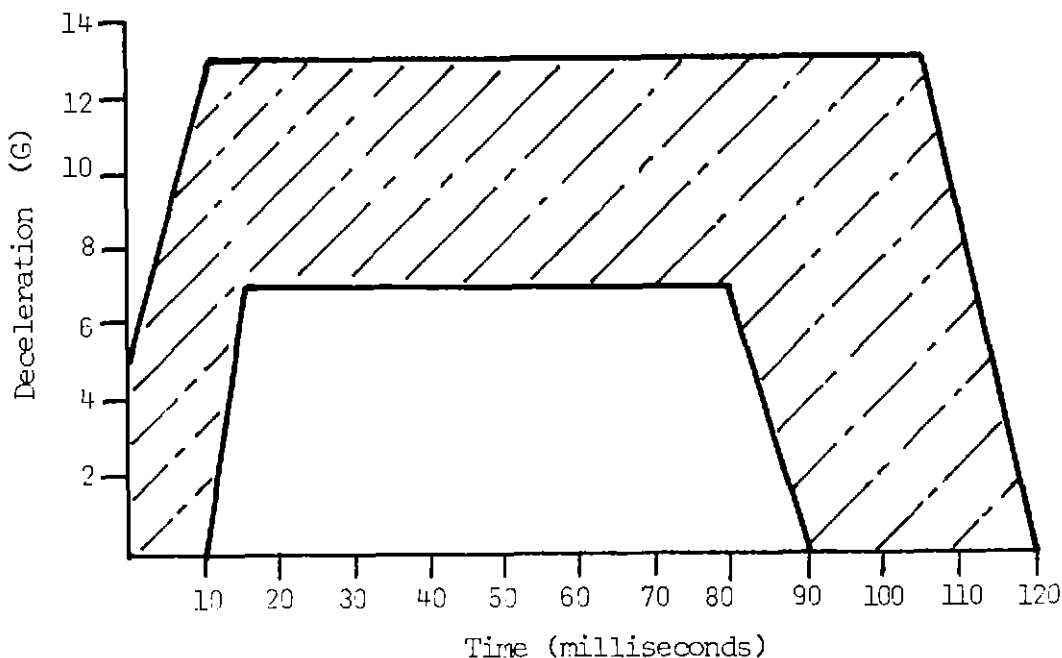
Note: The deceleration of the test platform should remain within the hatched area and peaks must not be outside this area for more than a total of 5 m.sec.

Subsequently, a dynamic test was developed to test the capability of the seat and its anchorages to retain an impacting occupant from the seat immediately behind, when subjected to a deceleration of 10 G from 32 kph. It involved a specified deceleration envelope for the test platform as shown in Fig.3.4.

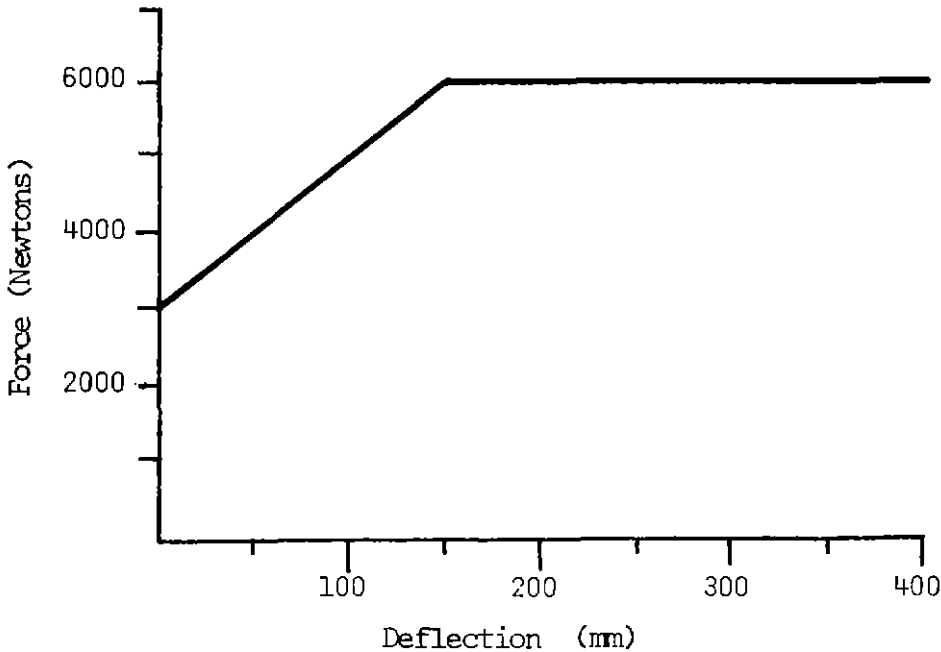
Fig. 3.5

for the static test had to fall within. This envelope is very similar in part to the American specification, although the Hungarian envelope involves a ceiling load 11% higher than the American specification and does not stipulate any minimum load requirement. The stiffness envelope is shown in Fig.3.5.

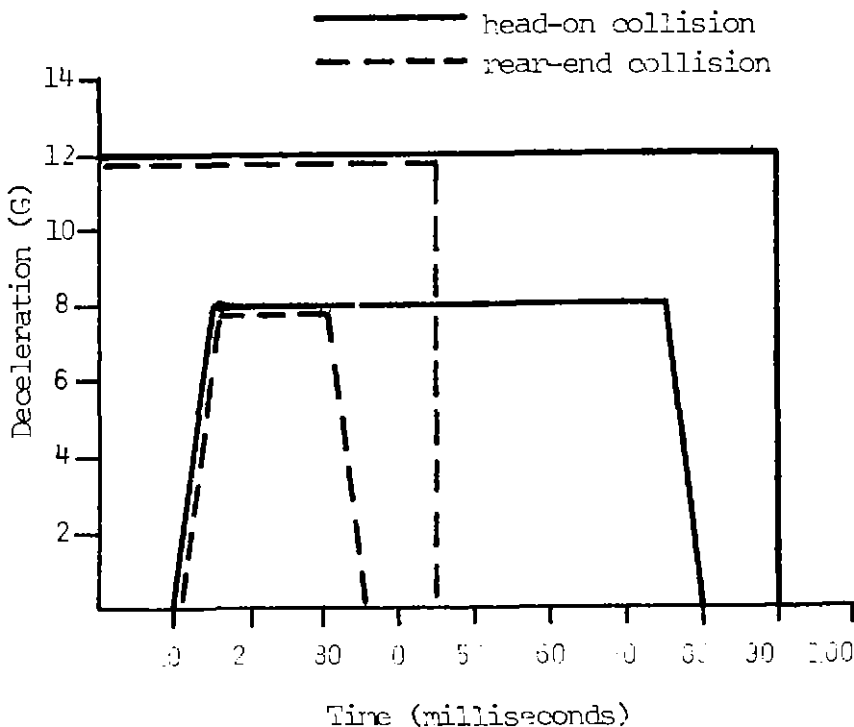
Fig. 3.6

This draft also defines the deceleration envelope of the dynamic test sled for both head-on and rear-end collision reproduction Fig.3.6.

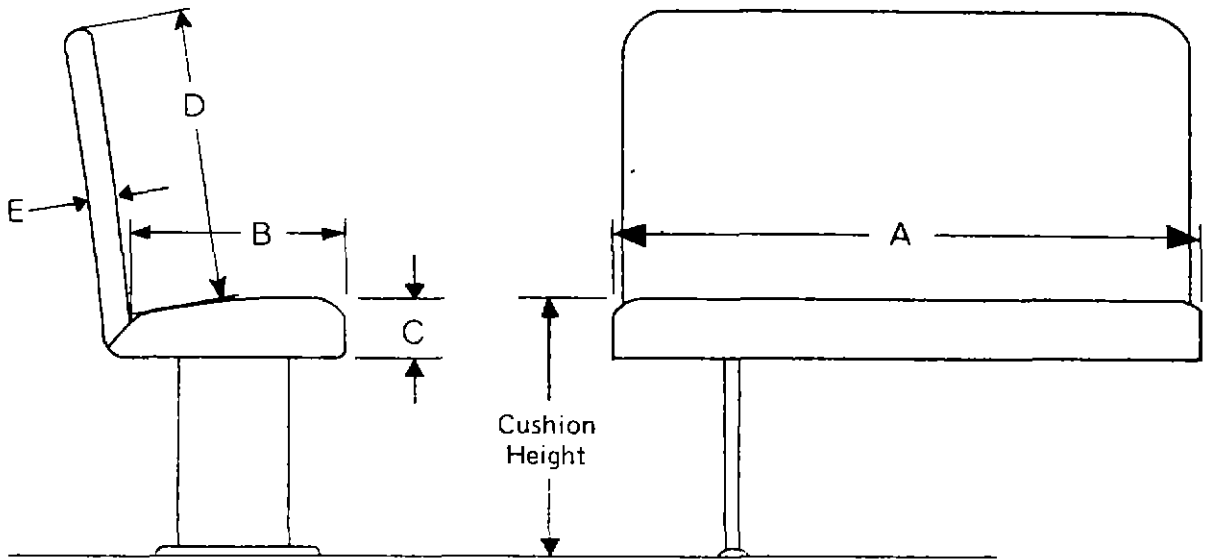
Fig.3.10 Omnibus Seating Standards Dimensions

If Figs.3.7 and Table 3.1 are compared with Fig.3.10 and Table 3.2 which are the equivalent seat dimension standards set down by the TRB of Victoria, it can be seen that the dimensions are very similar. Furthermore, the TRB regulations make particular note about seat spacing which is to be 660 mm and "measured horizontally on the centreline of the seating position at the level of the highest point of the seat cushion on the seat centreline".

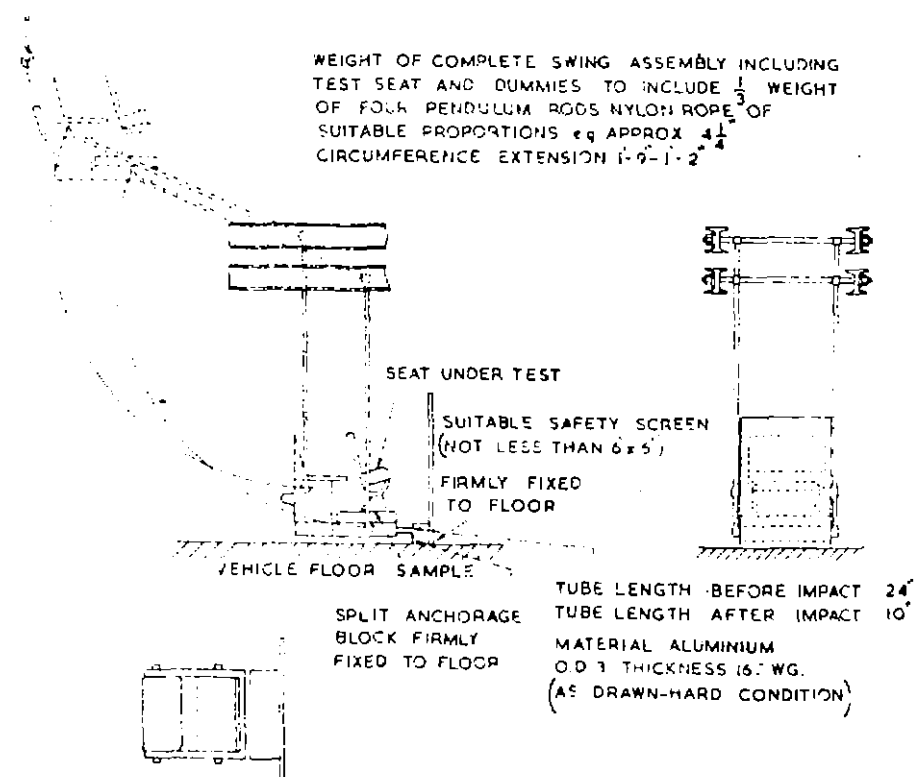
DEPARTMENT OF THE ENVIRONMENT
RIG FOR TESTING P.S.V. SEAT FRAMES

It would be possible to establish a much simpler dynamic test which would merely load the seat in a dynamic mode by means of an uninstrumented dummy. The result of the test would be subject to the interpretation by a qualified person of the damage to the dummy and the seat on completion of the test. The machinery necessary for such a test-bed would also be simpler and could be based on a pendulum design as in Fig.3.11. Such a device requires a simple means of winching the load to the required height.

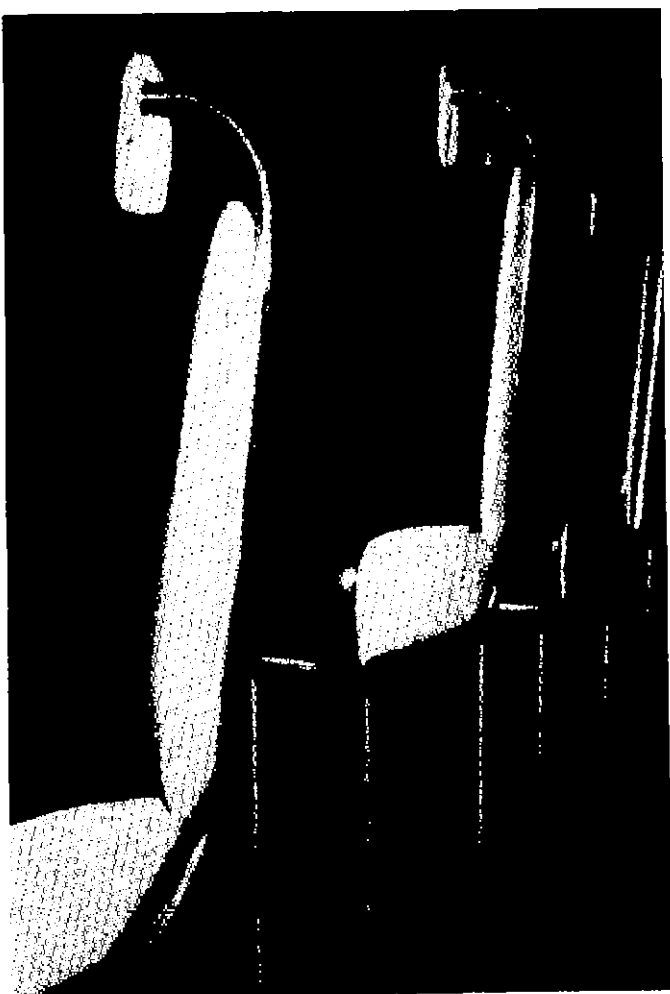
Photograph 4.11. An example of the roll-top seat. Note the increased height of the middle seat and the extra stiffening tube running between the legs. Two tabs, instead of one flat plate are welded to the seat legs to allow anchorage to the floor.

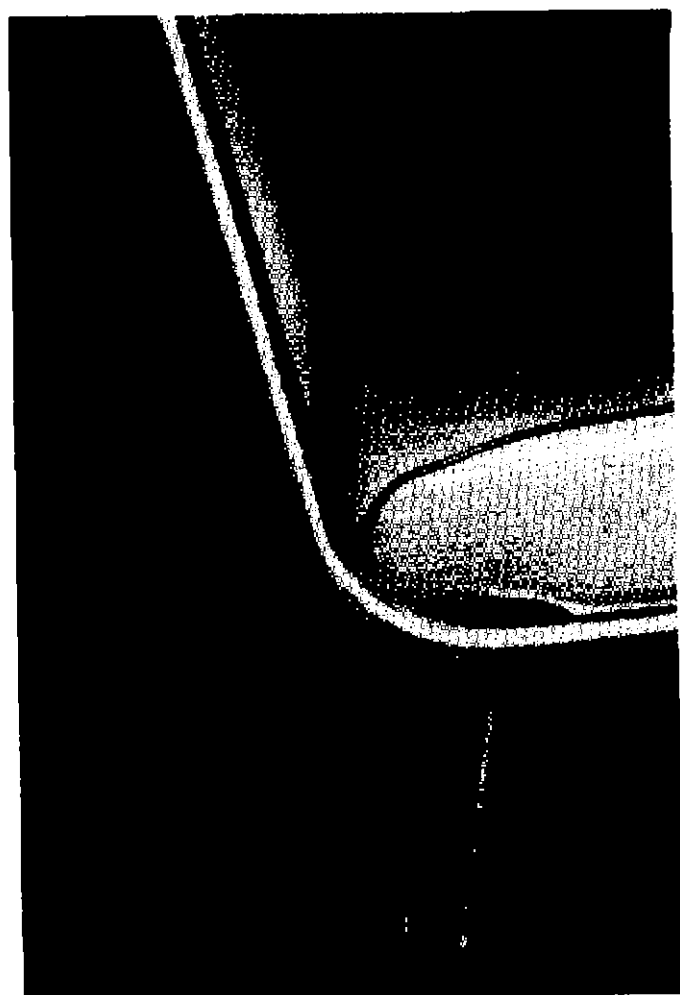
Photograph 4.12. A route bus seat exhibiting a thinly padded seat back.

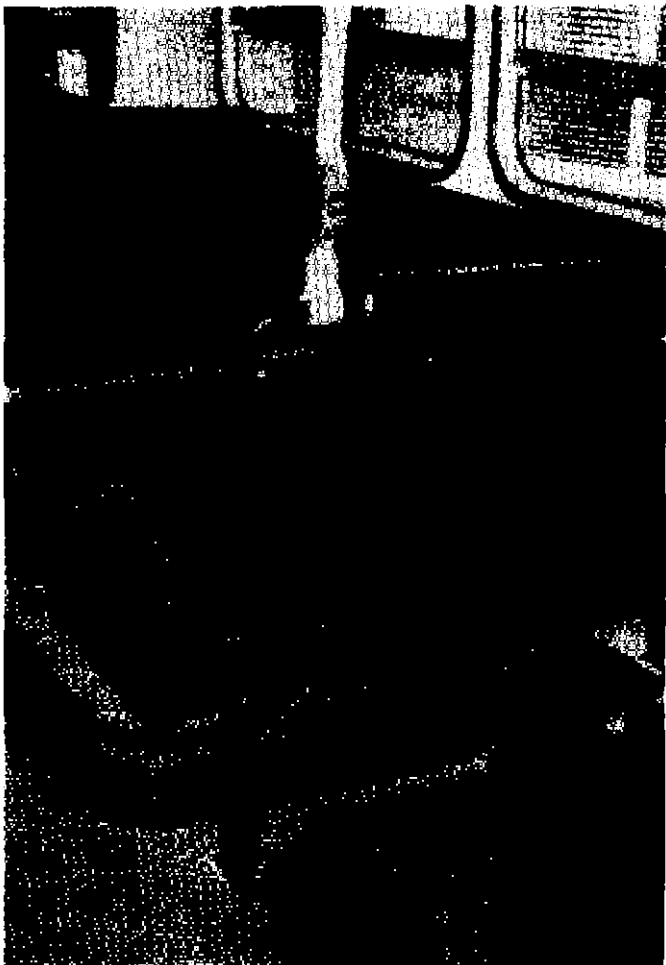
Photograph 4.14. The new generation transit bus. Note the large intrusion of the wheel arch into the passenger compartment due to the low floor height. The step seen in the photo may cause passenger falls while getting into or out of their seats. Note also the roll-top seat, small but laterally braced pedestal leg and the stop button integrated into the seat back attached stanchion.

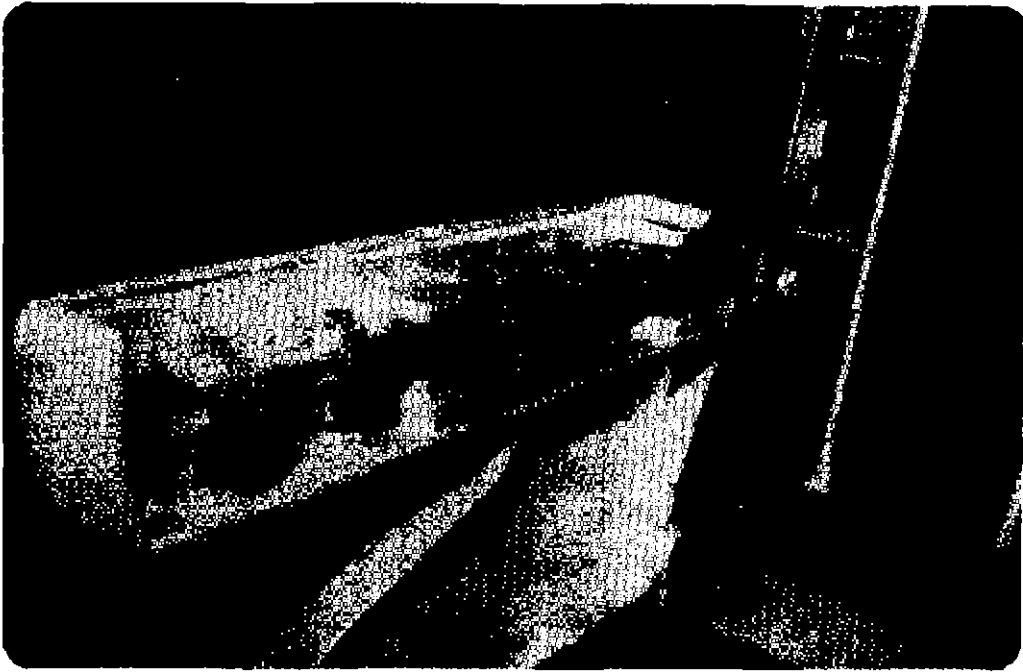
Photograph 4.15. A typical positive locking incremental reclining mechanism. Note pivoting point for the seat back on the armrest and the bush welded into the seat squab tubing which allows the securing of the reclining mechanism.
