Fact Sheet Norfolk Island PFAS Preliminary Site Investigation

In early–mid 2020, environmental consultants Senversa undertook a PFAS Preliminary Site Investigation (PSI) on Norfolk Island. The objectives of the PSI included investigation of potential PFAS source areas, identification of PFAS migration pathways and sensitive receptors, and the targeted assessment of drinking water sources across the island.

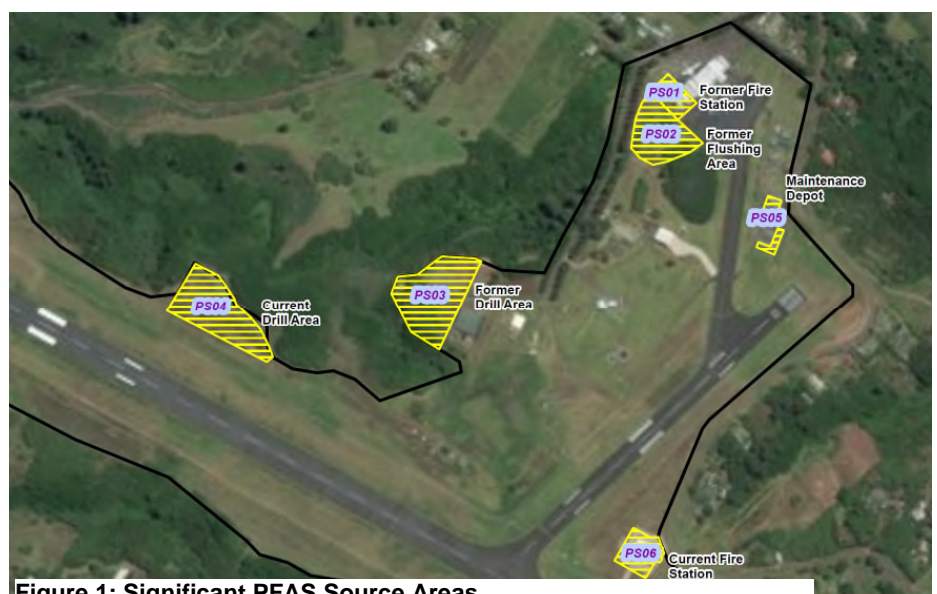
Figure 1: Significant PFAS Source Areas

Through review of historical land use and activities that used legacy AFFF, potential PFAS source areas were identified on and off the airport. Six on-airport areas (shown in **Figure 1** below) have been identified as the most significant potential source areas, as heavier application occurred for several years in these areas.
