# Christian's Minde Settlement, Jervis Bay Territory

Historic Heritage Management Plan—Volume 2 Inventories

June 2025

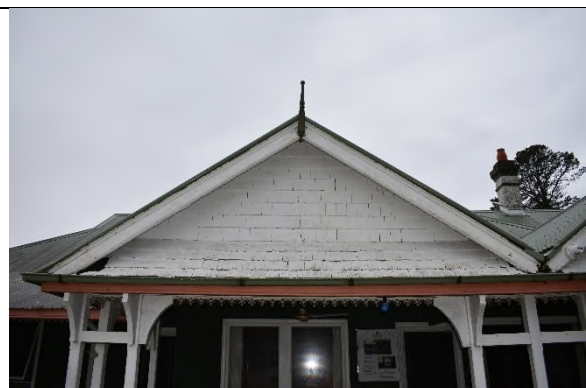
Figure 42 Shingled gable end, southwestern elevation.

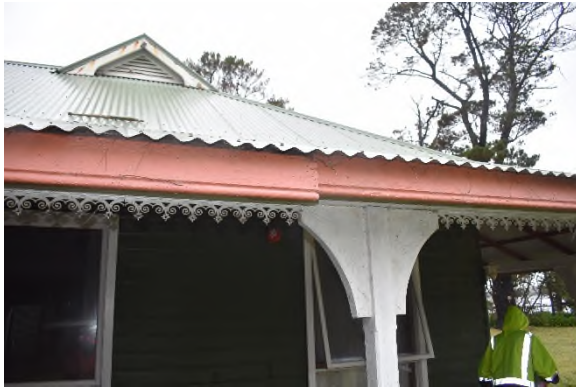
Figure 49 Misaligned fascia and plastic decorative lace work.

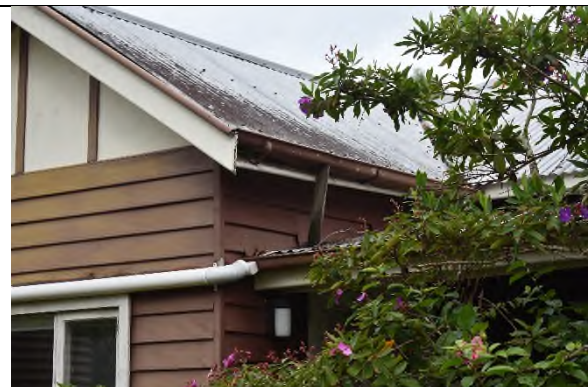
Figure 75 Ad hoc support for a gutter on Ardath Cottage.

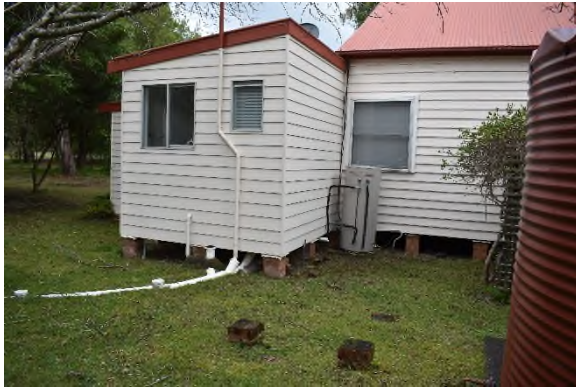
Figure 90 Northern elevation showing unsympathetic installation of services.

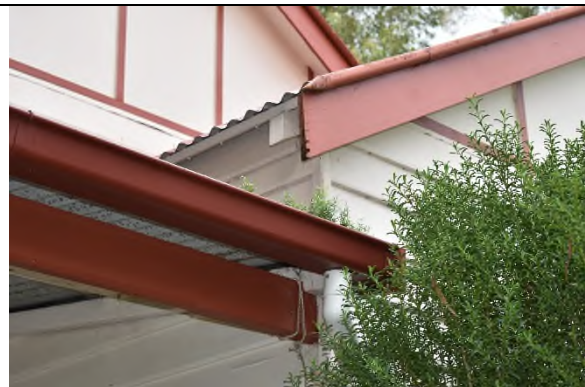
- The whole building is dirty and full of cobwebs. There is moss growing on shaded walls and gables, and leaf litter on the roof.
  - There are several areas of peeling paint.
  - Missing fascia and soffit lining on the southern side.
-

Figure 95 Vegetation growing in gutter of Pamir Cottage.

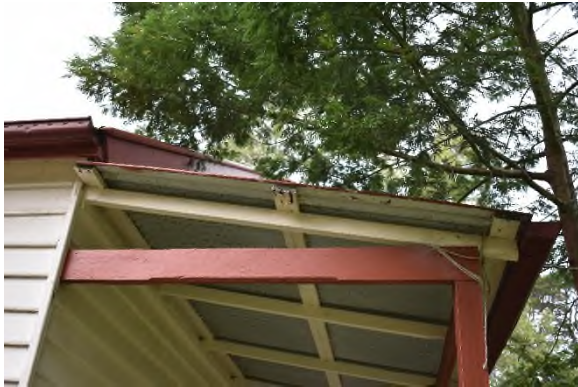
Figure 96 Verandah sheeting with no gutter.

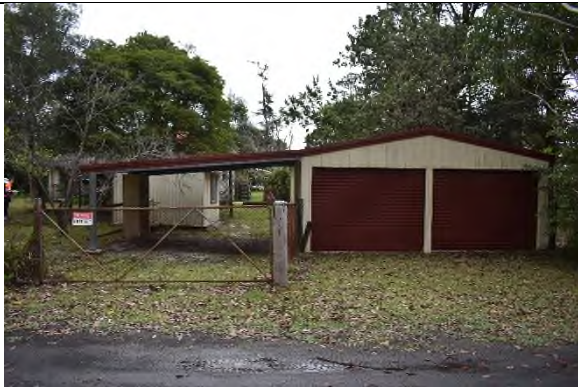
This building is in poor condition and is really only useful for storage.

Figure 98 Garage and other outbuildings.

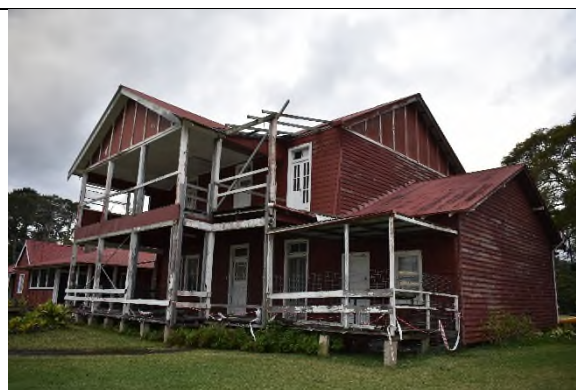
The main roof is pitched at c30 degrees with a single ridgeline running parallel to the building frontage and large gables on each side clad in fibre cement sheet with timber battens that are damaged. A transverse gable runs forward over the front verandah (western side). The narrow eaves are generally clad in timber boarding, with square profile timber fascias and bargeboards. The soffit lining is missing on the southern side at both the upper and lower levels. The original painted, corrugated galvanised steel roof has been re-sheeted with Colorbond steel, including flashings. There is no barge flashing to the gables, which allows water to enter the roof. On the upper storey on the southwestern corner a section of verandah roofing has been blown off in a recent storm.

Figure 130 Christian's Minde southwestern corner. Note verandah framing on upper level where roof sheeting has blown off.

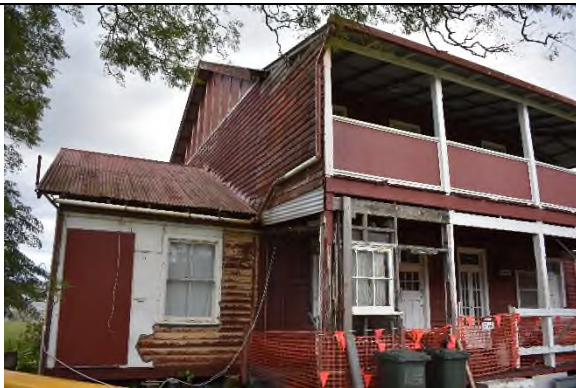
Figure 133 Southeastern corner of Christian's Minde. Exposed weatherboard on left and inset window in verandah are the location of a removed annexe.

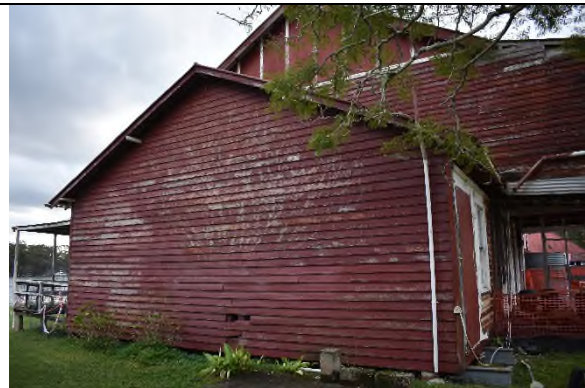
Figure 134 Southern elevation, with gaps in weatherboard on lower part of wall.

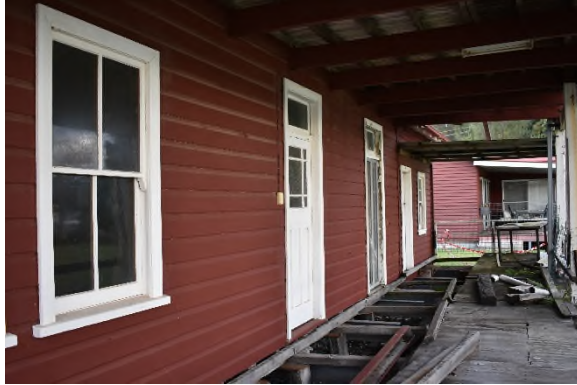
- Building appears to be on a lean towards the southeast.
  - Gutters are damaged or completely missing in many places.
  - Verandah has incomplete works, with timber floorboards removed for subfloor access.
  - Timber piers are decaying (metal support beams have been inserted to provide temporary replacement support).
  - A number of timber verandah elements are deteriorating, including posts, bearers and joists.
-

Figure 139 Western verandah, with removed floorboard to provide access to subfloor space.

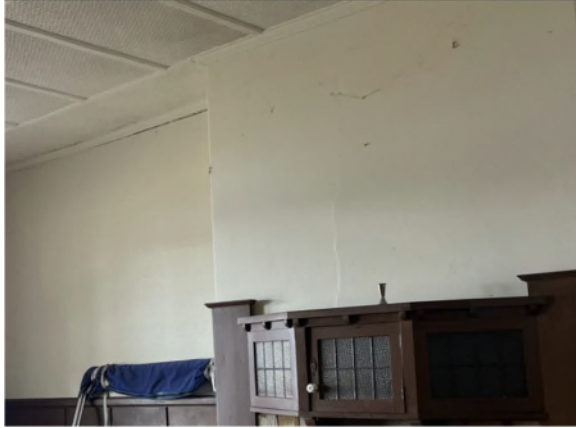
Figure 147 Ground floor interior, 2024, showing potentially significant cabinetry. (Source: ACOR Block 14 Building Audit Report)

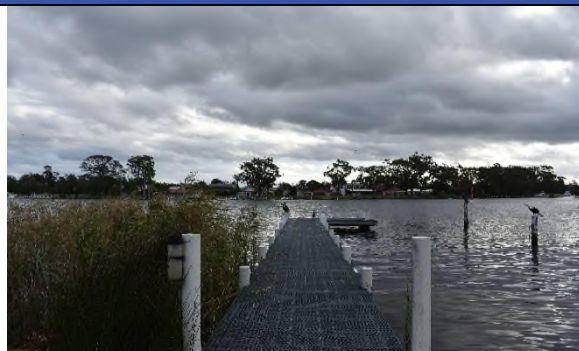
These structures are in varying condition. CM6 and CM11 are in good condition, CM8, CM9 and CM10 appear to be in fair condition, CM7 has collapsed and now only remnants of the boathouse foundations remain. The ad hoc structures are in good condition.

Figure 160 CM6—Block 14 jetty, looking towards Sussex Inlet.

| Element | Works | Location | Priority |
|---|---|---|---|
| <b>CM6—Jetty</b> | Retain and maintain the jetty structure and location as is in a useable condition.<br>Replace timber boards as necessary.<br>Repaint white poles as necessary. | Whole structure | Routine |

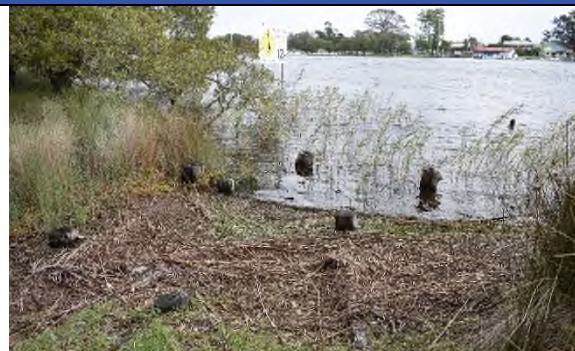
Figure 161 CM7, remnants of the boathouse footings.

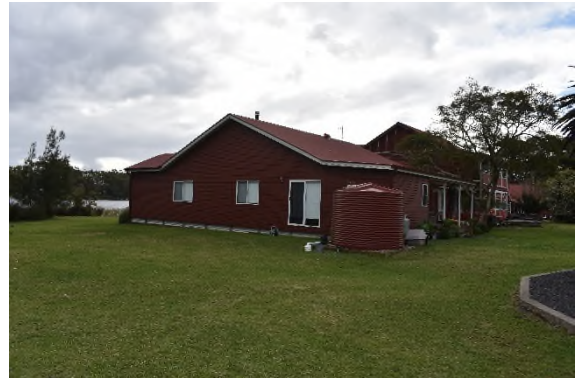
Figure 168 CM11 viewed from northeast.

Figure 169 CM11 viewed from south.

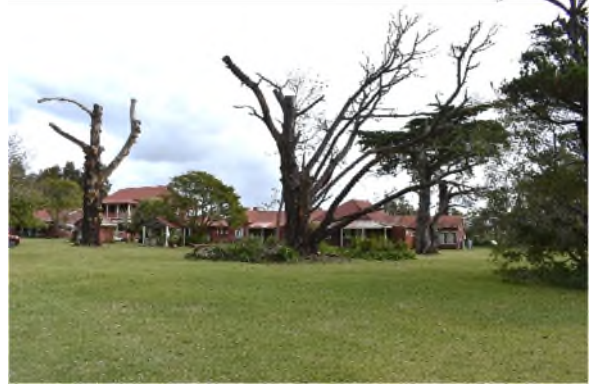
Some are healthy and, if they stay free from root compaction caused by adjoining works or uses, will be maintained for some years yet with minimal additional effort. Other pines in the same groups, however, are showing signs of senescence, and management policies will need to take this into account.

Figure 176 CP1 group of pines—the two pines at left and centre are dead.

There may be the opportunity to replace senescing trees (e.g. pines) with new plantings with similar characteristics, taking into account the site's location adjacent to Booderee National Park and changing climatic conditions. Suitable species for replanting would need to be identified through a tree replacement strategy.

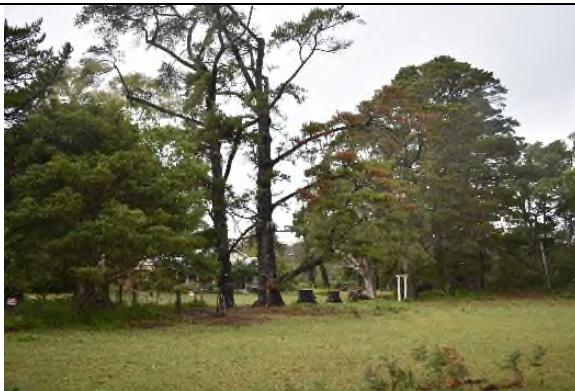
Figure 177 CP2 windbreak group near Ardath, viewed from Crown reserve. Note the felled tree stumps.
