**FLYING FISH COVE LANDSLIDE MITIGATION – ARUP / STAGE 1 CONTRACTOR RED LINE MARK UP**

**FLYING FISH COVE QUANTITATIVE LANDSLIDE RISK ASSESSMENT - GHD**

# Landslide Mitigation Concept Design Report

## Flying Fish Cove, Christmas Island

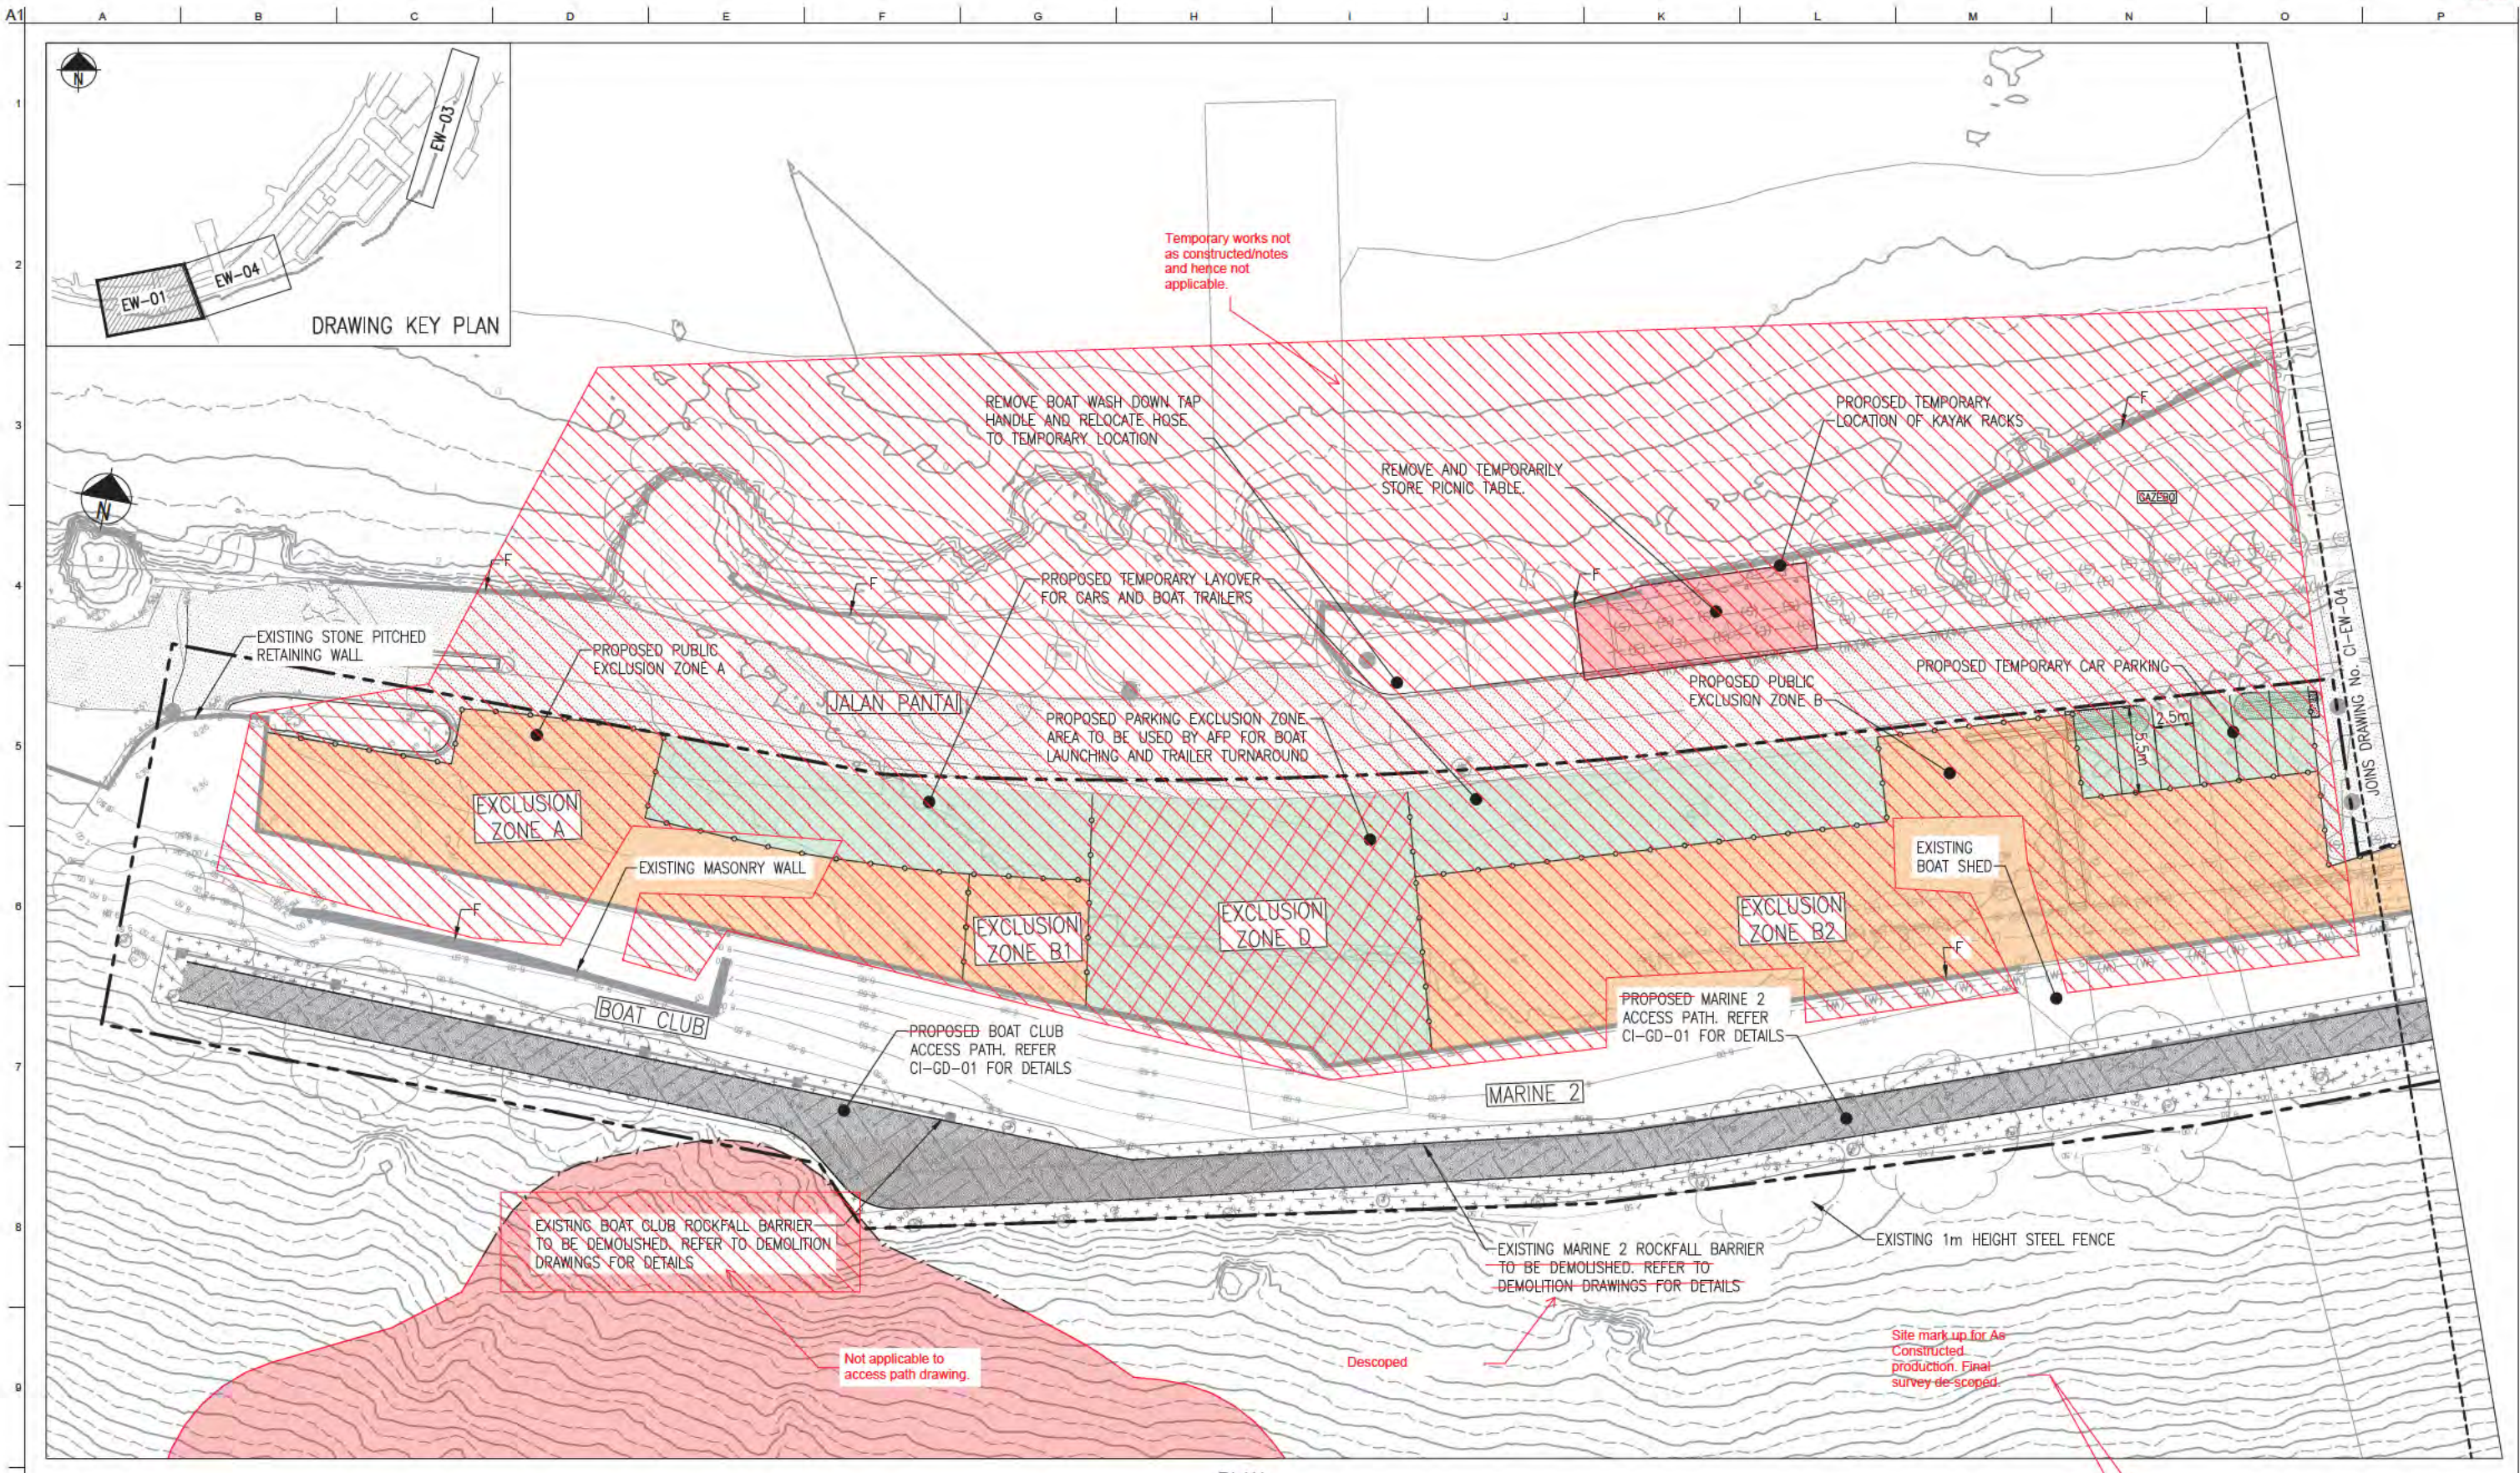
Temporary works not as constructed/notes and hence not applicable.

Not applicable to access path drawing.

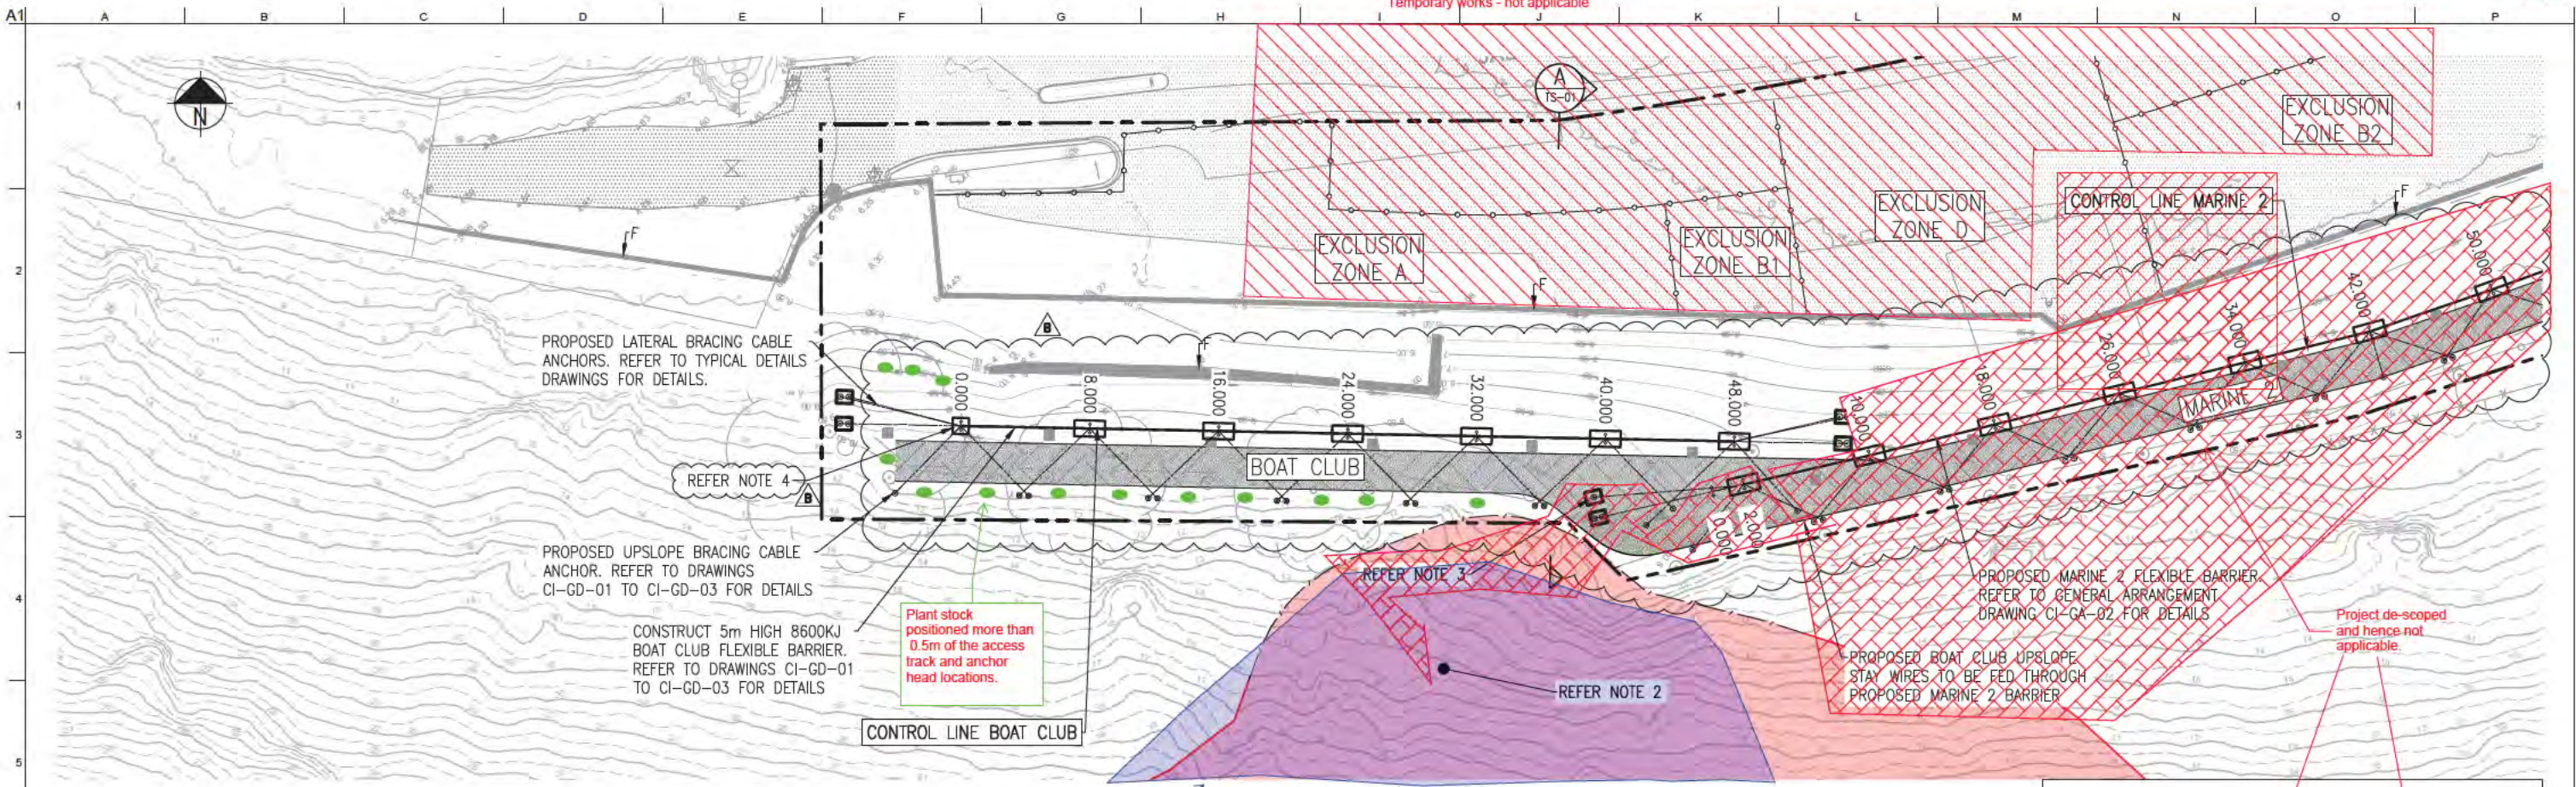
PLAN  
SCALE 1:200

Ecology exclusion zone due to possible nesting tree as noted on site with Ecoscape ecology consultant, as per BAR. Area outside the work zone and mainly inaccessible.

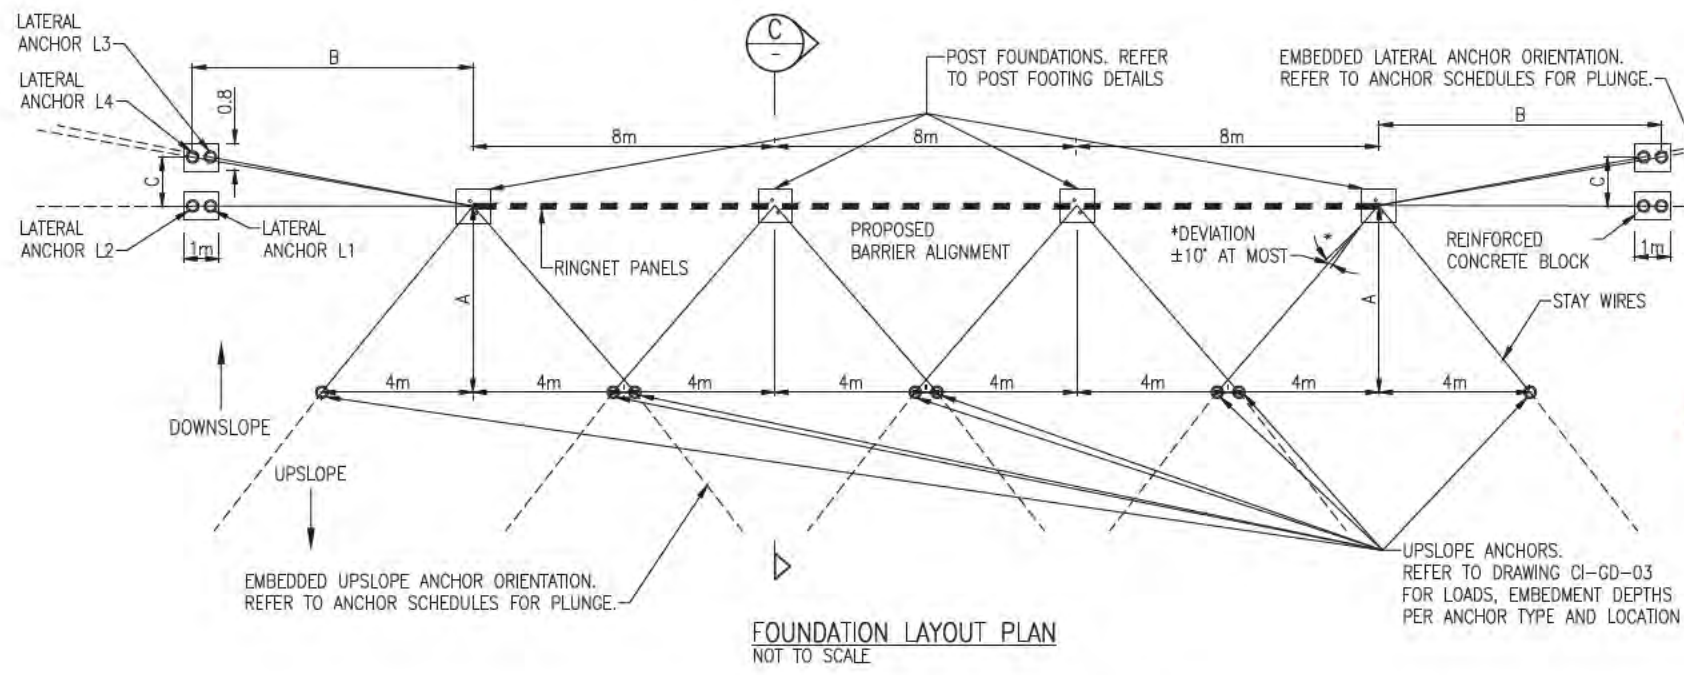
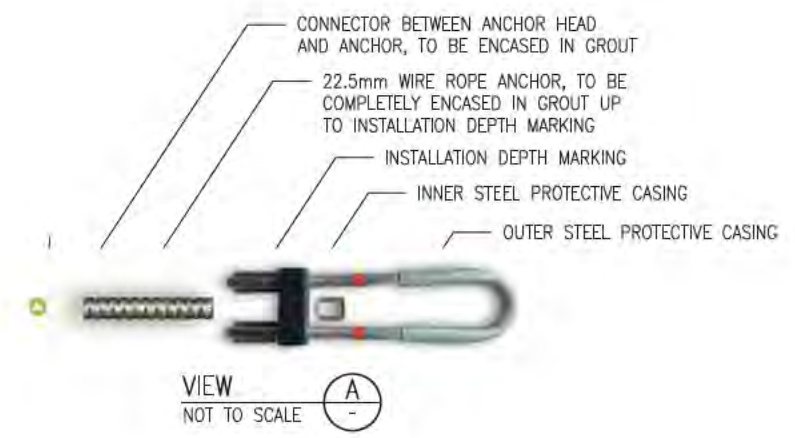
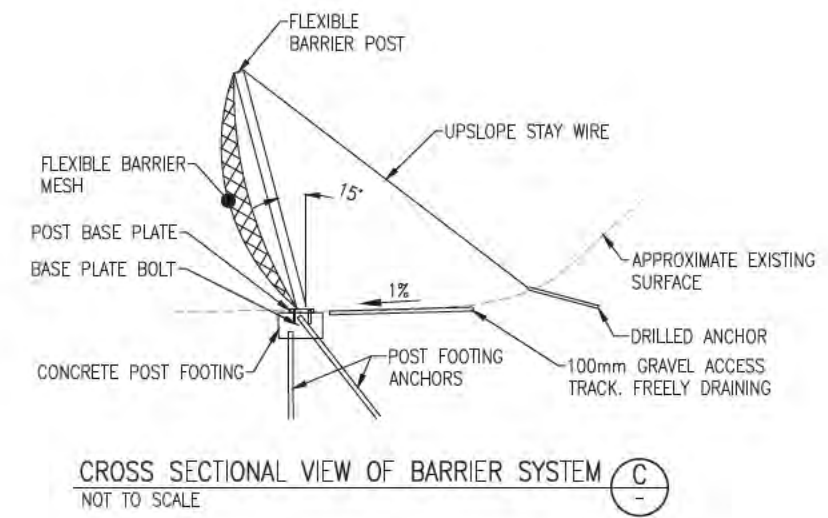
**FLEXIBLE BARRIER GEOMETRY**

Project descope and hence not applicable.

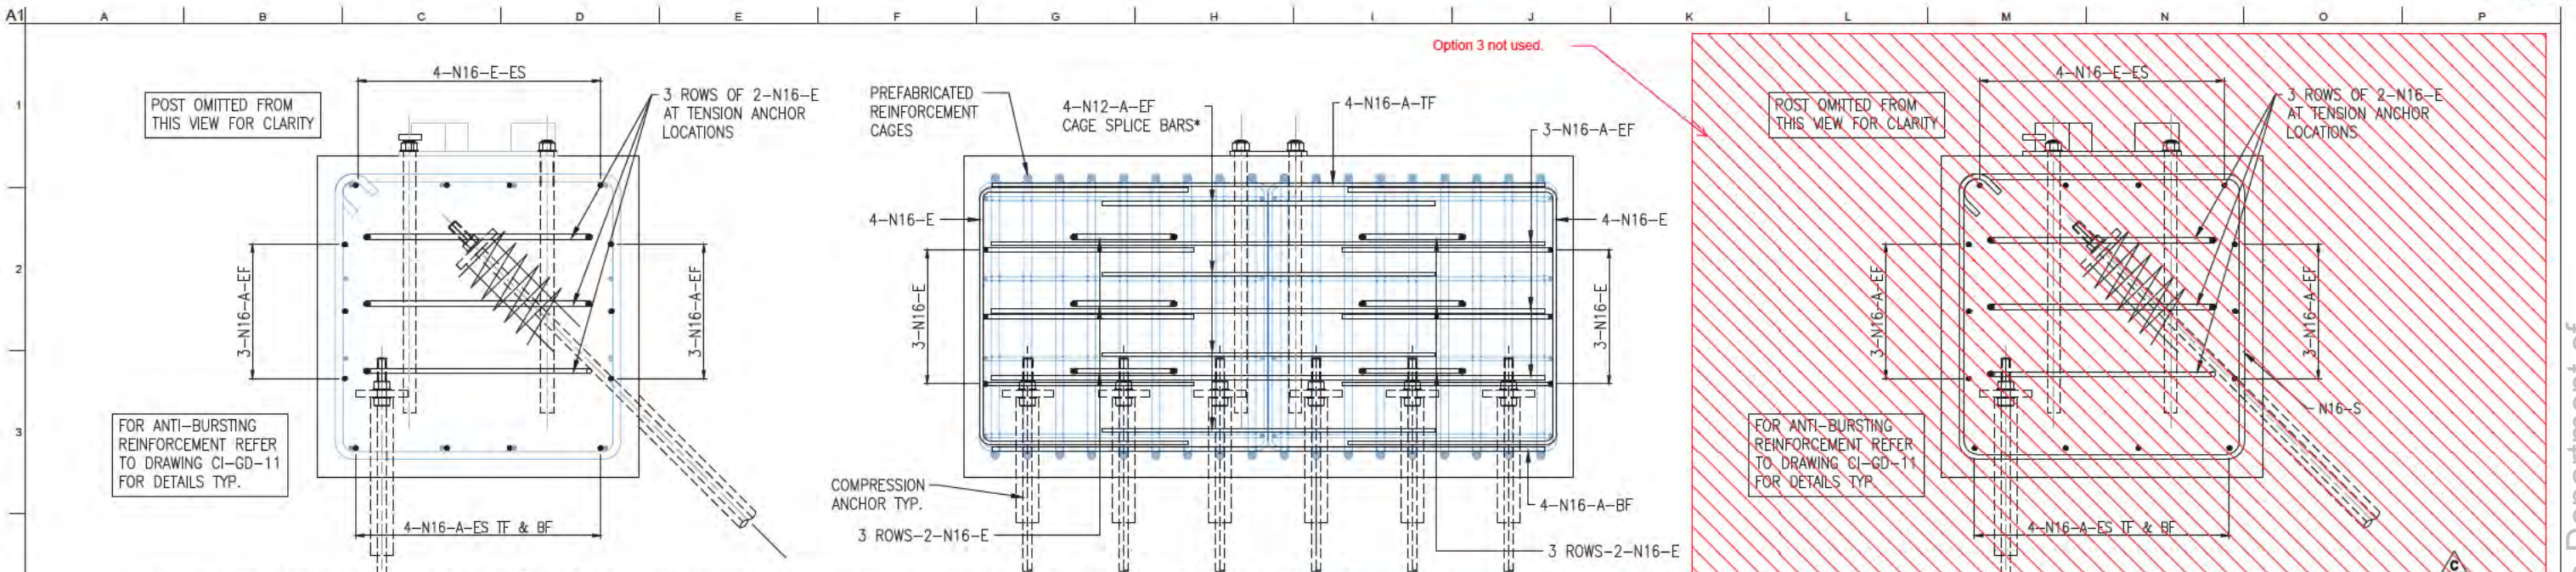
**REINFORCEMENT OPTION 1** (REFER NOTE 'ALTERNATIVE REINFORCEMENT OPTIONS')  
**POST FOUNDATION PLAN - USING TWO SQUARE CAGES THAT HAVE N12 AND N24 BARS AS SHOWN ON DRG CI-GD-06 AND CI-GD-07**  
 SCALE 1:10  
 Reinforcement used for Footings BCB8, 16, 24, 32, 40 & 48. Not used. Project descope and hence not applicable.

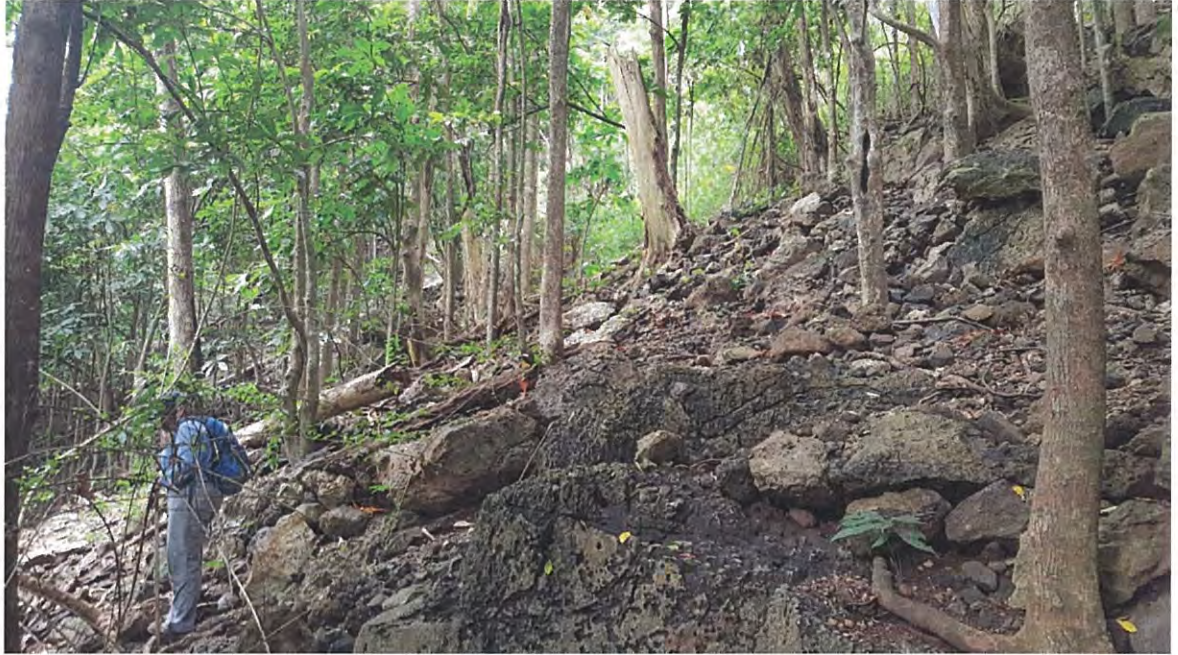
**Figure 4. Talus Slopes Above the Marine 1 Building**

The overall slope is generally stepped in profile and comprises a number of steep (35° to 40°) slope elements, separated by sub-vertical cliffs, that occur particularly near the upper part of the slope (Figure 4). The western part of the Cove is narrower and particularly steep and comprises predominantly cliffs. The main cliff-line that caps the escarpment is up to about 40m high. This cliff-line is for the most part not accessible due to the steep slopes and smaller intermediate cliffs below. A secondary cliff line is located about one-third of the way down the escarpment and is up to about 20m high. This cliff-line transitions into a series of broken cliffs towards the north and before petering out complexly. Where GHD observed this cliff-line above the Boat Club / Marine Building area, it was found to be extensively covered by Banyan Trees and the associated roots (Figure 5).

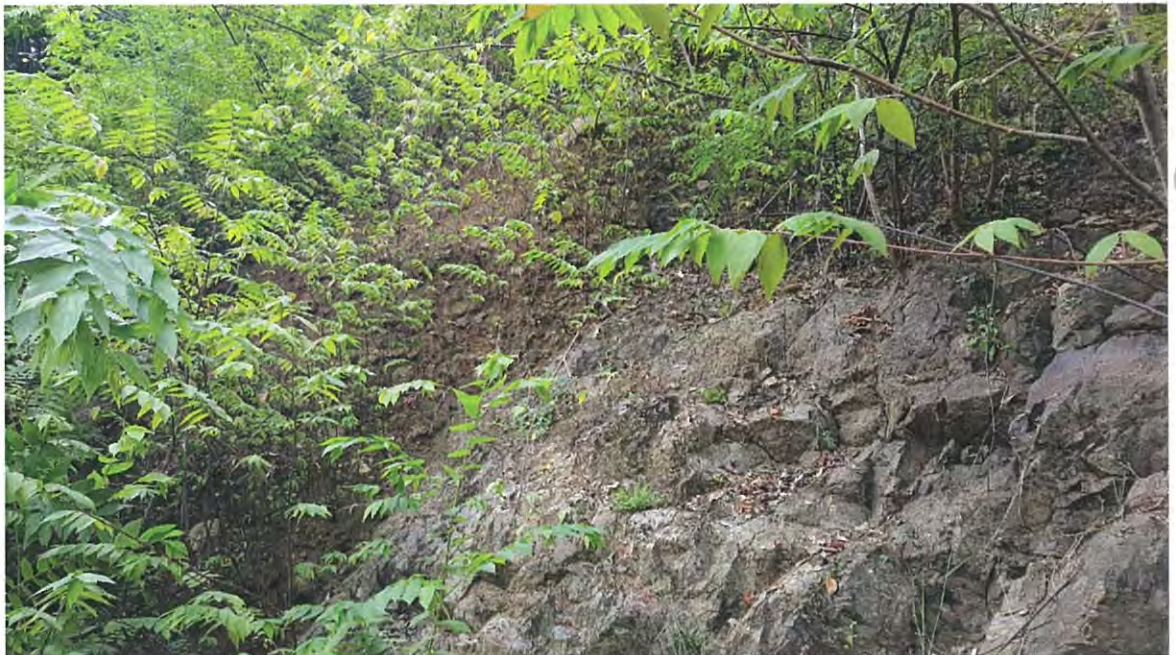
**Figure 6. Soil Profile (left) Exposed in Flank of Basketball Court' landslide**

The soils on the slopes appear to be typically fairly thin based on the widespread occurrences of rock exposures and soil exposures we observed in landslide scarps. For example, the soil profile exposed in the flank of the 'Basketball Court' landslide is only about 1m to 1.5m thick and overlies an irregular rock profile (Figure 6). The soils appear to contain highly variable mixtures of clay and gravel, with clay contents estimated to be up to about 20%.

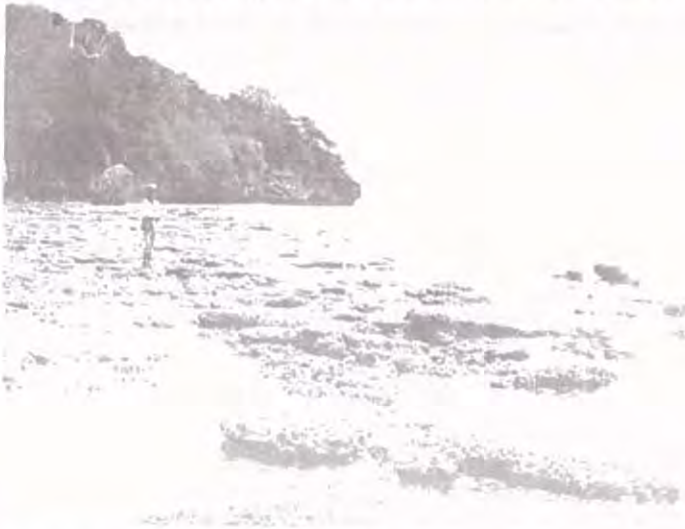
<p>Photograph of southern section of reef near the Boat Club ramp, note the large boulder in the background (Andrews, 1900)</p>

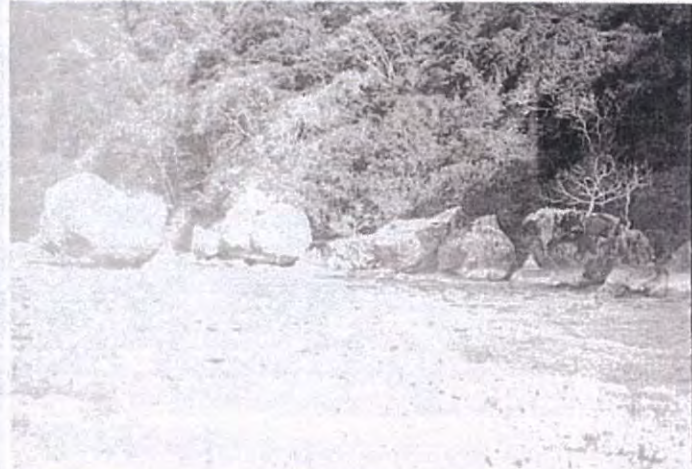
Photograph indicating the size of limestone boulders reaching the base of the cliff (unconfirmed location within Flying Fish Cove).

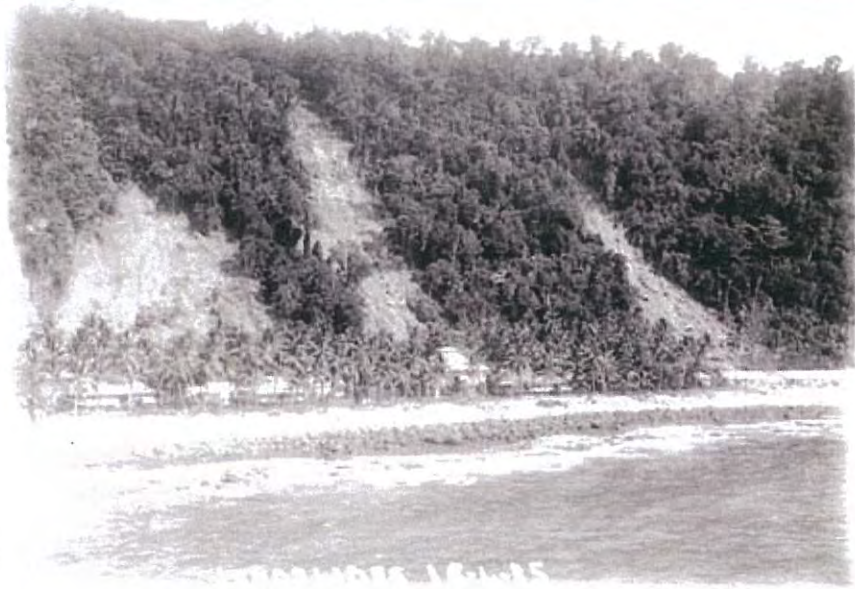
Photograph of three of the 1935 landslides. It is estimated that the far right landslide is potentially coincident with the present day position of the Marine building.

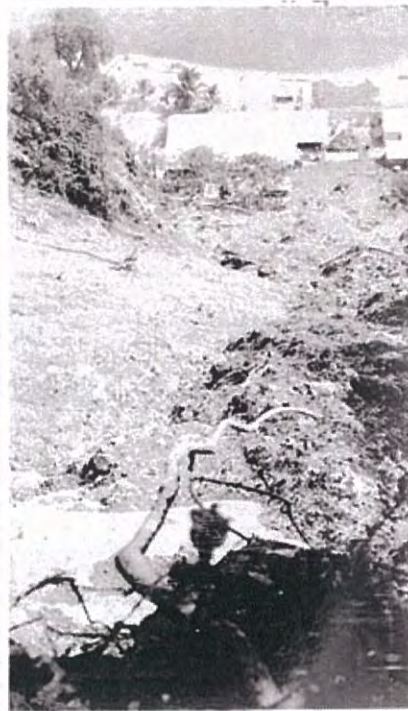
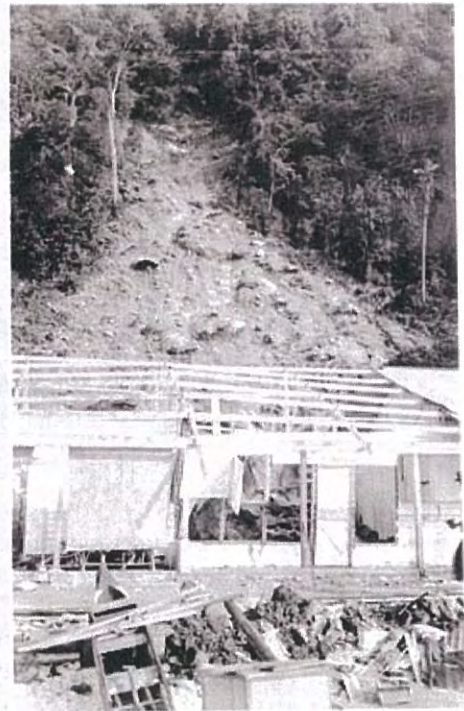
Landslide above the Malay house, from the top of the slide. Note the extent of landslide run out.

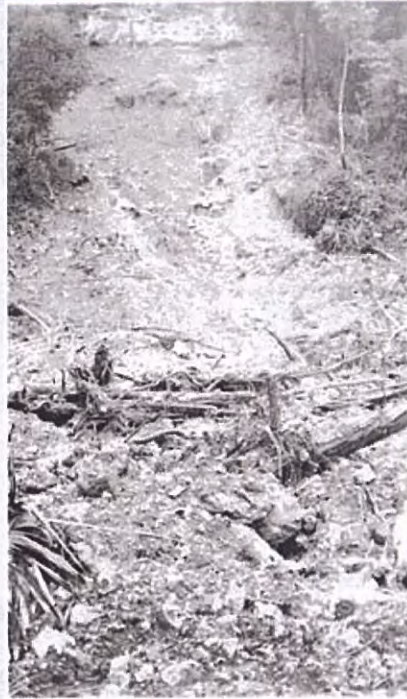
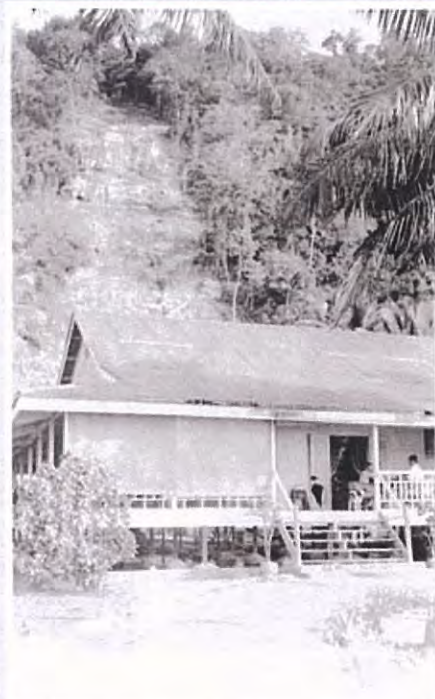
Photographs of landslide debris behind Howell Jones' house (left) and landslide scarp behind Number 9/10 bungalow (right), unknown current location.

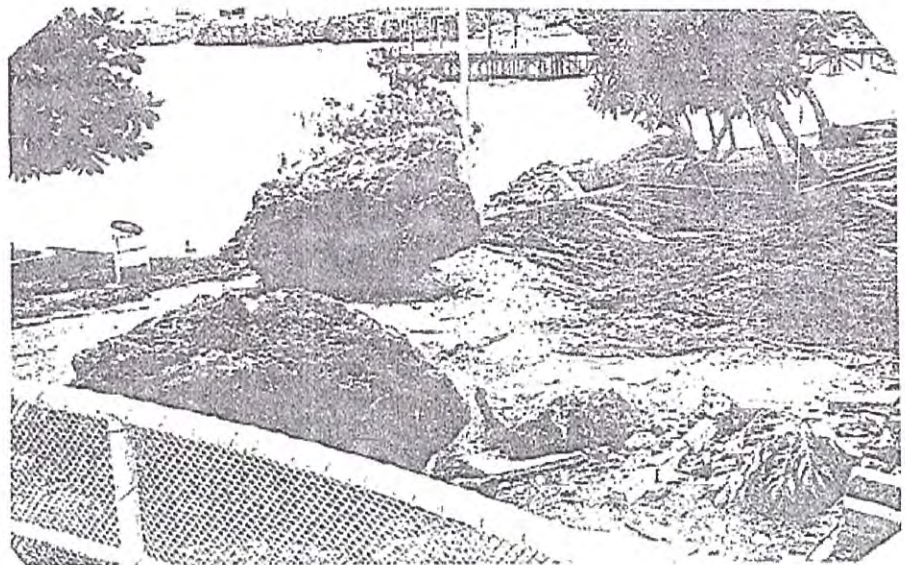
The largest of the boulders, approximately 6m<sup>3</sup>, came to rest on the road.

View of the large boulders reaching the shoreline

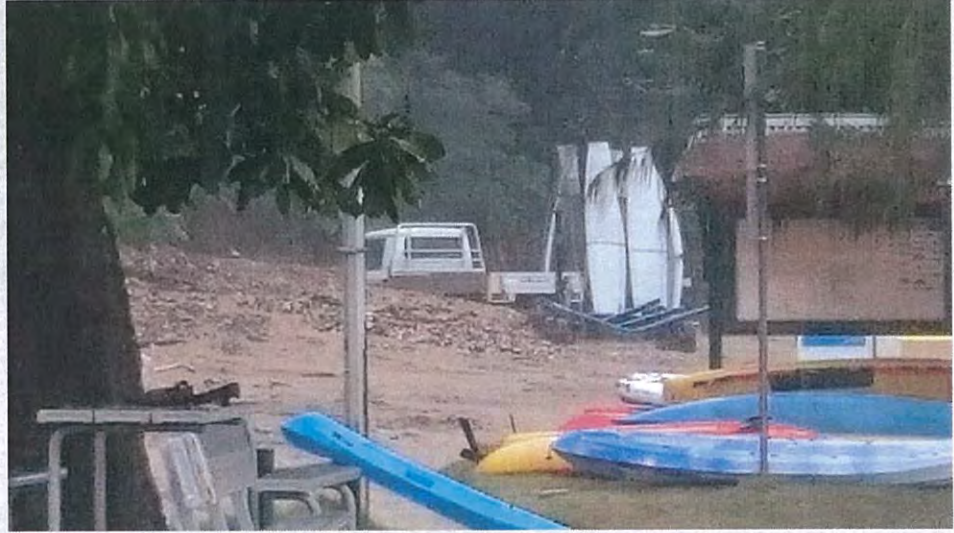
Debris within the Boat Club car parking area (source: Lisa Preston, Facebook).

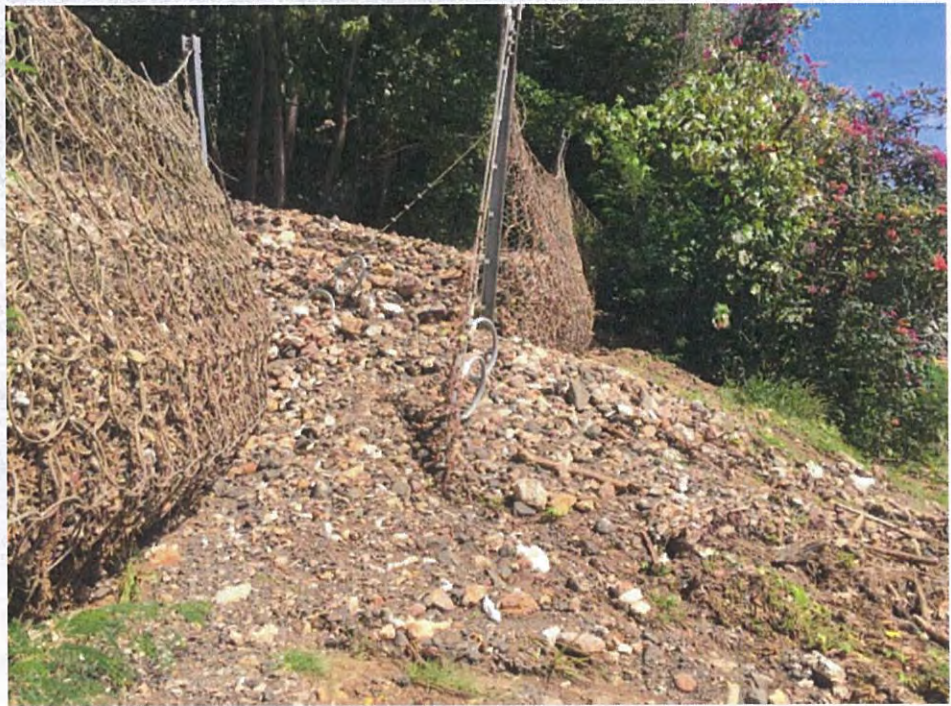
Boat Club landslide debris captured at fence line
