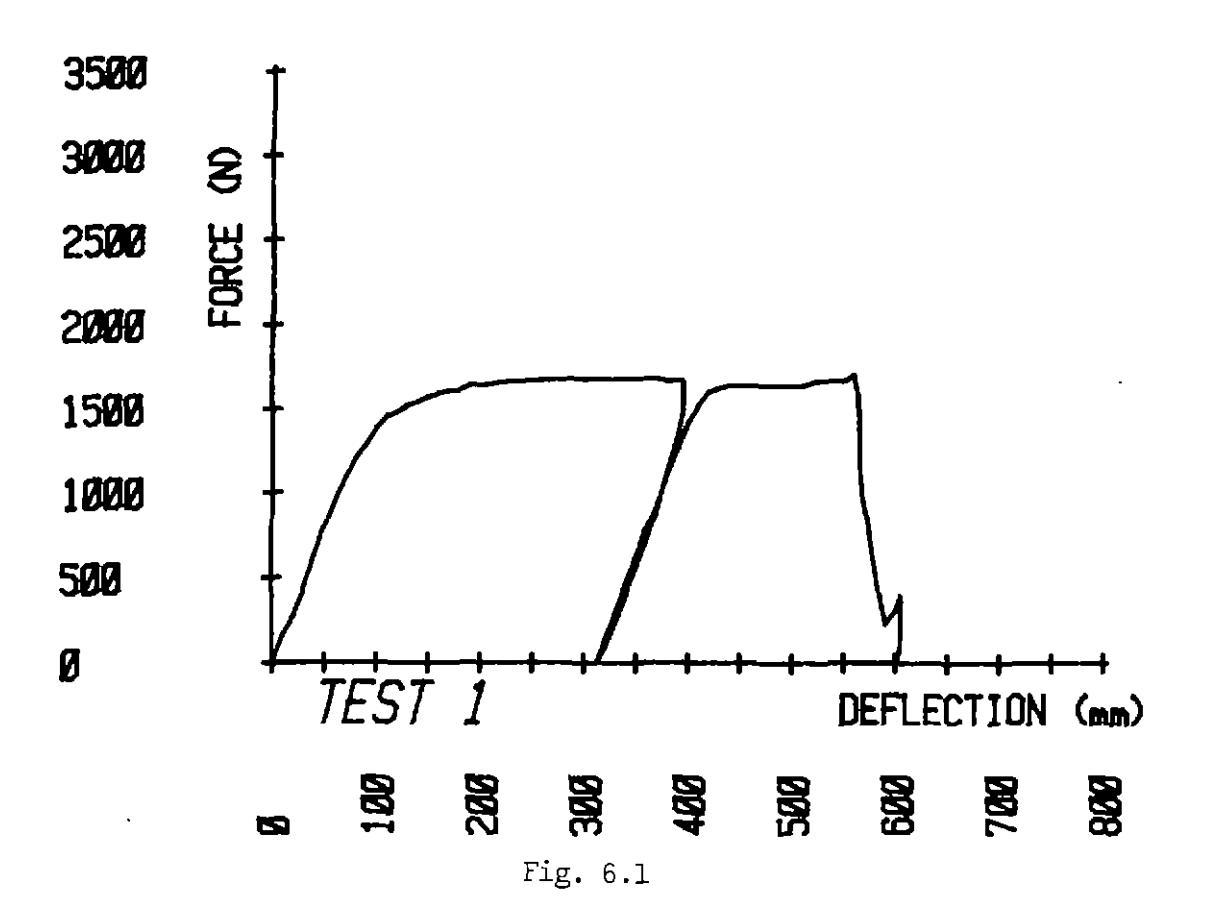
Failure of this seat resulted from the bending of two components governing the pivoting of the two seat squabs (Photo 6.2). The external vertical seat squab tube of each seat back is crimped at the base of the squab to allow welding of a bush which forms the pivoting axis of the

seat backs. The squab tubing extended downward below the bush and acted as a lever for the spring/piston device used to control seat back angle. One of the members that bent was this lever section of the squab tube. The bending took place at the point where the crimped and non-crimped tube met, just above the pivoting bush. The other component that underwent bending was the bracket used to attach the seat squabs on both external sides of the seat to the seat sub frame (Photo 6.1). The crimped section of squab tubing which acted as a lever for the reclining mechanism is also used as a positive stop for seat back movement. The seat back pivots forward until the crimped tube comes up against a plate welded to the seat sub frame. As a result of the bending of both the anchorage bracket for the seat squabs and the crimped tube at the base of the seat backs, the crimped tube slipped past the reclining stopping plate, (Photo 6.2). Thus the load was no longer taken by the stopping plate and was transferred through the crimped tube to the spring/piston reclining device situated underneath the seat cushions near the external edges of both cushions.

The ultimate failure of the seats took place when shafts from both spring/piston reclining devices fractured suddenly (Photo 6.3). The shaft, which runs through these pistons had a threaded end which is screwed into a shackle mounted at the end of the crimped seat squab tube. The fractures occured at the end of each of these shafts where the threaded section commences (Photo 6.4). Once the fractures had occurred both seat backs were free to pivot forward unrestrained. Since both shafts fractured simultaneously, there was no skewing of the seat.

There was no apparent anchorage distortion.
