Report No.	Date	Pages	ISBN	ISSN
CR 155	June 1995		0 642 51261 2	0810-770X

**STUDY OF HEAVY VEHICLE CRASHES IN URBAN AREAS**

Report on Heavy Vehicle Black Spot Investigations - Melbourne

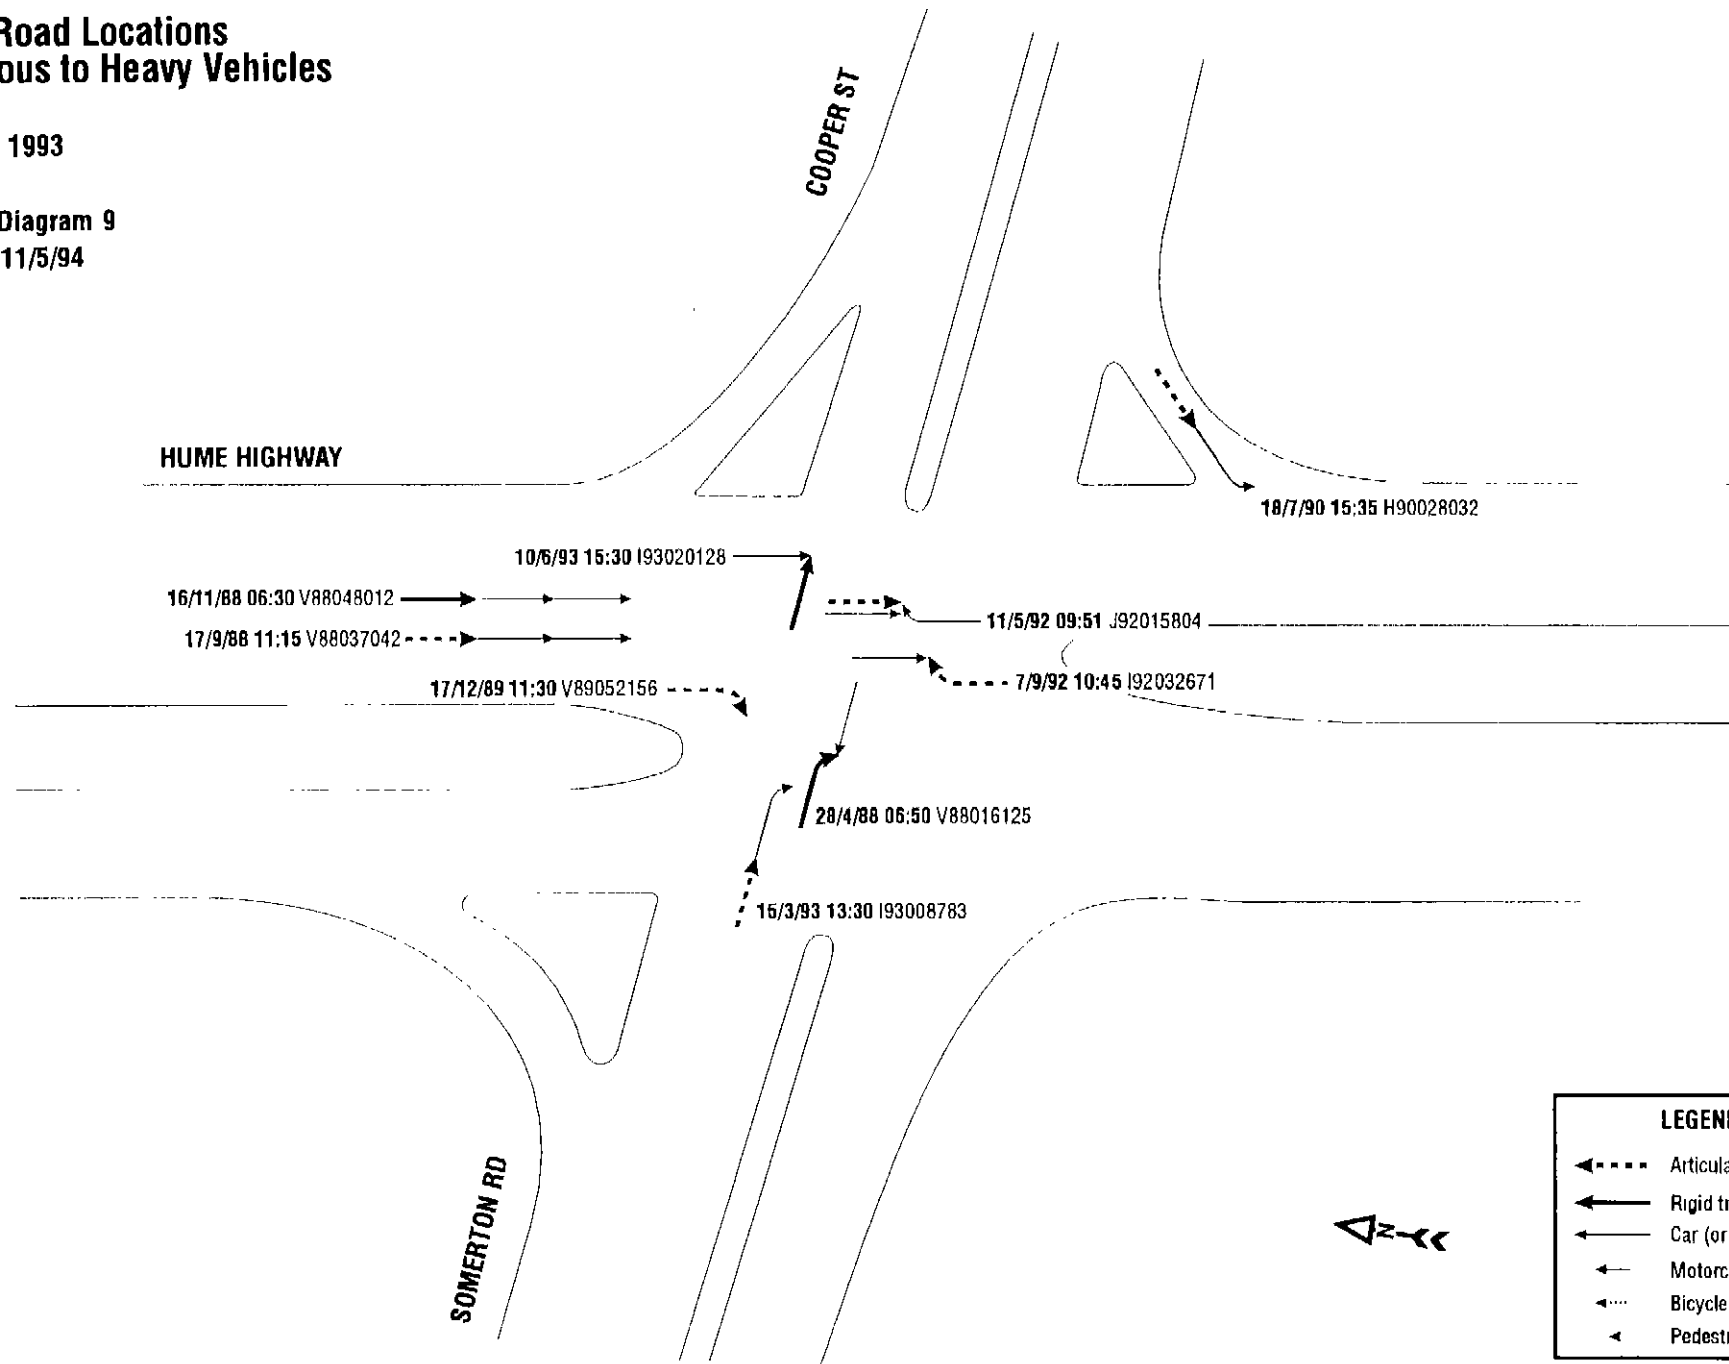
Collision Diagram 9  
Prepared 11/5/94

- **high vehicle speeds and congested traffic conditions.** Adjusting to urban traffic conditions and lower speeds could present some difficulties in judgement for motorists in general, and for drivers of heavy vehicles in particular, given that many drivers would have been travelling for long periods in rural highway/freeway conditions before encountering this set of intersection signals;

- the drivers of heavy vehicles being unable to stop in time to avoid colliding with stationary or near-stationary vehicles (rear-end collisions are characteristic of traffic signal crash patterns generally). The cause may be due to the **inferior braking performance** of heavy vehicles compared to lighter vehicles and/or to **poor skid resistance** of the highly trafficked pavement (or perhaps due to oil dropped by passing or queued vehicles together with wet pavement) and/or to **incompatible decision-making** by drivers of light and heavy vehicles when faced with a red or changing signal display.

- drivers in general **failing to comply with right turn phases**, i.e. red signals or arrow displays, though there is no evidence to suggest that heavy vehicles are over-involved in right-through crashes compared to other vehicle types;
- **inadequate gap selection** by the driver of a heavy vehicle may have been a factor in one of the three crashes of this type.

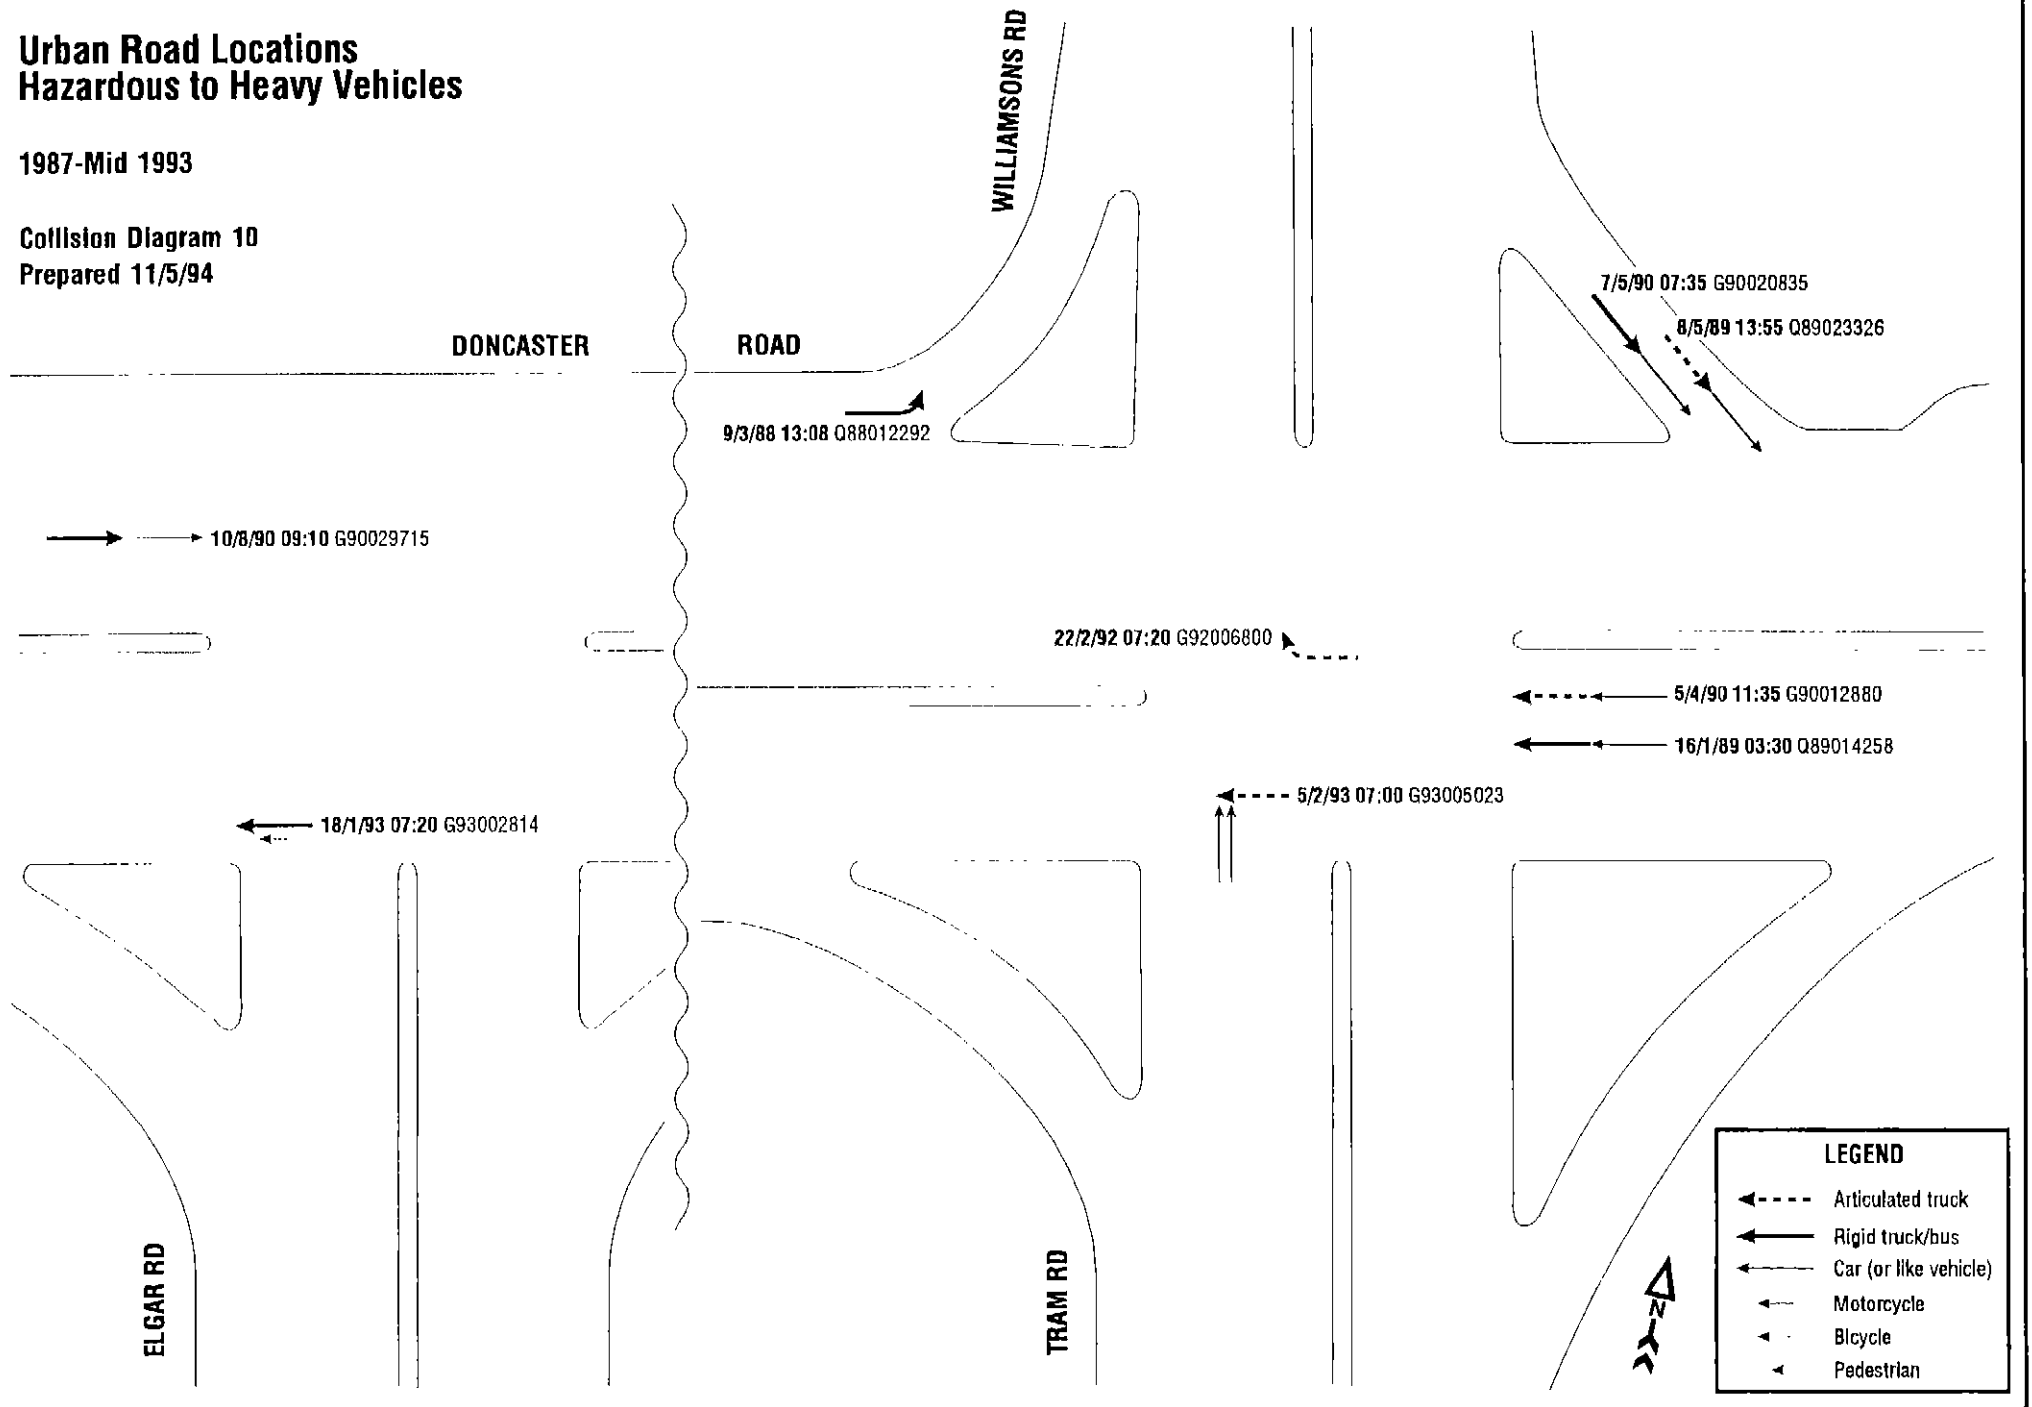
Collision Diagram 10  
Prepared 11/5/94

- **high vehicle speeds and congested traffic conditions** on Doncaster Road:
- in two of the three rear-end crashes involving heavy vehicles on Doncaster Road, the heavy vehicle was struck from behind by another vehicle. In the other case, the heavy vehicle skidded on a **wet pavement** when braking in response to a **red signal** (rear-end collisions are characteristic of traffic signal crash patterns generally);

- **left turn slip lane geometry** of the type situated on the N-E corner may, because of its relatively long sweeping path, generous width for a single lane and low angle of intersection with conflicting through lanes, cause safety problems for left turners using them. Vehicle speeds tend to be high and detection of conflicting traffic is made more difficult by drivers having to look backwards as they approach the conflict area. **Brake failure** was cited as a possible factor in one instance, while in the other case both vehicles attempted to enter the lane side by side.

- one crash (fatal) involved the driver of a heavy vehicle **failing to comply with the red signals**. Signal displays appear adequate, as do the inter-green/all-red periods. The downhill gradient on the west bound approach to the intersection may have been a factor in this crash:
- another crash involved a right turning articulated vehicle whose speed was excessive for the **combination of downhill gradient and adverse super-elevation** for a right turner. Advisory warning signs for the drivers of heavy vehicles are already in place.
