DEPARTMENT OF INFRASTRUCTURE AND REGIONAL DEVELOPMENT

# Norfolk Island Roads Audit and Strategy Report

301015-03669 – REP-001

01 September 2015

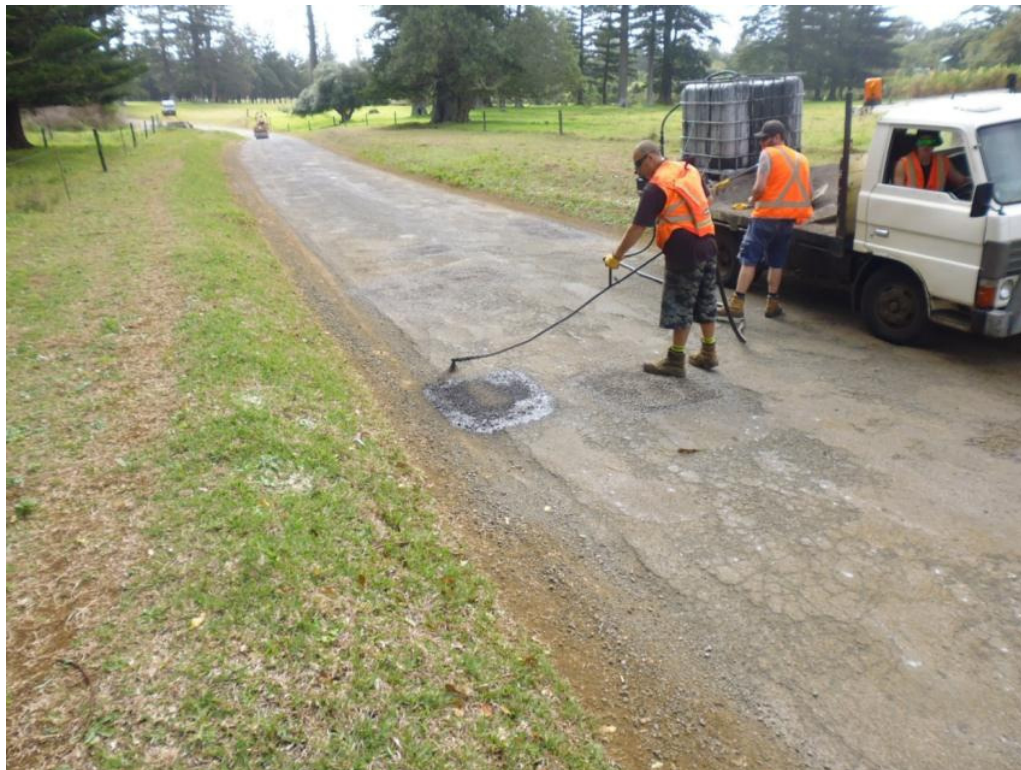
Maintenance similarly suffers from a lack of specifications, defined intervention levels and treatment options. The only maintenance observed was emergency repair of potholes and the system used for repair of potholes does not always address the most urgent repair the soonest.

**Patching Crew fixing potholes on Anson Bay Road**

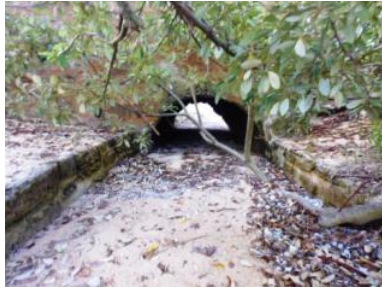
**Bay Street Culvert From North**

Should drainage flow into Emily Bay be required, then the channel could be dredged.

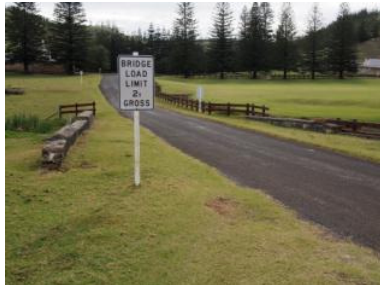
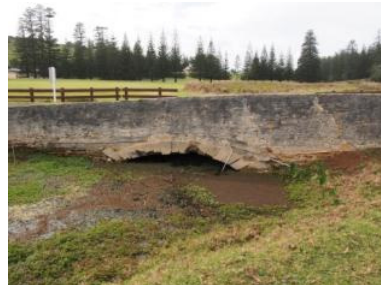
Approach from South

Arch from upstream (West)

1. Accept gradual deterioration of the bridge structure.
2. Perform a thorough investigation to determine the cause of the failure of the bridge structure and provide methods for strengthening and repair.

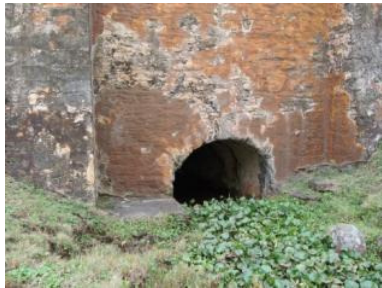
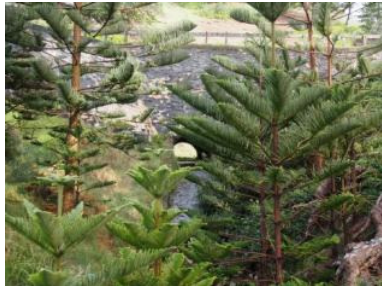
**Culvert from upstream side**

**Culvert and spillway from downstream side**

Periodic monitoring for maintenance requirements

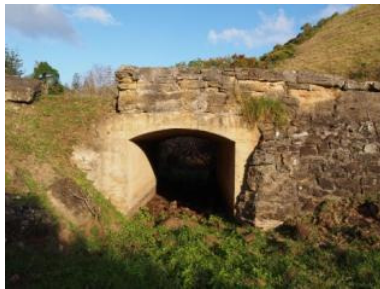
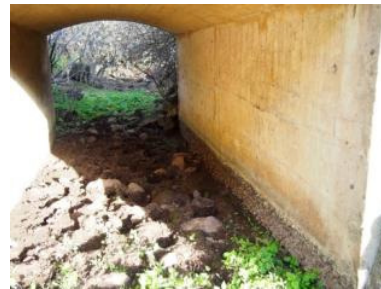
**Culvert from downstream side**

**Culvert wall**

The rock headwalls are still in need of repair.

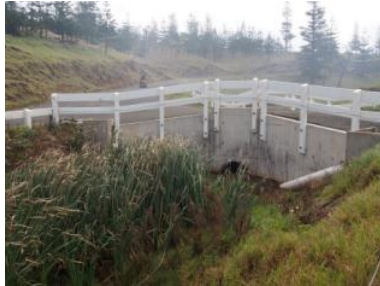
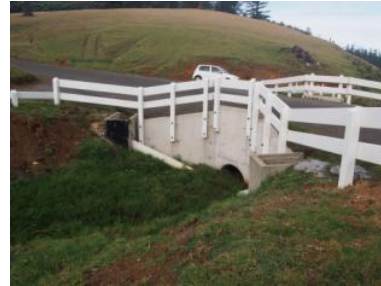
The original culvert has recently been replaced with a reinforced concrete structure. The structure is in very good condition with no visible signs of deterioration

**Culvert from downstream side**

**Road gullies discharging to drainage channel**

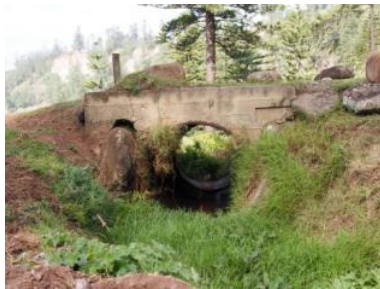
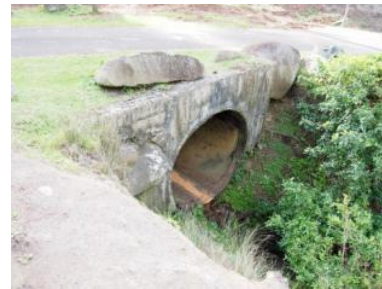
**Inlet to upstream culvert**

**Outlet to upstream culvert**

Plan to replace the steel pipe culvert with a new RC pipe or box culvert.

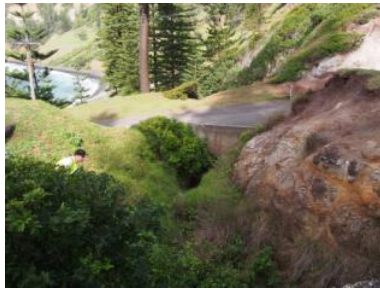
**Inlet to downstream culvert**

Repair cracked and spalling concrete to reinstate full protection to reinforcement within the RC pipe.

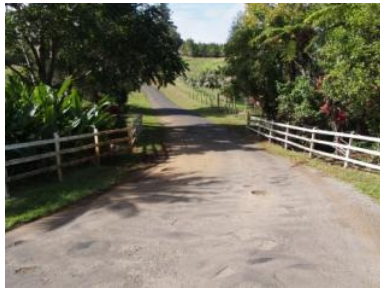
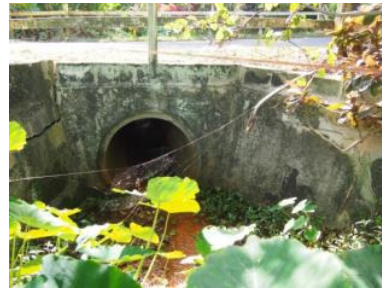
Culvert crossing viewed from West

Inlet to culvert

General maintenance - Repair the cracks in the headwalls.

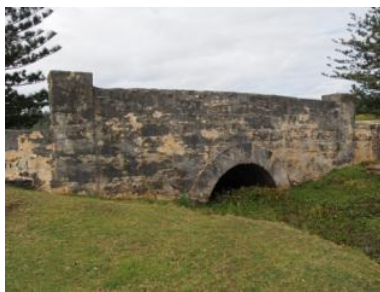
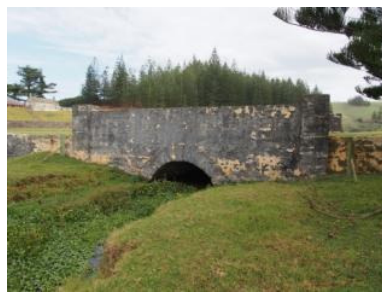
*Pier Street Bridge is a heritage rock arch bridge 3m diameter and 9m span. The bridge is in good condition with some superficial marks on the surface of the rock headwalls.*

The bridge remains in good condition with no additional signs of deterioration.

Arch from upstream side

Arch from downstream side

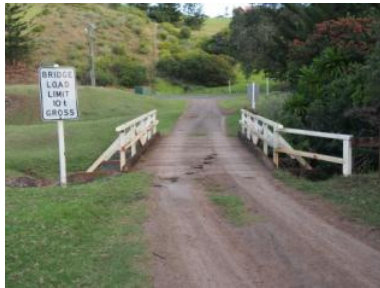
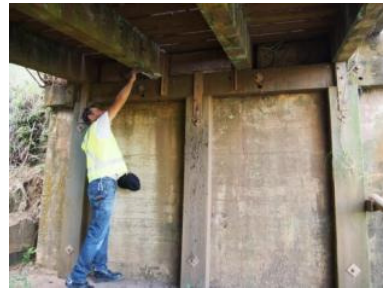
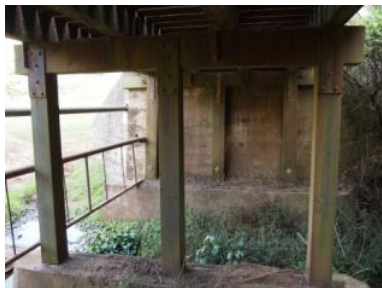
**Bridge approach from north**

**Northern abutment and bridge support frame**

**Central and southern support frames**

1. General maintenance to include periodic removal of accumulated dirt on the deck to minimise moisture at interface of timber members.
2. Guardrail is in need of repainting.
3. The northern header beam should be replaced.
