# Landslide Risk Management Plan

## Endorsed for Use – December 2025

The Christmas Island Rockfall Risk Management Plan (RRMP) was a result of the 1997 Parliamentary Standing Committee on Public Works report on the Implementation of Rockfall Risk Reduction Strategies on Christmas Island (Appendix C). The RRMP recognised the Commonwealth's commitment to reducing rockfall risk across Flying Fish Cove.

To reflect the impact of debris flow landslides on Flying Fish Cove, the RRMP was significantly updated in 2025 and has been renamed the Landslide Risk Management Plan (LRMP) (this document).

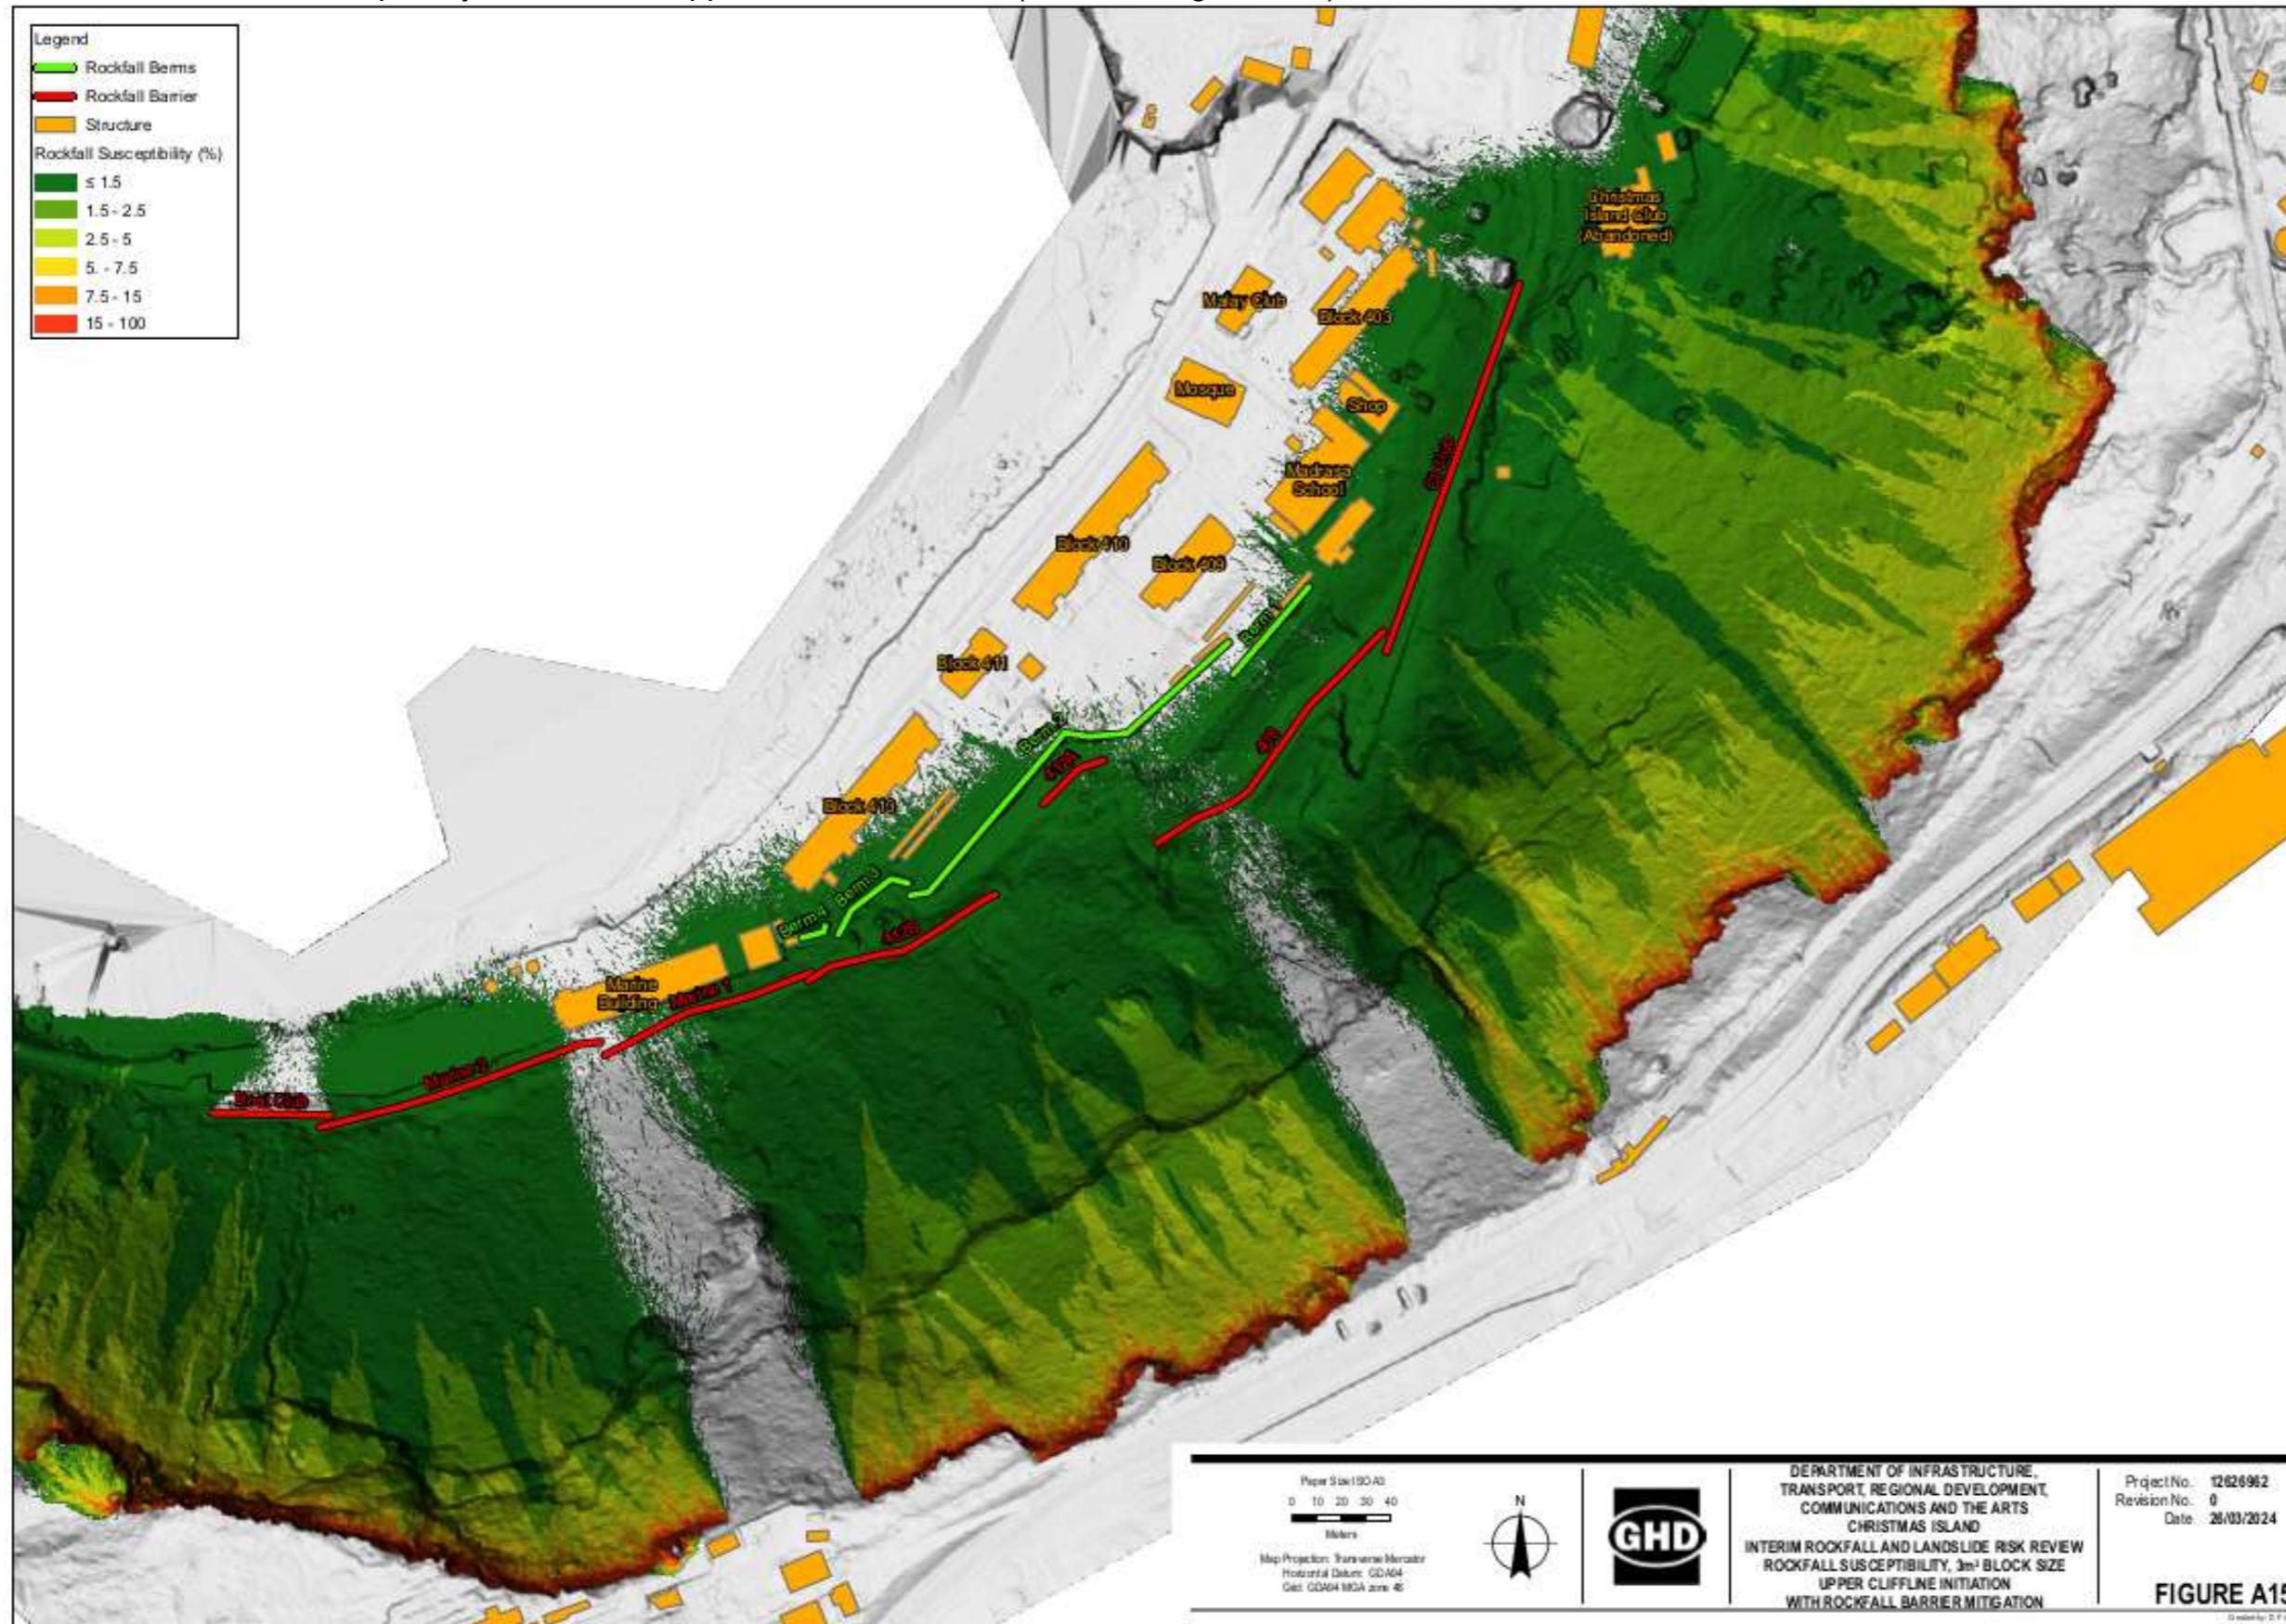
FIGURE 1 – Rockfall Susceptibility, 3 m<sup>3</sup> Block, Upper Cliff line Initiation (With existing barriers)

The areas of Flying Fish Cove identified to be at risk due to rockfalls from the upper cliff line are indicated in Figure 1 and Figure 2 and from the intermediate cliff line in Figure 3 and Figure 4. It should be noted that a rockfall could conceivably extend beyond the probable limit of rockfall defined in the figures, but that the risk of this happening is considered to be negligible.

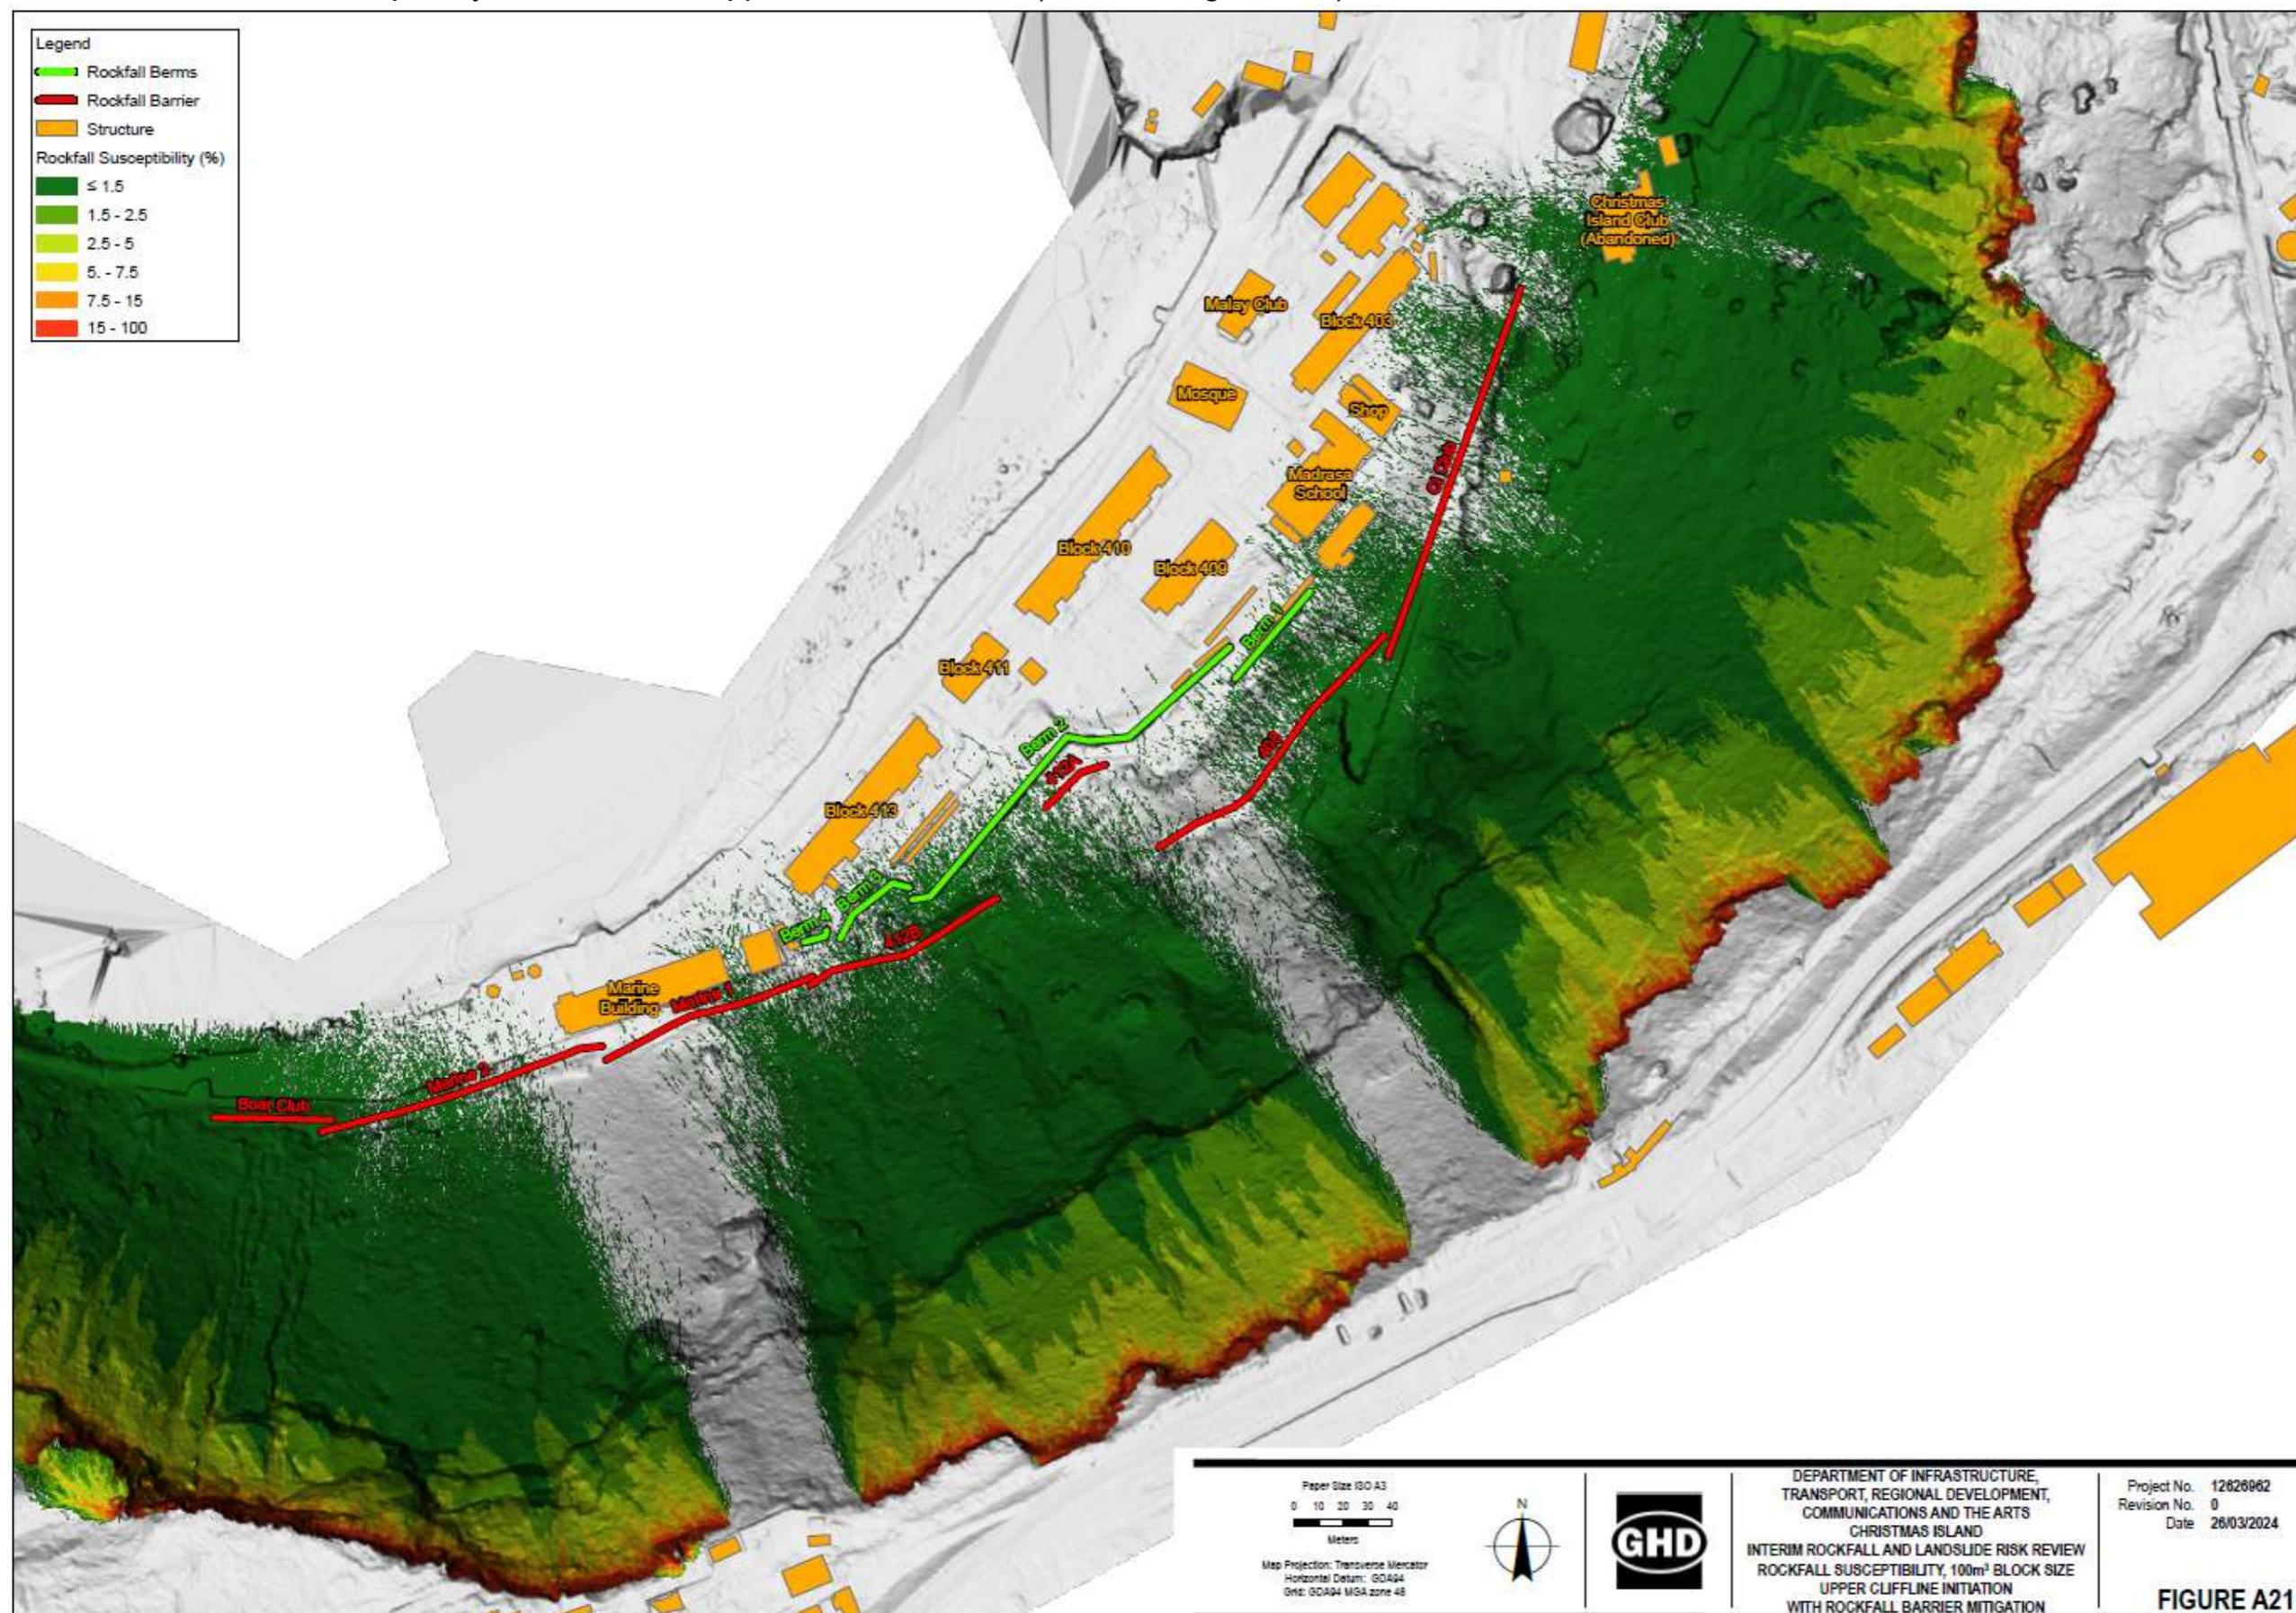
FIGURE 2 – Rockfall Susceptibility, 100 m<sup>3</sup> Block, Upper Cliffline Initiation (With existing barriers)

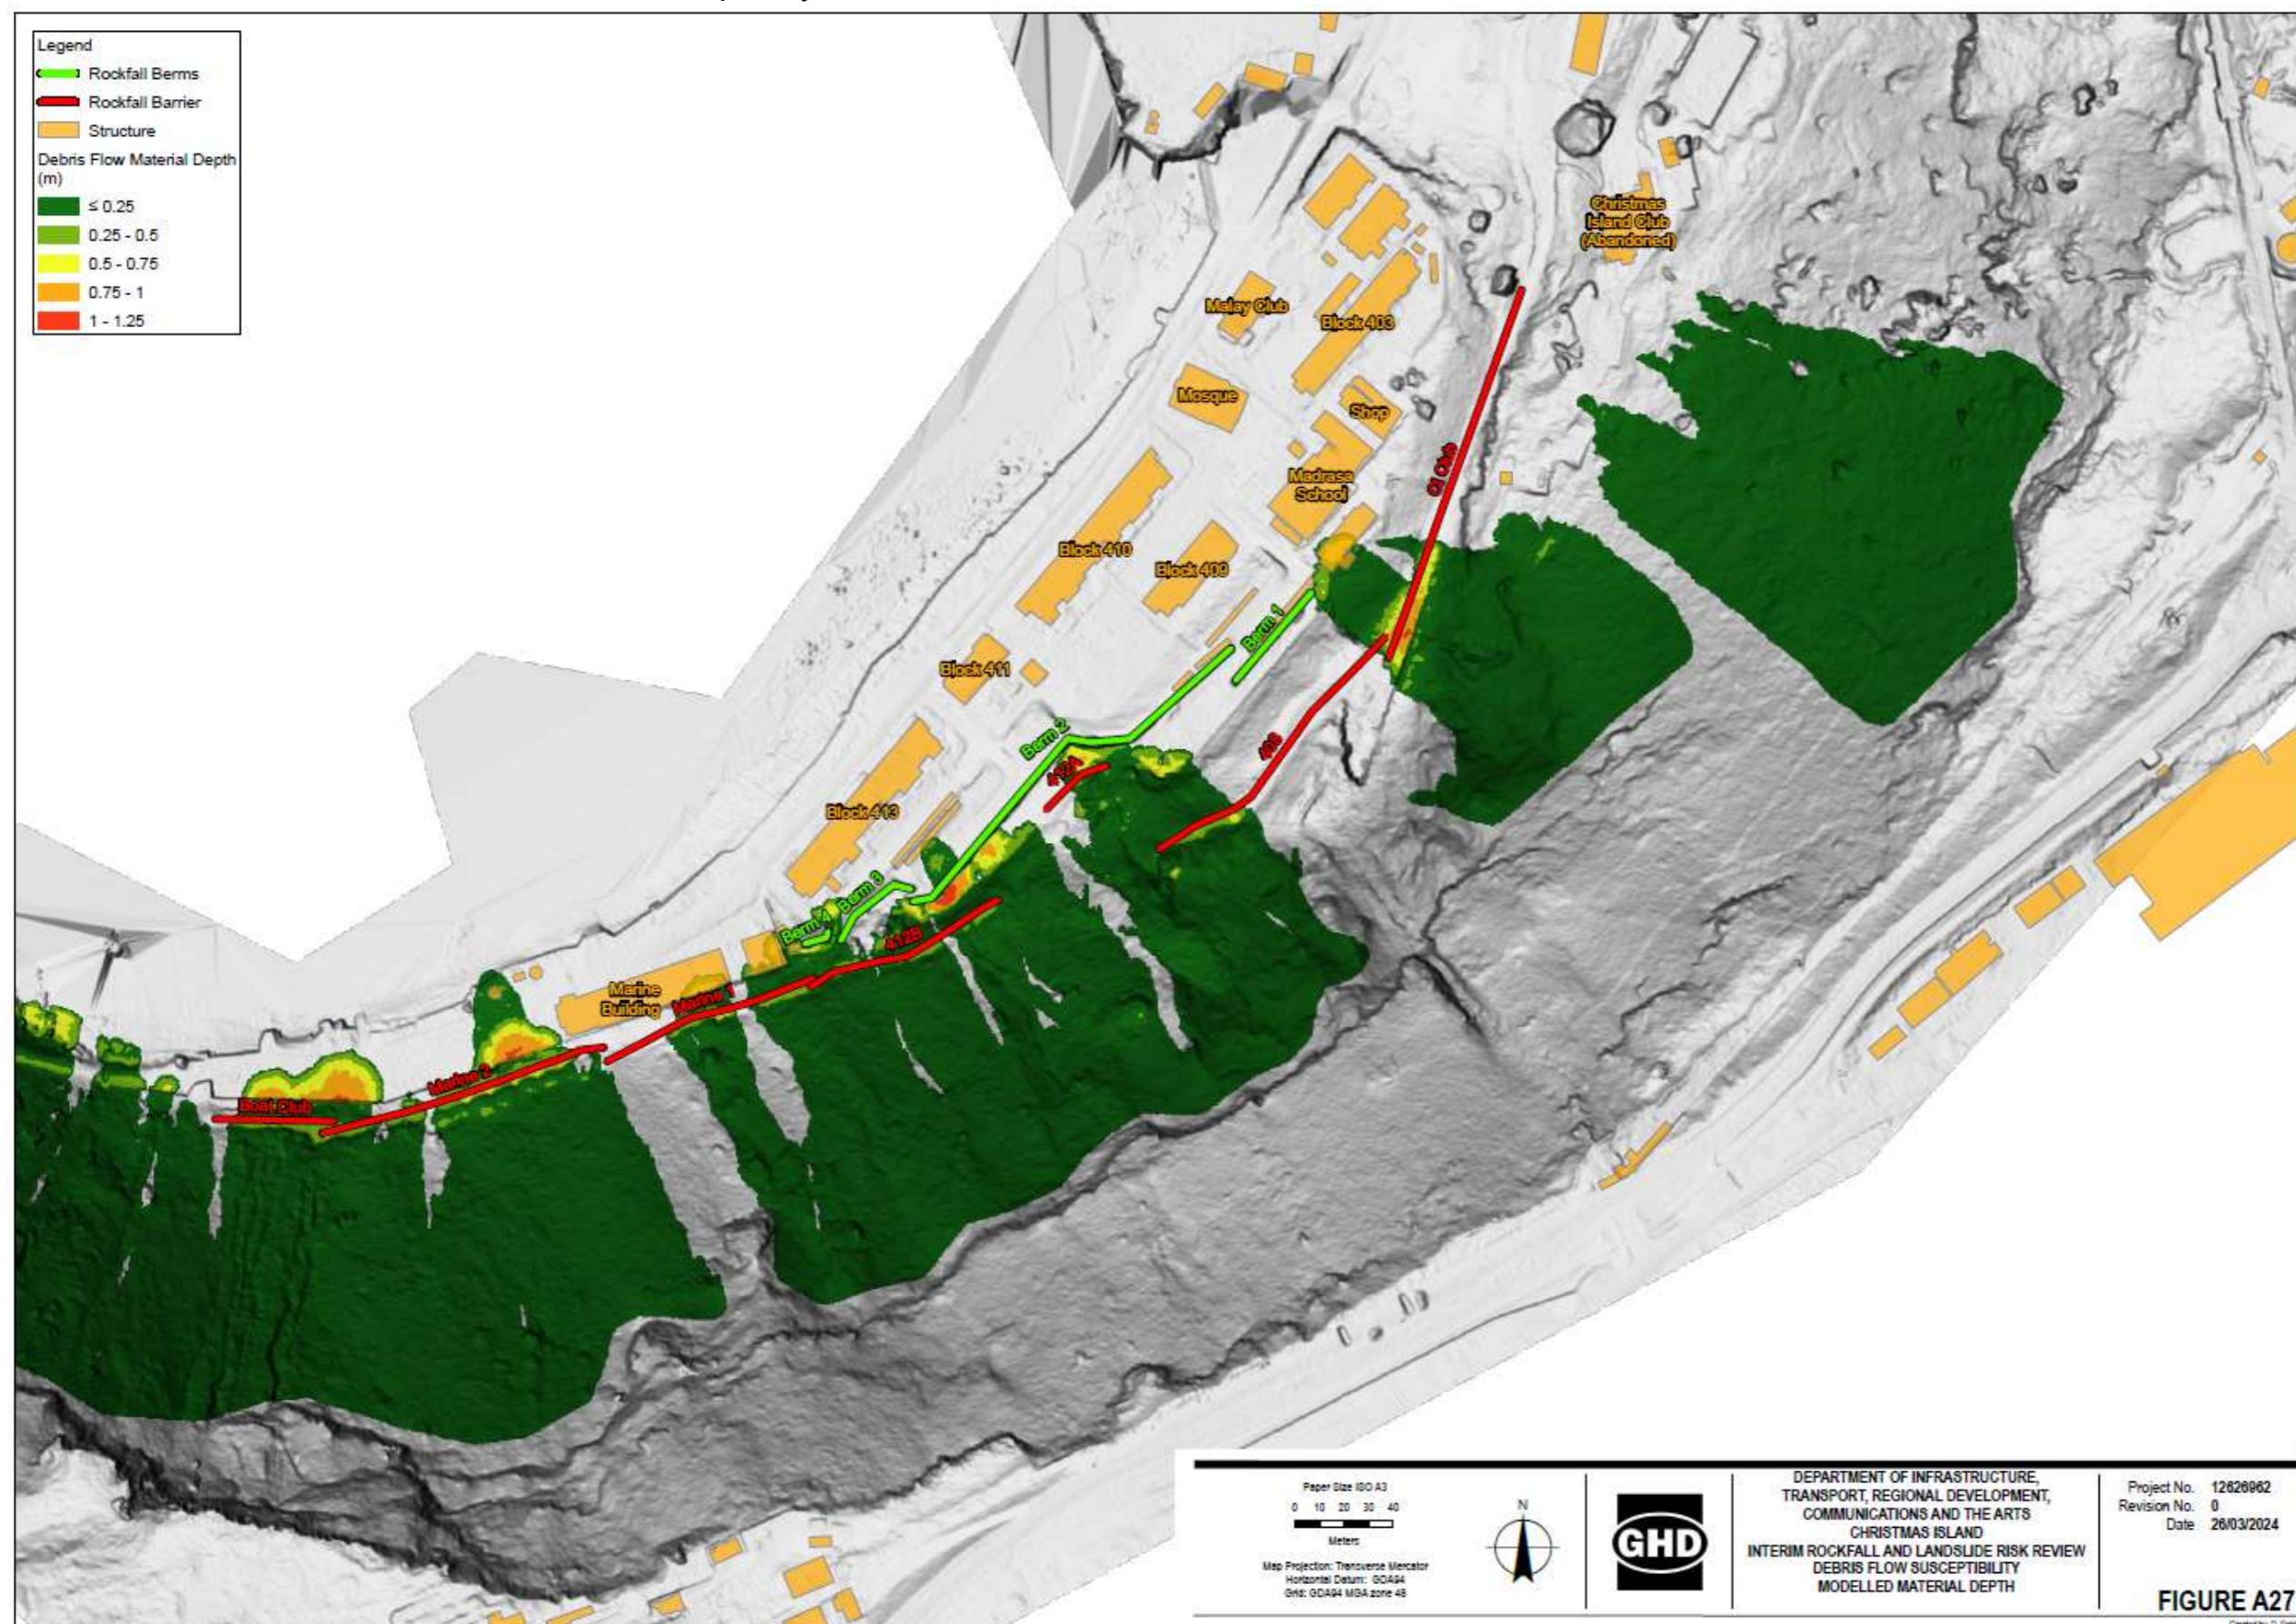
FIGURE 5 – Areas of Debris Flow Landslide Susceptibility

The areas of Flying Fish Cove identified to be at risk due to debris flow landslides are indicated in Figure 5 (with barriers). It should be noted that a debris flow could conceivably extend beyond the probable limit of defined in the figures, but that the risk of this happening is considered to be negligible.
