Rockfall Risk Management Plan

Emergency Management Committee
Christmas Island

The Christmas Island Rockfall Risk Management Plan (RRMP) is a result of the 1997 Parliamentary Standing Committee on Public Works report on the Implementation of Rockfall Risk Reduction Strategies on Christmas Island. The RRMP recognises the Commonwealth's commitment to reducing rockfall risk across Flying Fish Cove.

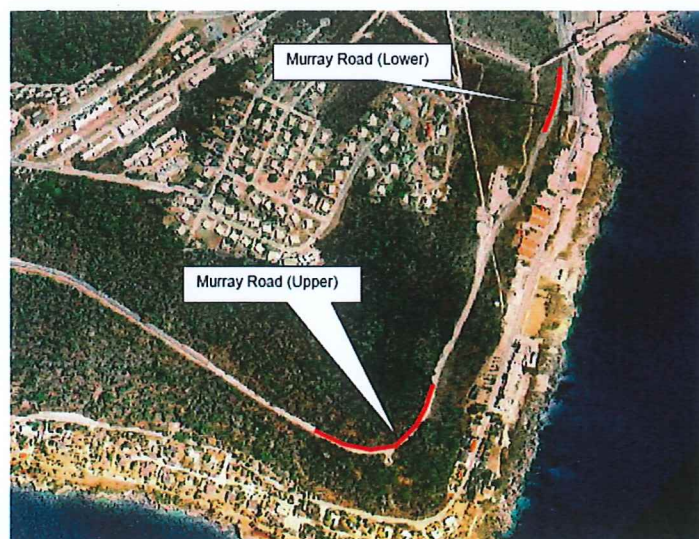
Figure 1 – Murray Road Rockfall risk investigation sites.

In September 2008, inspections of rockfall risk areas on Murray Road were arranged by the Commonwealth and carried out by geotechnical engineering consultants from ARUP. Two sites on Murray Road were specifically investigated and these are shown in Figure 1 below.

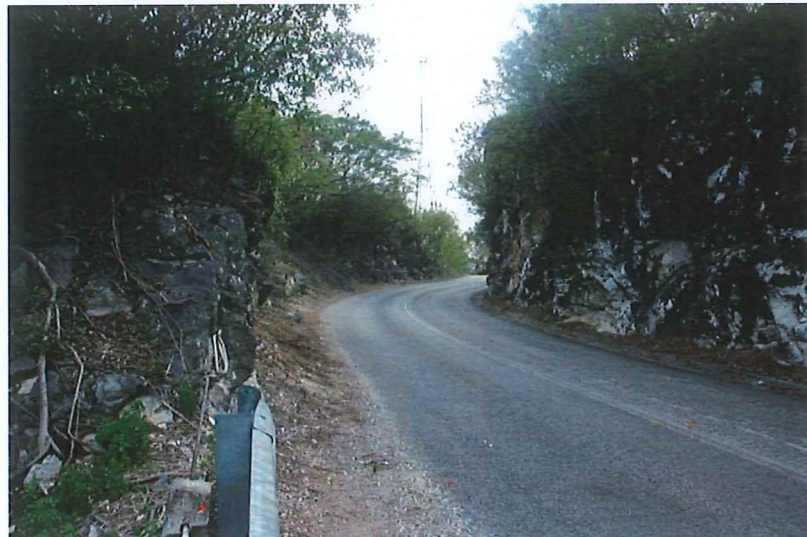
Figure 2 – Murray Road upper site.

The first site - Murray Road Upper is shown in Figure 2. It consists of a “box cut” with slopes on both sides of the road within a ninety degree bend. Specific site details are as follows:

- The length of this site is approximately 200m;
- The cuttings on both sides of the road are up to about 4m high and vary in angle from near vertical to approximately 60°;
- The cuttings are formed in very thin soil and rock. The material surface is very rough and there is evidence of both erosion and small rock falls;
- The posted speed limit is 60km/h and sight distance on the bend is generally less than the required 60m;
- Two signs warning of falling rocks and slippery road surface are posted uphill of the site;
- A crash barrier exists on the down slope (northern side) of the road below the site.
