# Kingston Pier Channel Construction Project

## Public Environment Report

Department of Infrastructure, Transport, Regional Development, Communications and the Arts

17 January 2023

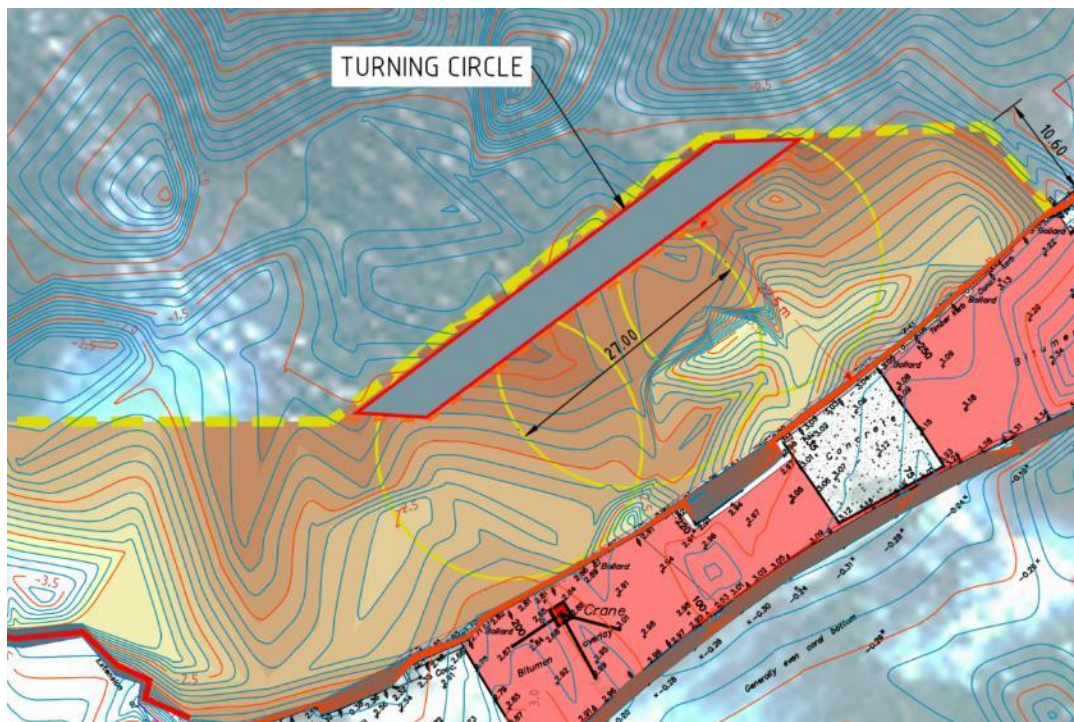
Figure 1-30 Option 3a reduced channel width (grey shading with red outline) compared to Option 3 (yellow dashed line).

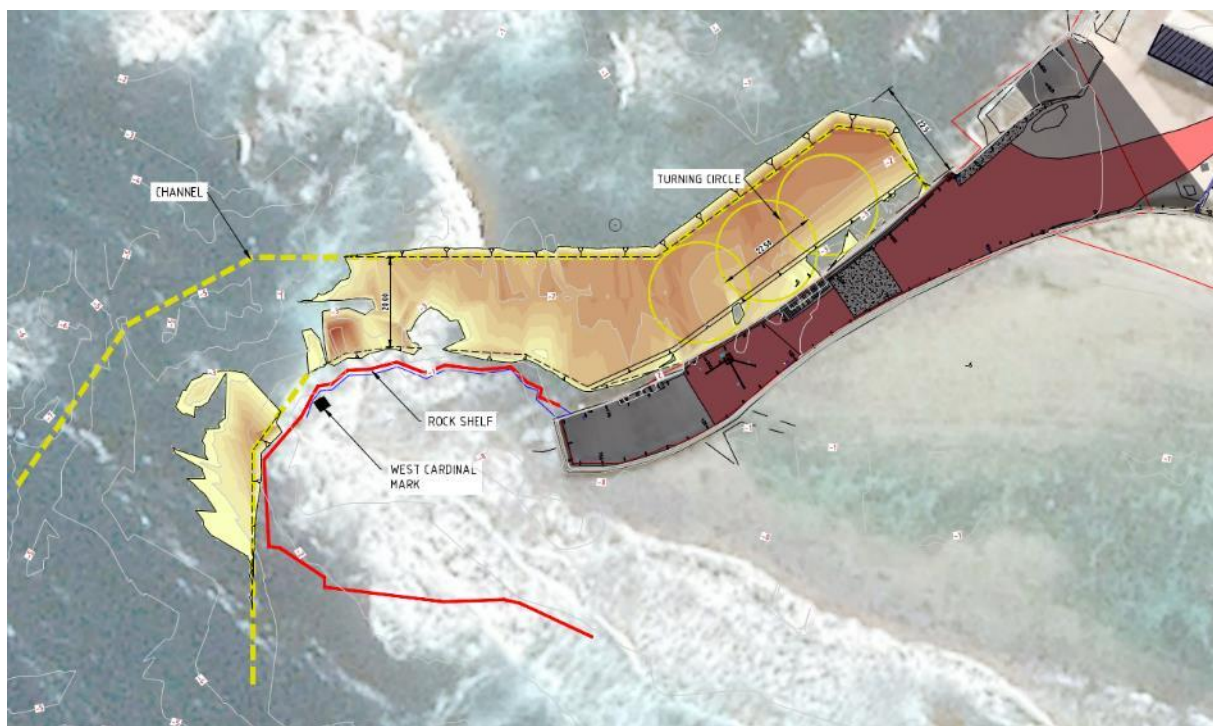
Figure 1-31 Preferred channel design alignment and volume cut.

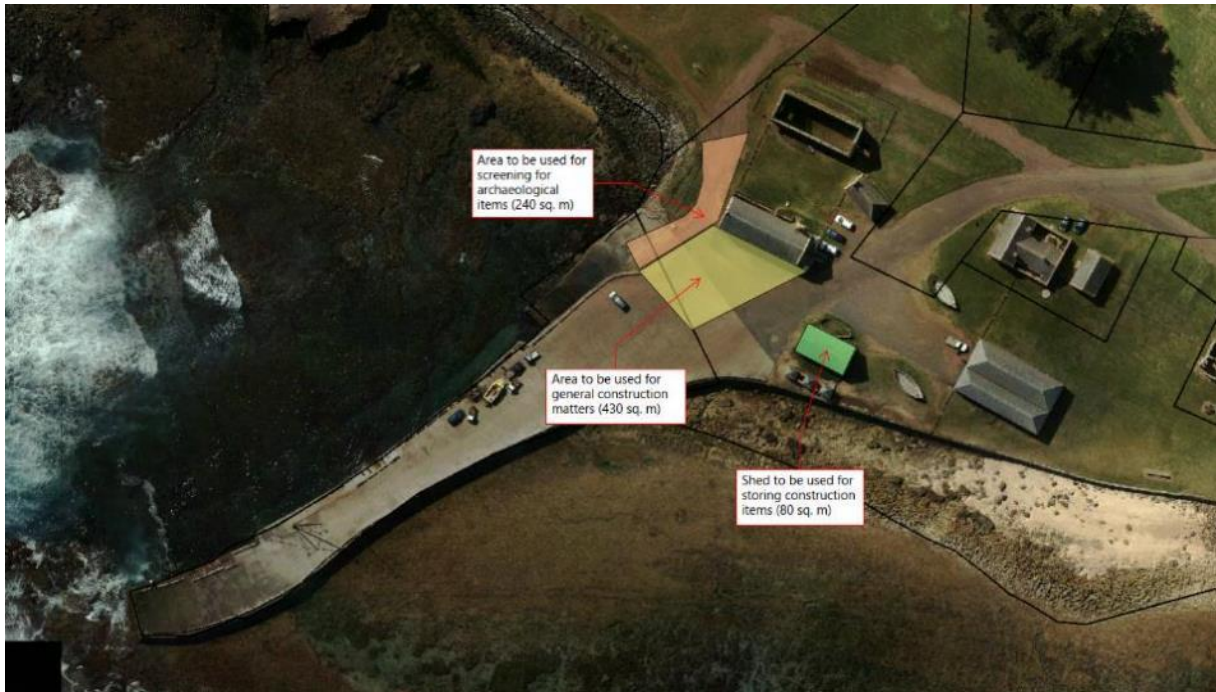
Figure 1-33 Contractor's site establishment.

Site establishment would involve set up of the construction ancillary facilities which includes use of the nearby sheds on the pier for storage of plant and equipment. Temporary portable utilities including water tanks or a generator would be set up. A sieve station would be set up near the boat ramp for screening of archaeological artefacts from the sediment layer (Figure 1-33).

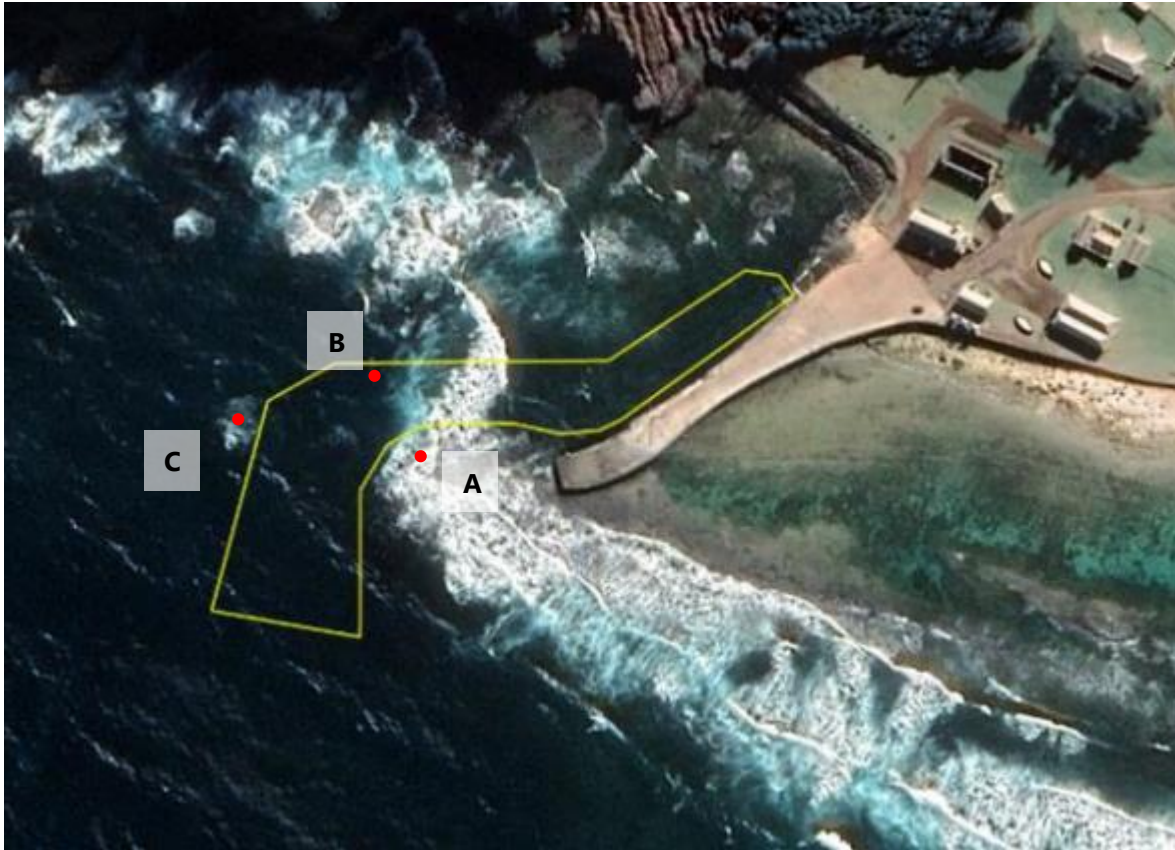
Figure 1-35 Proposed navigation marker locations A, B and C.

- Location A – located on the edge of the rock shelf (see point “A” on figure)
- Location B – located on the edge of the channel (see point “B” on figure)
- Location C – located on the bombora west of the reef rock shelf (see point “C” on figure).

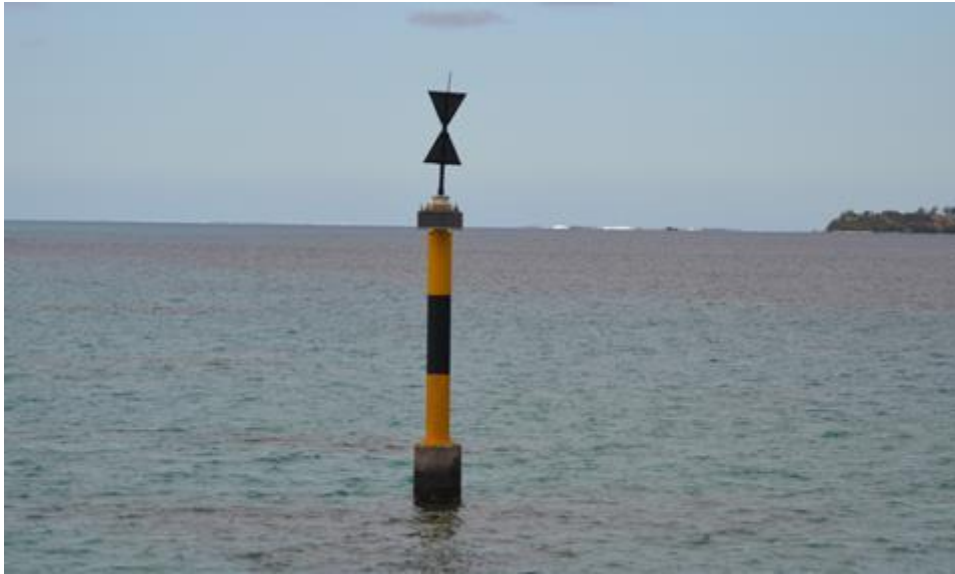
Figure 1-36 West Cardinal Mark.

The navigation marker would be bolted to the rock shelf at low tide and extend 1.5 metres above highest astronomical tide (HAT).

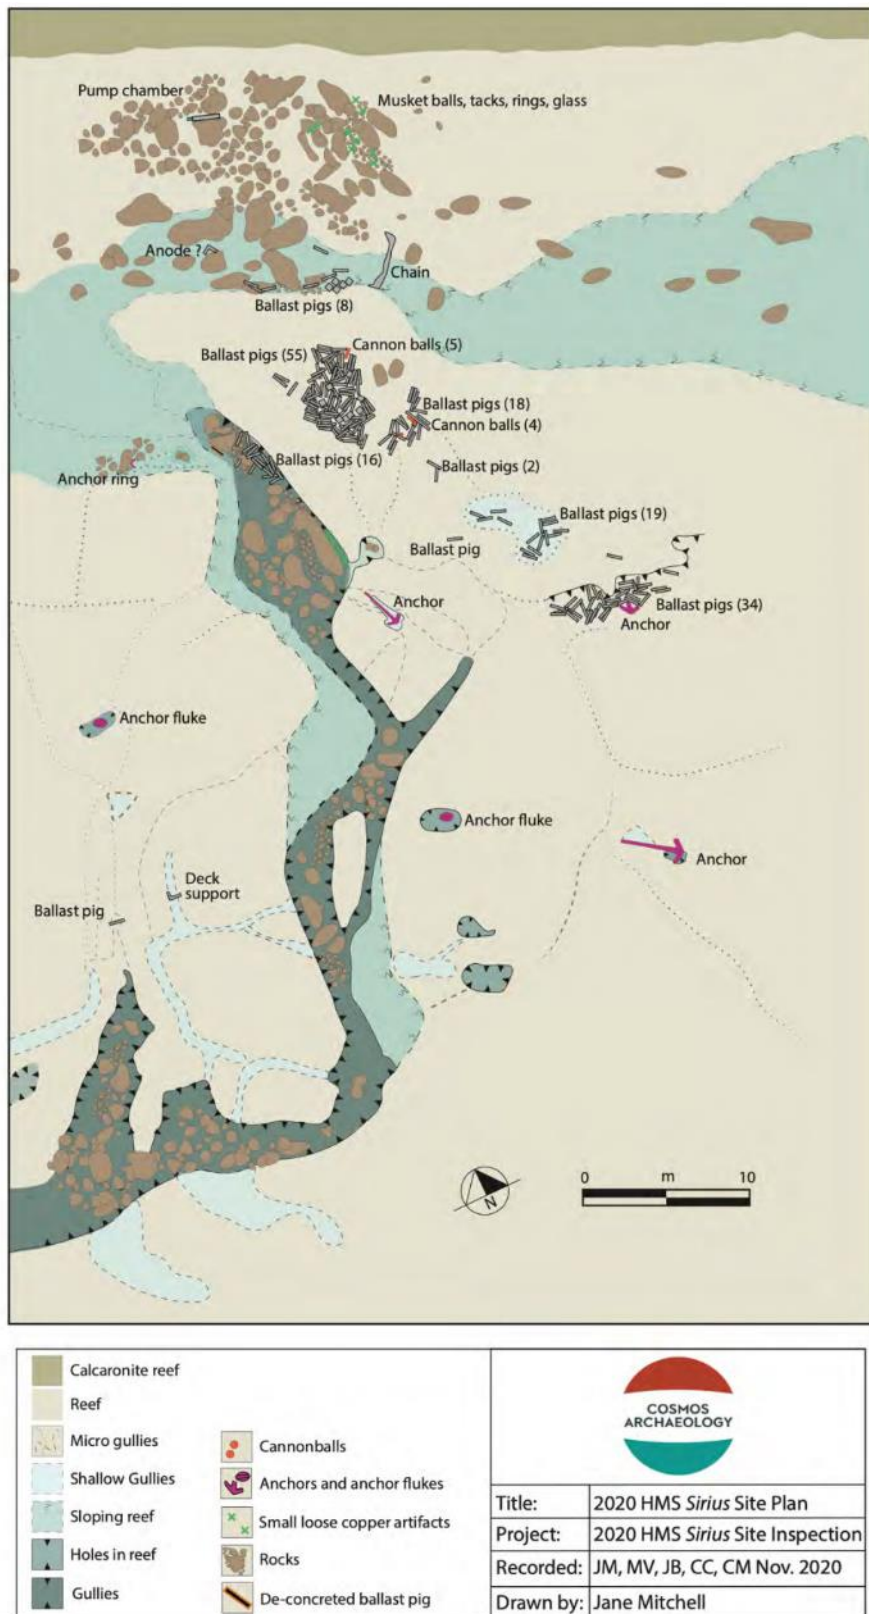
Figure 2-6 Updated HMS *Sirius* site plan (Source: Cosmos Archaeology 2020b).

As a result of the 2020 inspection, the 1989 site plan was updated by Cosmos Archaeology (2020b) to incorporate these changes as shown in Figure 2-6. It has also been digitised and made into a layer within the new site plan, thus keeping the history in one location.
