West Island 2018 Erosion Vulnerability

West Island 2018 Inundation Vulnerability
2018 500yr ARI Flood Depth (cm)

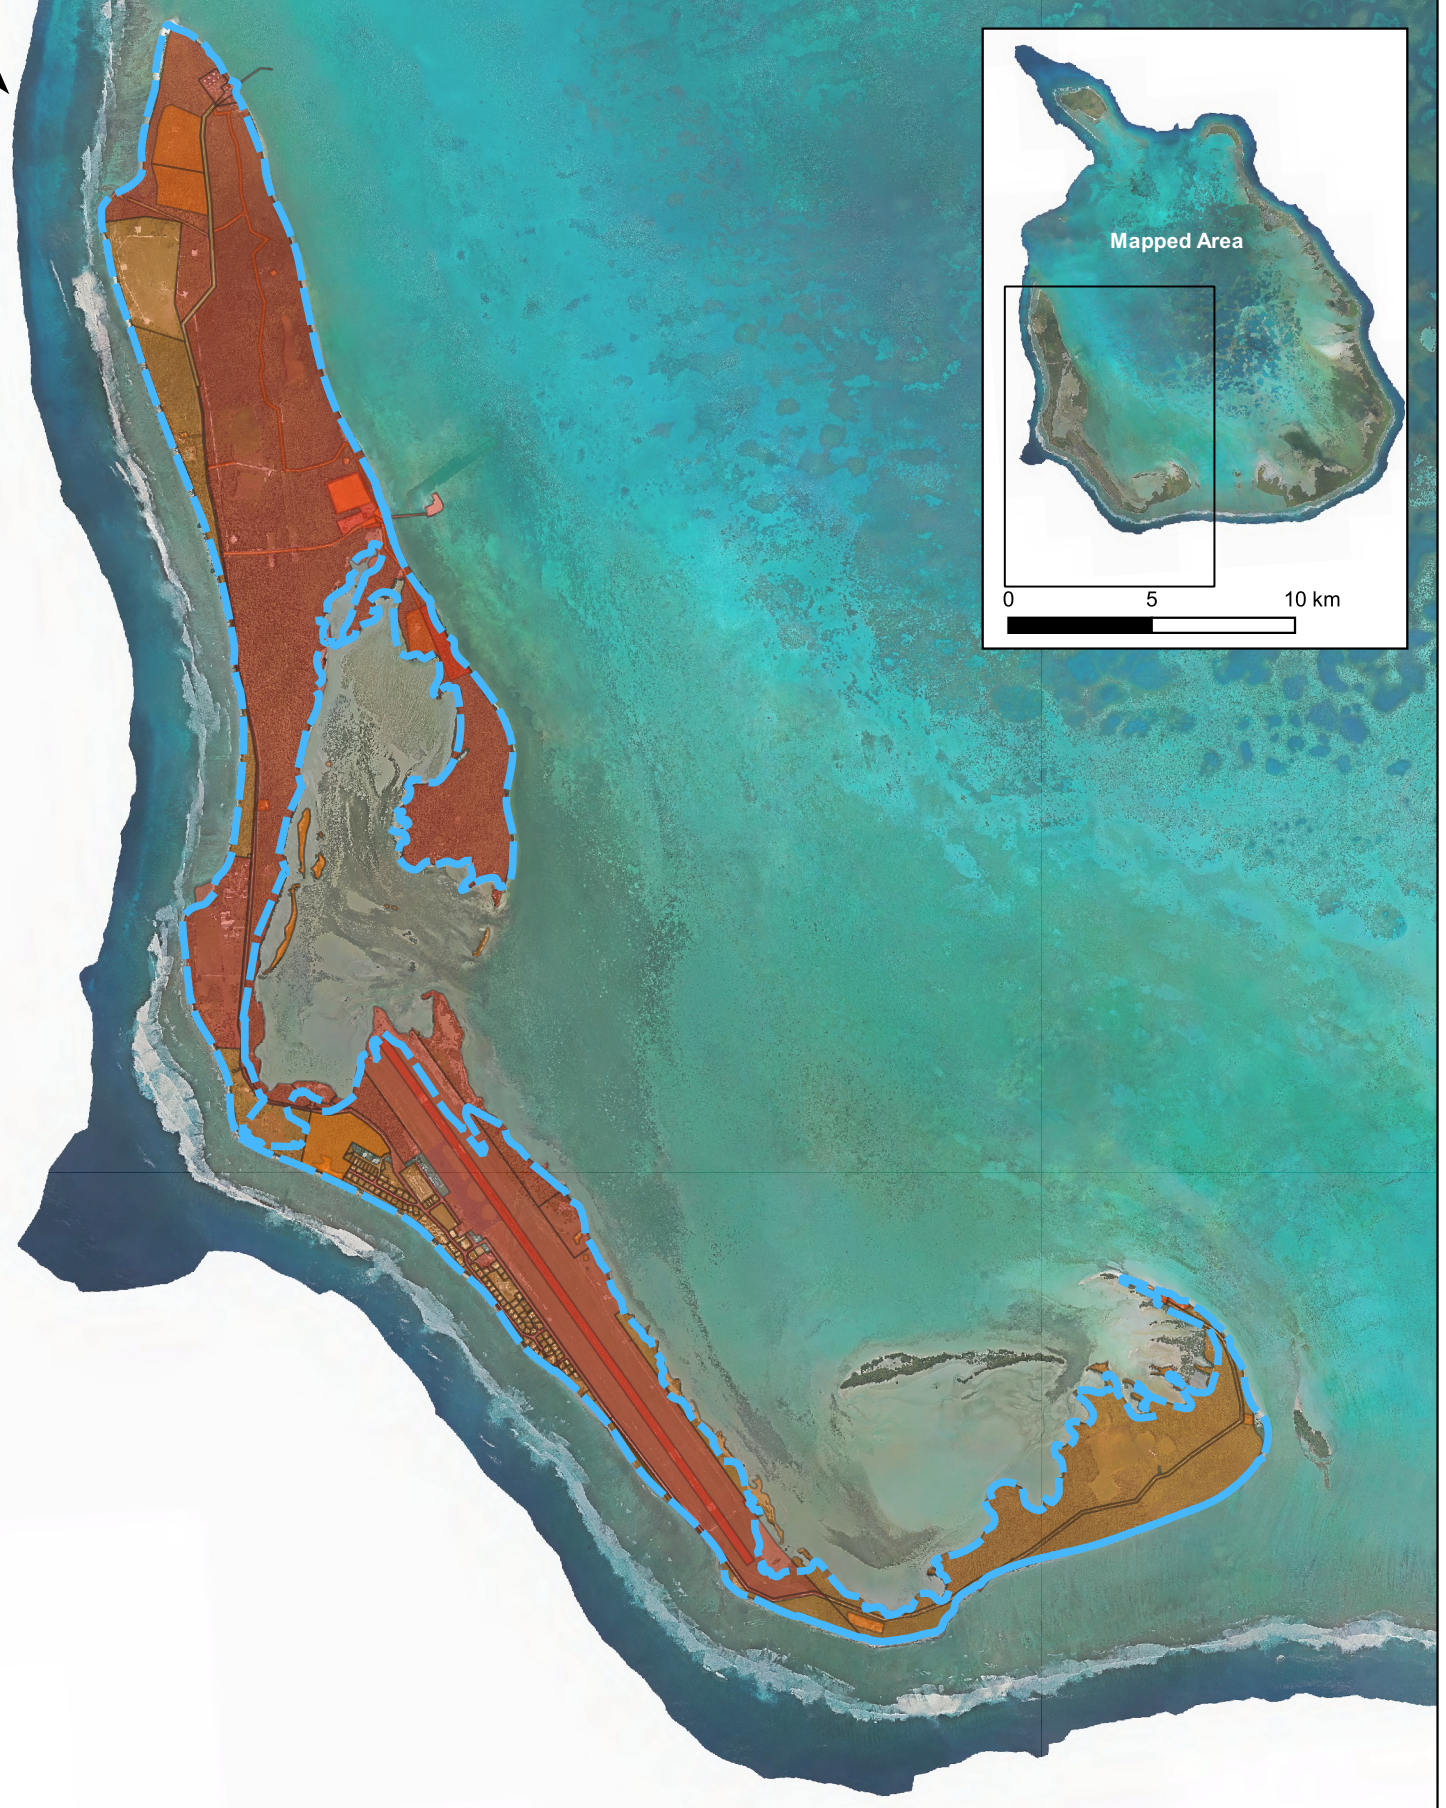
- 2018 Erosion Hazard Line
- 2018 Erosion Vulnerability
 - EXTREME
 - HIGH

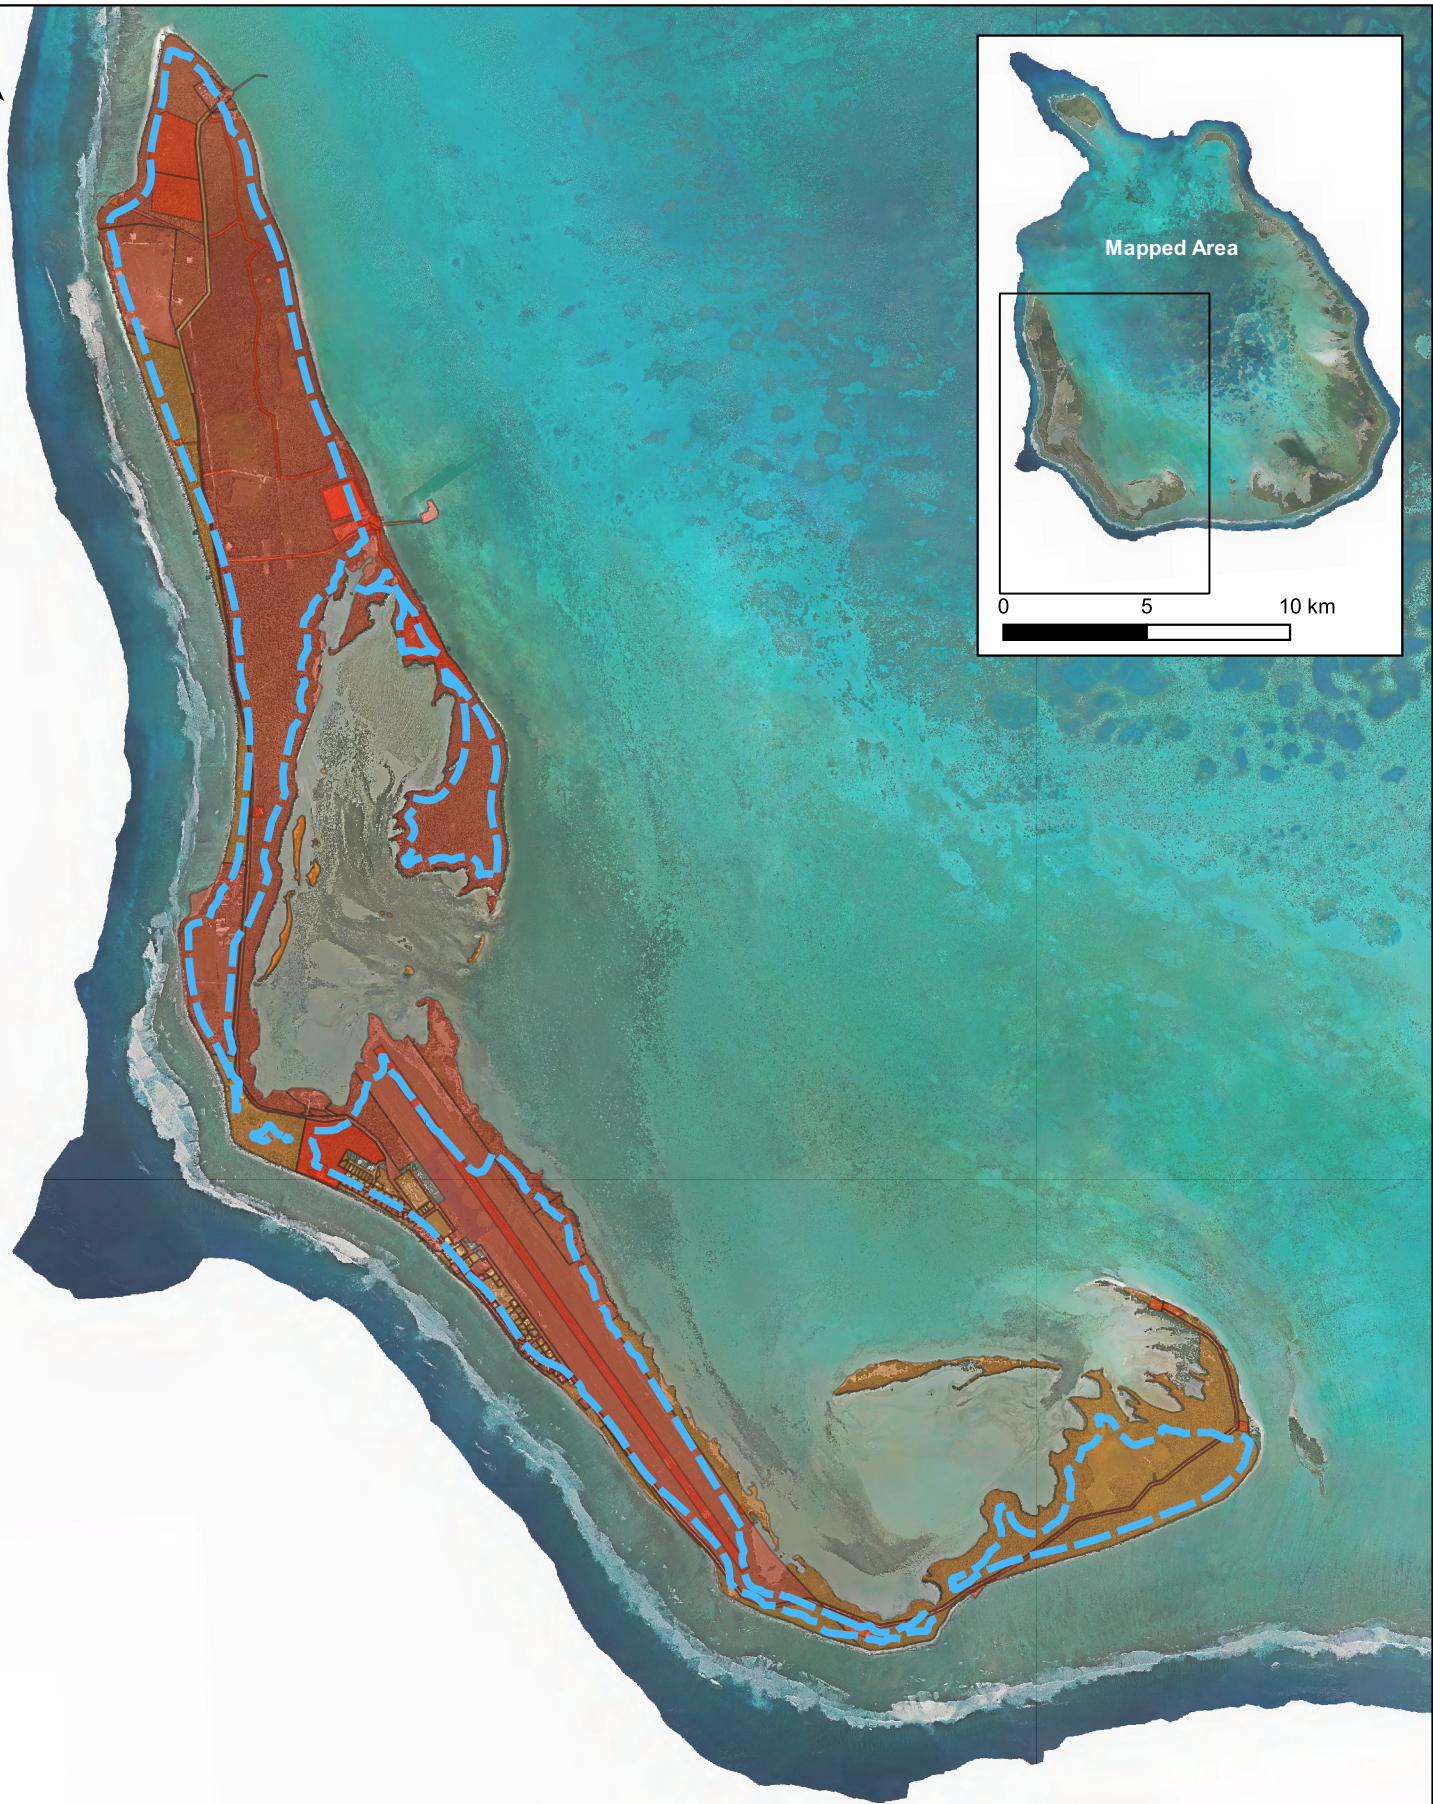
West Island 2068 Erosion Vulnerability

- 2068 Erosion Hazard Line
- 2068 Erosion Vulnerability
 - EXTREME
 - HIGH

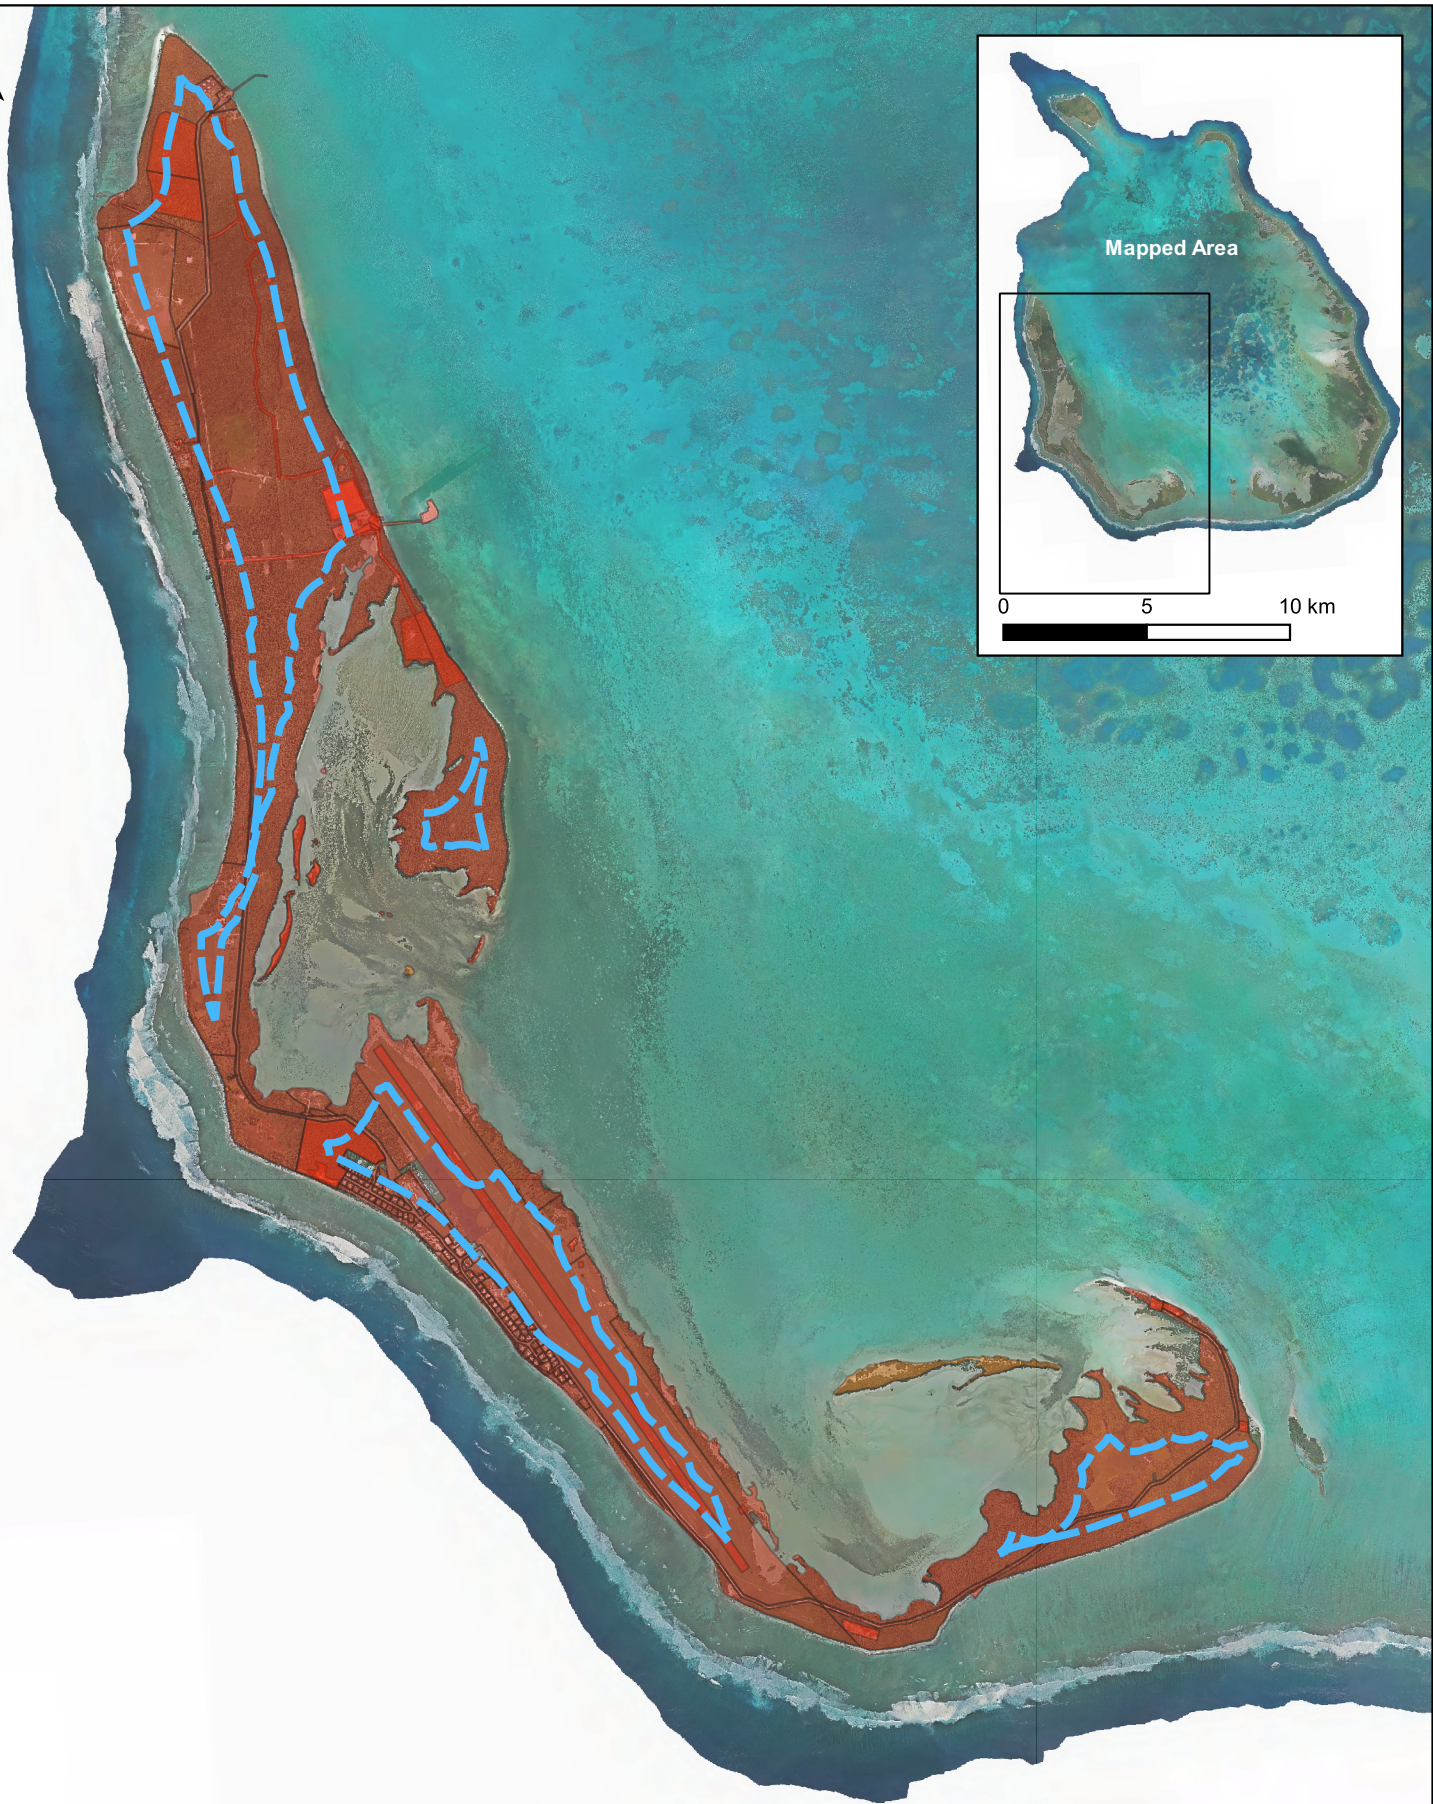
West Island 2118 Erosion Vulnerability

2118 Erosion Hazard Line
-

EXTREME
-

HIGH

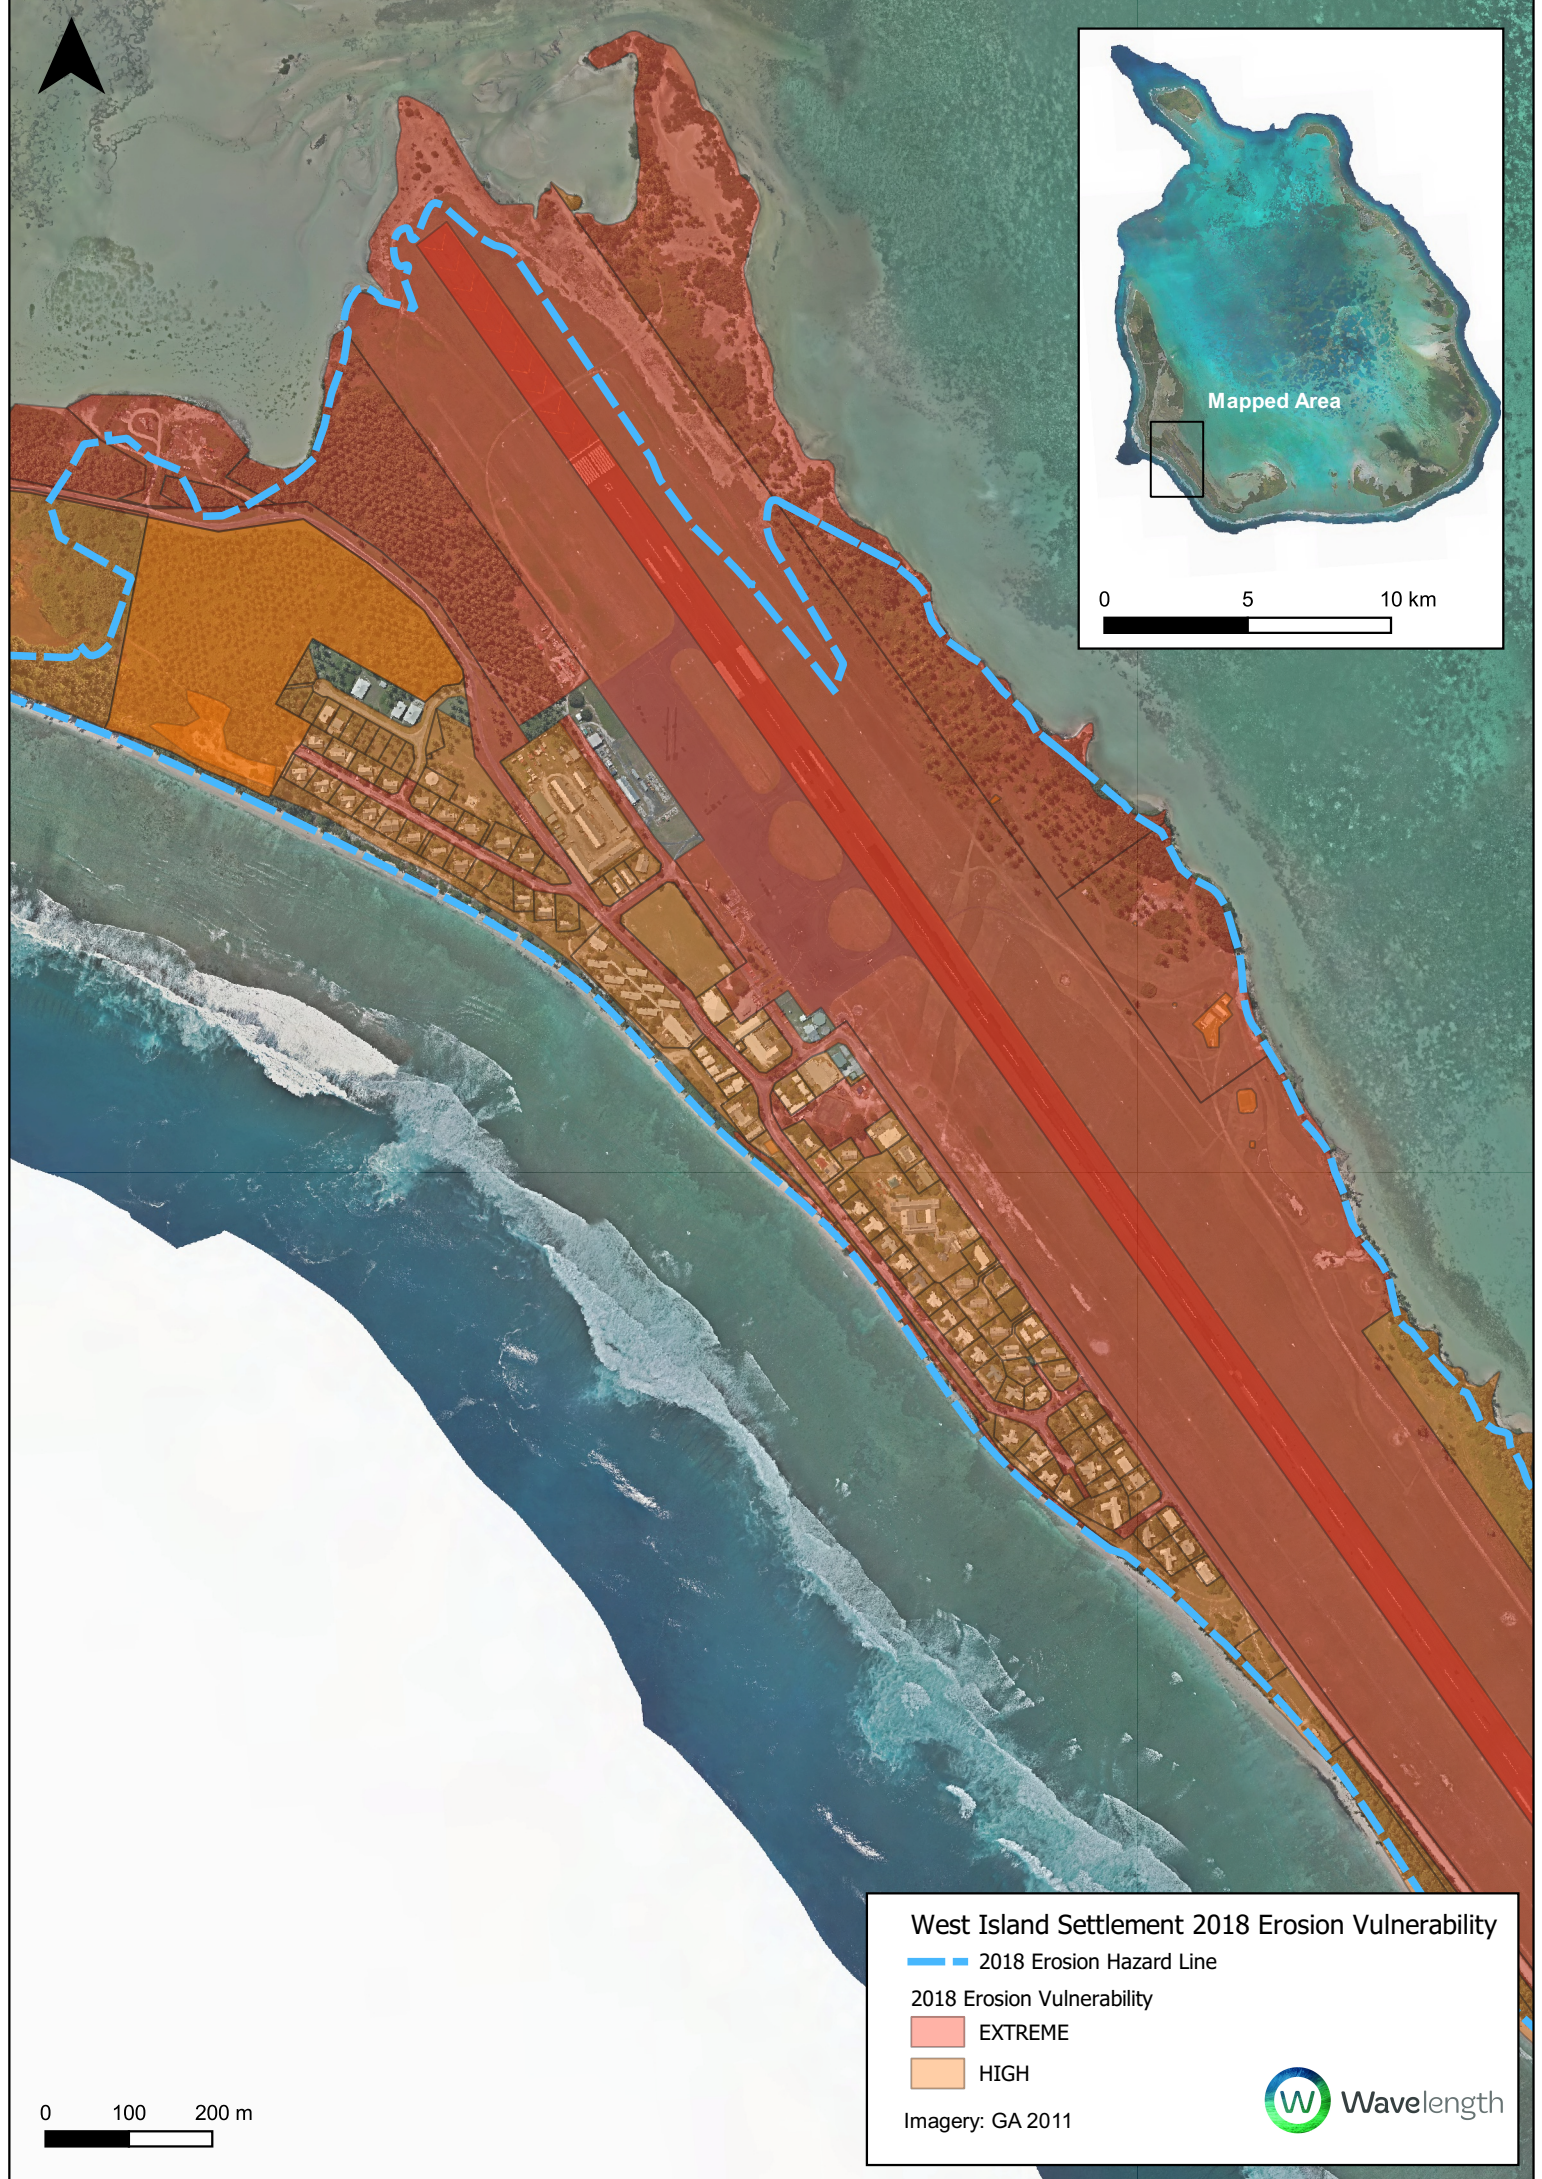
West Island Settlement 2018 Erosion Vulnerability

— 2018 Erosion Hazard Line

2018 Erosion Vulnerability

EXTREME

HIGH

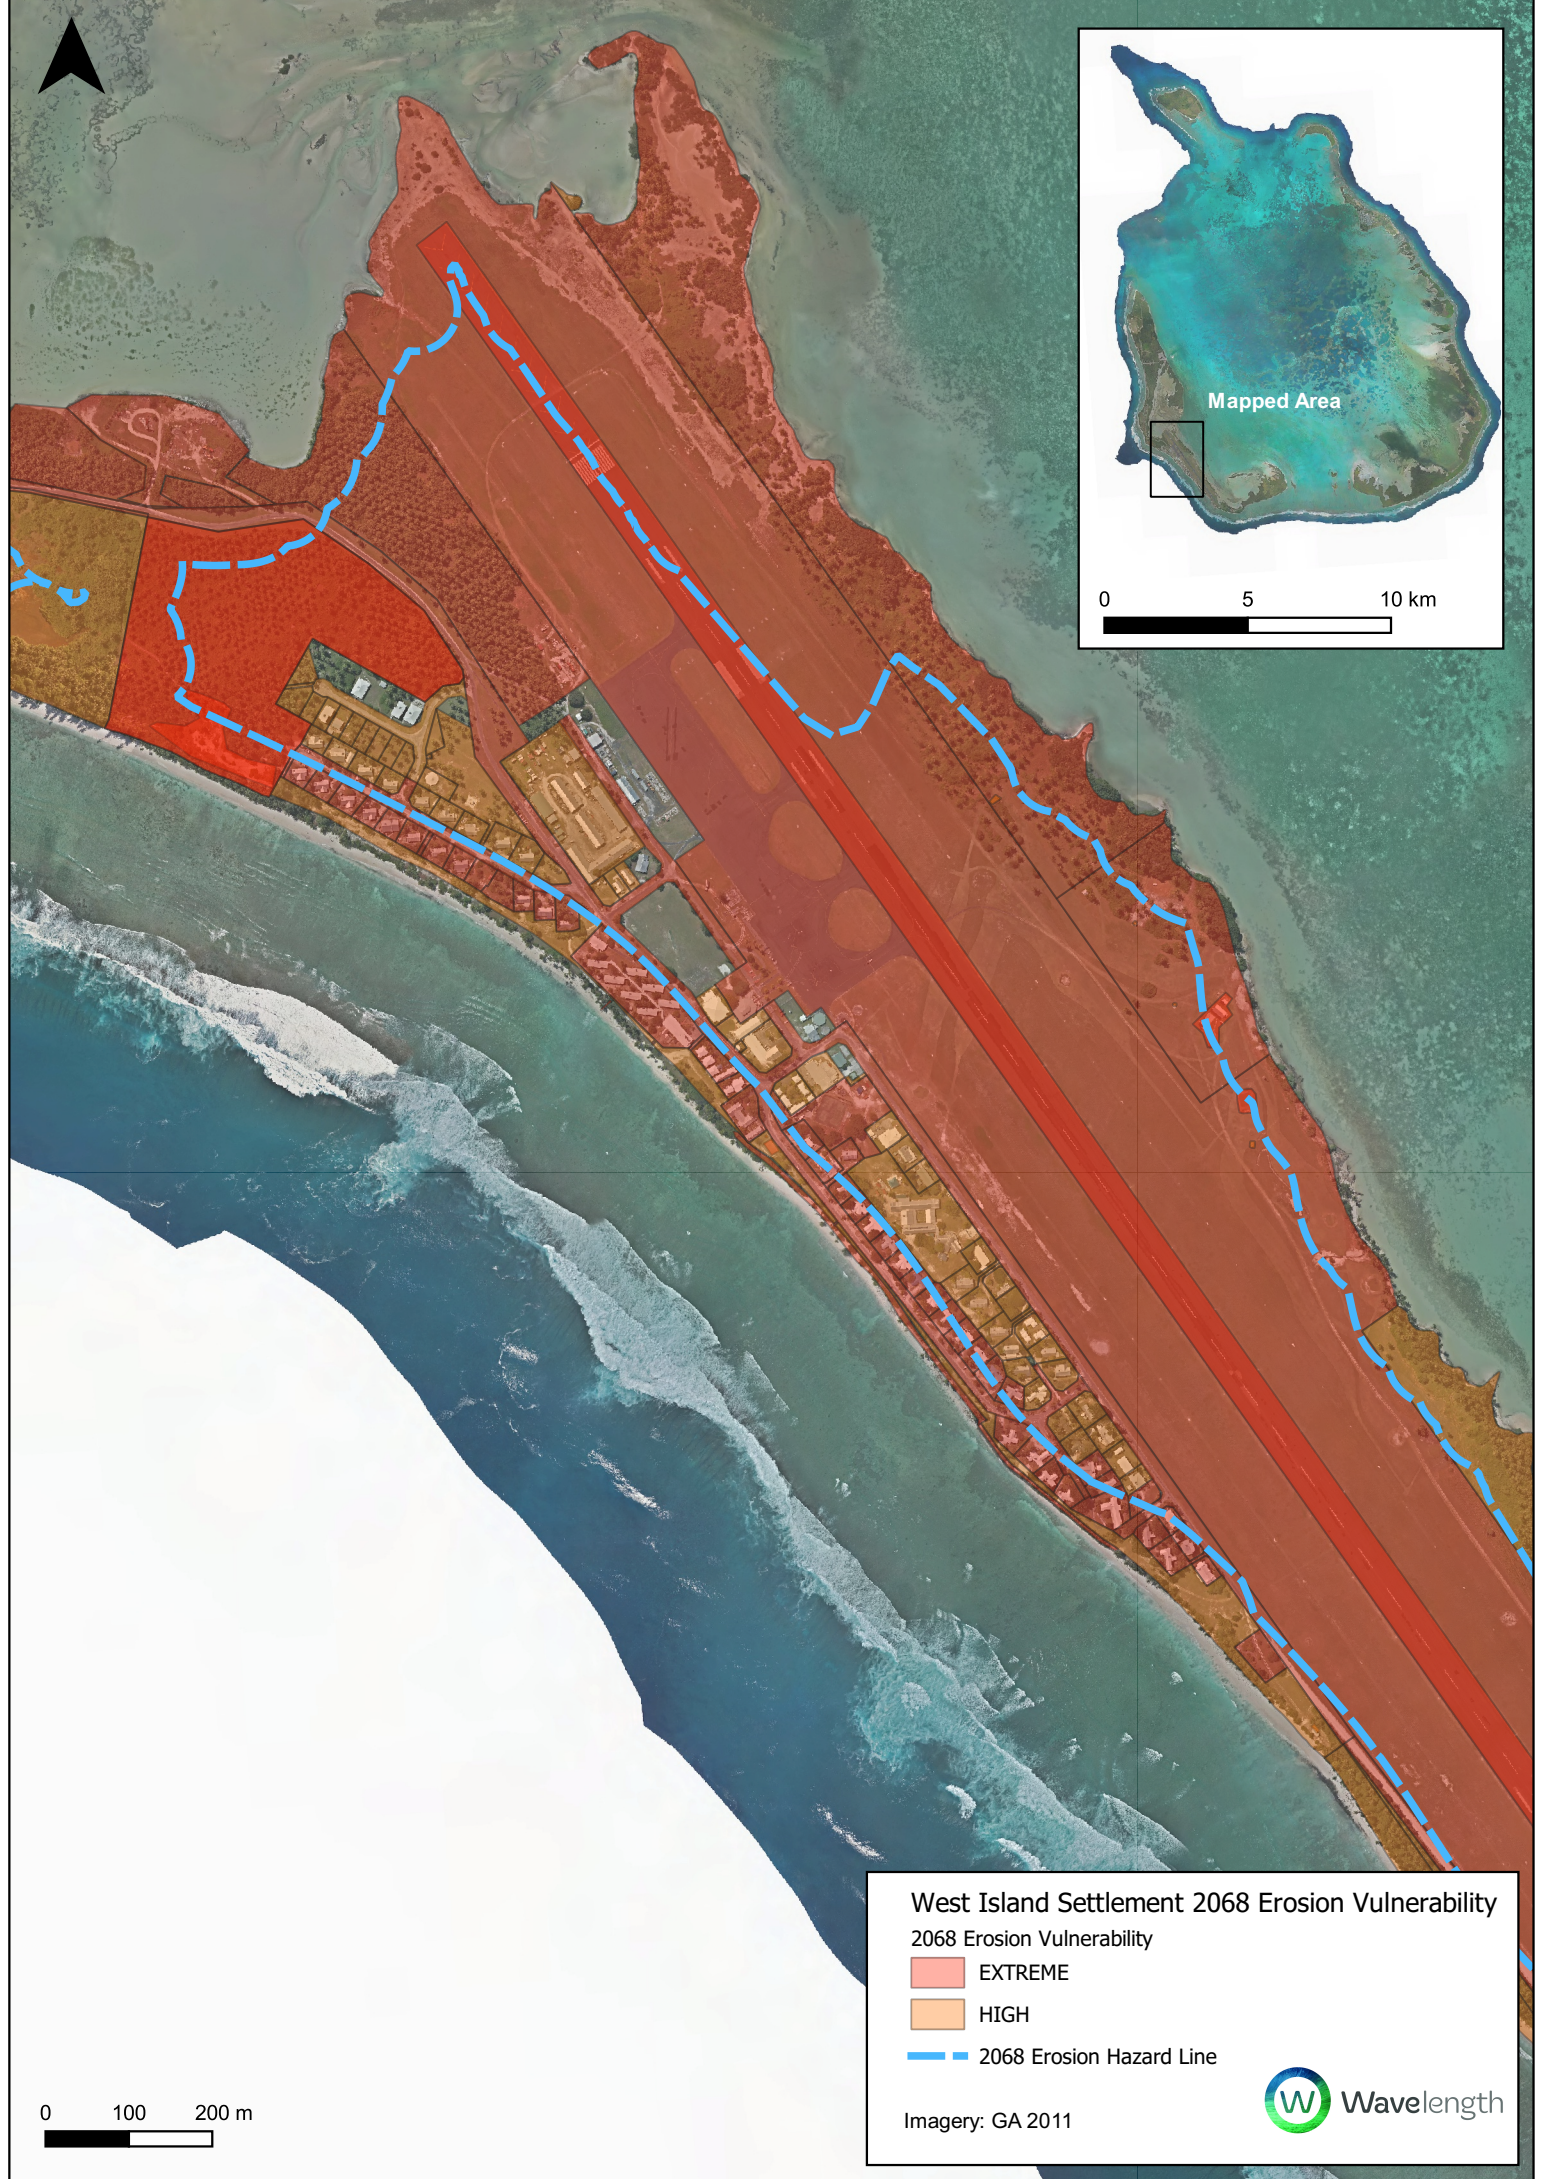
West Island Settlement 2068 Erosion Vulnerability

2068 Erosion Vulnerability

- EXTREME
- HIGH
- 2068 Erosion Hazard Line

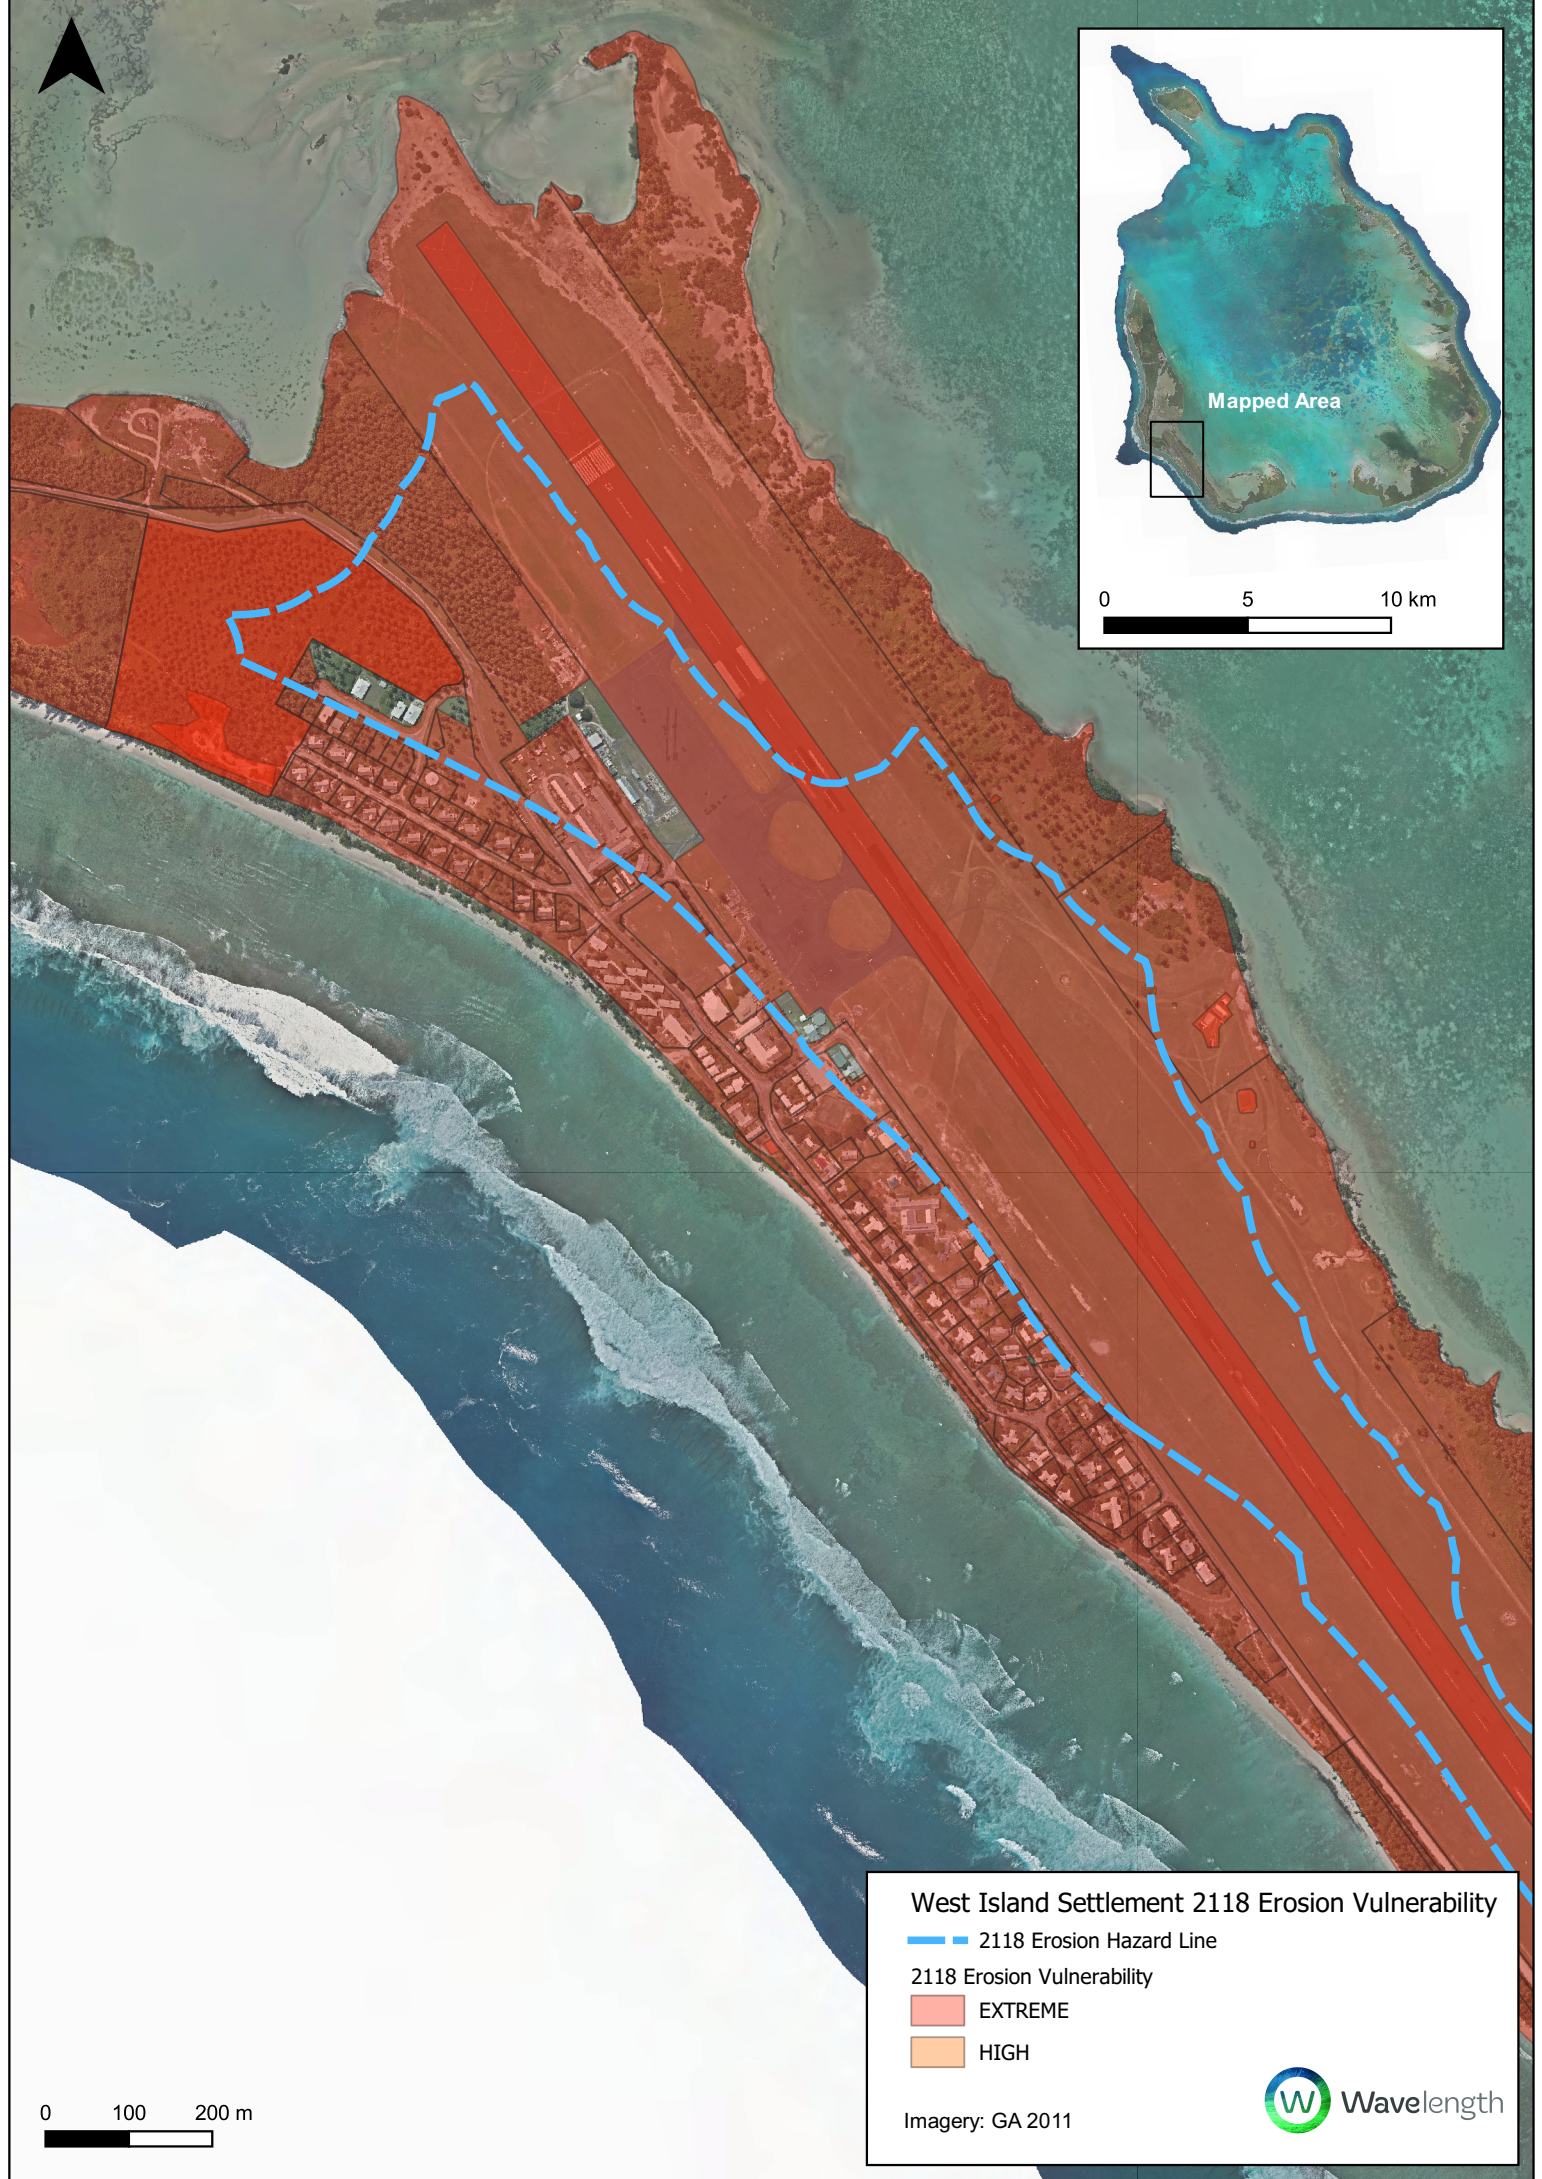
West Island Settlement 2118 Erosion Vulnerability

— 2118 Erosion Hazard Line

2118 Erosion Vulnerability

EXTREME

HIGH

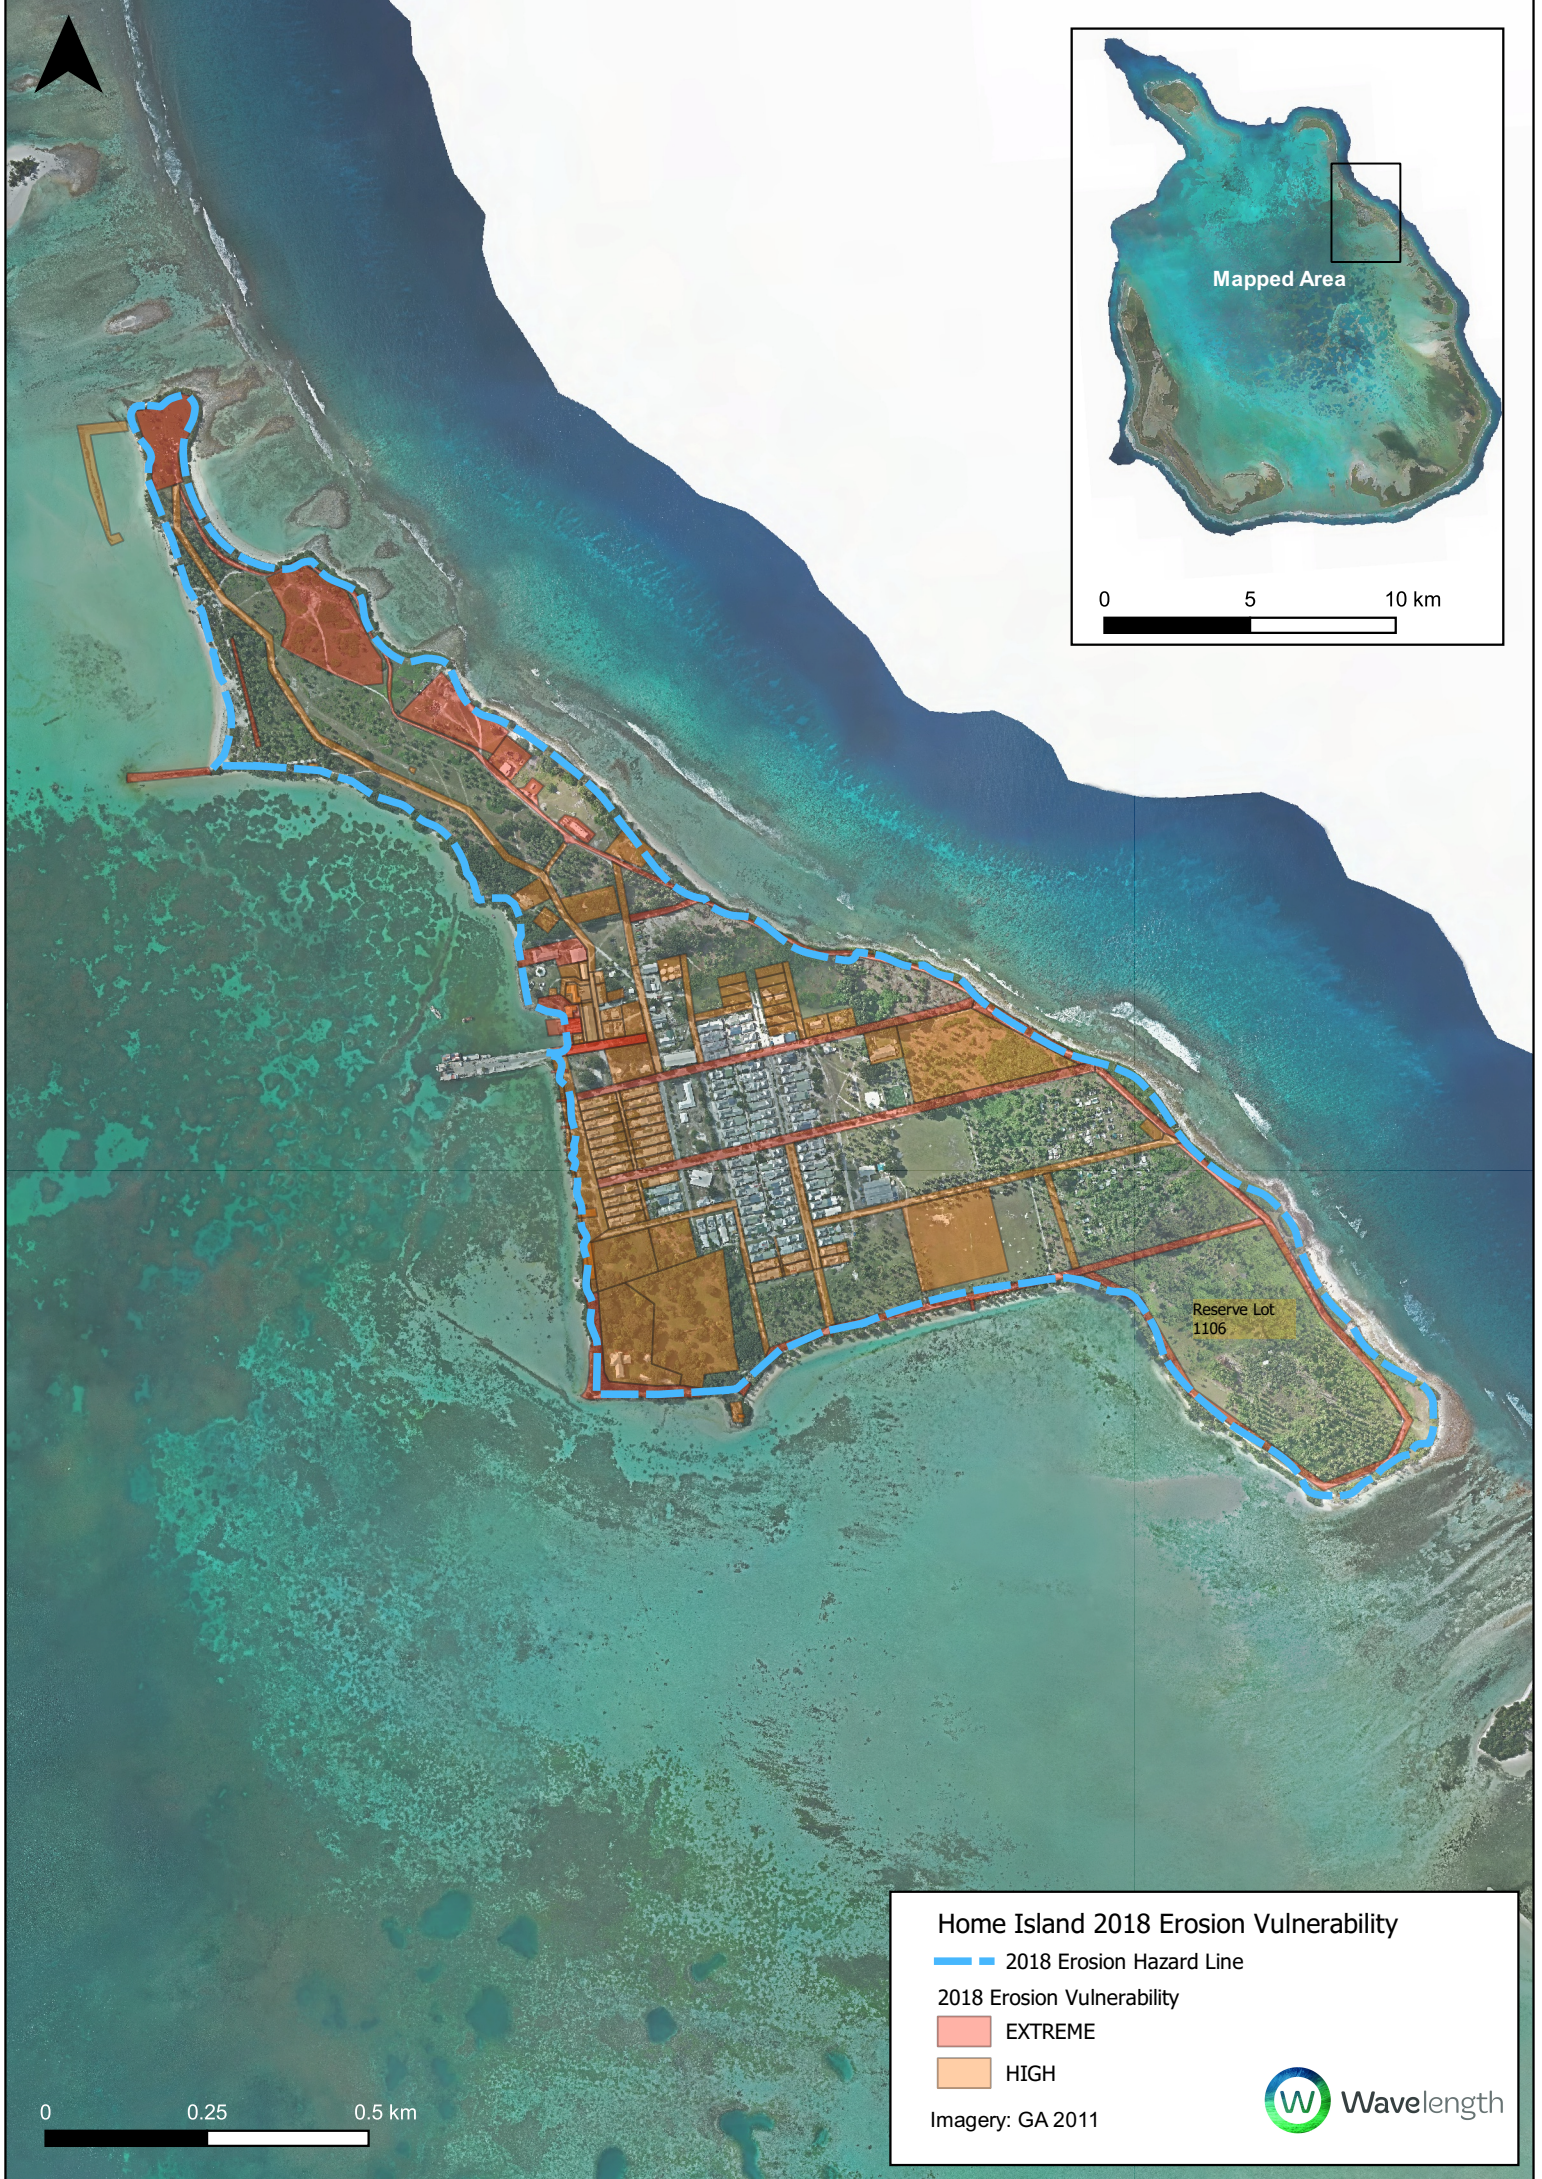
Home Island 2018 Erosion Vulnerability

- 2018 Erosion Hazard Line
- 2018 Erosion Vulnerability
 - EXTREME
 - HIGH
