West Island 2018 Erosion Vulnerability

West Island 2018 Inundation Vulnerability
2018 500yr ARI Flood Depth (cm)

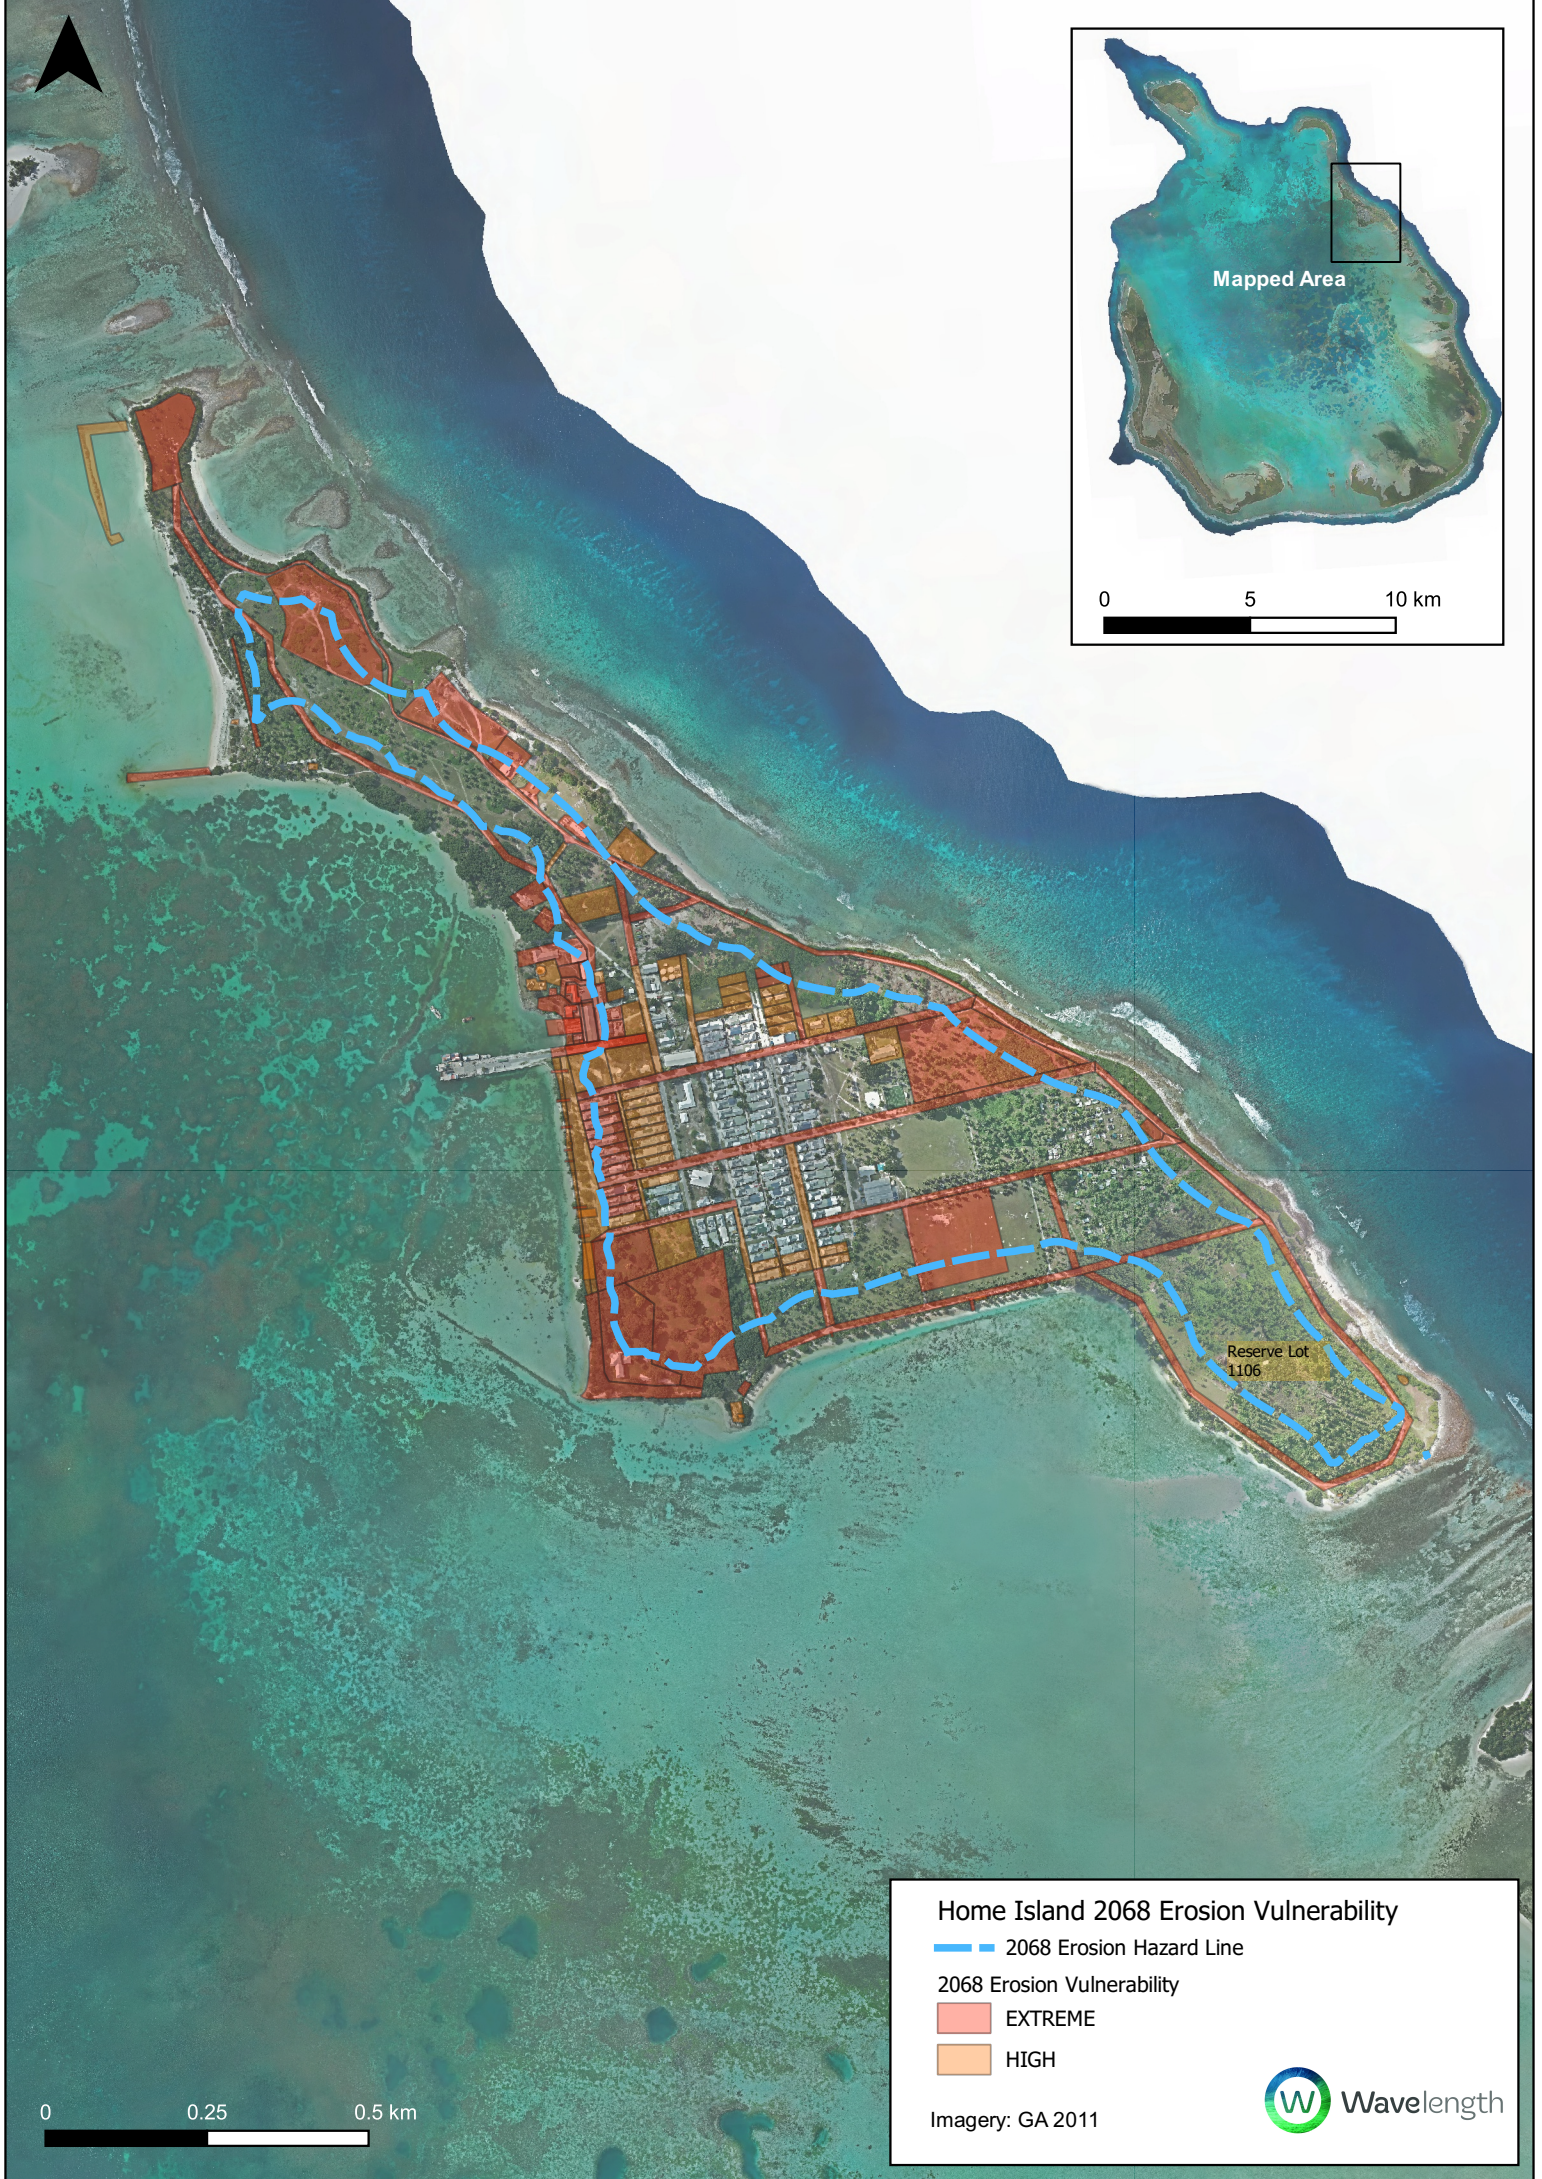
Home Island 2068 Erosion Vulnerability

- 2068 Erosion Hazard Line
- 2068 Erosion Vulnerability
 - EXTREME
 - HIGH

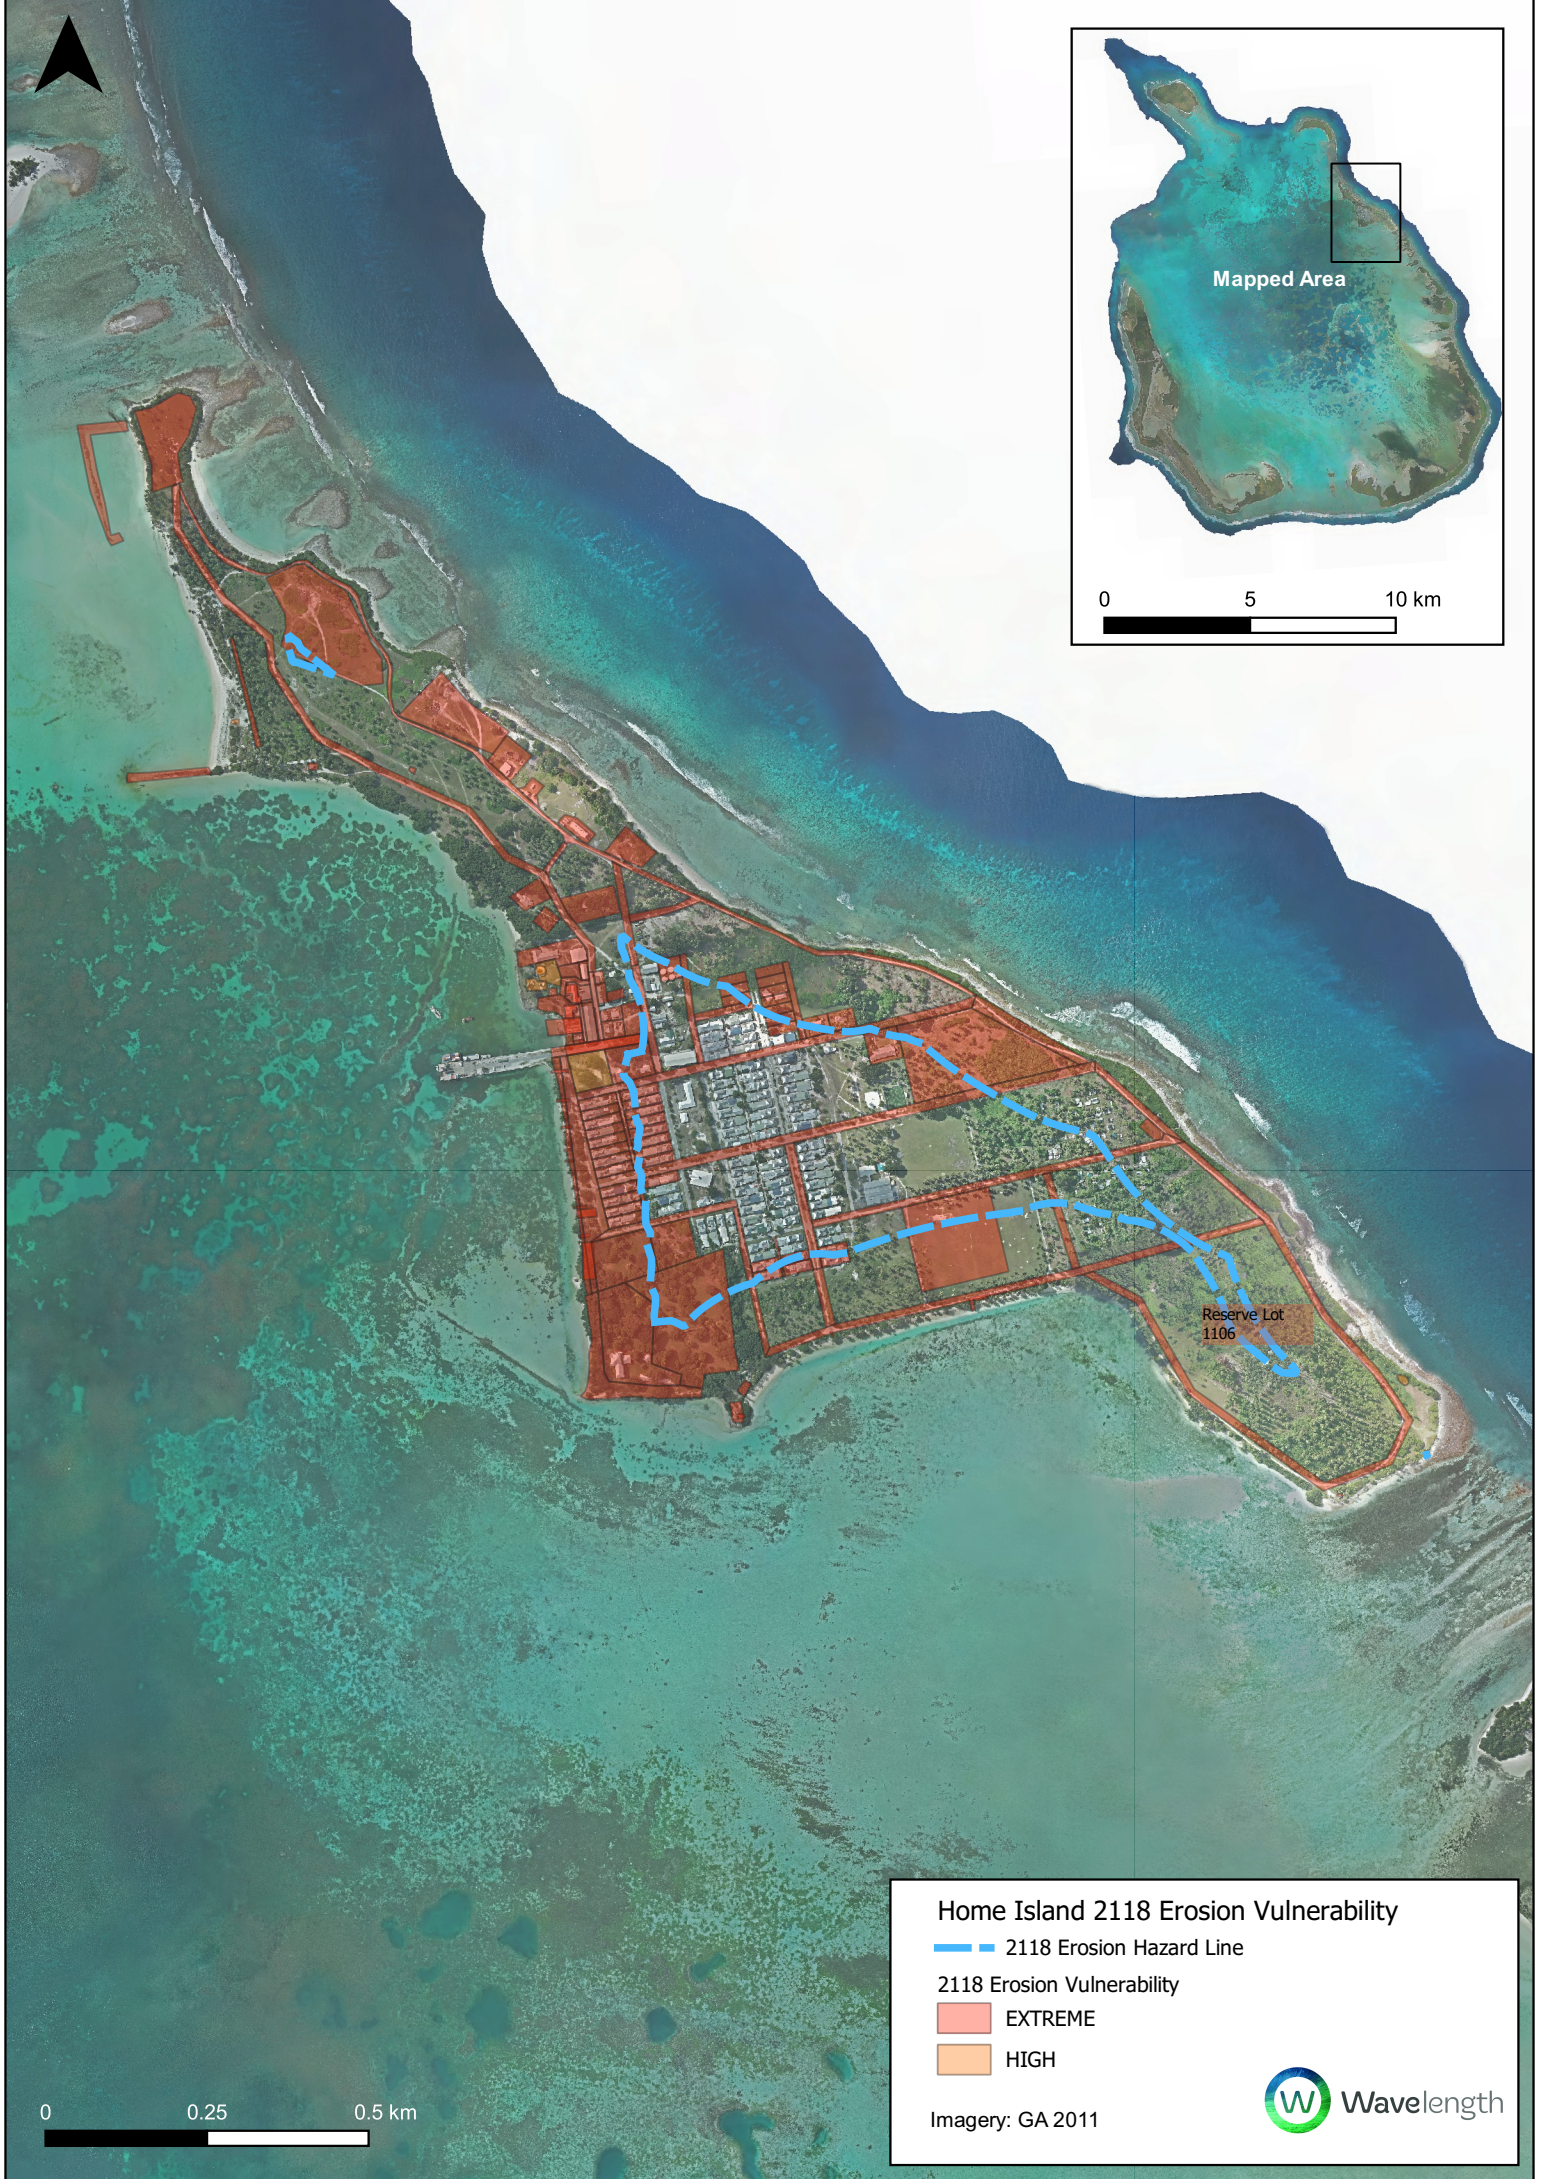
Home Island 2118 Erosion Vulnerability

— 2118 Erosion Hazard Line

2118 Erosion Vulnerability

- EXTREME
- HIGH

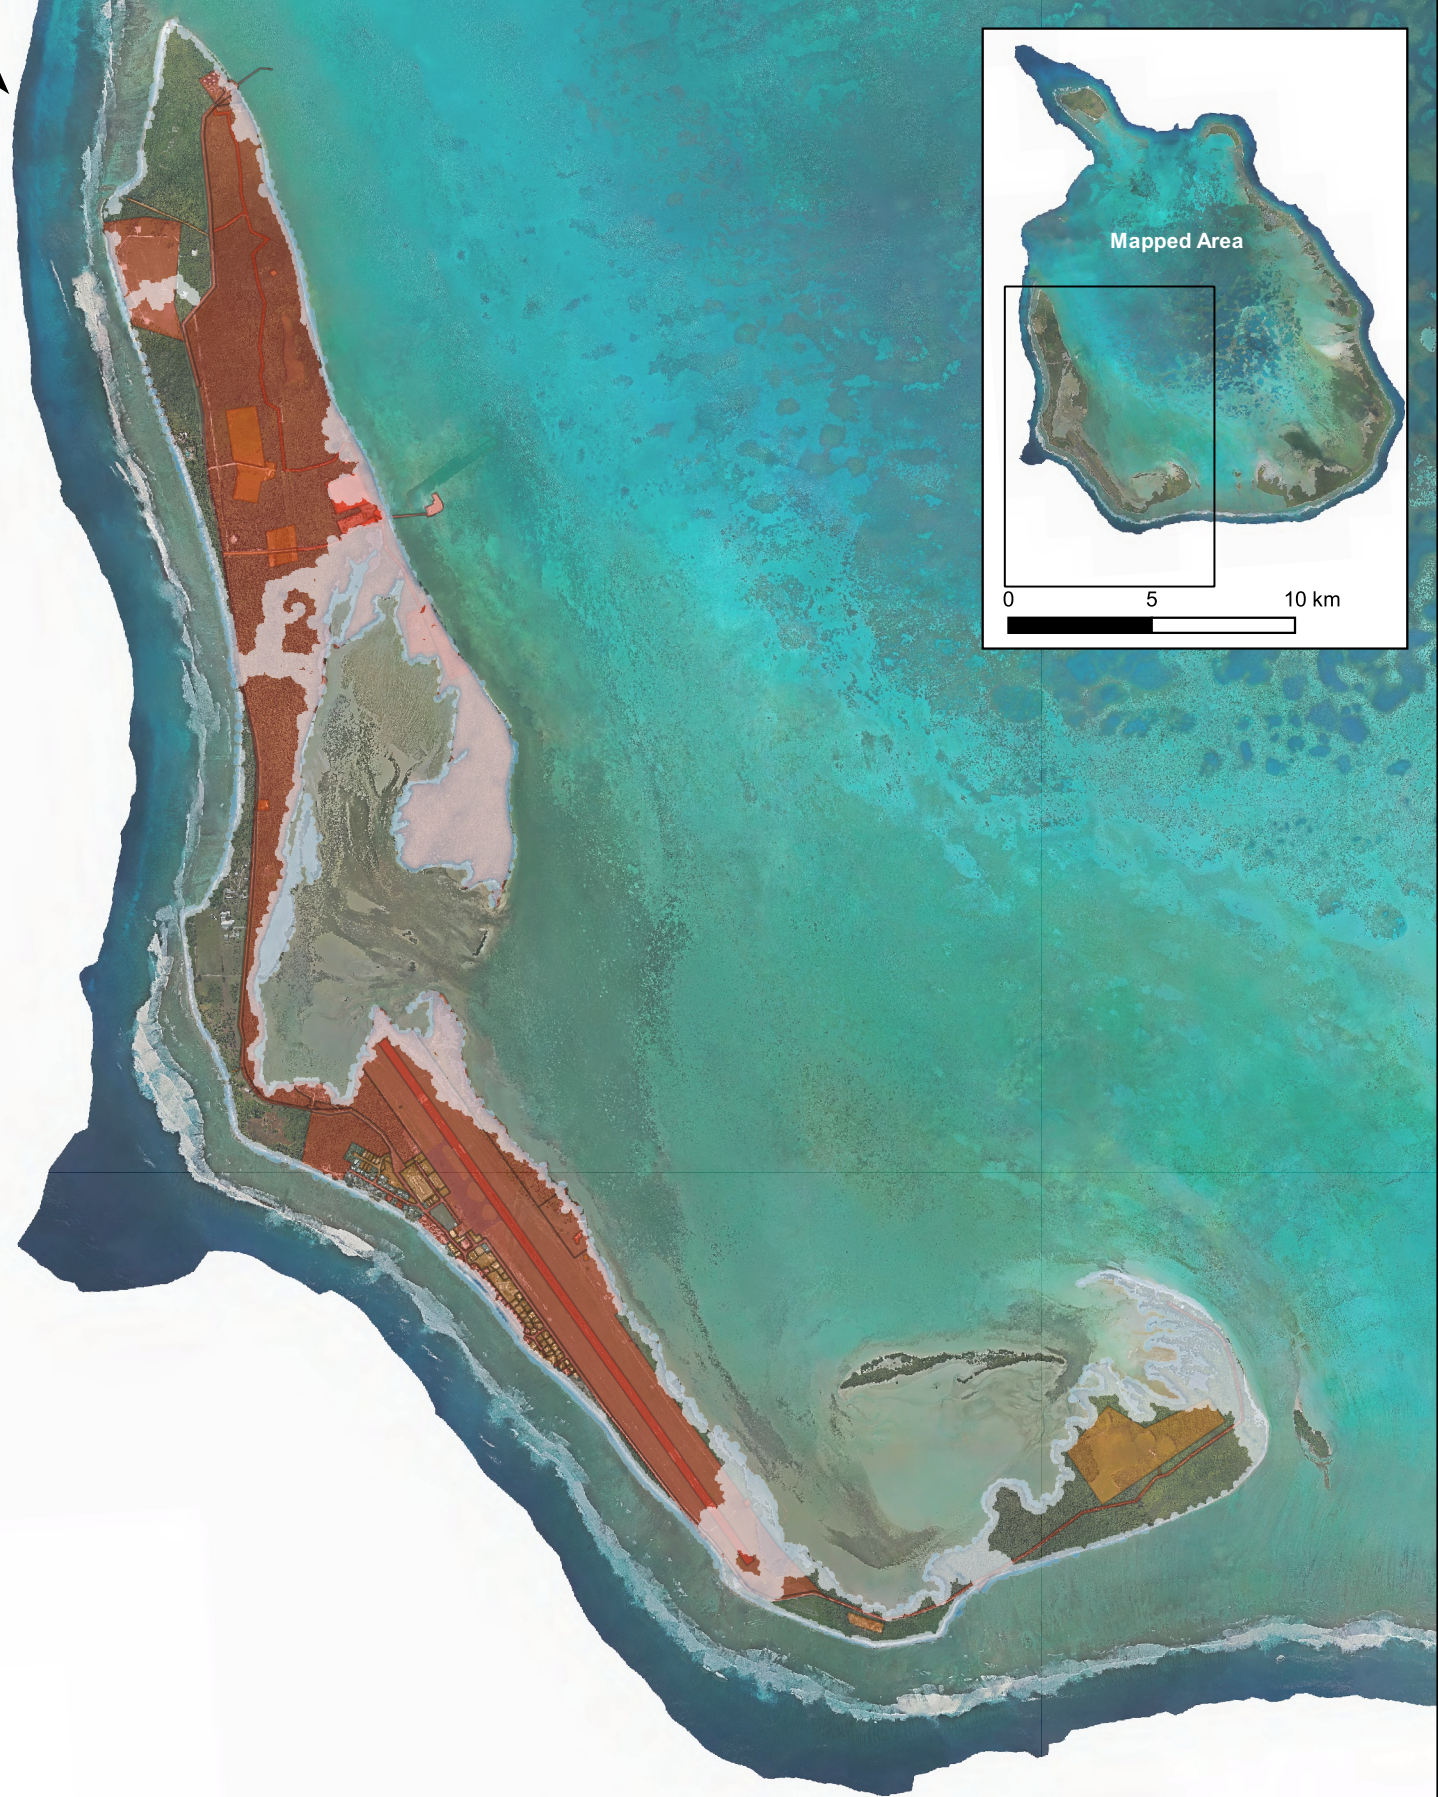
300
0

2018 Inundation Vulnerability

EXTREME
HIGH

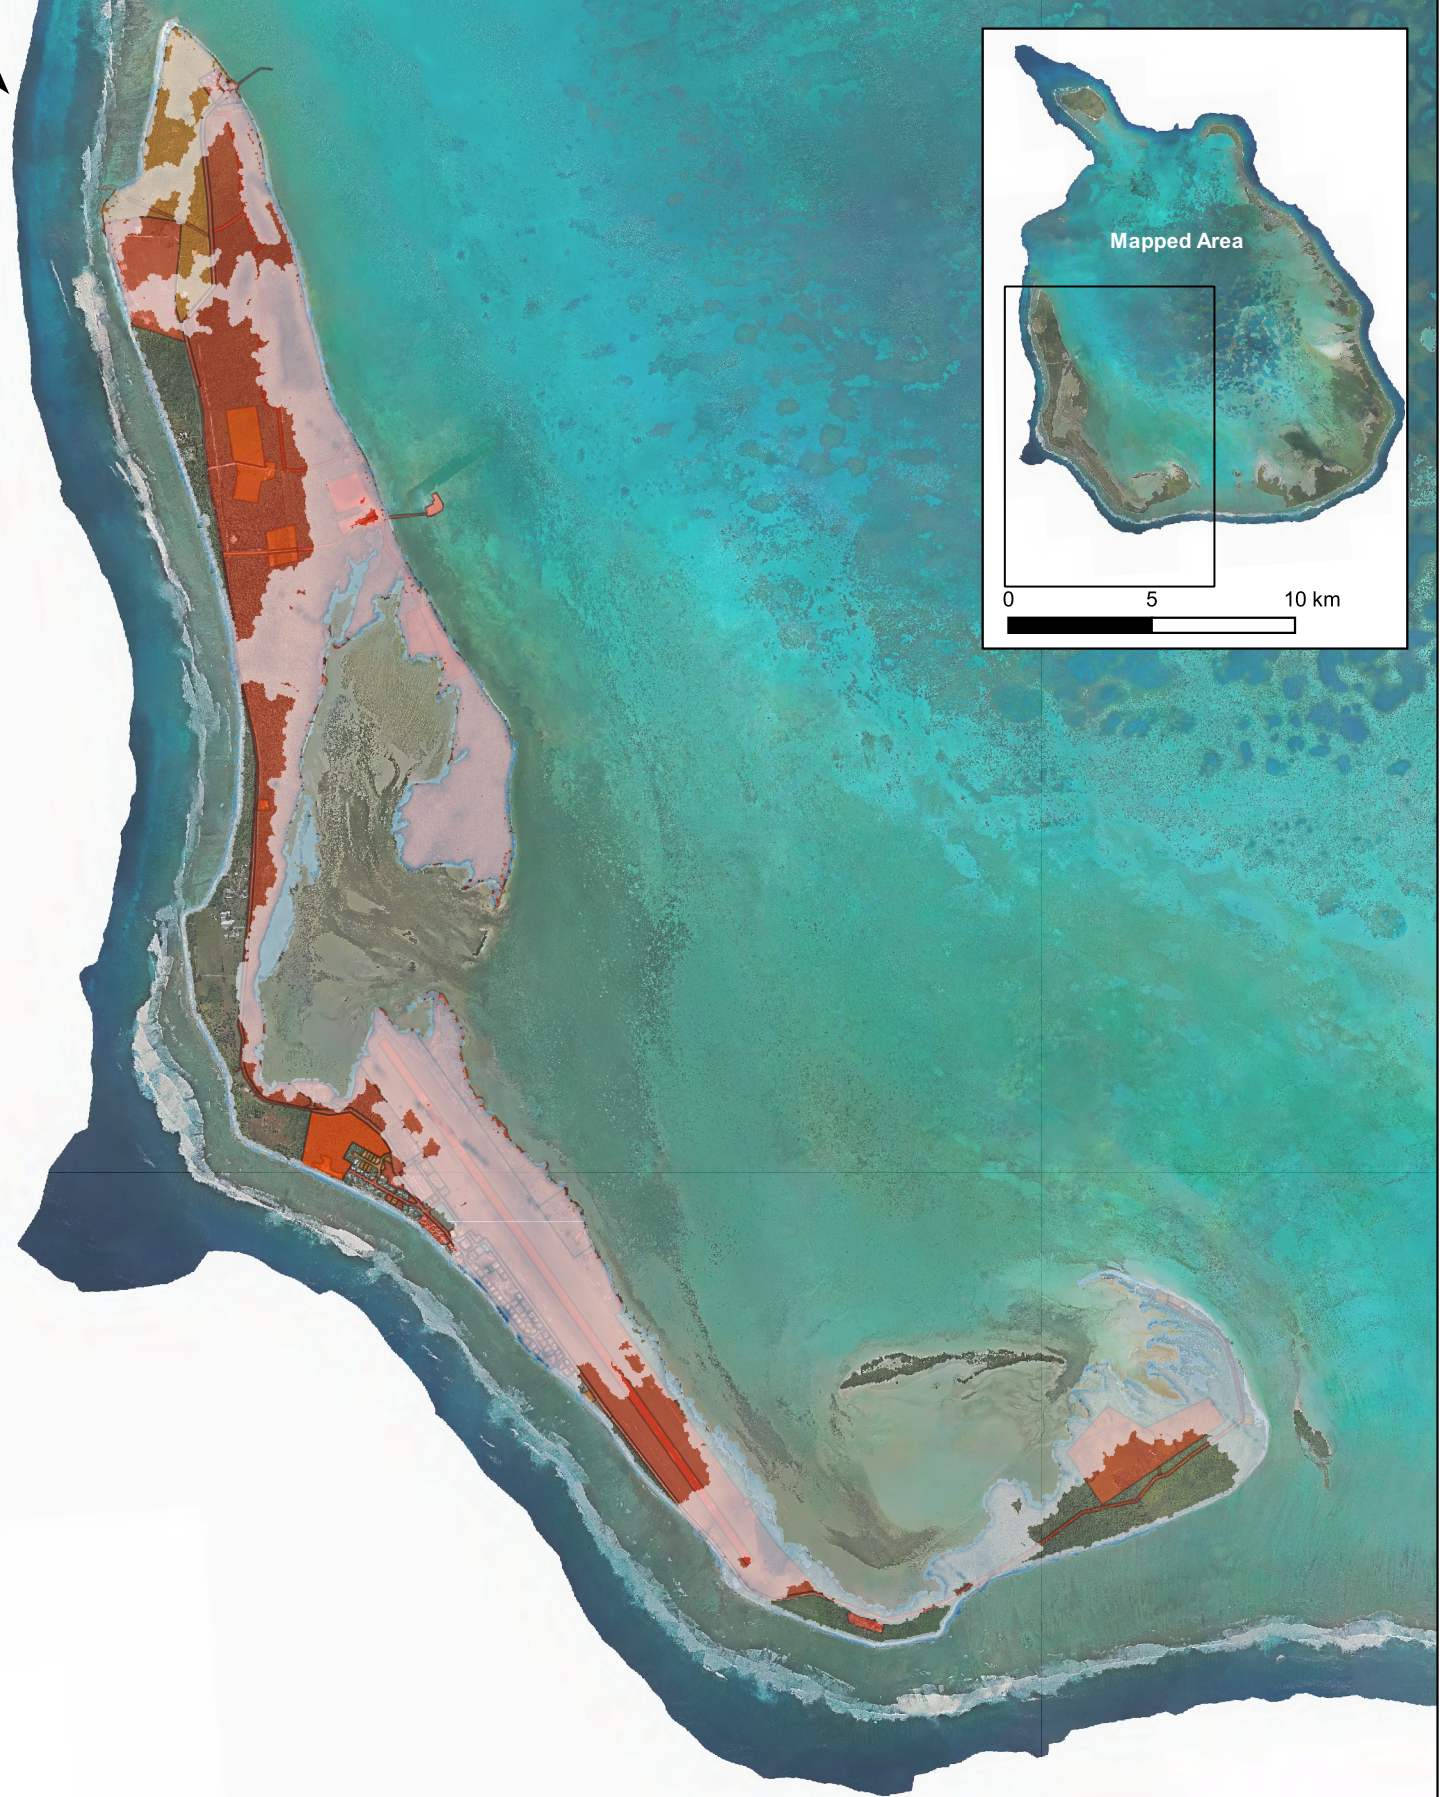
West Island 2068 Inundation Vulnerability
2068 500yr ARI Flood Depth (cm)

300
0

2068 Inundation Vulnerability

EXTREME
HIGH

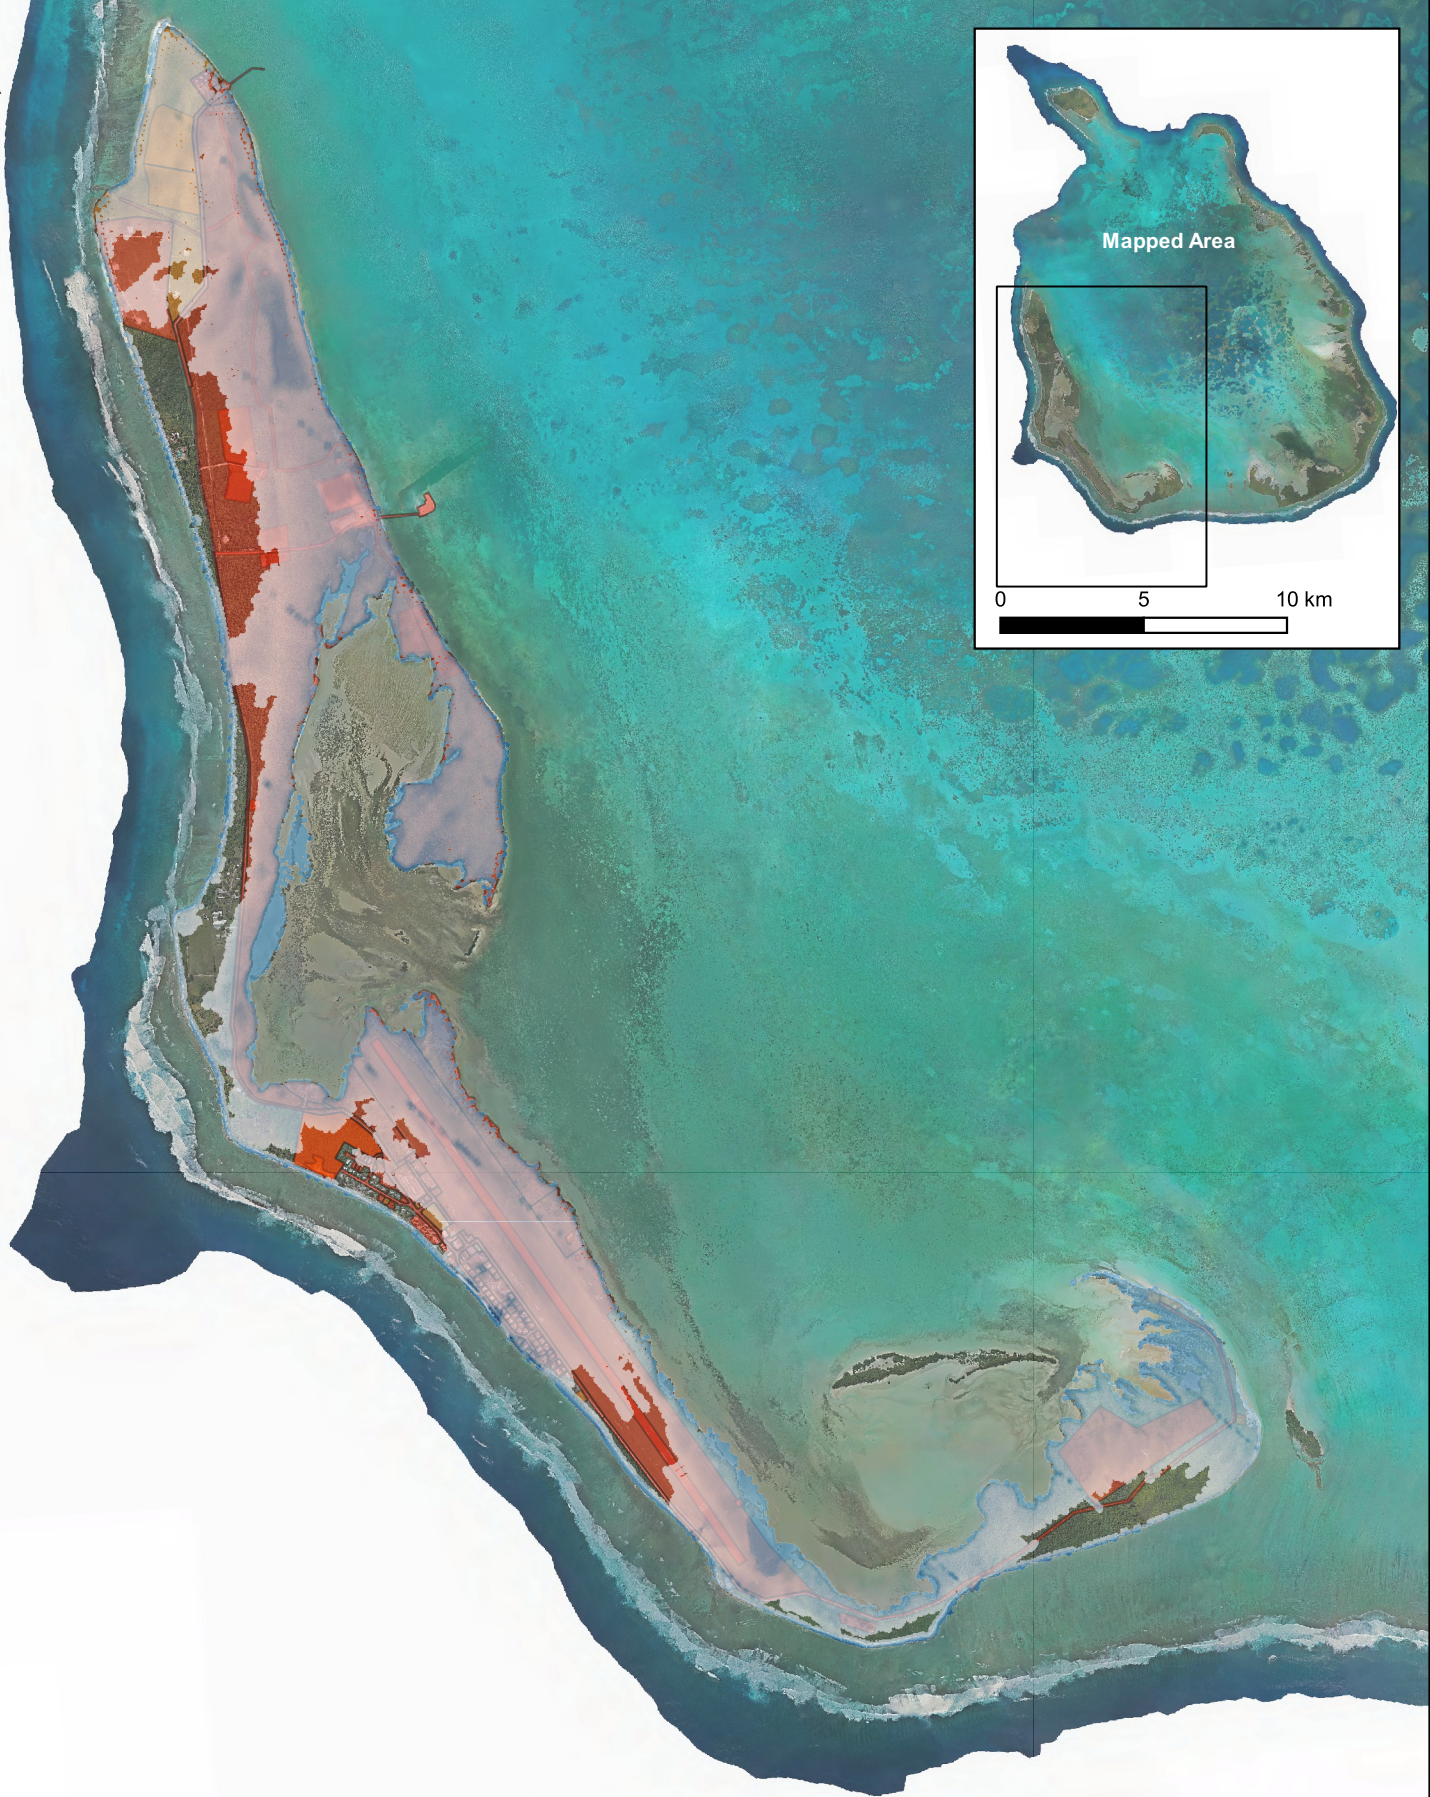
West Island 2118 Inundation Vulnerability
2118 500yr ARI Flood Depth (cm)

Blue gradient	300
White	0

2118 Inundation Vulnerability

Red	EXTREME
Orange	HIGH

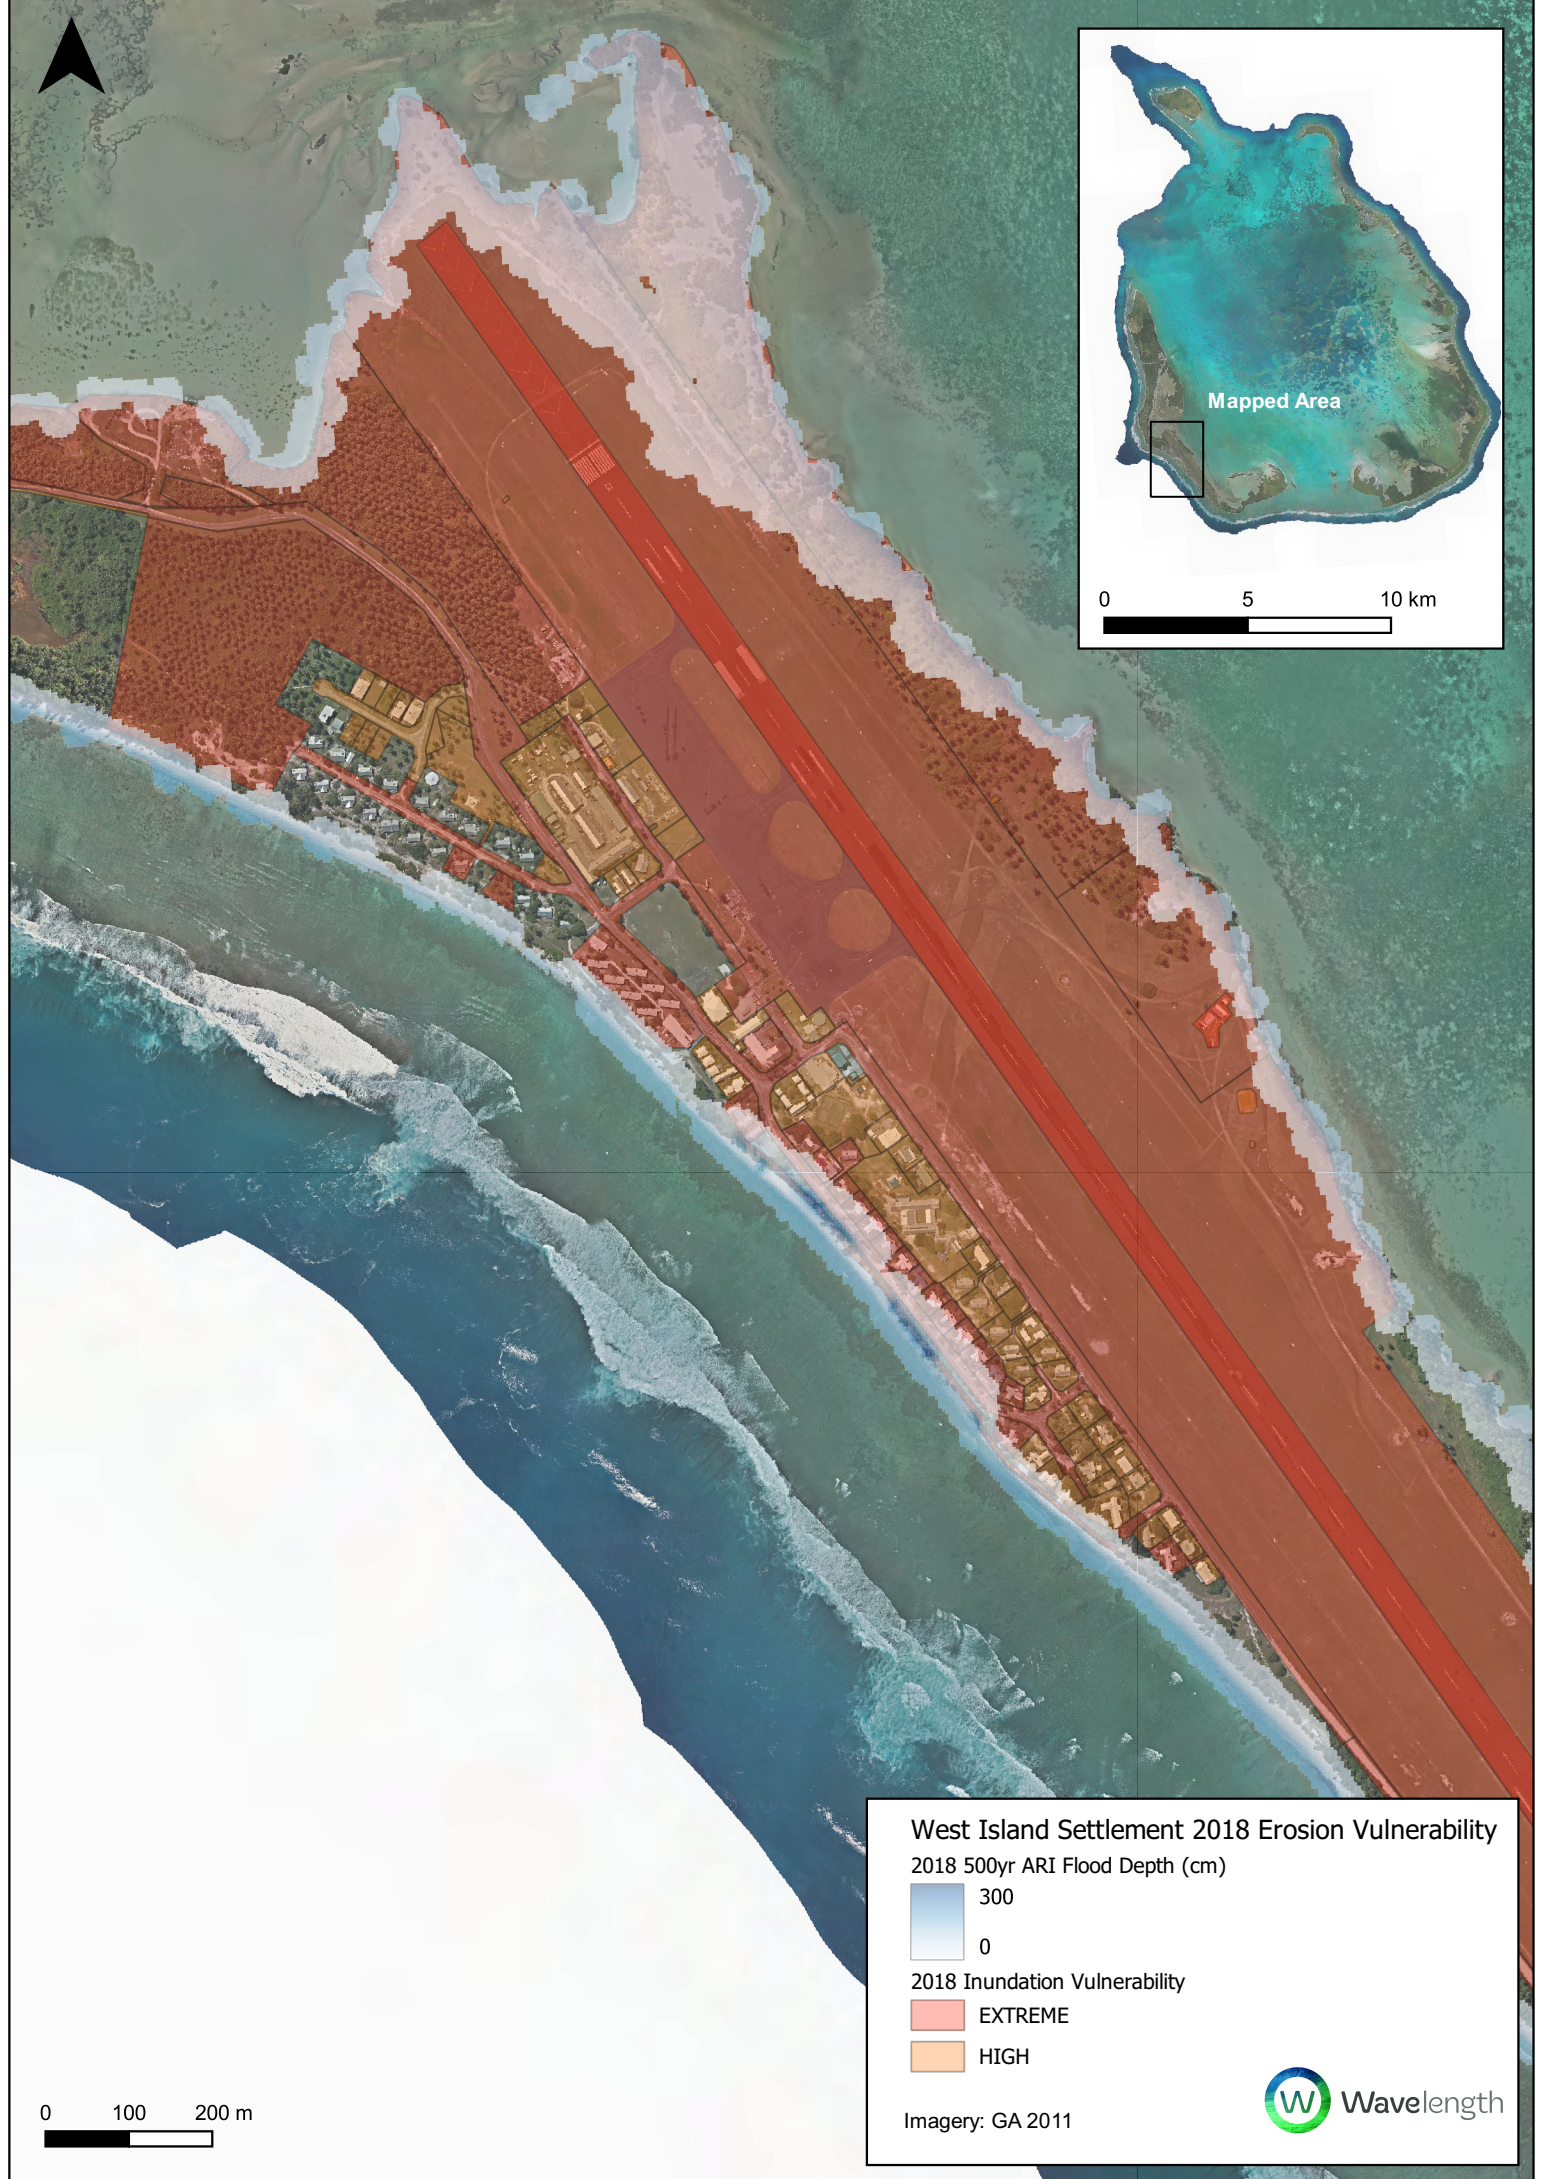
West Island Settlement 2018 Erosion Vulnerability
2018 500yr ARI Flood Depth (cm)

2018 Inundation Vulnerability

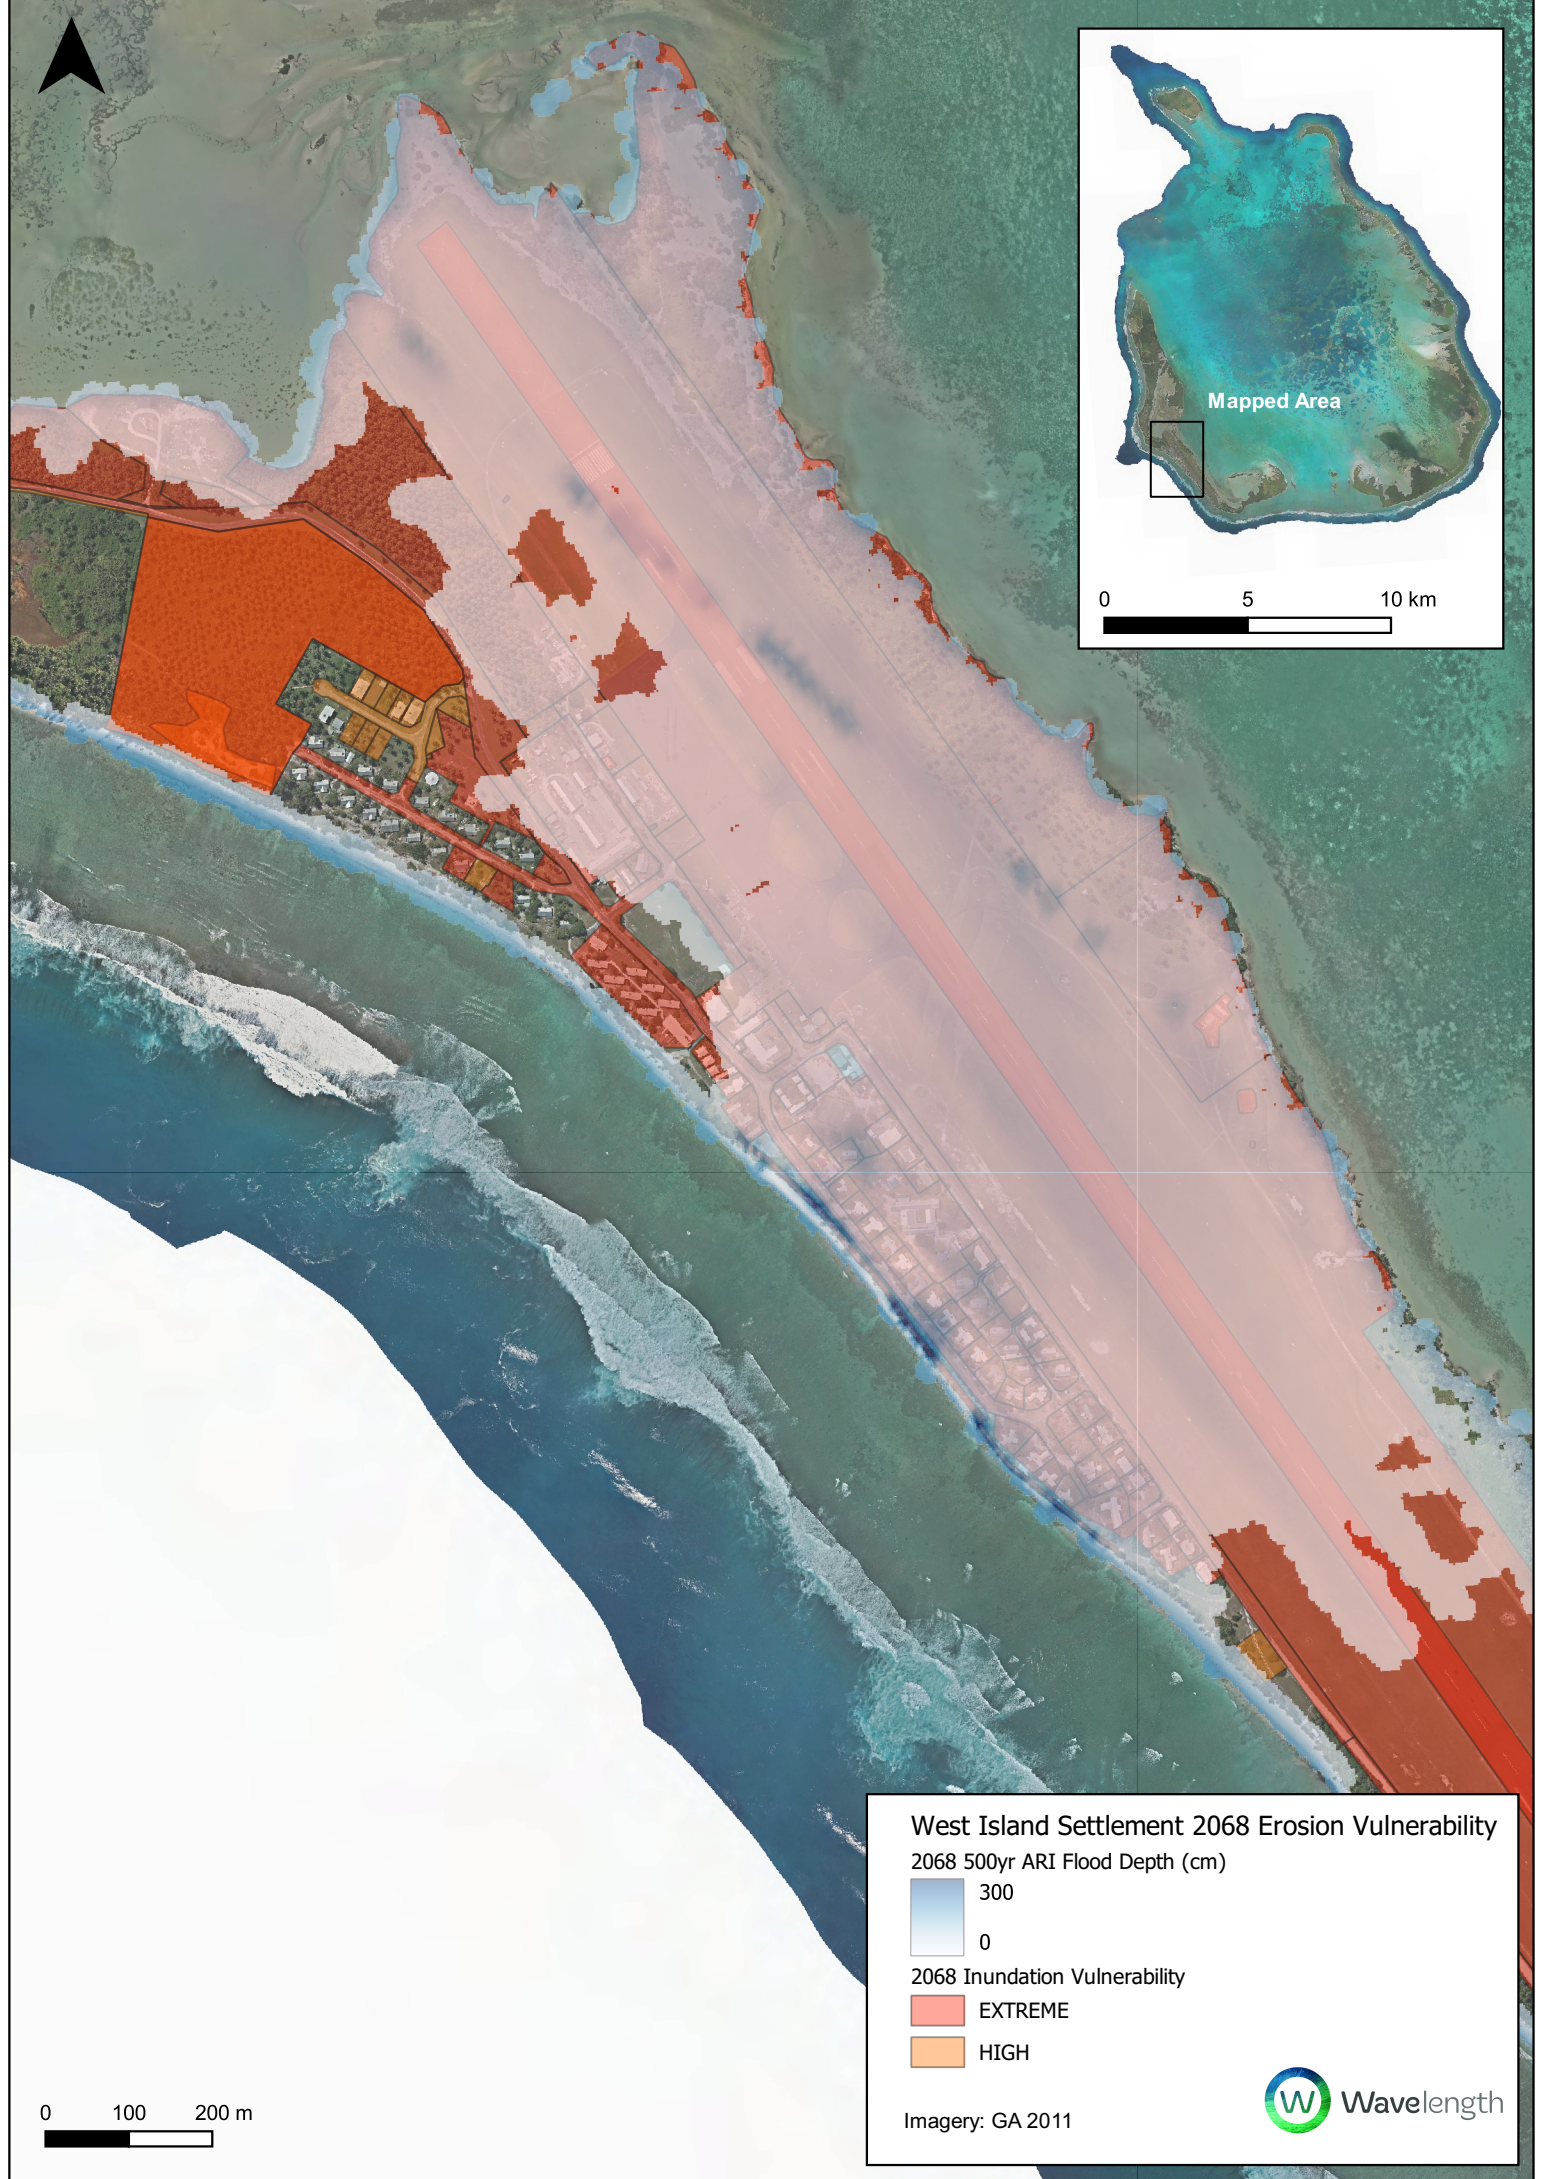
West Island Settlement 2068 Erosion Vulnerability

2068 500yr ARI Flood Depth (cm)

2068 Inundation Vulnerability
