West Island 2018 Erosion Vulnerability

West Island 2018 Inundation Vulnerability
2018 500yr ARI Flood Depth (cm)

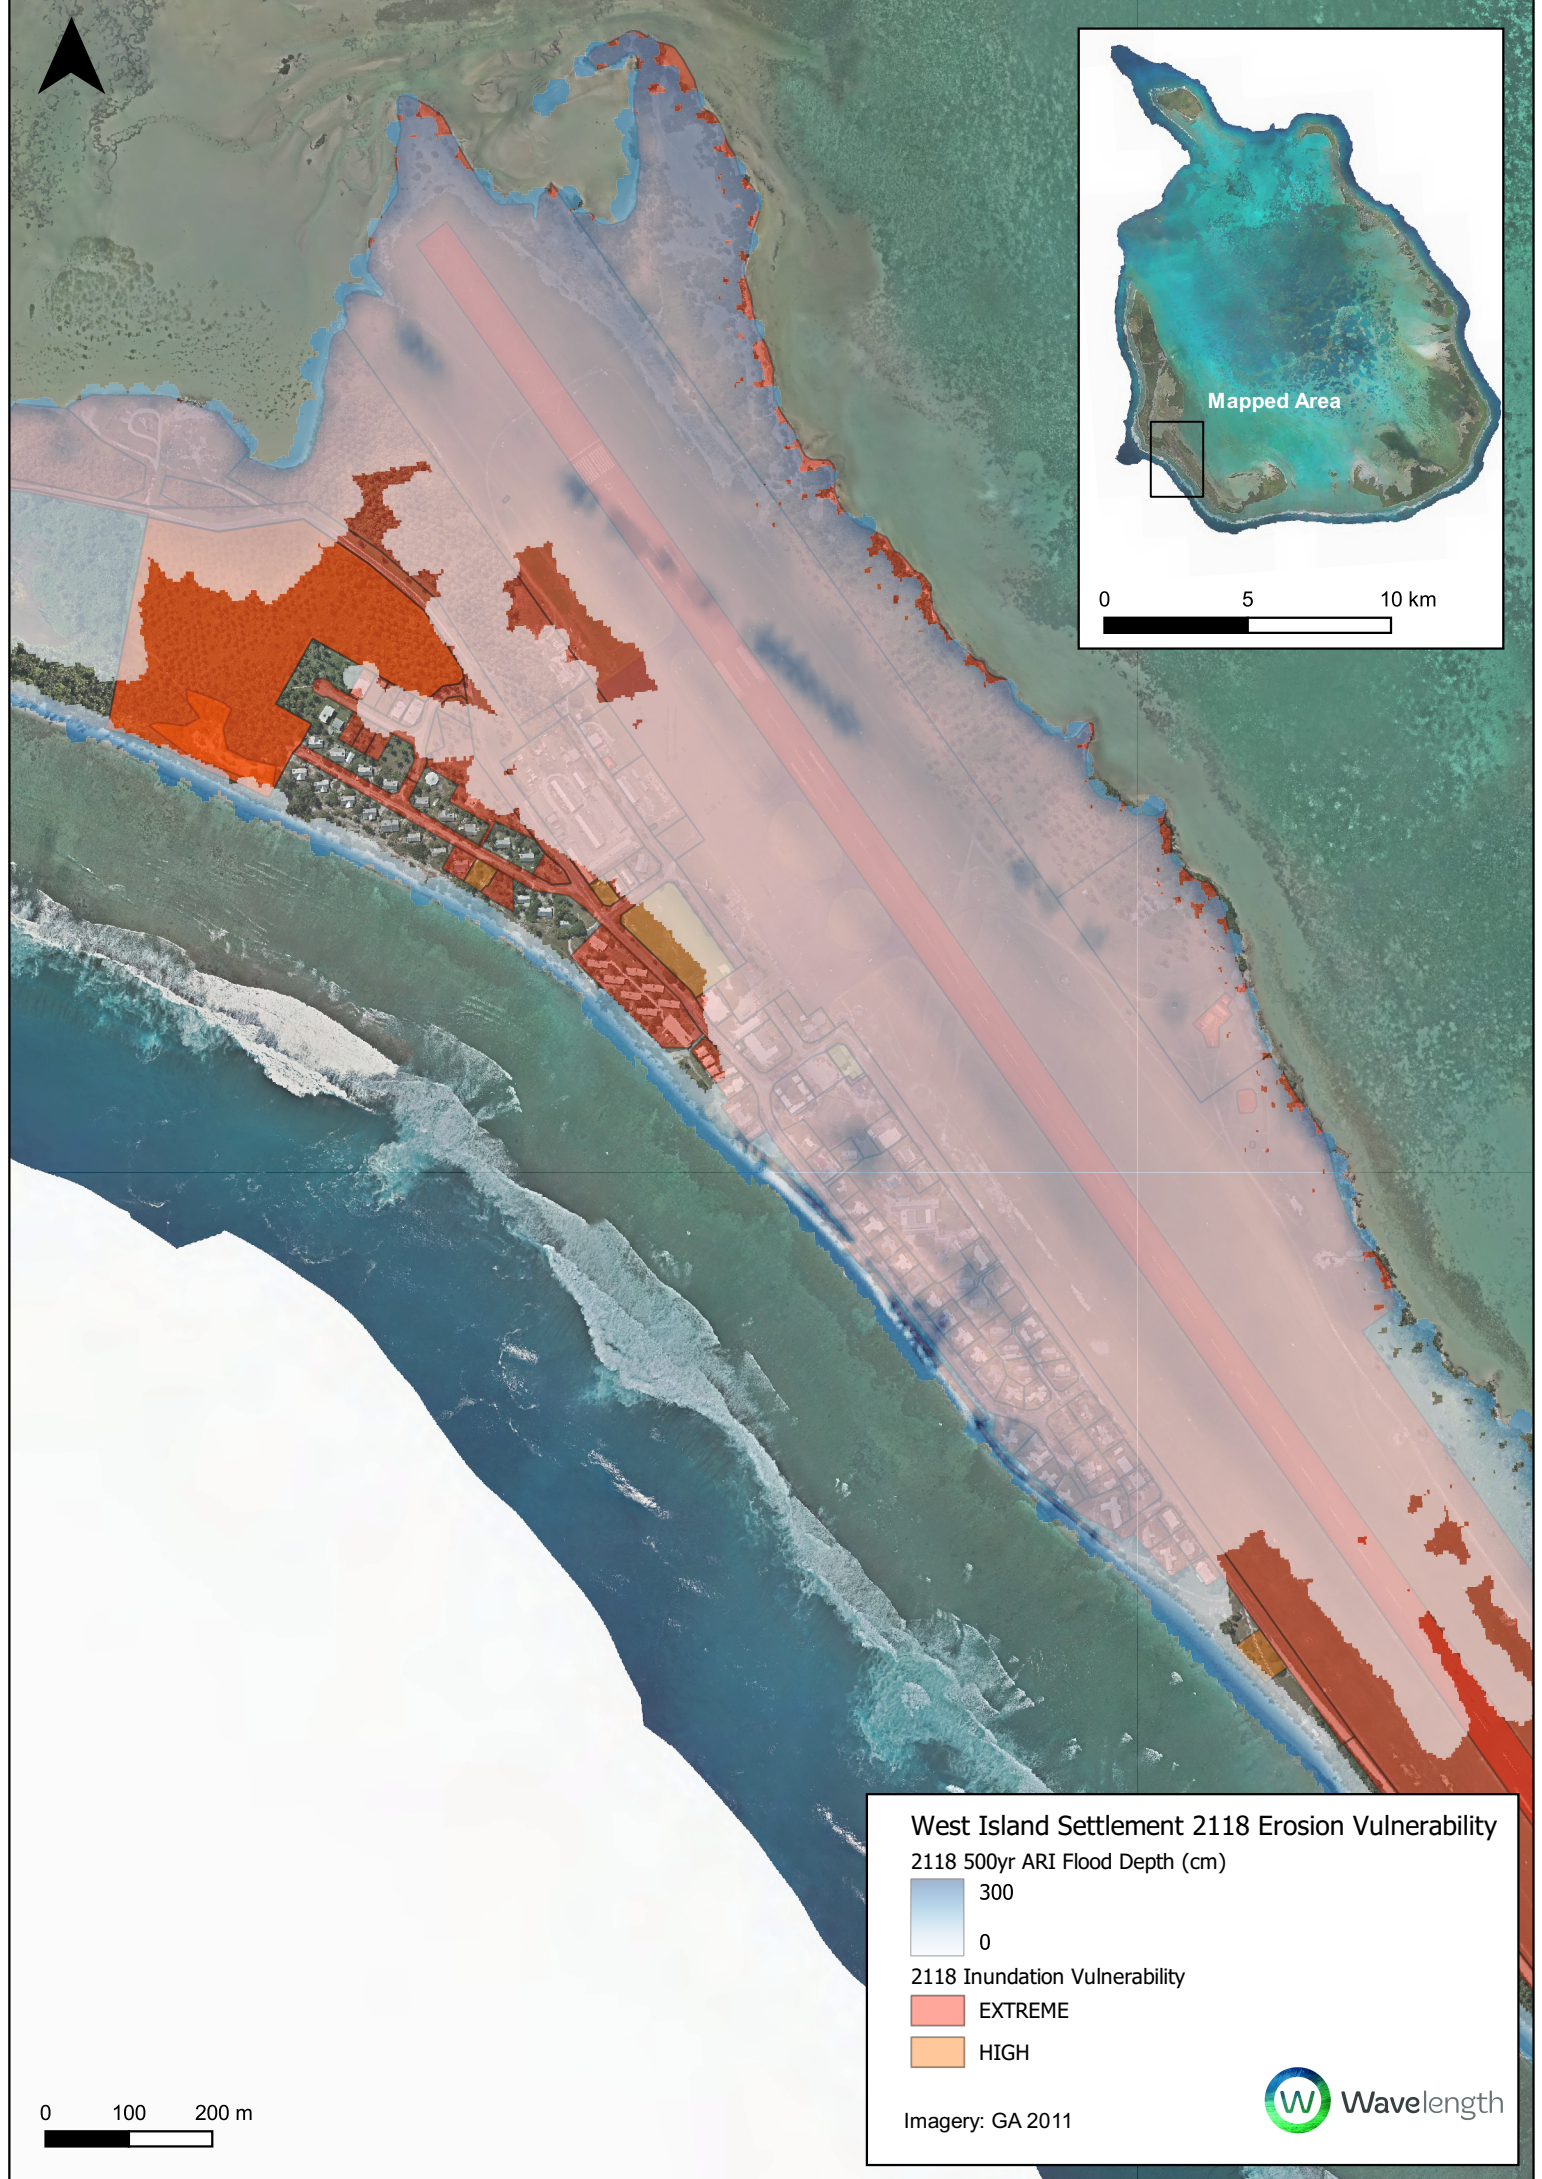
West Island Settlement 2118 Erosion Vulnerability

2118 500yr ARI Flood Depth (cm)

2118 Inundation Vulnerability

EXTREME

HIGH

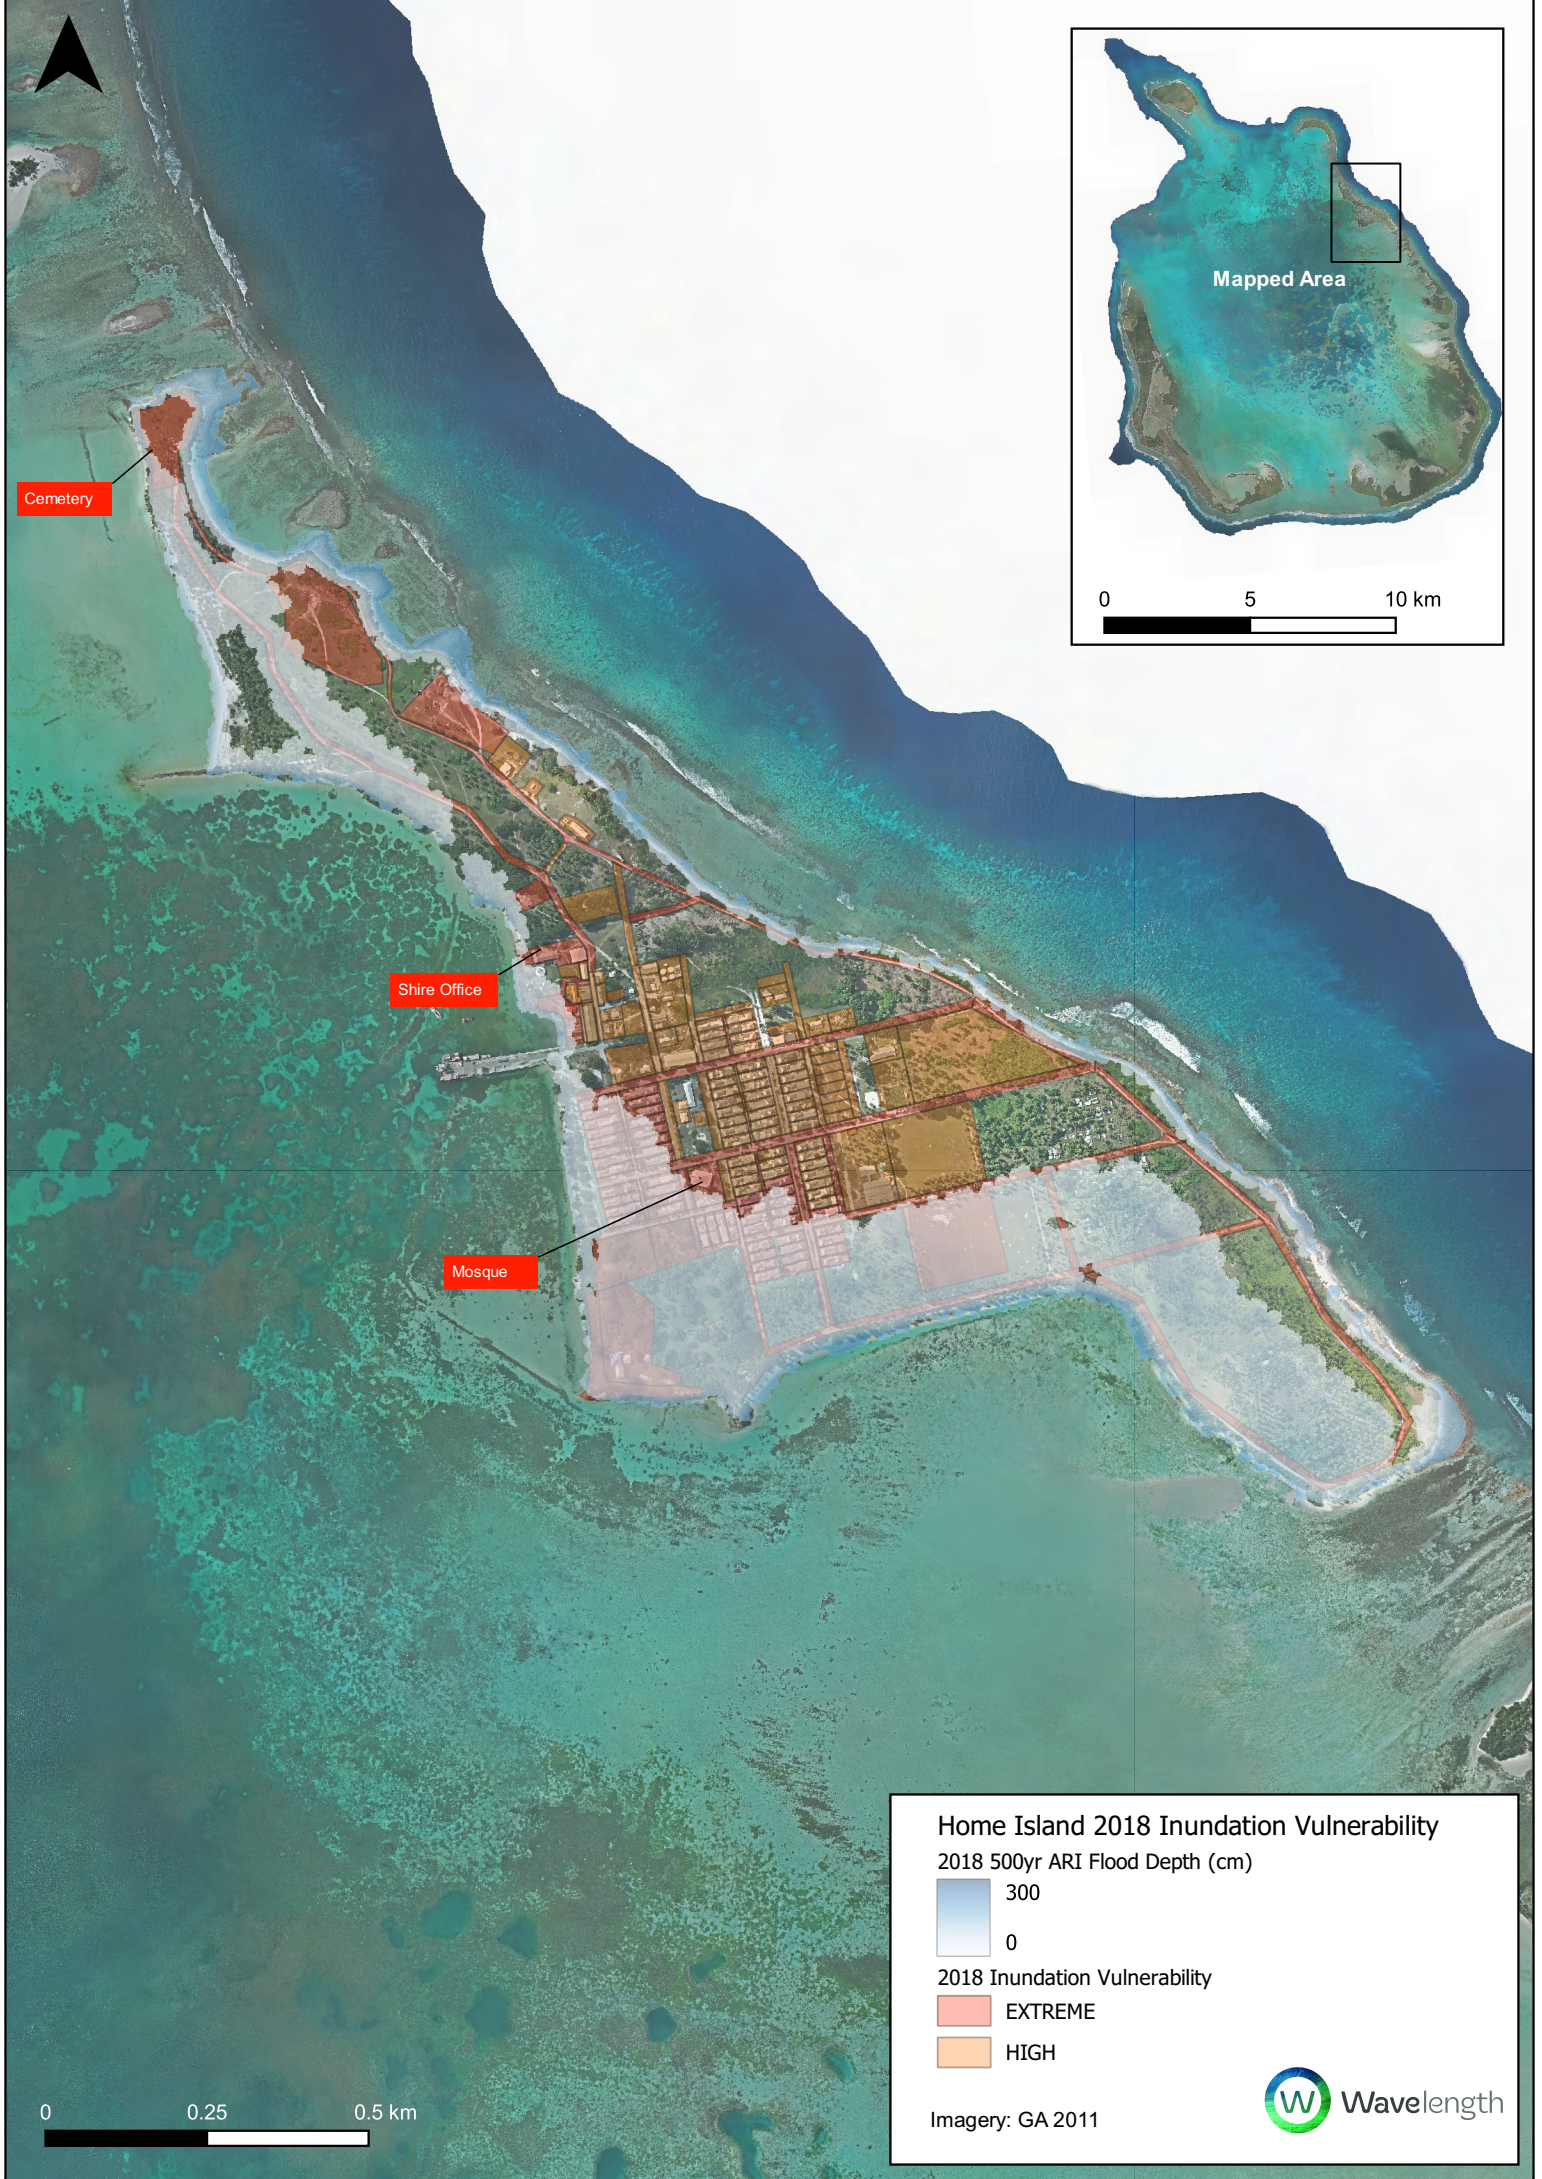
Home Island 2018 Inundation Vulnerability
 2018 500yr ARI Flood Depth (cm)

300
0

2018 Inundation Vulnerability

EXTREME
HIGH

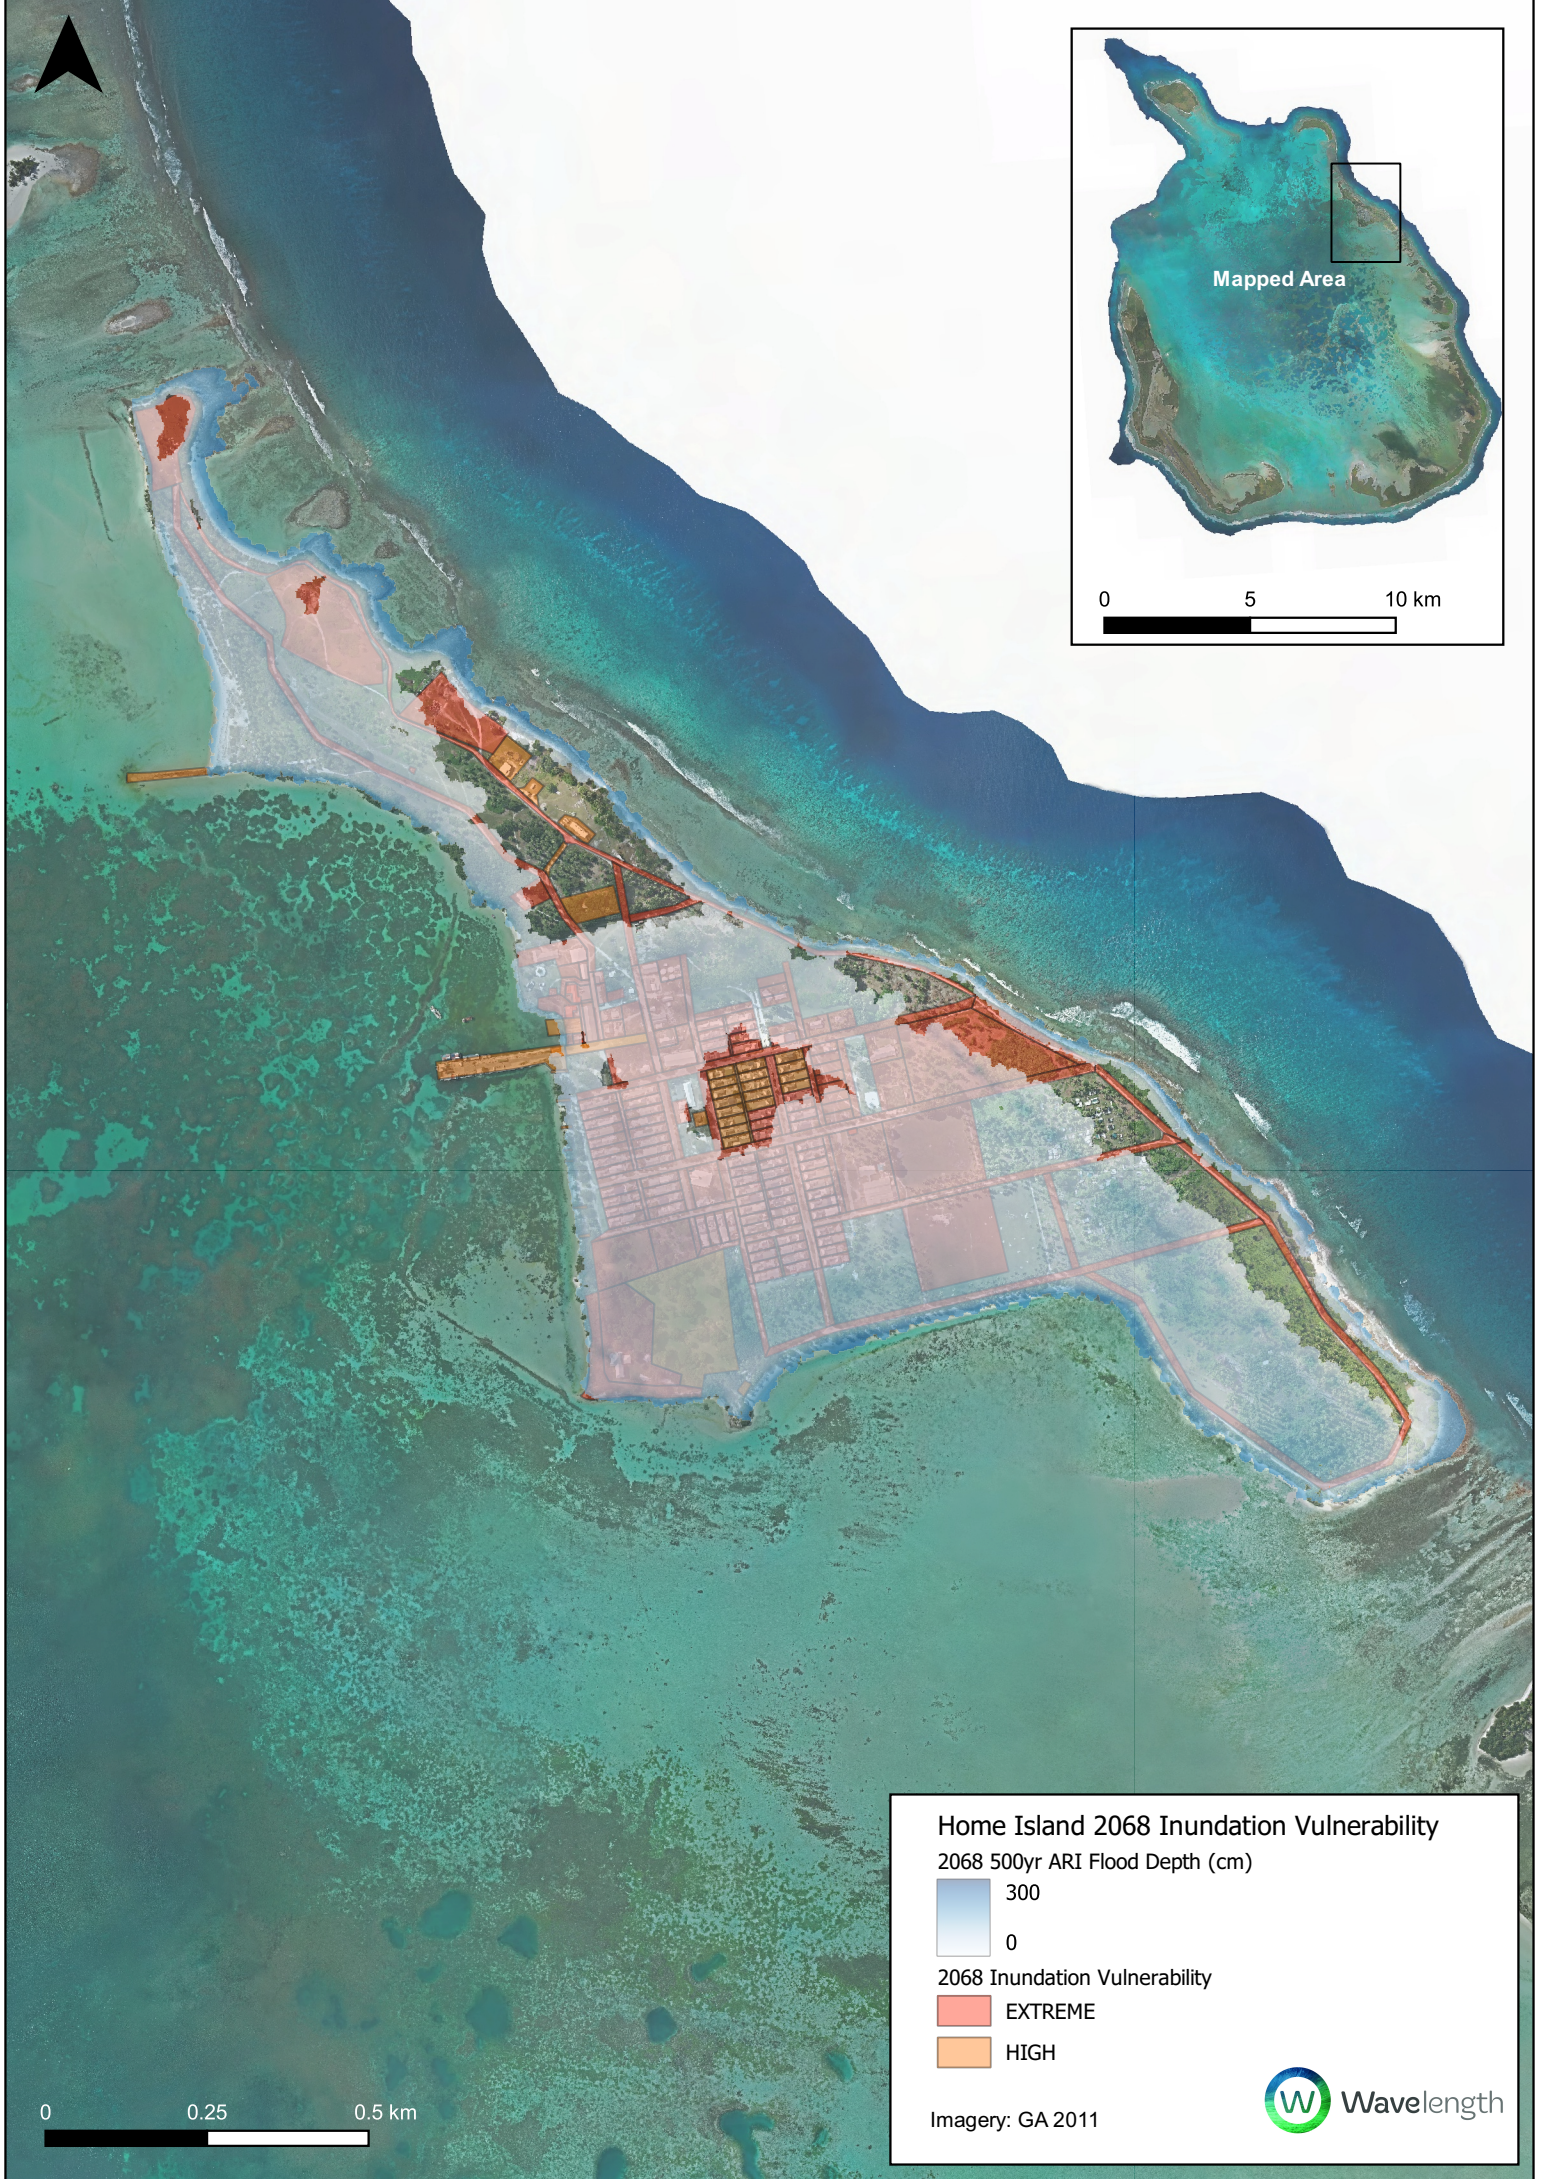
Home Island 2068 Inundation Vulnerability

2068 500yr ARI Flood Depth (cm)

300
0

2068 Inundation Vulnerability

EXTREME
HIGH

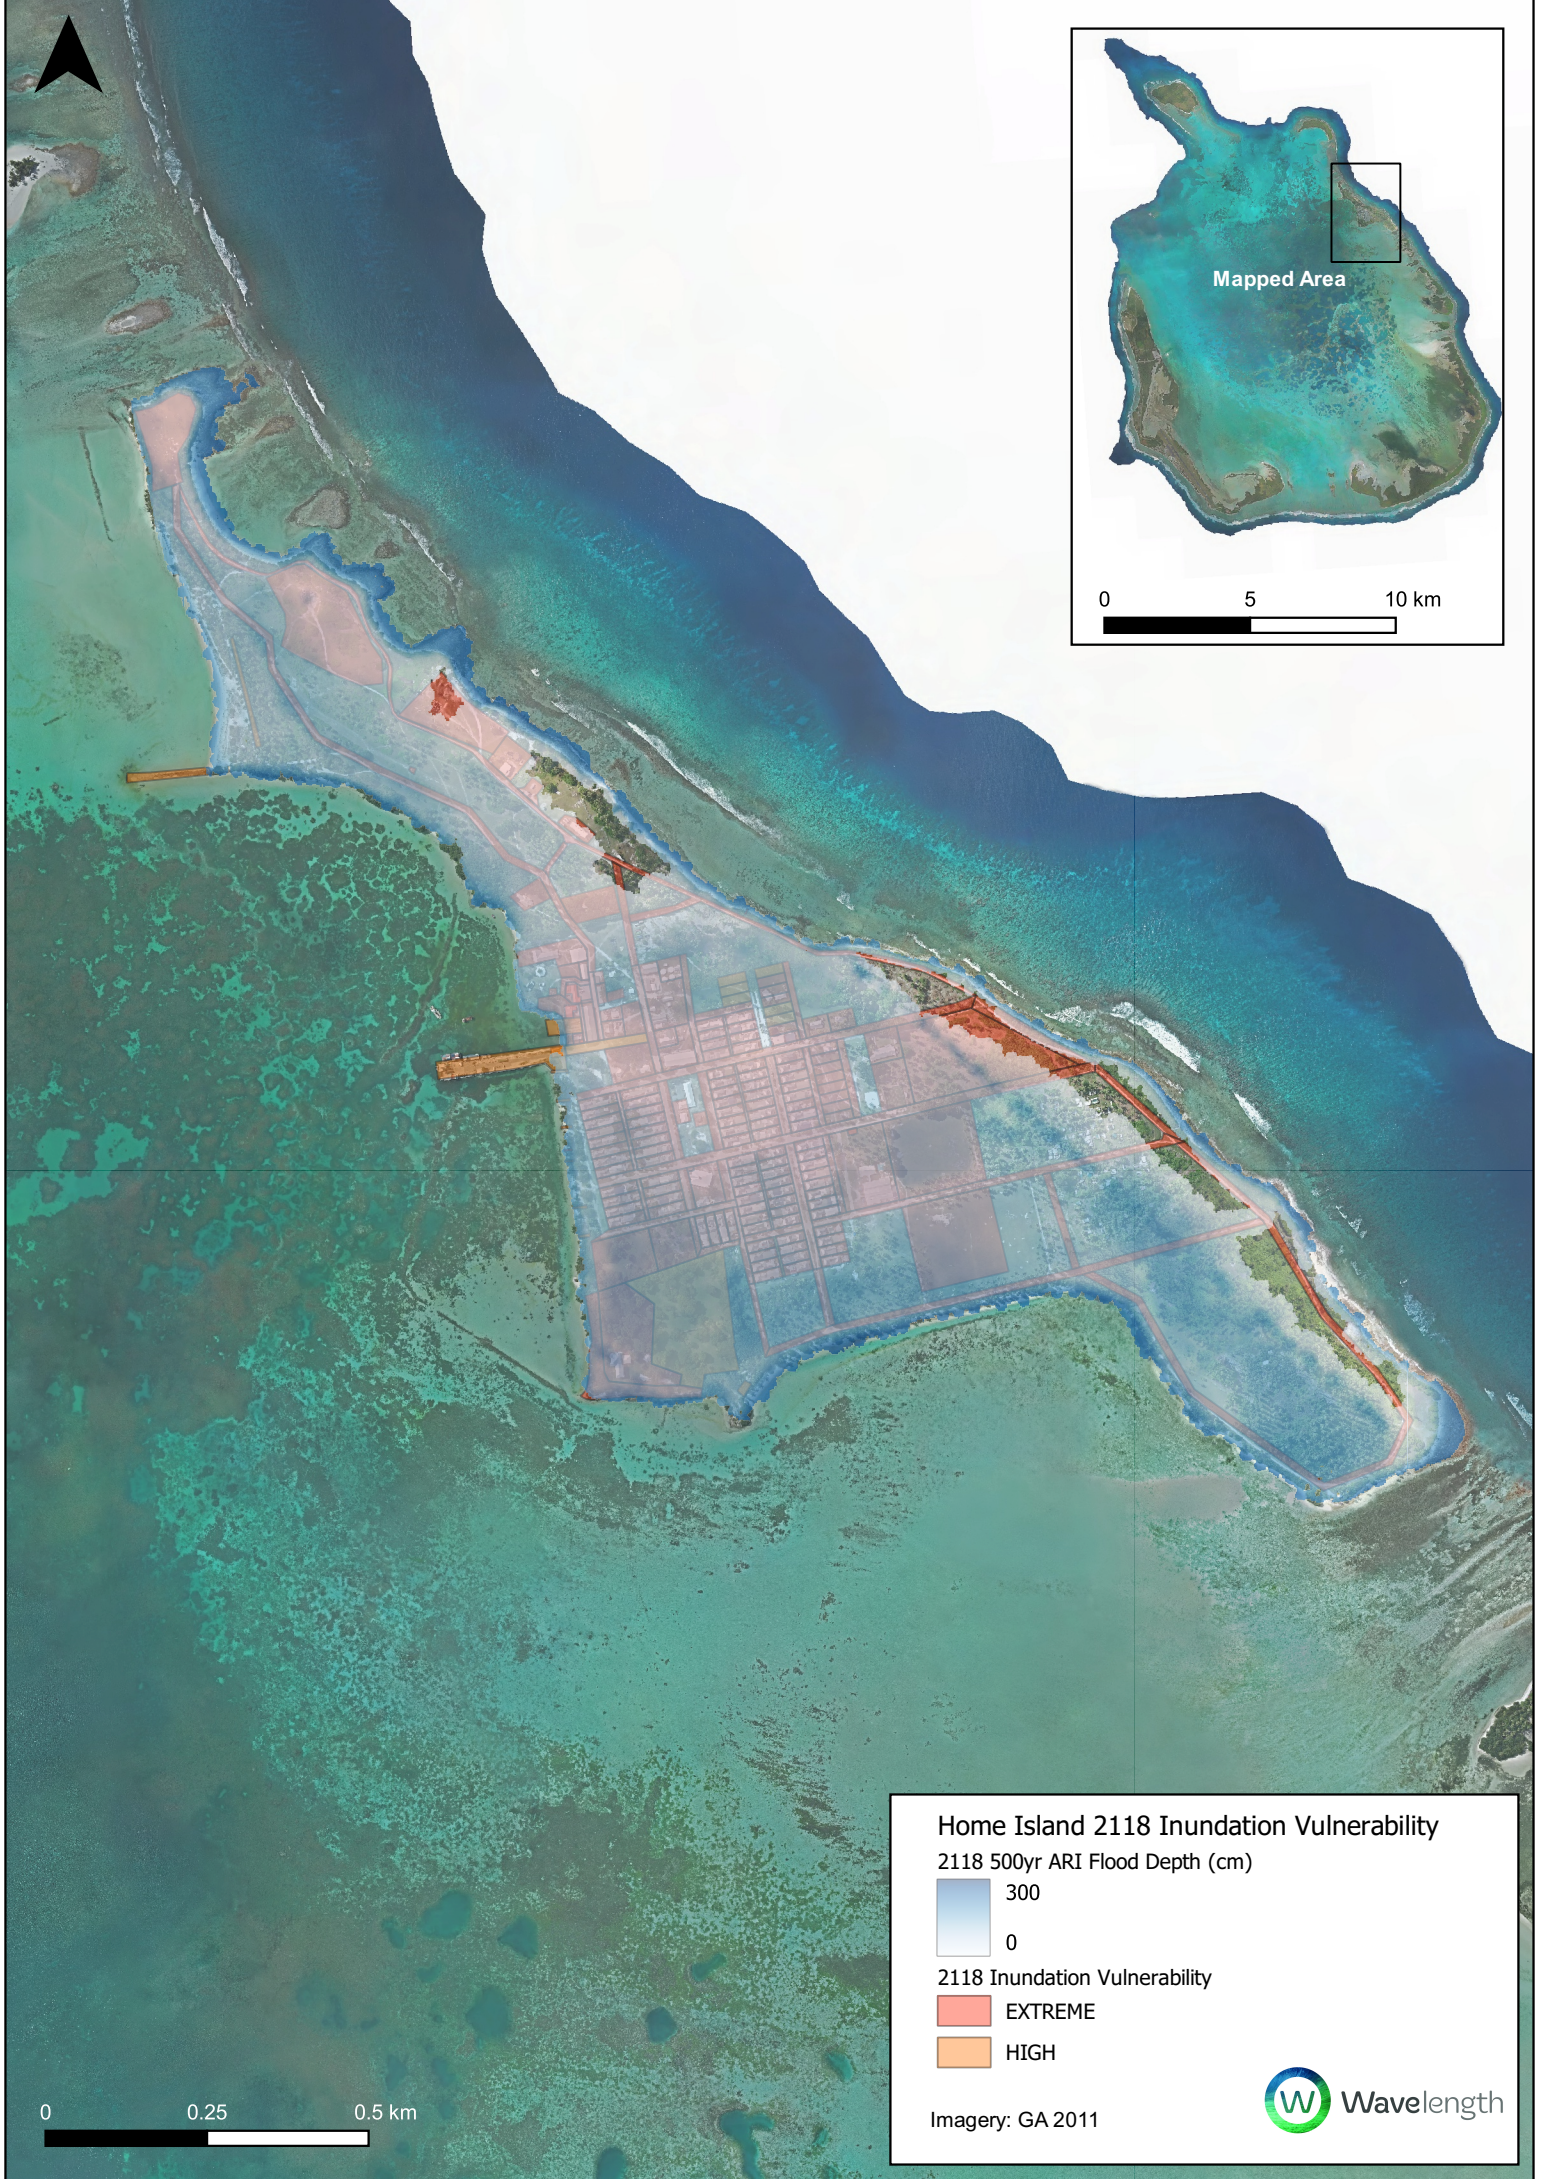
Home Island 2118 Inundation Vulnerability

2118 500yr ARI Flood Depth (cm)

2118 Inundation Vulnerability
