Norfolk Island Water Resource Assessment

Summary report

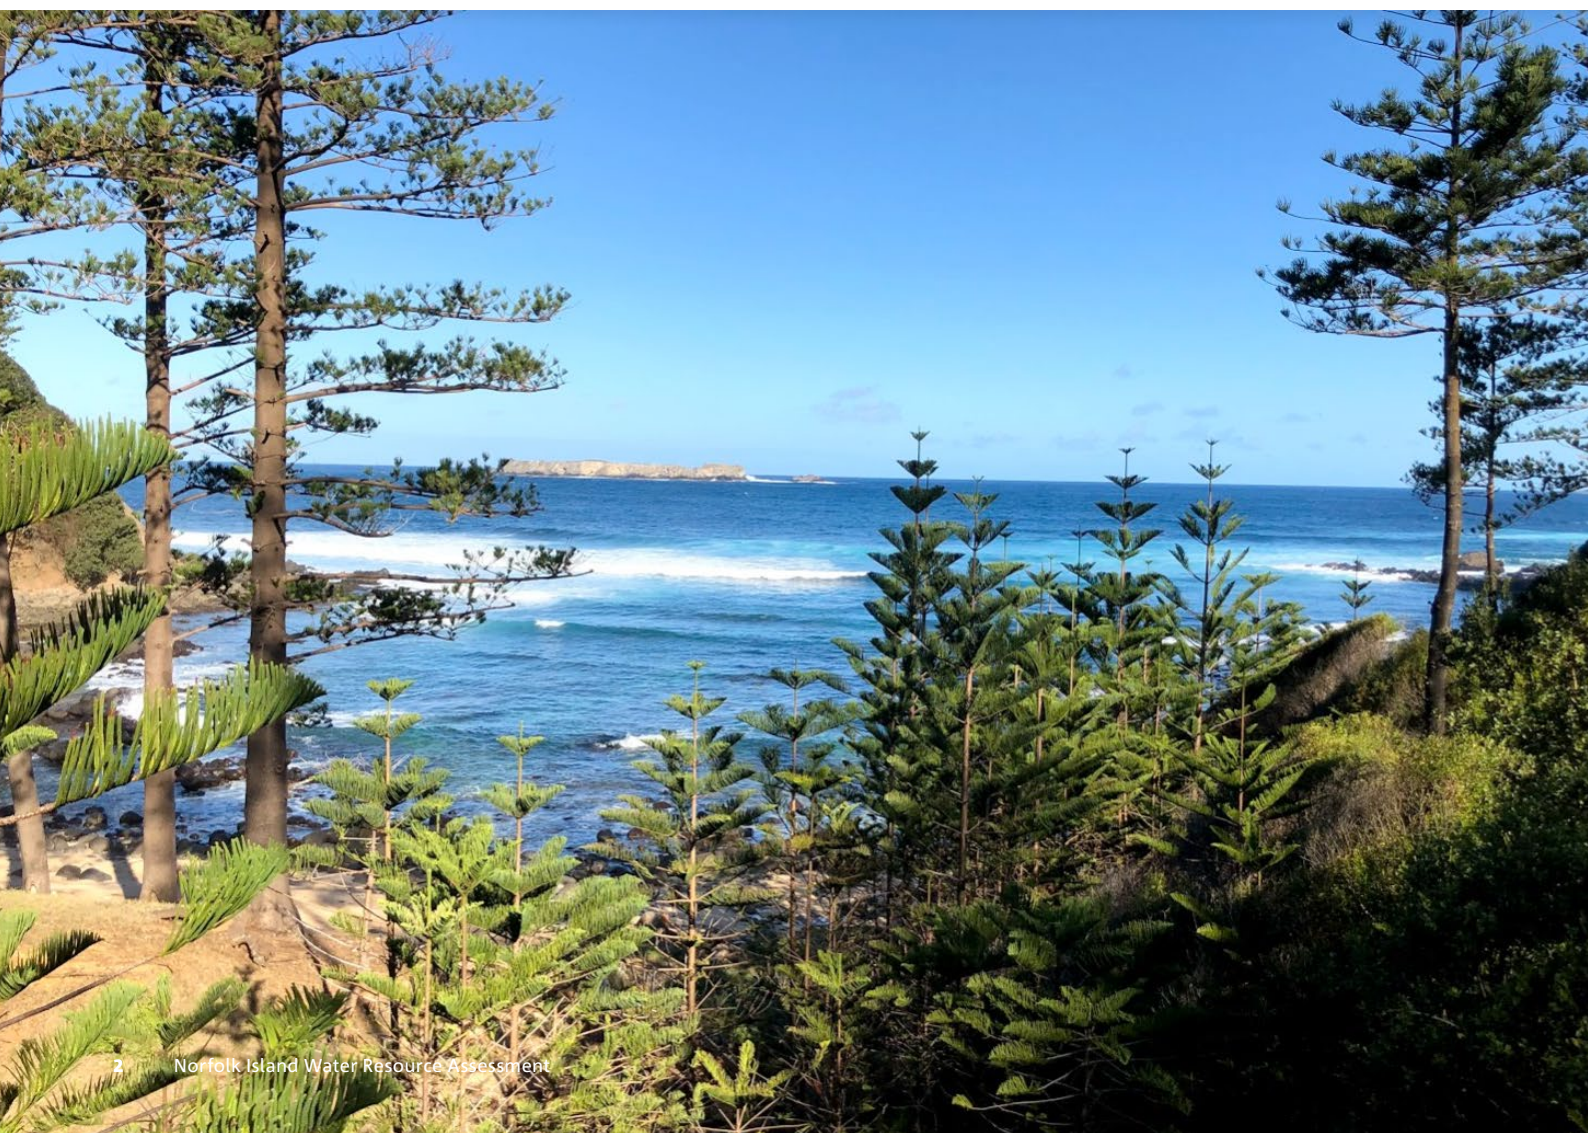
Figure 1 Norfolk Island

Norfolk Island is a subtropical island in the Pacific Ocean approximately 1500 km south-east of Brisbane. The island, a remnant volcano, has an area of 35.7 km² (Figure 1) and is largely comprised of basaltic rocks and tuffs that are weathered deeply, with rich and highly permeable soil.

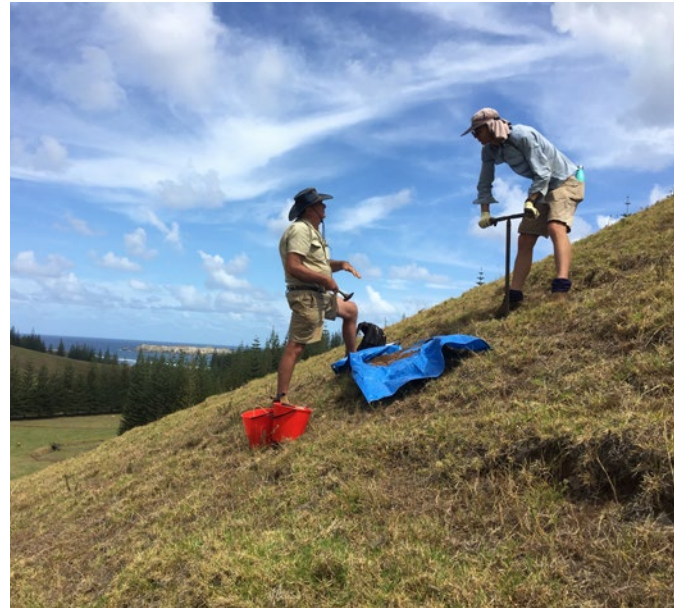
Soil sampling near the Kingston and Arthur's Vale Historic Area. Profile descriptions to determine key soil and landscape attributes were investigated at 106 locations across the island.

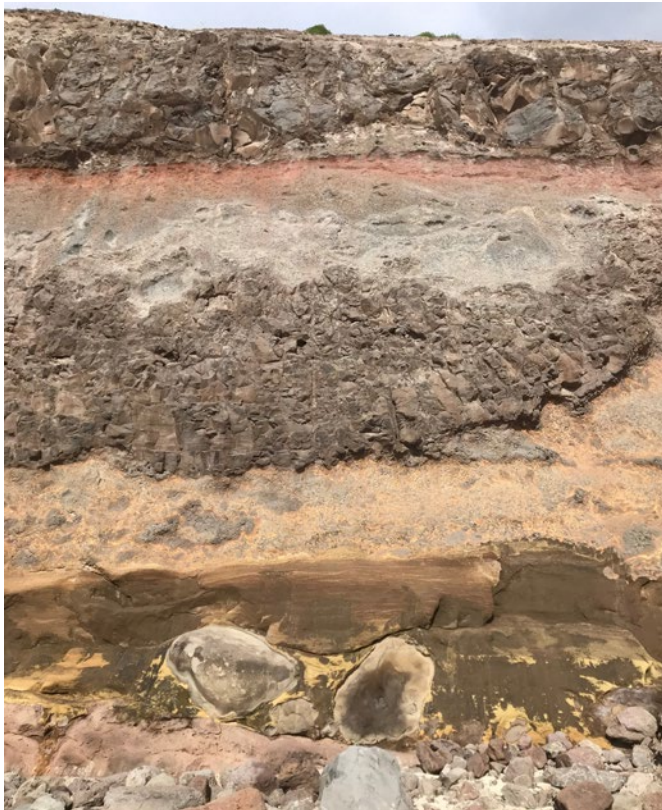
Interbedded basalt flows and ash layers behind Cascade Pier. An example of the high heterogeneity below the ground surface.

Subaerial eruptions of lava flowing down from the volcanic vent and subsequent successive lava flows with interbedded tuff layers have created a complex hydrogeological environment exhibiting high heterogeneity.

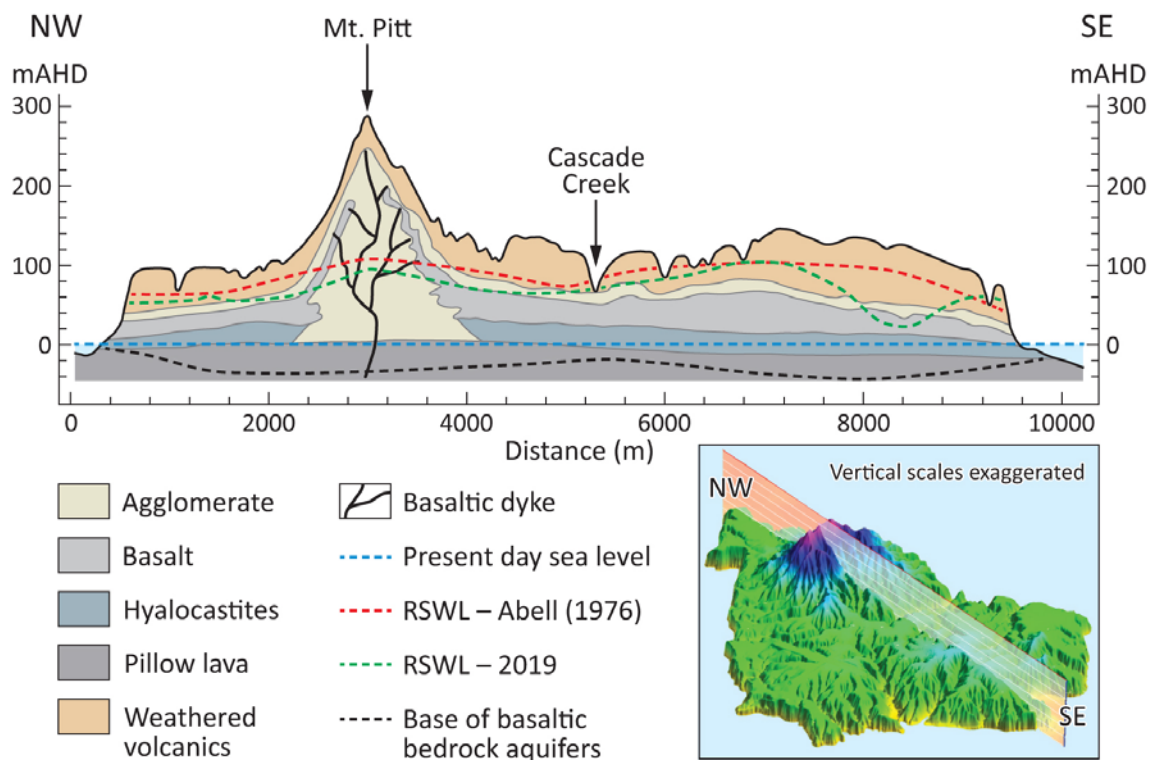
Figure 2 Hydrogeological cross-section including a comparison of reduced standing water level (RSWL) surfaces from 1976 and 2019

Bottom right inset is the location of the northwest–southeast slice through the geological model. Diagram based on data extracted from the geological model.

- Groundwater flow systems on Norfolk Island are localised, broadly following the major drainage basins and aquifers are generally hydraulically interconnected with vertical leakage from the weathered volcanics recharging the underlying agglomerate and basalt aquifers.

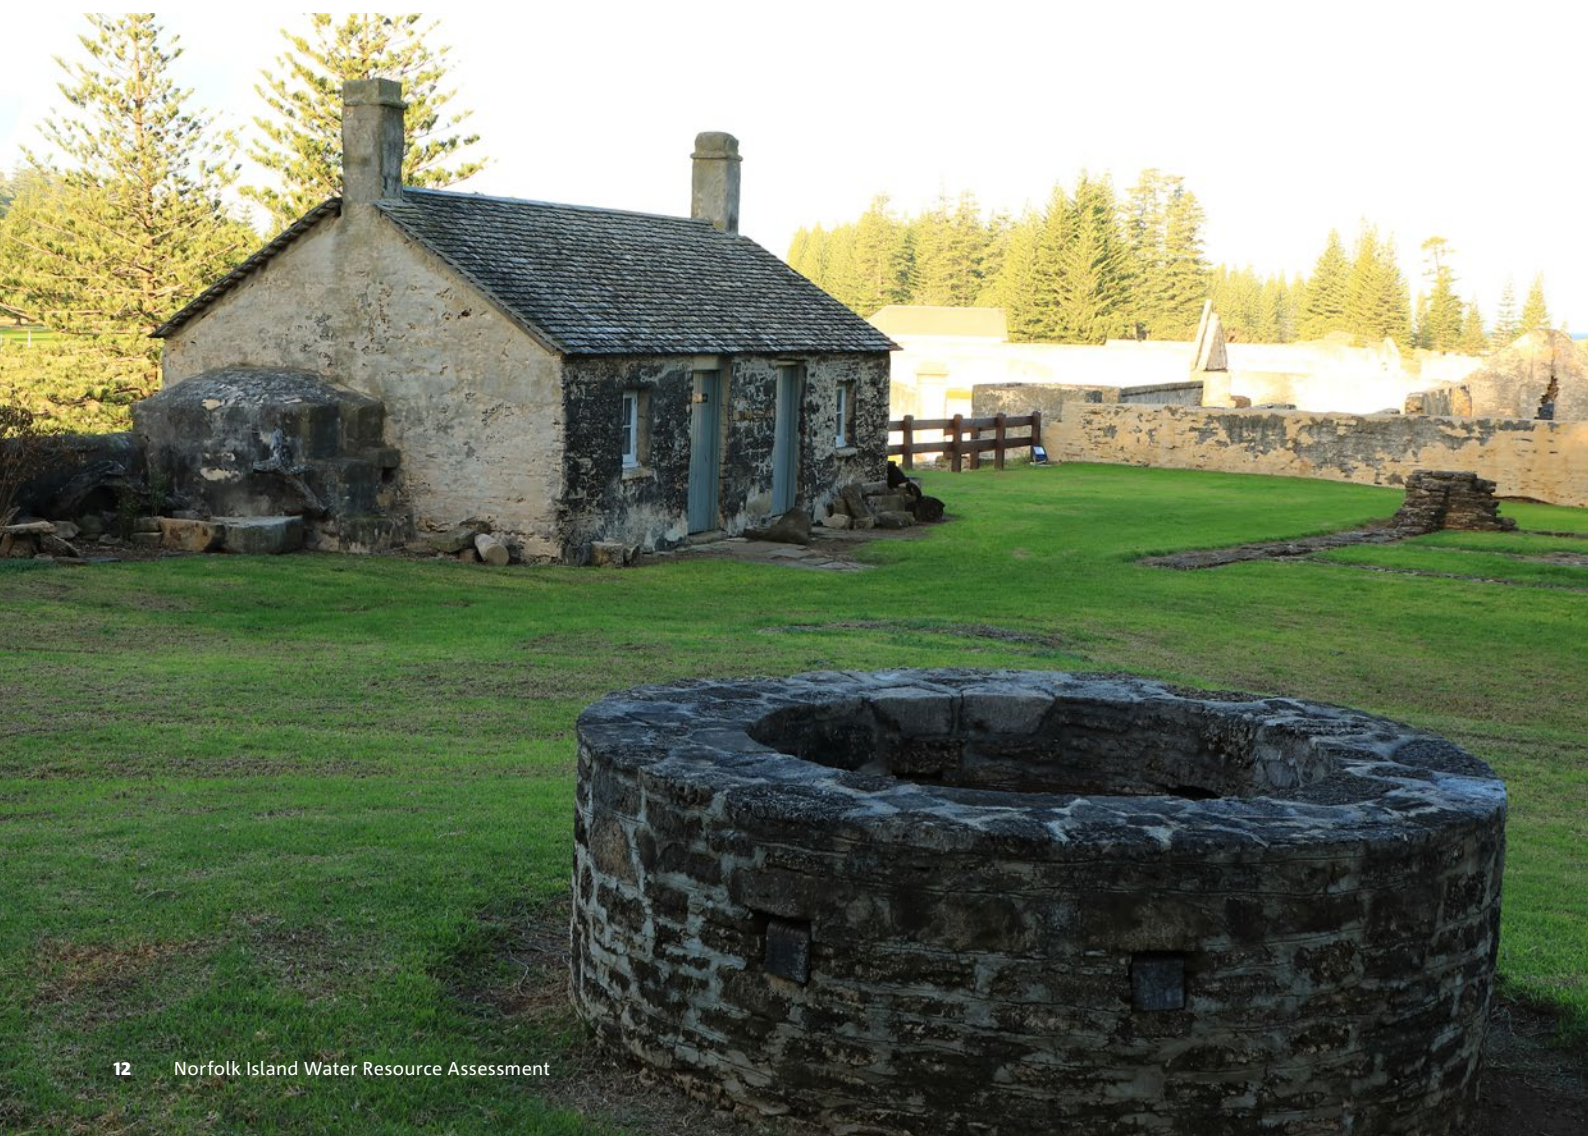
A convict built well and dwelling within the Kingston and Arthur's Vale Historic Area. The water level in 63 wells and bores were measured as part of the Assessment.

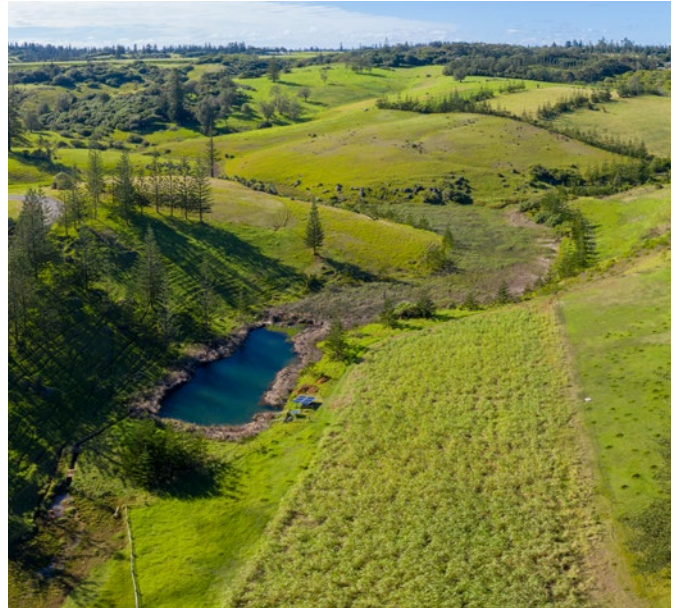
Headstone Dam, one of three community watering point on Norfolk Island. Acidic peat soils can be seen along the base of the creek.

The existing Headstone Dam has a number of defects including water seeping through the embankment foundation.

- Its reservoir retains water, despite not being lined, because it is situated on acid peat soils, which unlike much of the surrounding landscape are only moderately permeable.
- The development of a new dam at Headstone offers the opportunity of ensuring sound foundations. However, if the reservoir were to extend beyond the extent of the acid peat within the drainage line, the base of the reservoir would need to be lined. This would require the acid peat material to be excavated because it would not be able to hold the weight of the water above the lining.
- Excavated acid peat on Norfolk Island would need to be carefully transported, treated and continually managed to avoid potential impacts on human and animal health,

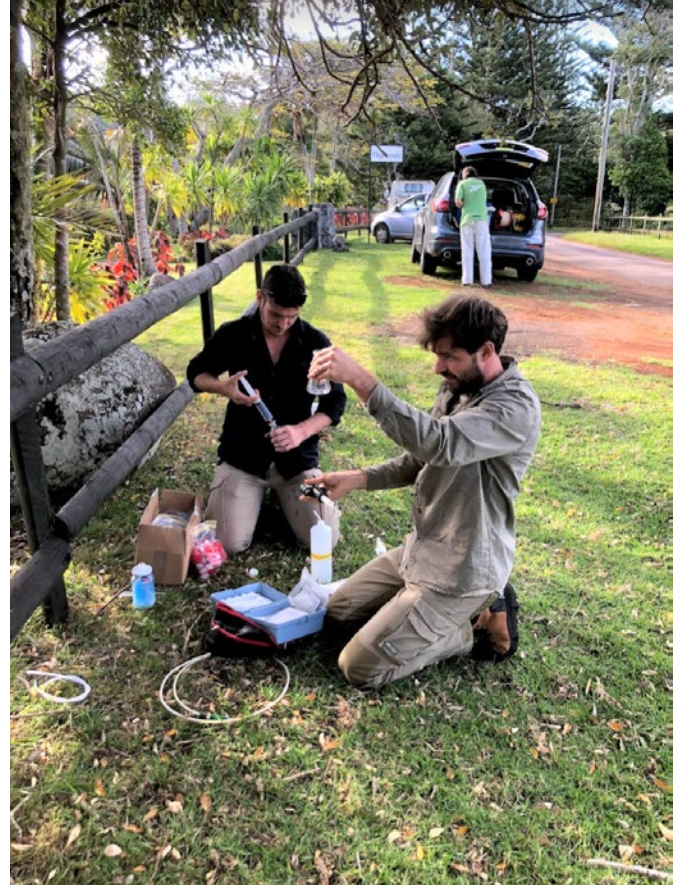
Field chemistry on Norfolk Island.

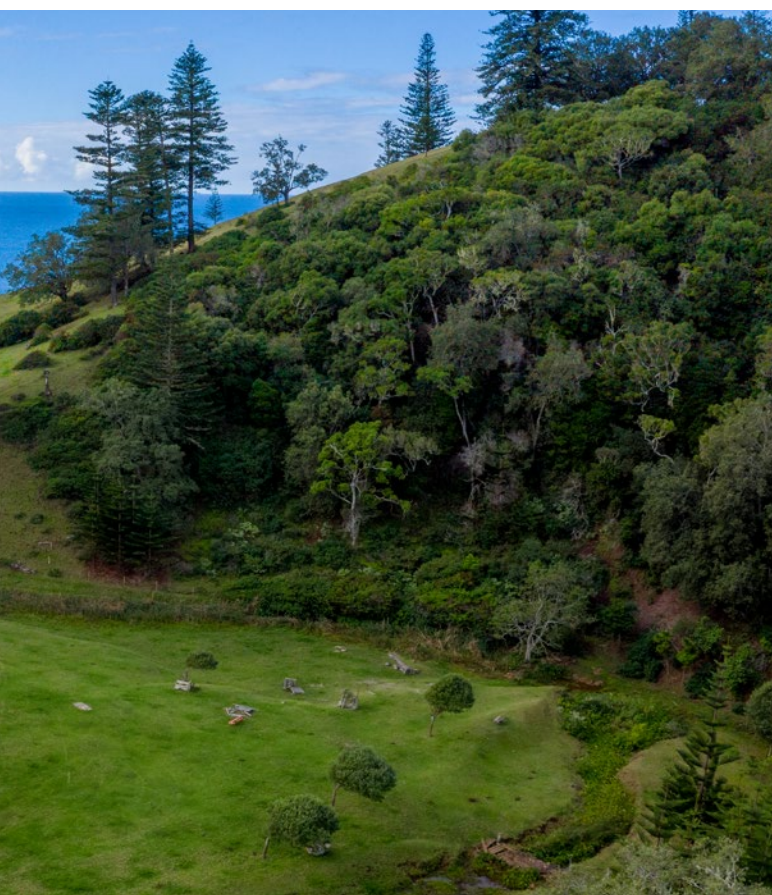
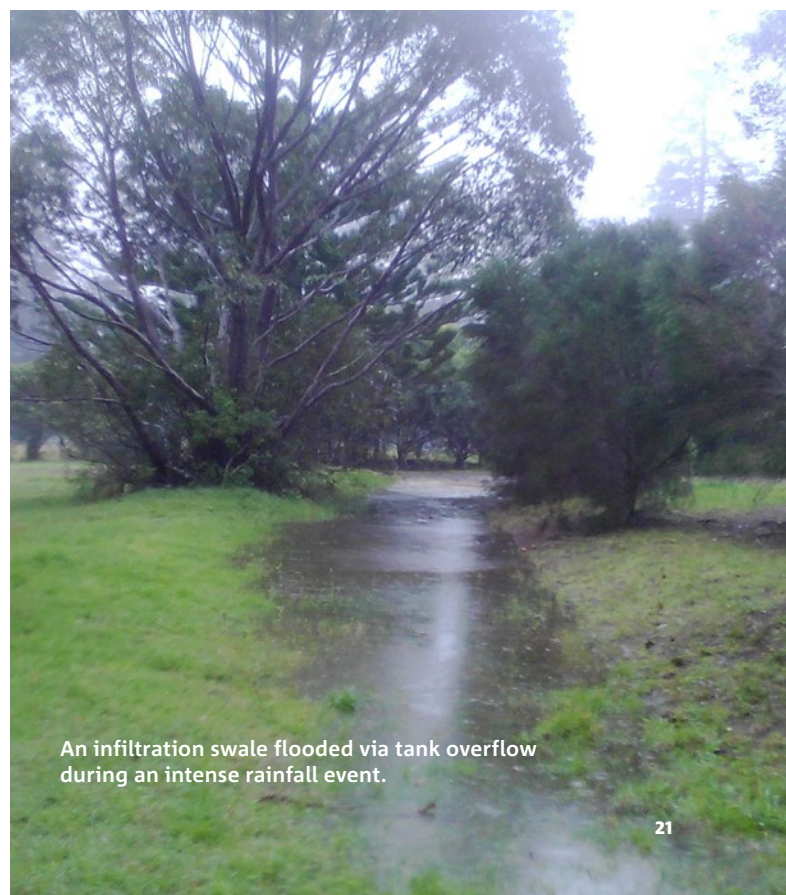
An infiltration swale flooded via tank overflow during an intense rainfall event.

- Swales can capture and infiltrate locally produced runoff from impermeable surfaces such as roads, roofs and overflowing rainwater tanks. In addition to providing local benefits in terms of increasing soil water and localised recharge, they can arrest flow to protect against soil erosion, be used to convey water and treat the quality of water.

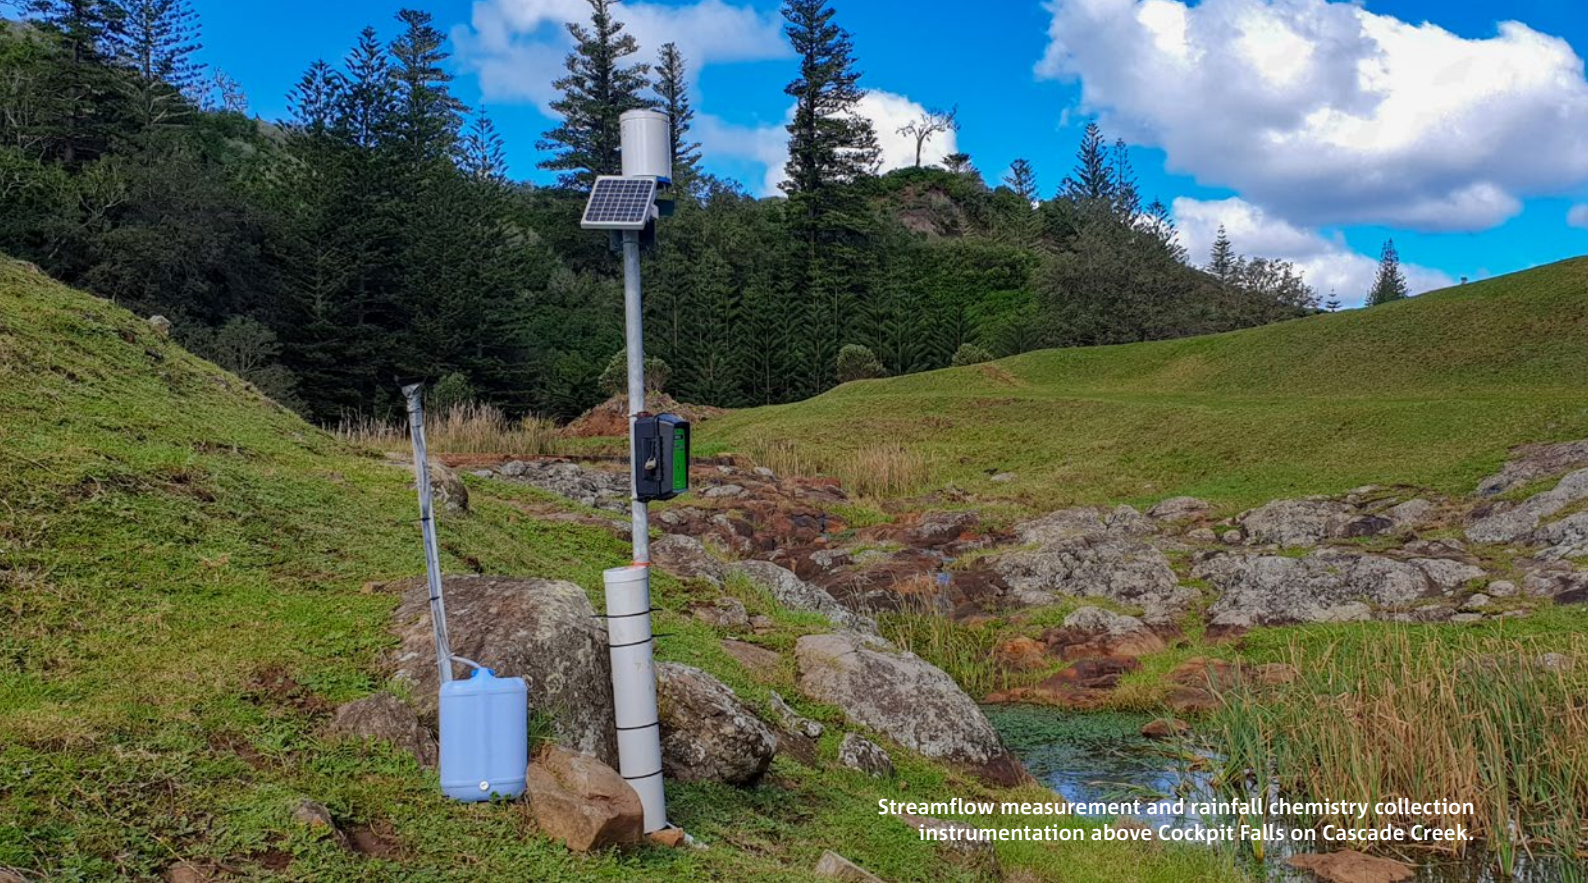
Streamflow measurement and rainfall chemistry collection instrumentation above Cockpit Falls on Cascade Creek.
