# Christian's Minde Settlement, Jervis Bay Territory

Historic Heritage Management Plan—Volume 2 Inventories

June 2025

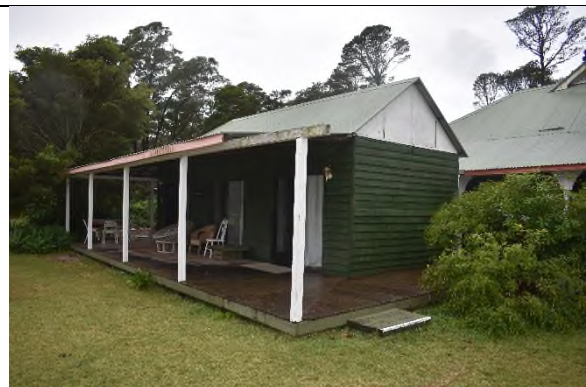
Figure 48 Northern annexe with unfinished verandah frame.

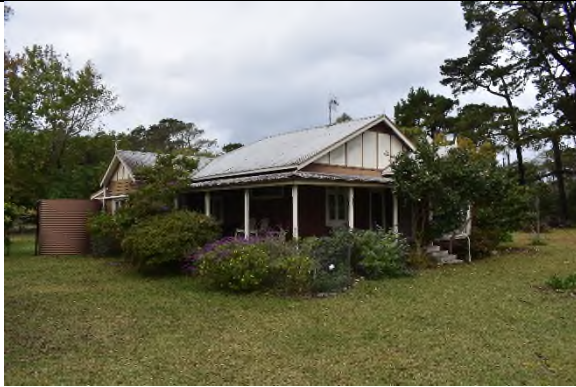
- the main chimney breast requires repointing;
- the main chimney leaks in heavy rain events;
- some areas with bouncy floors, suggesting decaying piers; and
- the external northwestern corner of the roof leaks onto the timber verandah, causing damage to the timber.

Figure 72 Northwestern corner of Ardath Cottage.

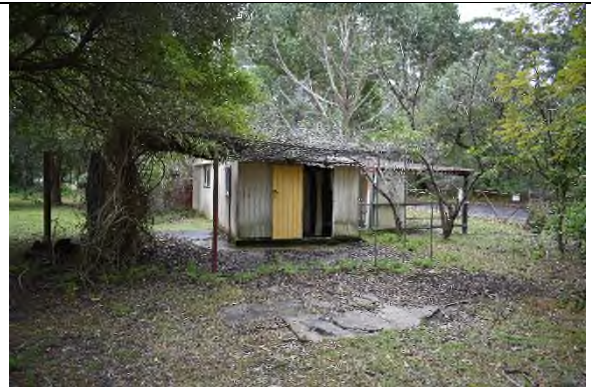
Figure 99 P2—laundry.

- The shed should be stabilised and managed to prevent further deterioration.
- The laundry (P2) could be removed.
- Consider removing the intrusive window from the rear gable.

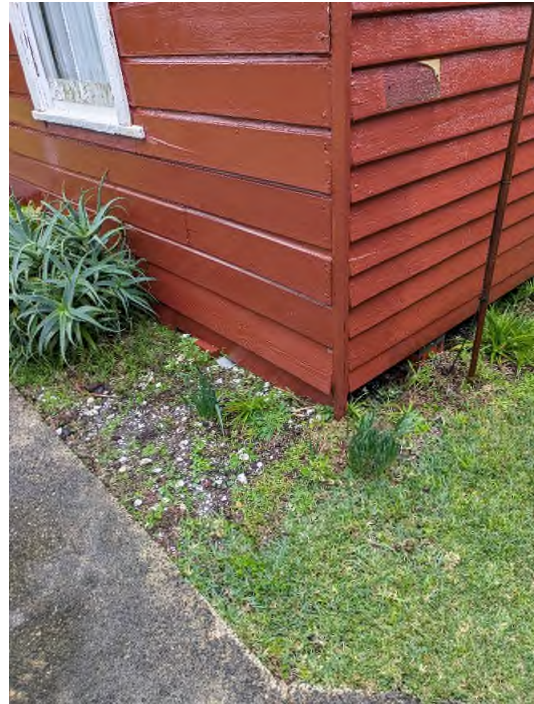
Figure 116 Shell midden under the southwestern corner of the building.

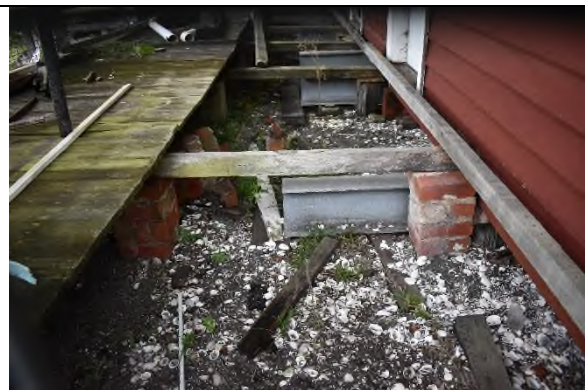
Figure 142 Midden, visible under verandah.

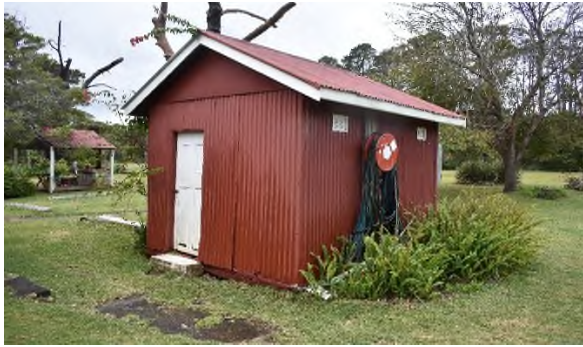
These structures are in varying condition. CM6 and CM11 are in good condition, CM8, CM9 and CM10 appear to be in fair condition, CM7 has collapsed and now only remnants of the boathouse foundations remain. The ad hoc structures are in good condition.

Figure 162 CM8—pumphouse.

| <b>CM8—<br/>Outbuilding<br/>(pumphouse)</b><br><br><b>CM9—Garage<br/>and shed</b><br><br><b>CM10—<br/>Firefighting<br/>garage</b> | These outbuildings should be maintained in a useable condition and to a standard that does not impact upon the heritage values of the site. Refer to Section 2 for general conservation guidelines on maintenance of these structures. | Whole structures | Routine |

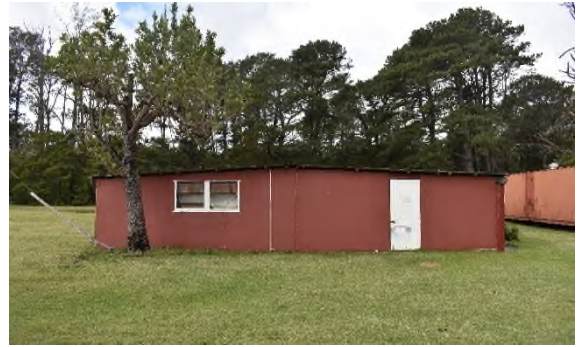
Figure 163 CM9—garage and shed.

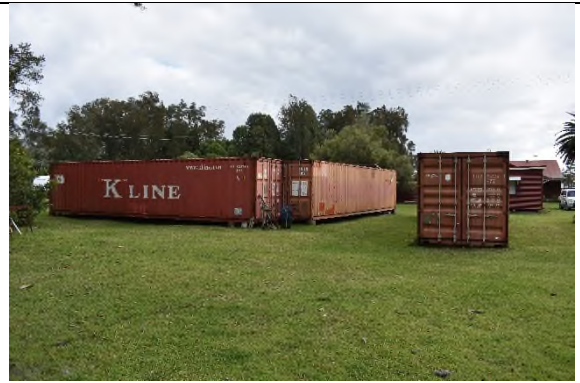
Figure 165 Ad hoc shipping containers (CM9a). These should be removed.

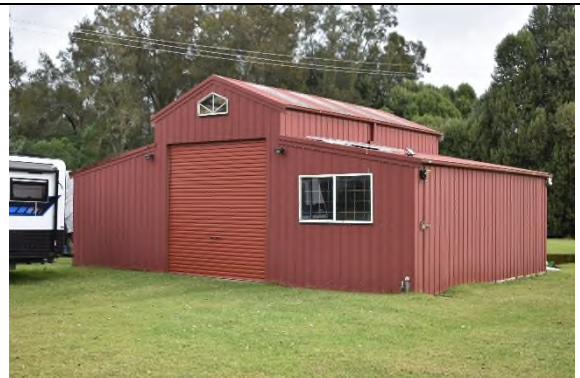
Figure 167 CM10—fire-fighting garage.

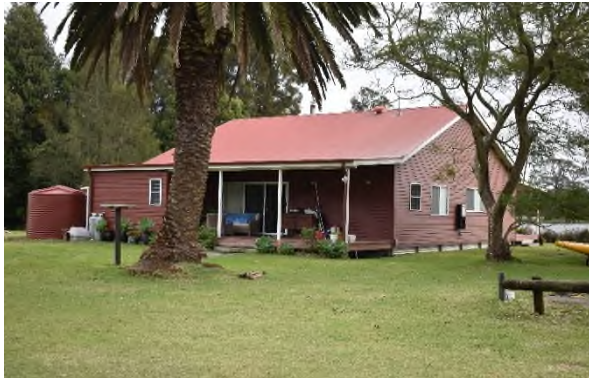
Figure 168 CM11 viewed from northeast.

Figure 169 CM11 viewed from south.

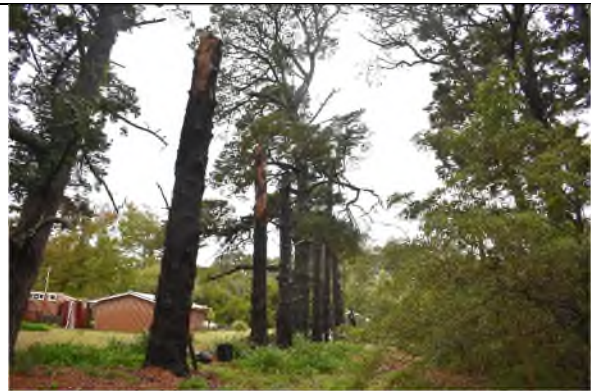
Figure 178 CP2 group of pines to the south of Ardath. Note the lopping of some trees.

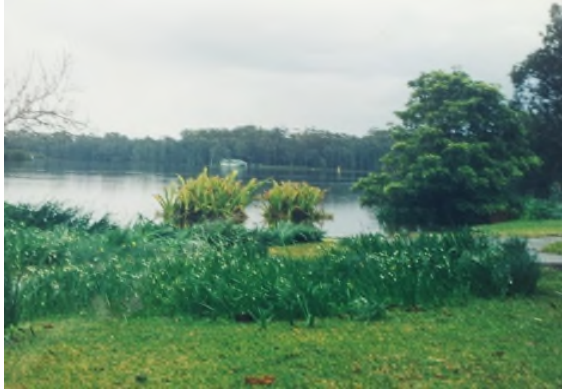
The bulb field (CP4) has been damaged by lawn mowing but the bulbs still appear according to the current lessees. They were not visible at the time of GML's inspection in 2025.

Figure 181 Photo of bulbs growing on foreshore c2002. (Source: Peter and Pam Ellmoos collection)

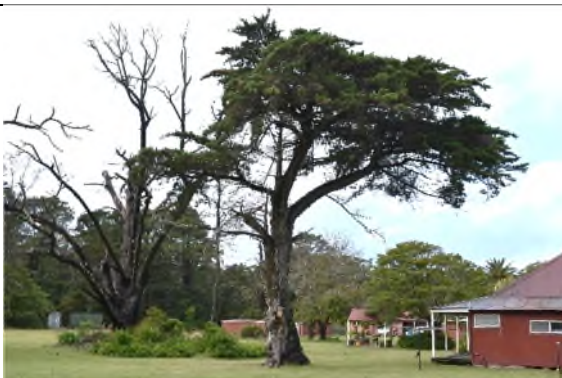
Similarly, the cypress behind Building CM1 of Block 14 (CP7) is senescent, with almost 30% of the trunk and canopy dead. The Canary Island Date Palms (CP8) are in good condition. The European olive (CP9) is still youthful by that species' standards. CP15 is directly on the riverbank in a precarious position, and may fall in the future as the riverbank continues to erode.

Figure 185 CP7 Monterey cypress on Block 14.

There may be the opportunity to replace senescing trees (e.g. pines) with new plantings with similar characteristics, taking into account the site's location adjacent to Booderee National Park and changing climatic conditions. Suitable species for replanting would need to be identified through a tree replacement strategy.

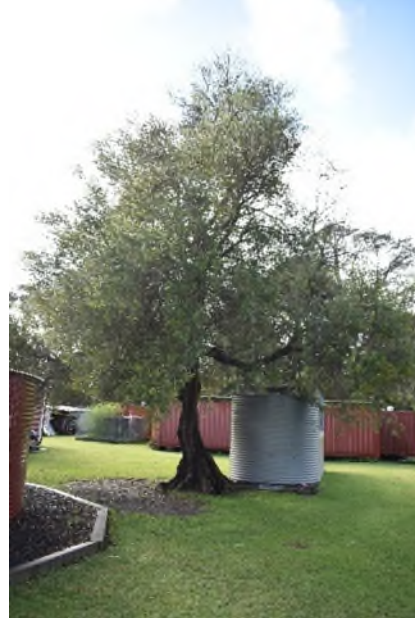
Figure 188 CP9 olive tree south of CM5.
