## CASE SUMMARIES

RS 01 - RS 80

N.H.&amp;M.R.C. Road Accident Research Unit

Road Accident Study 1996-97

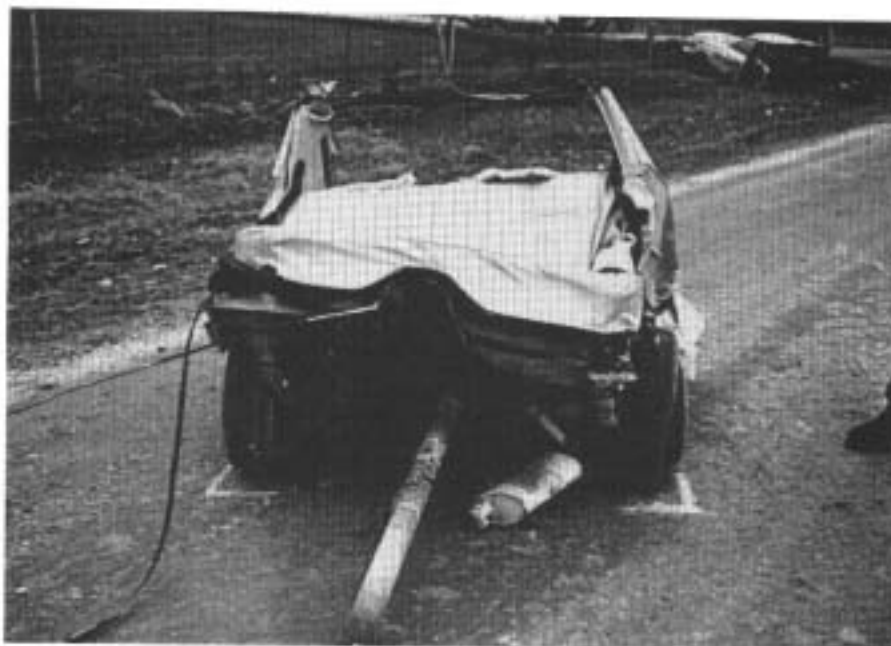
FIGURE A1: Crash 01. Detached rear section of Datsun 120Y Sedan with front section and Unit 1 visible in background.

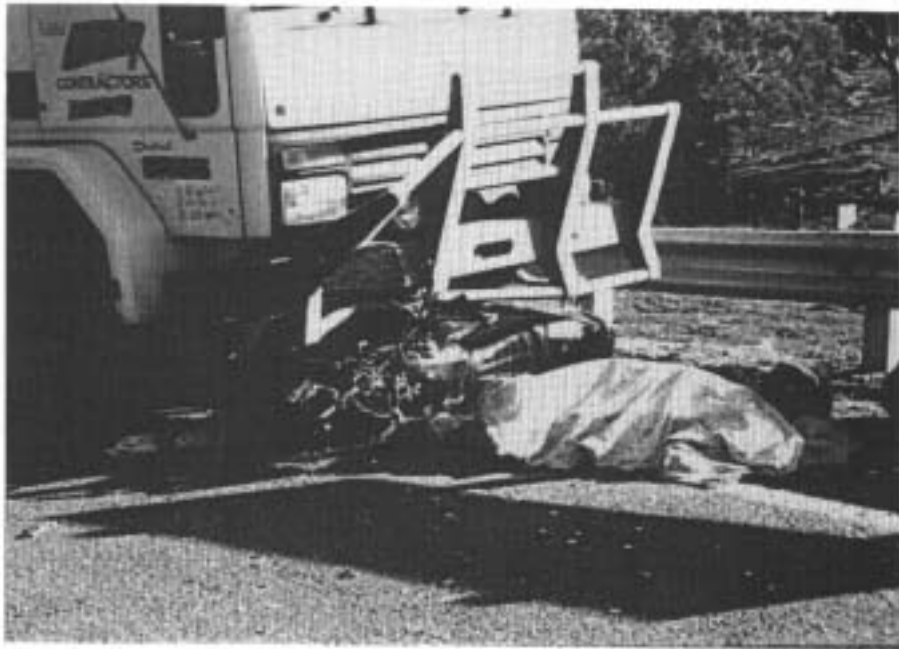
FIGURE A5: Crash 05. Final positions of motorcycle and dump truck. The motorcycle came to rest wedged under the front of the dump truck.

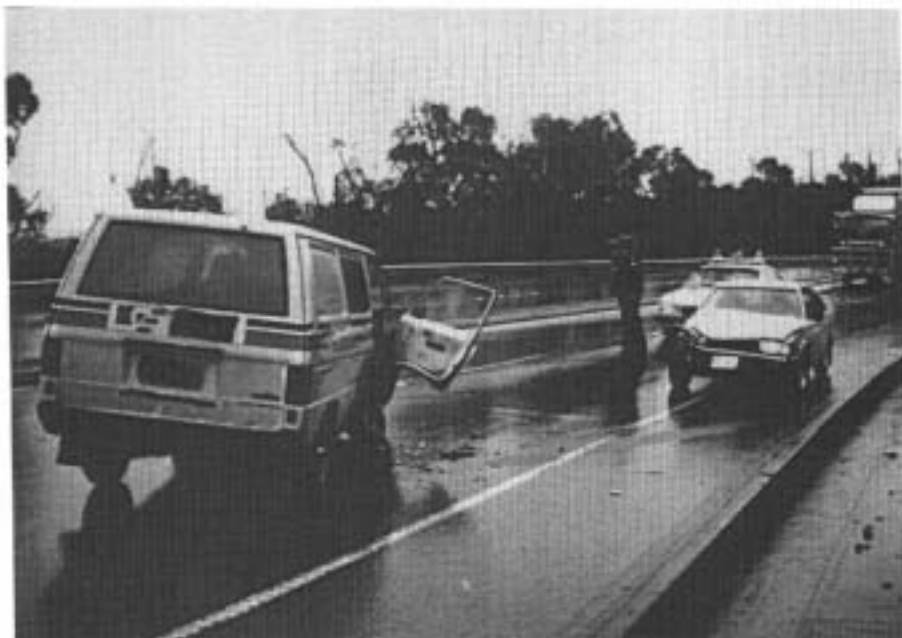
FIGURE A13: Crash 13. Final positions of forward control van and Honda Accord.

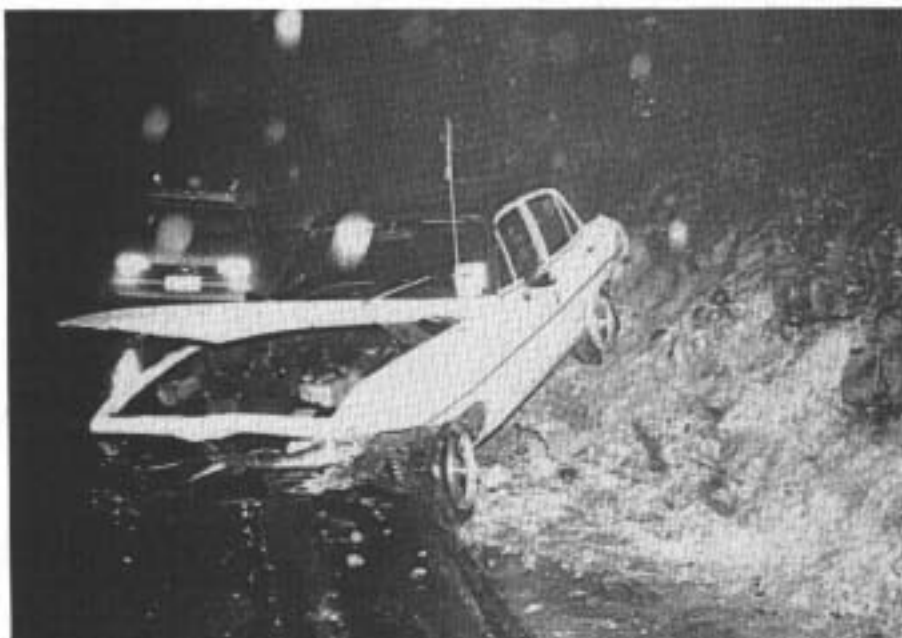
FIGURE A14: Crash 14. Final position of Holden Torana.

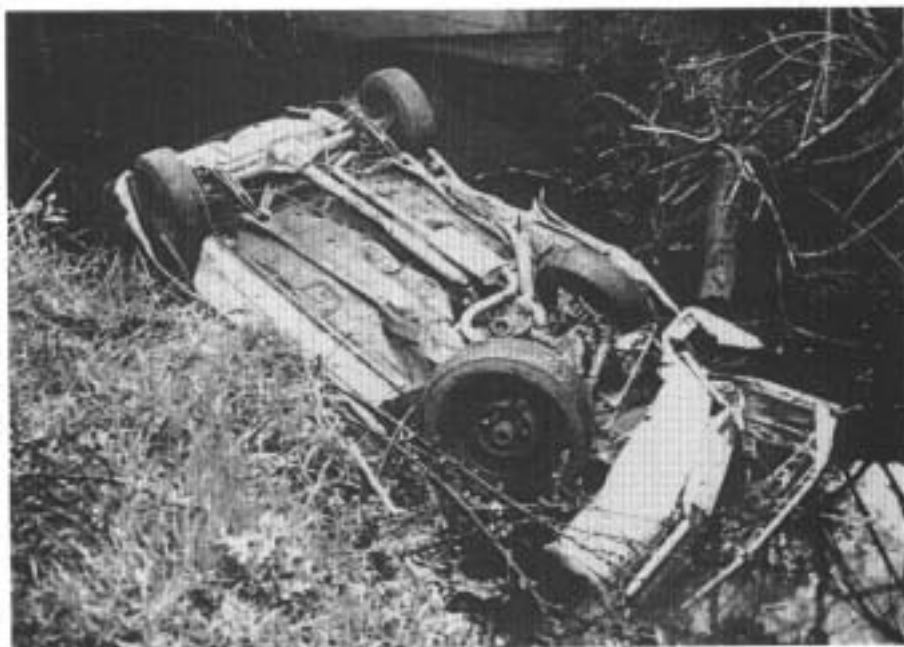
FIGURE A23: Crash 23. The final position of the car on its roof in a stream.

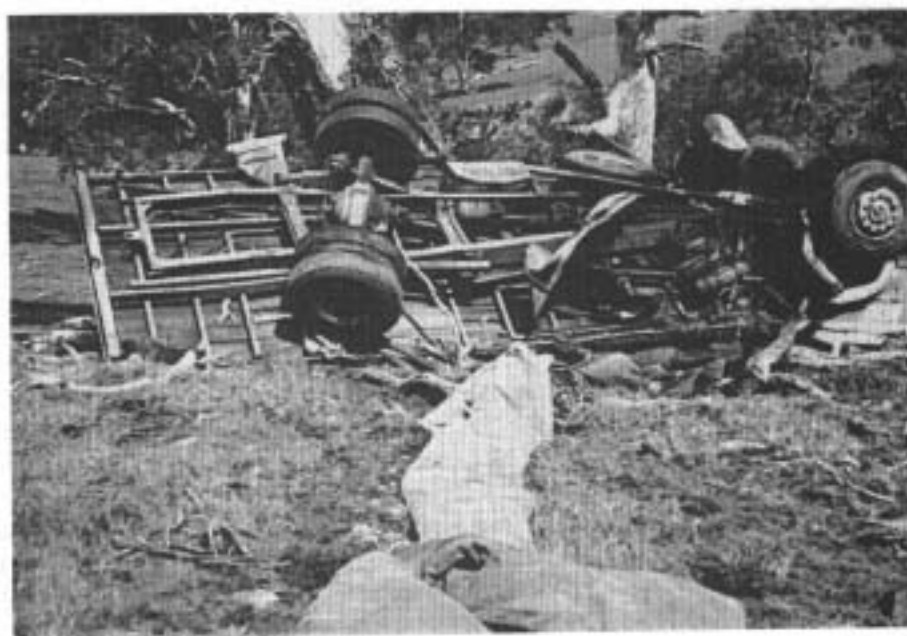
FIGURE A24: Crash 24. The final position of the tray top truck which came to rest against a large tree, after rolling down a steep hill.

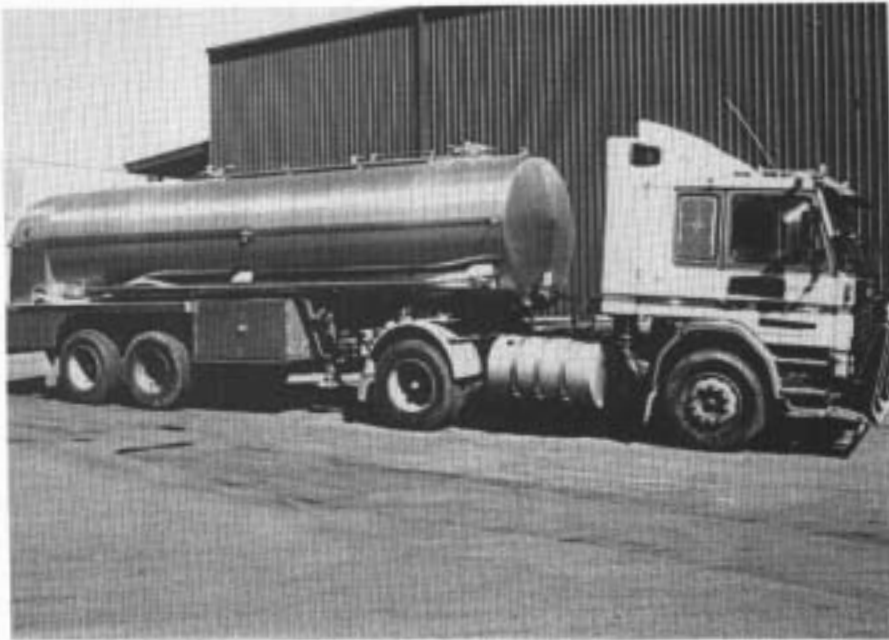
FIGURE A29: Crash 27. Milk tanker struck in front of right rear wheels by a car.

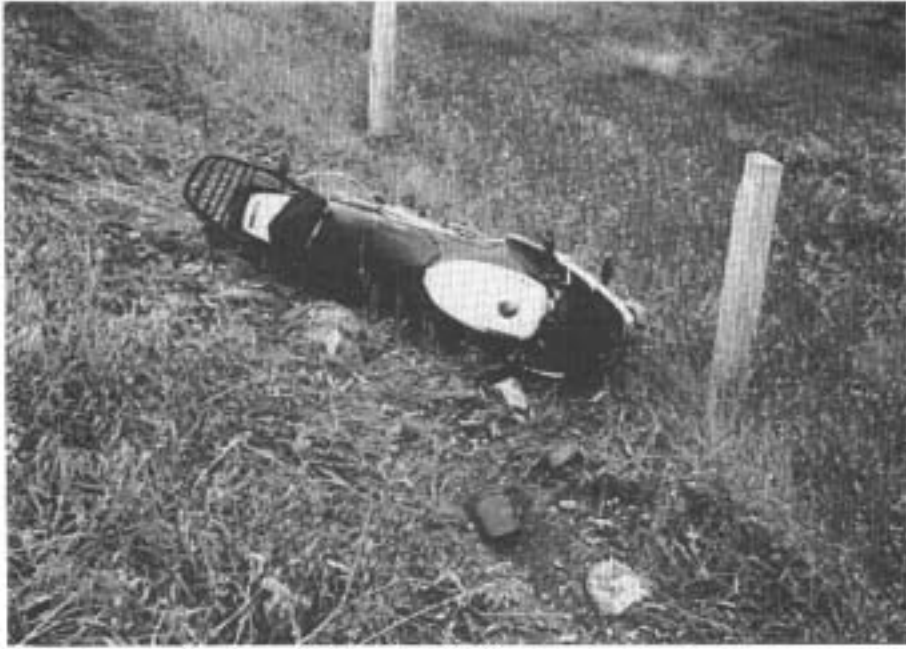
FIGURE A33: Crash 30. Final position of the motorcycle.

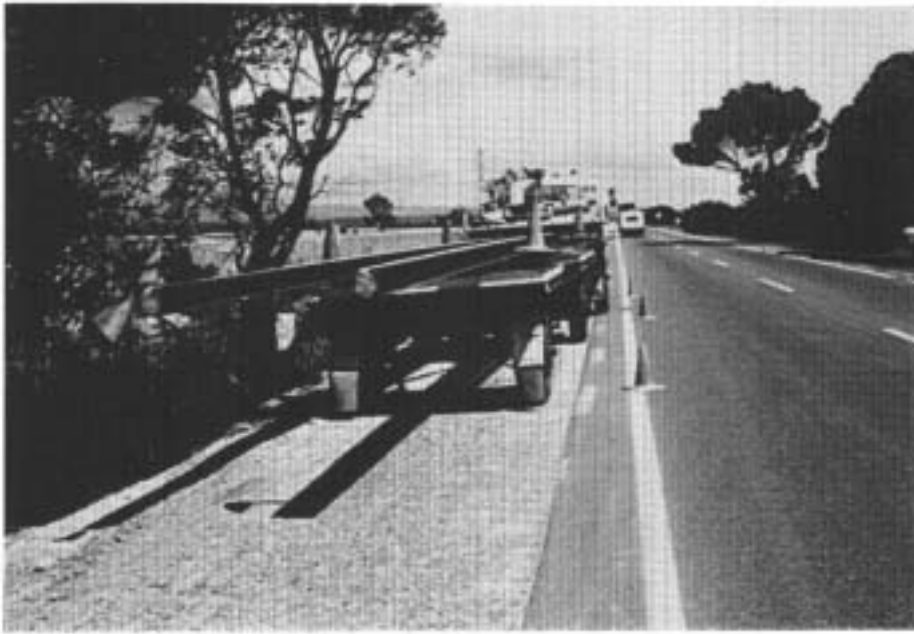
FIGURE A37: Crash 33. Tray top truck. Note poles protruding from rear of trailer.

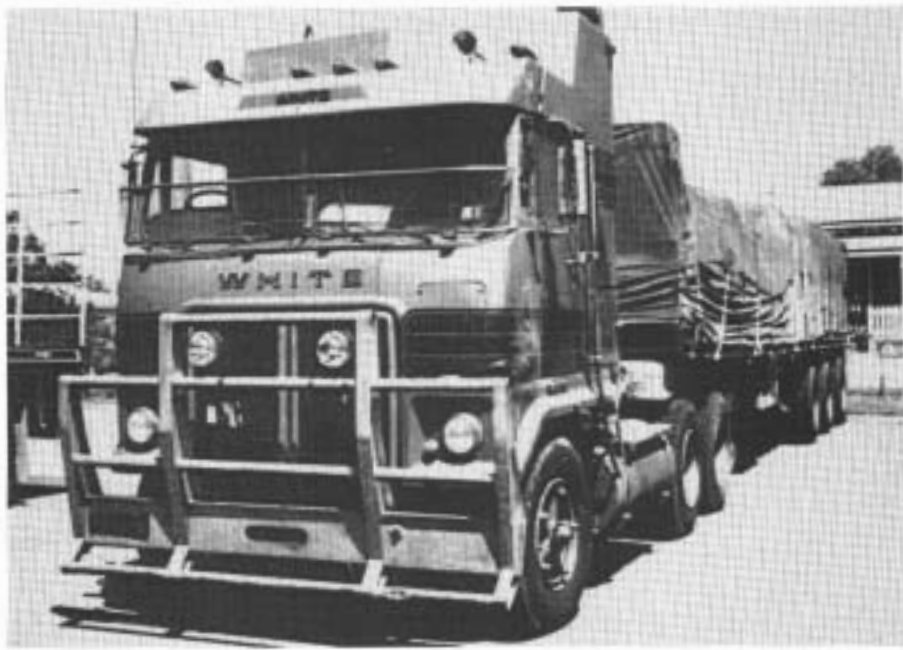
FIGURE A39: Crash 34. Laden semi-trailer which struck rear of bicycle.

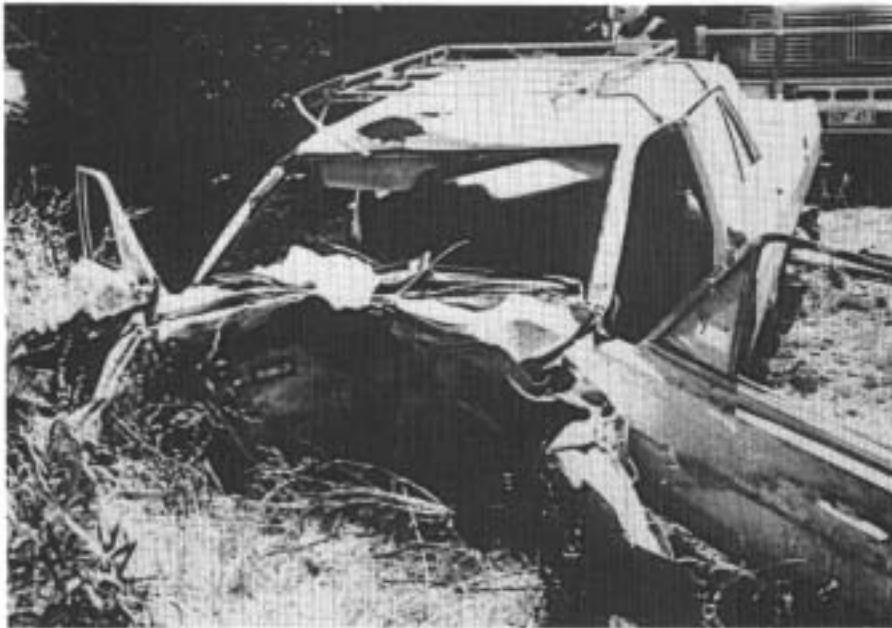
FIGURE A41: Crash 36. The passenger compartment of the car in its final position. The engine compartment, which separated in the second impact with a tree, came to rest in the trees behind the passenger compartment.
